Inspection Photos

Operator: CAERUS WASHCO LLC - 86610

Location ID: 335016

Inspection Doc: 718100722

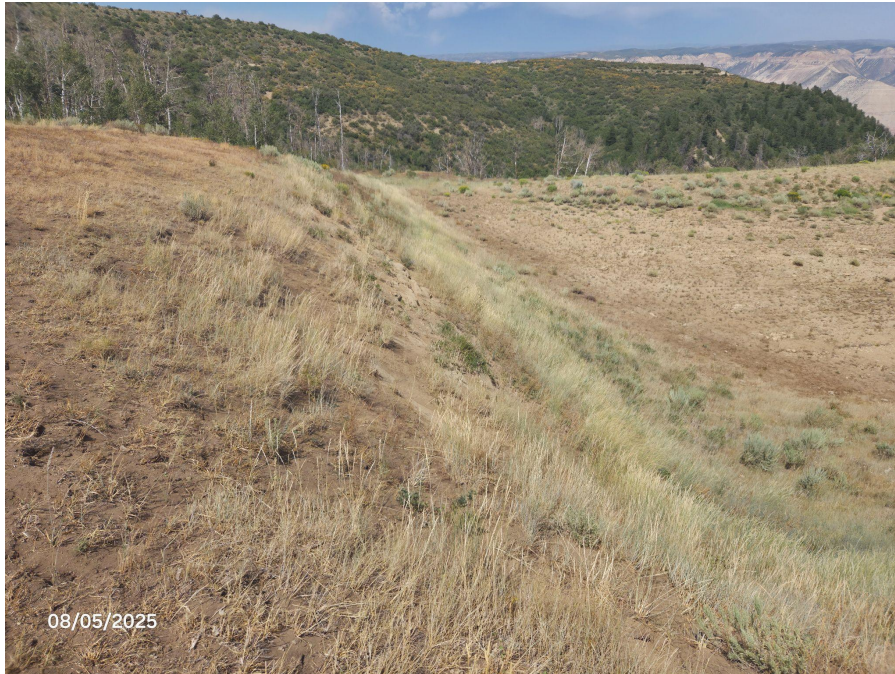
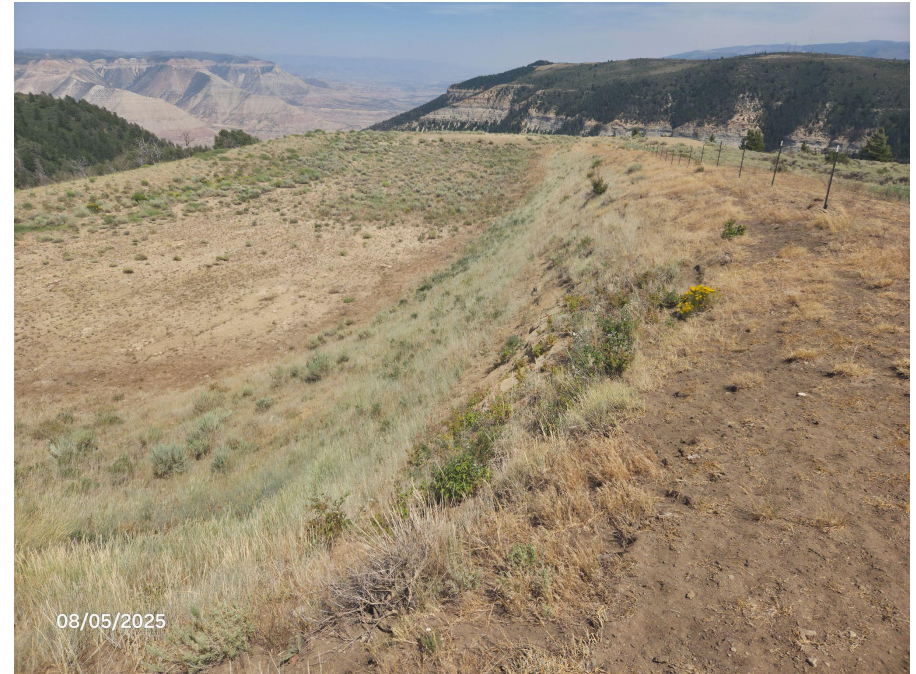
Photo 1: Photos taken from the southwest corner of the Location, facing north and east. Photos examples showing Location has not met ECMC 1003.c.(2) desirable vegetative cover requirements.

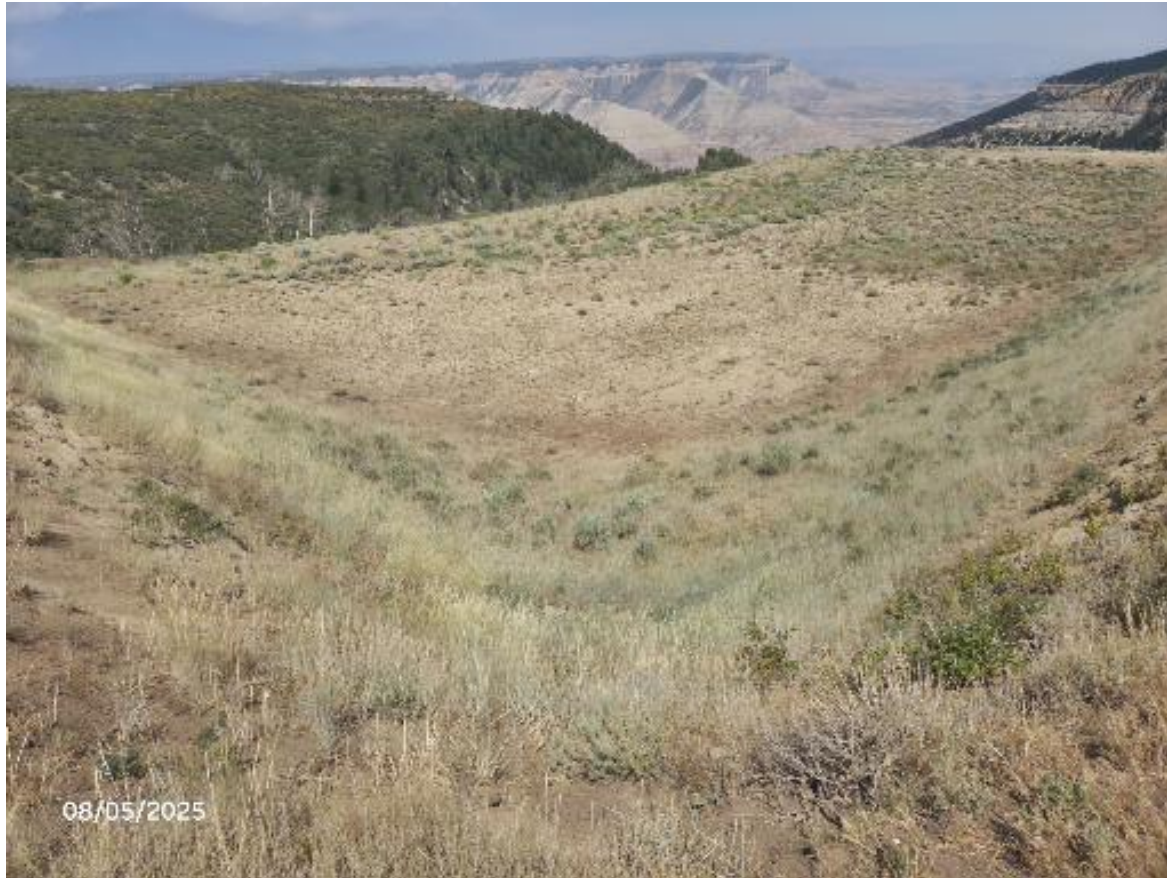
Photo 2: Photo taken from the southwest corner of the Location, facing northeast. See comments under photo 1.

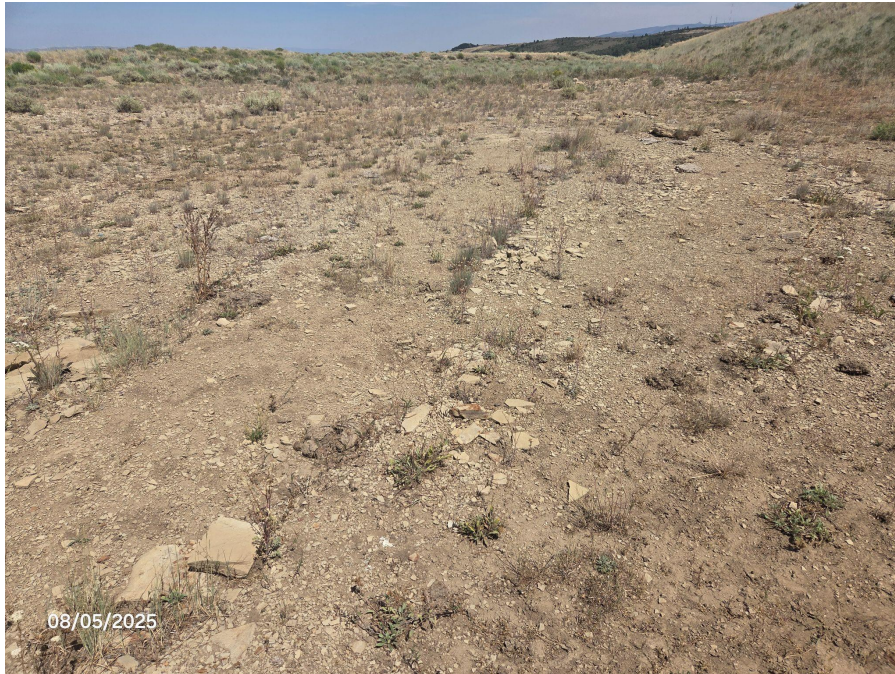
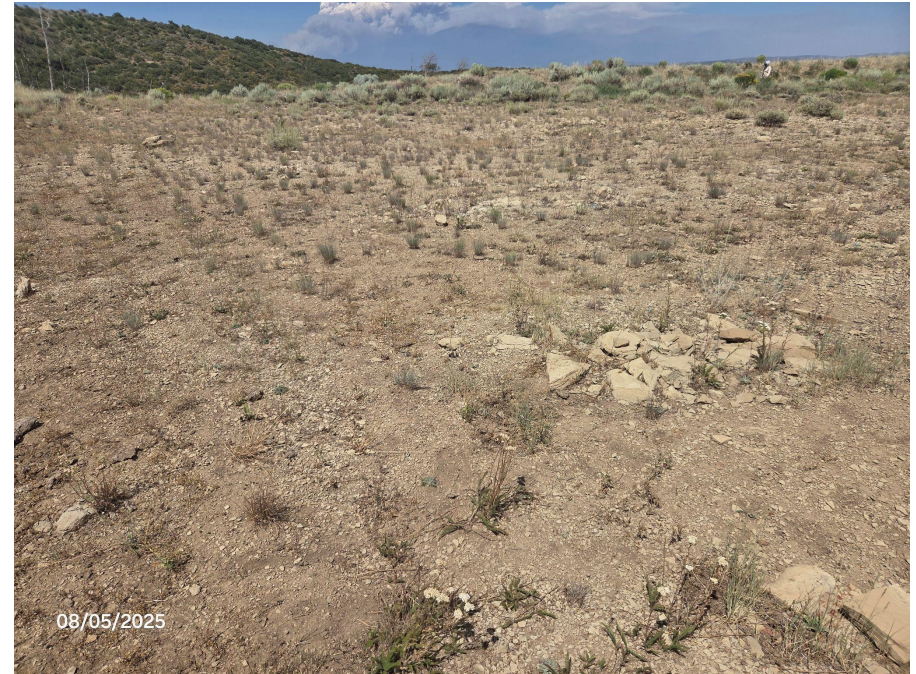
Photo 3: Photos taken from the southwest corner of the former pad area, facing east and north. Photos examples showing Location has not met ECMC 1003.c.(2) desirable vegetative cover requirements.

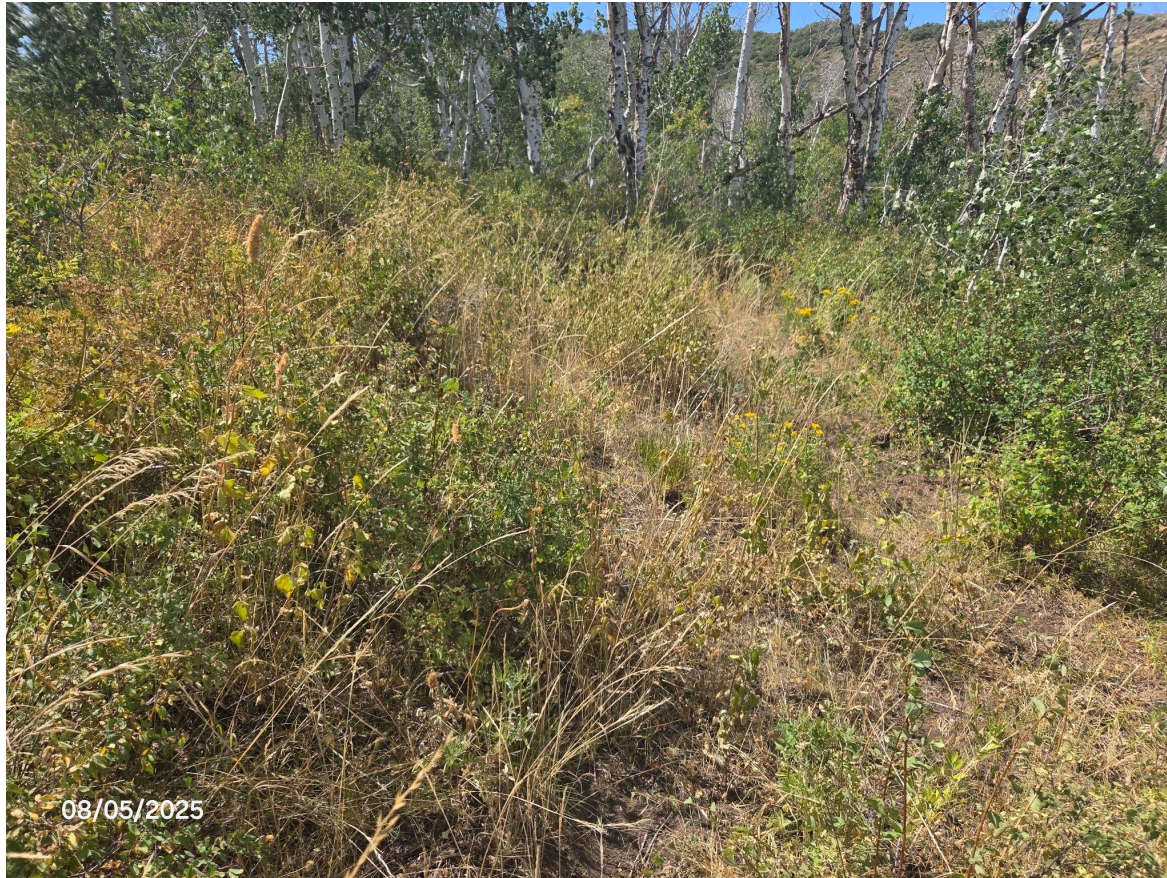
Photo 4: Photos taken from the adjacent reference for comparison; Location has not met ECMC 1003.c.(2) 80% desirable vegetative cover requirements to that of the adjacent reference areas.
