Noble Energy, Inc. – 100322 – DJ Basin
Lilli Unit N-5 Facility
 SESW, Section 5, Township 8 North, Range 58 West
 Weld County, Colorado

Excavation Soil Sample Location Map - Sidewalls
 (12/06/2024 – 04/08/2025)

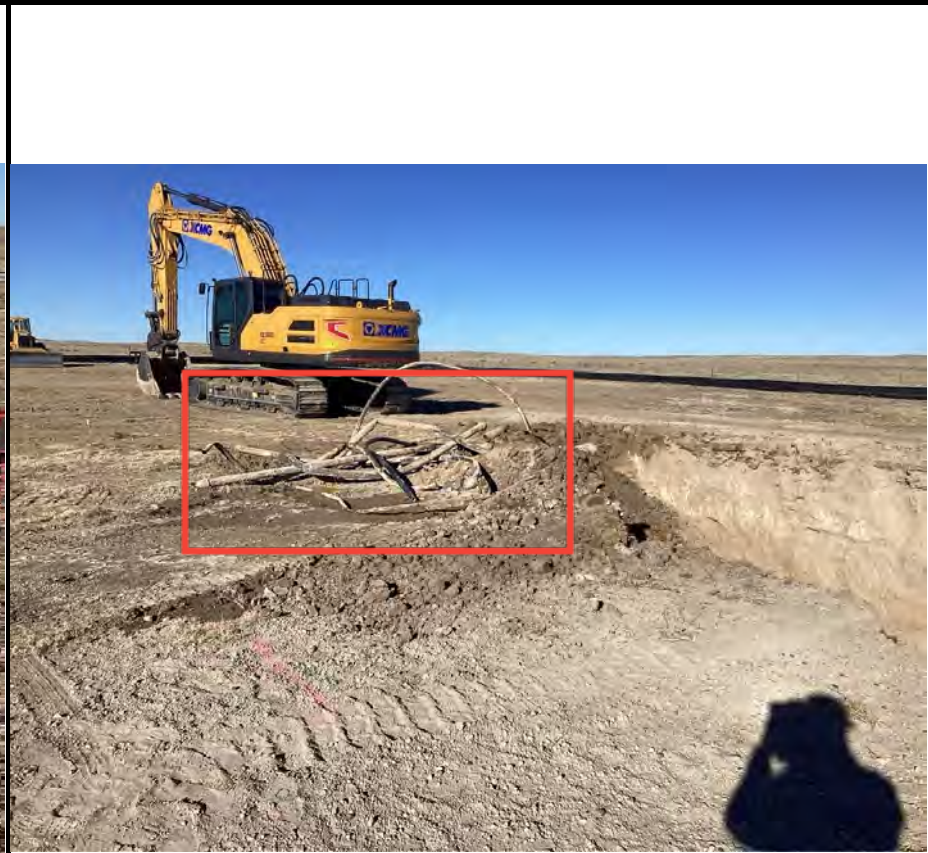
Equipment ID: HYDROVAC holes		Equipment Type:	
Material:	Volume:	Contents:	
Notes/Conditions:

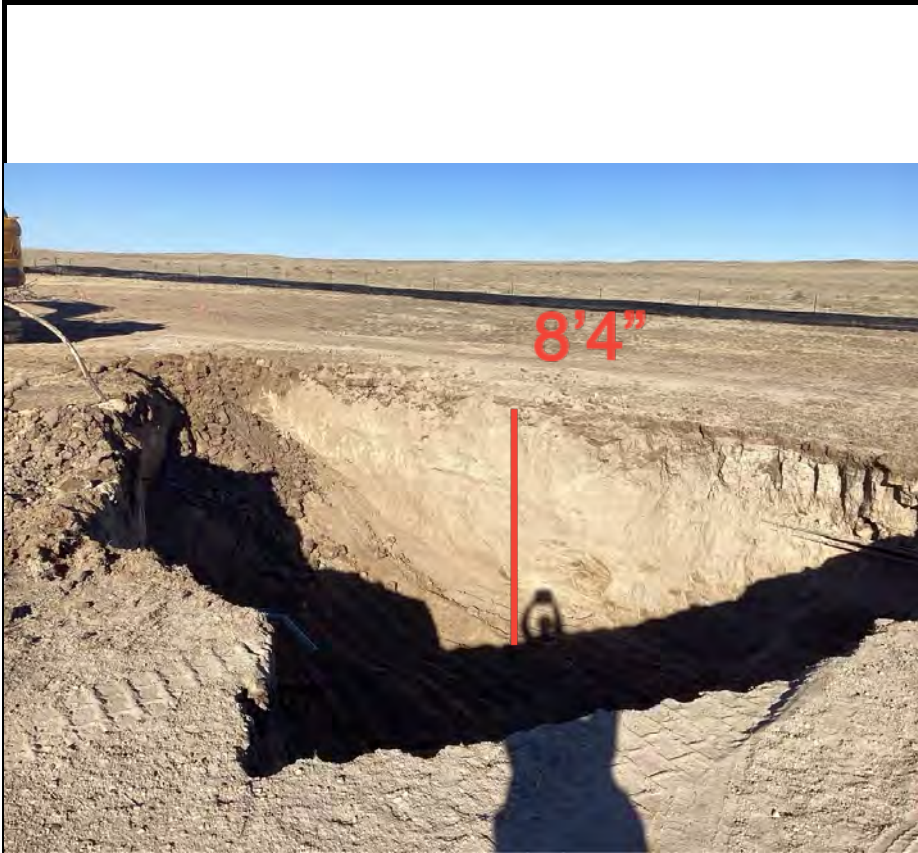
Equipment ID: After first load		Equipment Type:	
Material:	Volume:	Contents:	
Notes/Conditions:

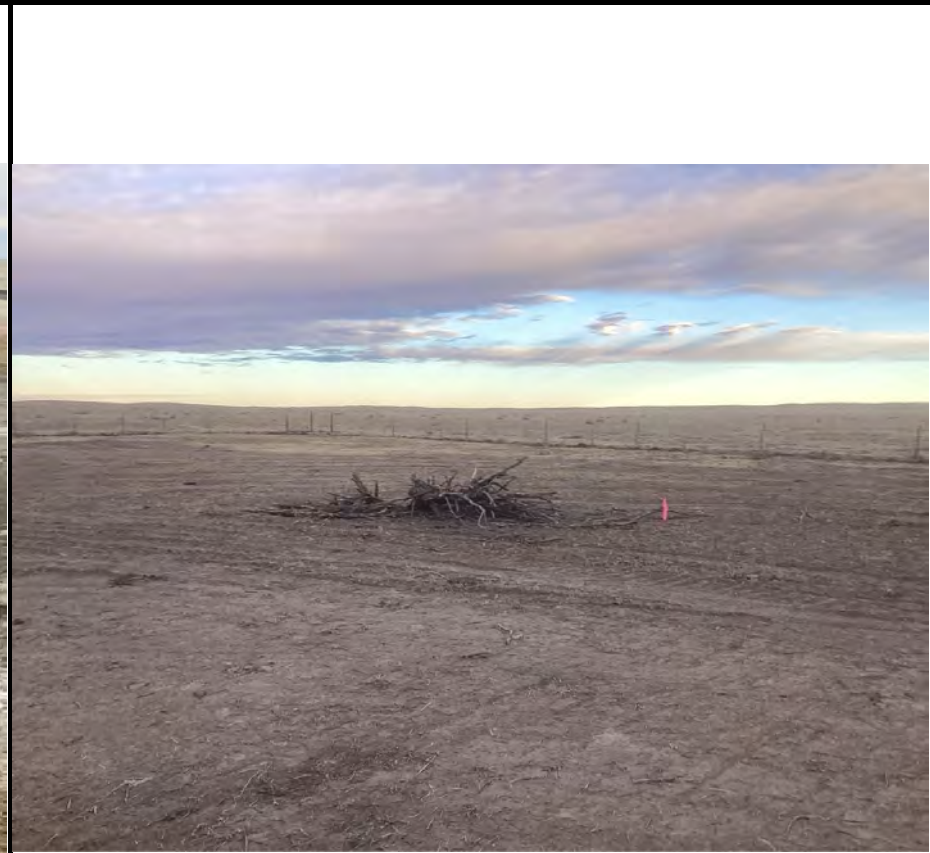
Equipment ID:		Equipment Type:	
Material:	Volume:	Contents:	
Notes/Conditions: Excavating at the start of day

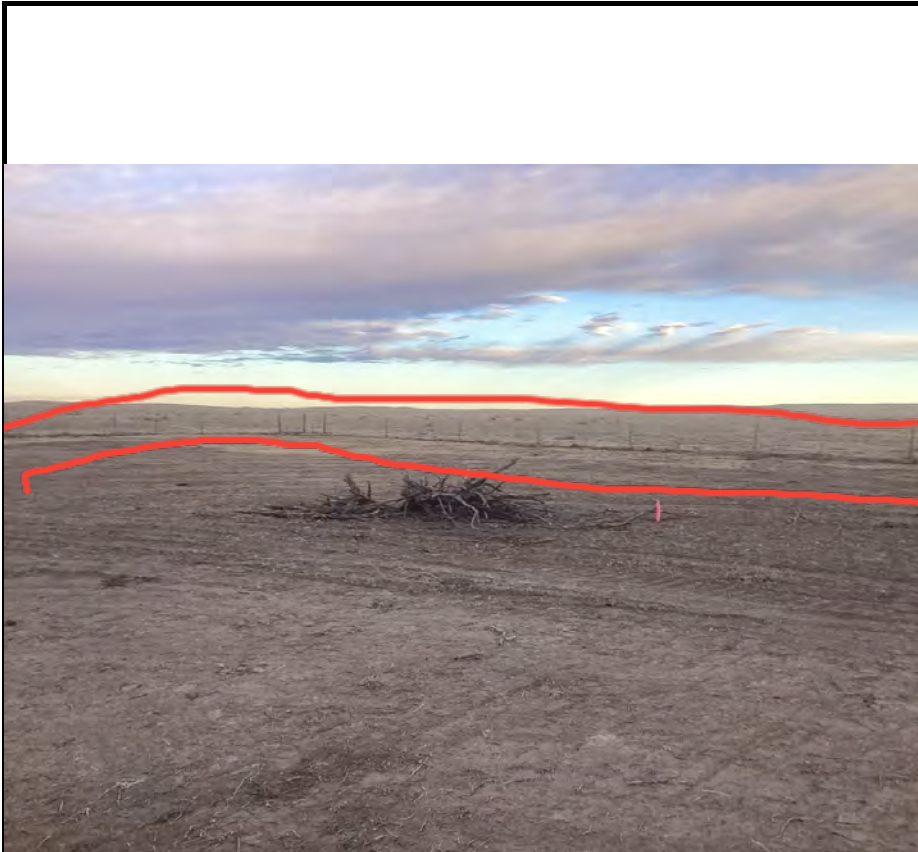
Equipment ID:		Equipment Type:	
Material:	Volume:	Contents:	
Notes/Conditions: Missing silt fence

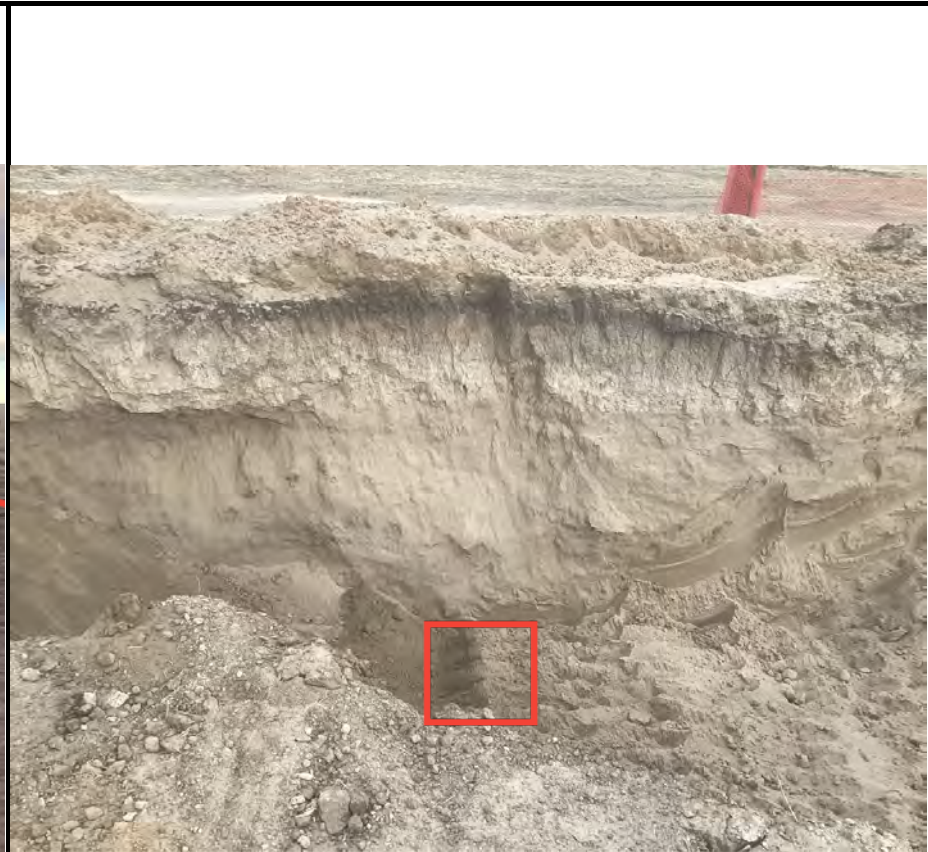
Equipment ID: SS03@10'		Equipment Type:	
Material:	Volume:	Contents:	
Notes/Conditions: Facing north

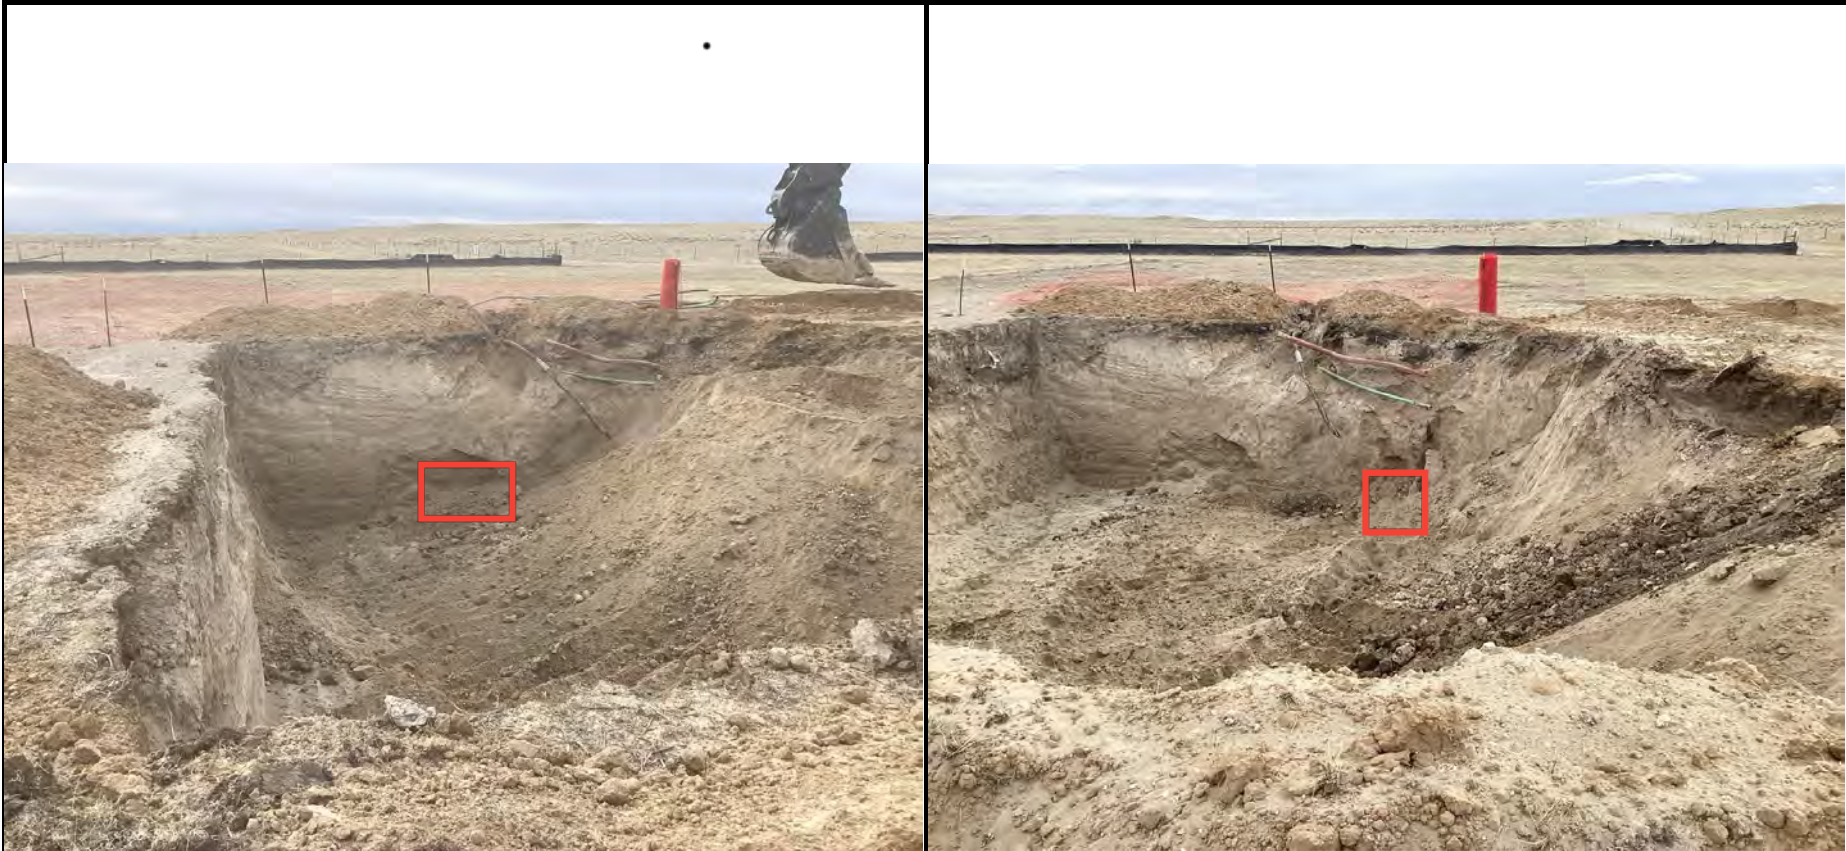
Equipment ID: SS04@10'	Equipment Type:	
Material:	Volume:	Contents:

Notes/Conditions: Facing south

Equipment ID: SS05@10'	Equipment Type:	
Material:	Volume:	Contents:

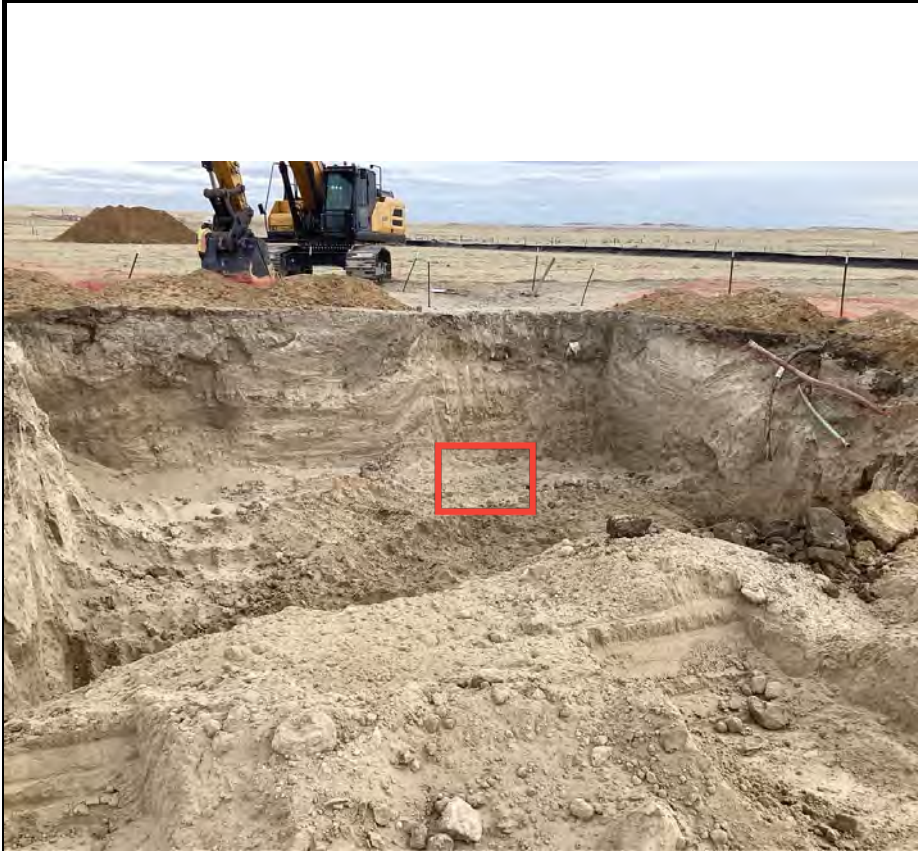
Equipment ID:SS06@10'

Equipment Type:
Material:
Volume:
Contents:
Notes/Conditions: Facing east

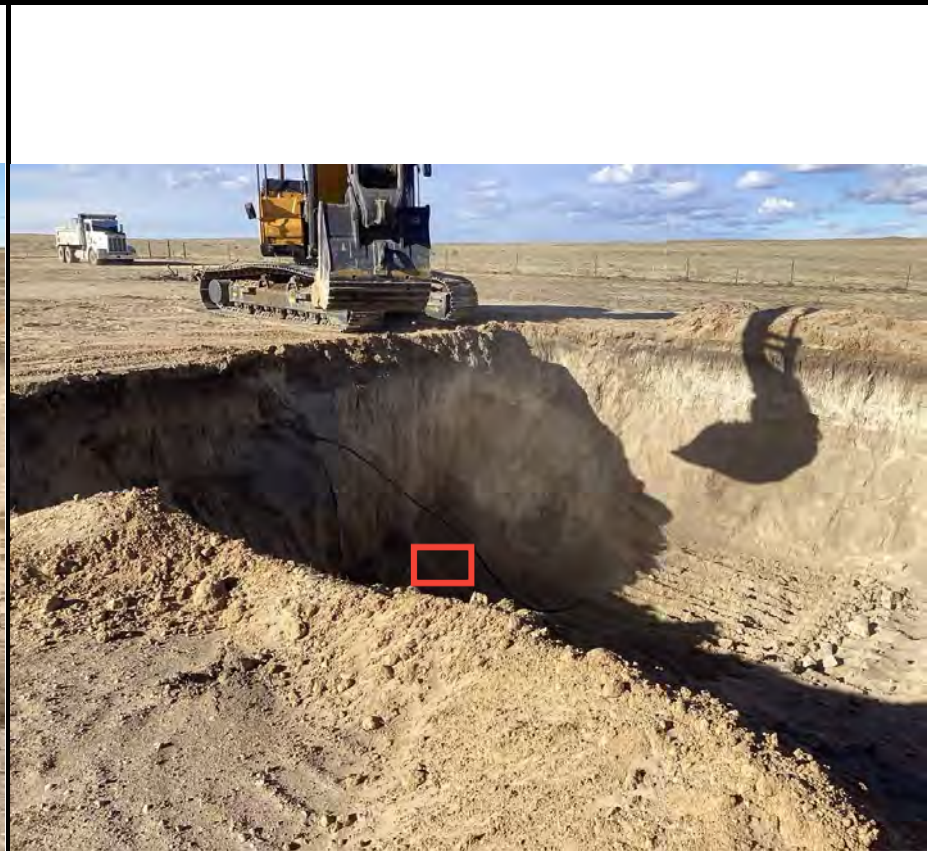
Equipment ID: SS07@10'		Equipment Type:	
Material:	Volume:	Contents:	
Notes/Conditions: FACING WEST

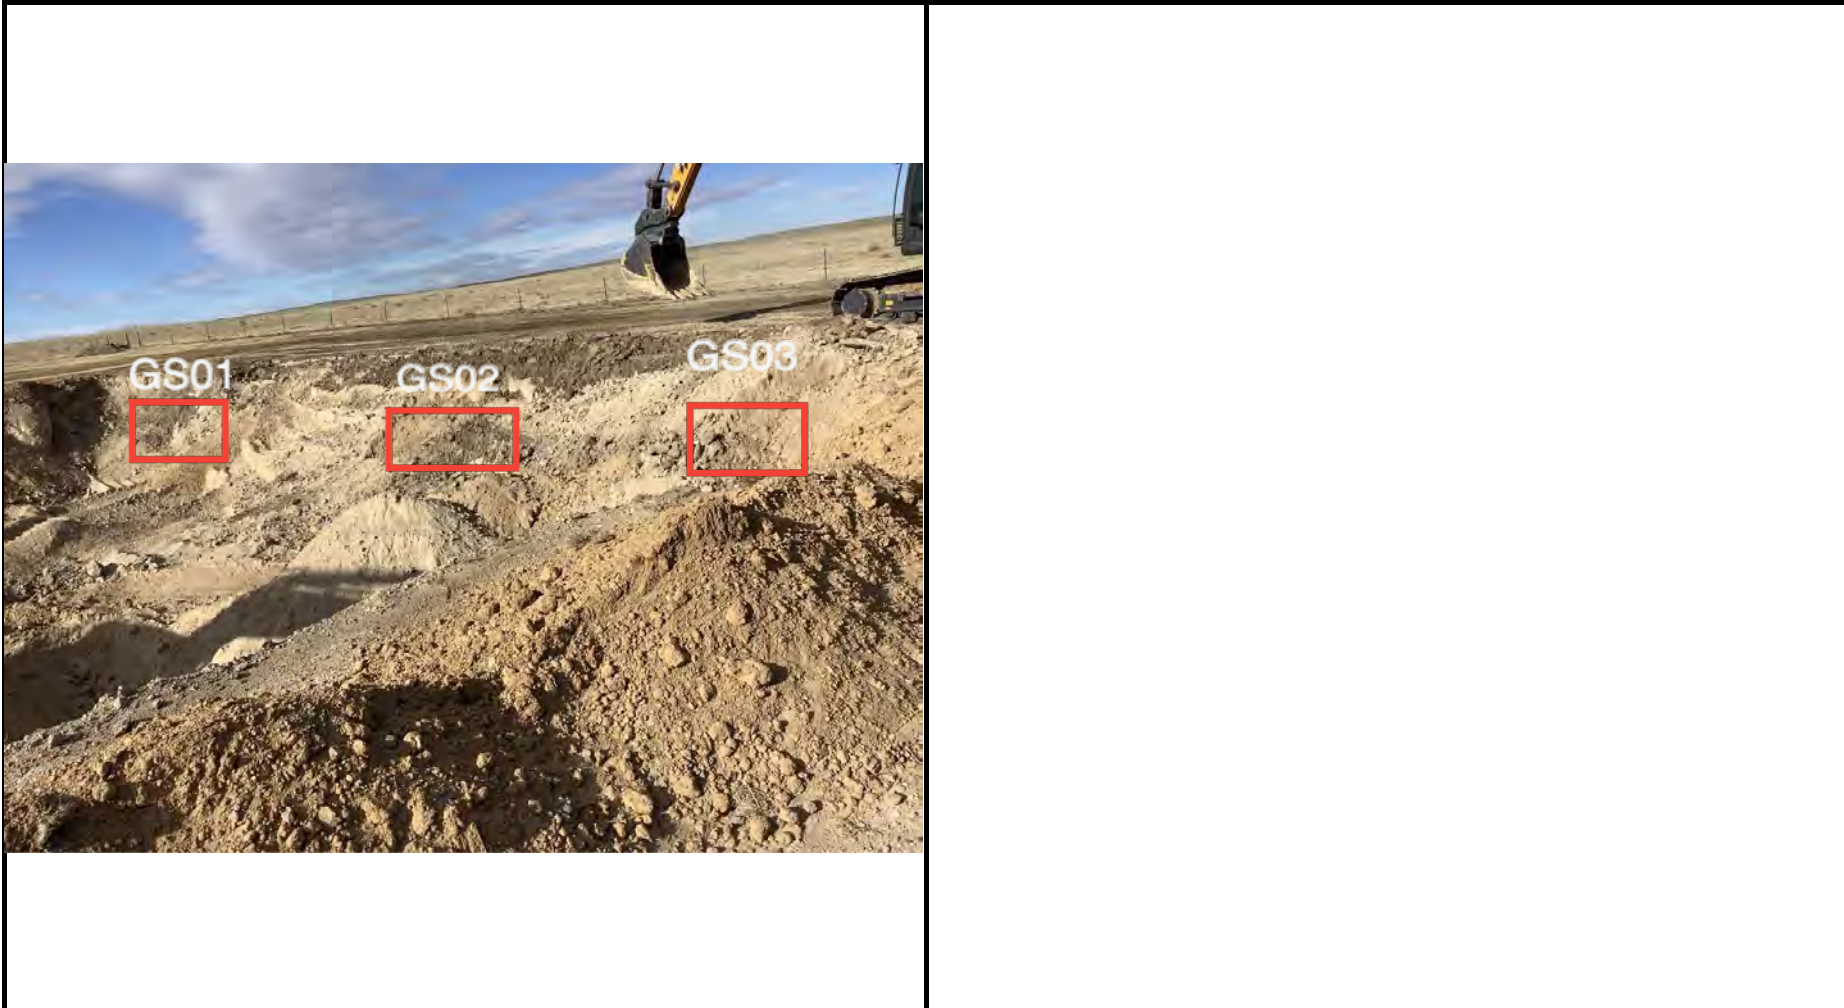
Equipment ID:		Equipment Type:		Equipment ID:		Equipment Type:	
Material:	Volume:	Contents:		Material:	Volume:	Contents:	
Notes/Conditions: Grab soil samples taken on the northern slope to confirm that the soil is clean All three samples had no signs of staining or odor and had low PID. Sloping to the north is almost complete				Notes/Conditions:

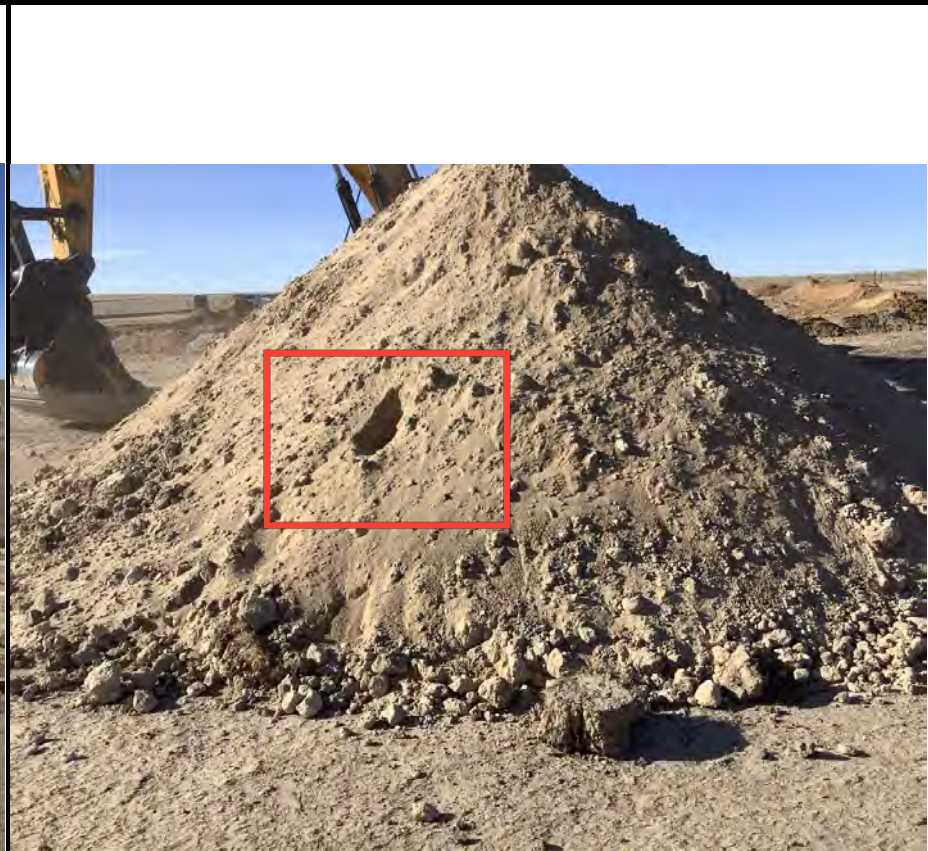
Notes/Conditions: Facing North
 Overburden pile from the northeast corner had elevated PID and a slight odor and will be hauled off and not used for backfill

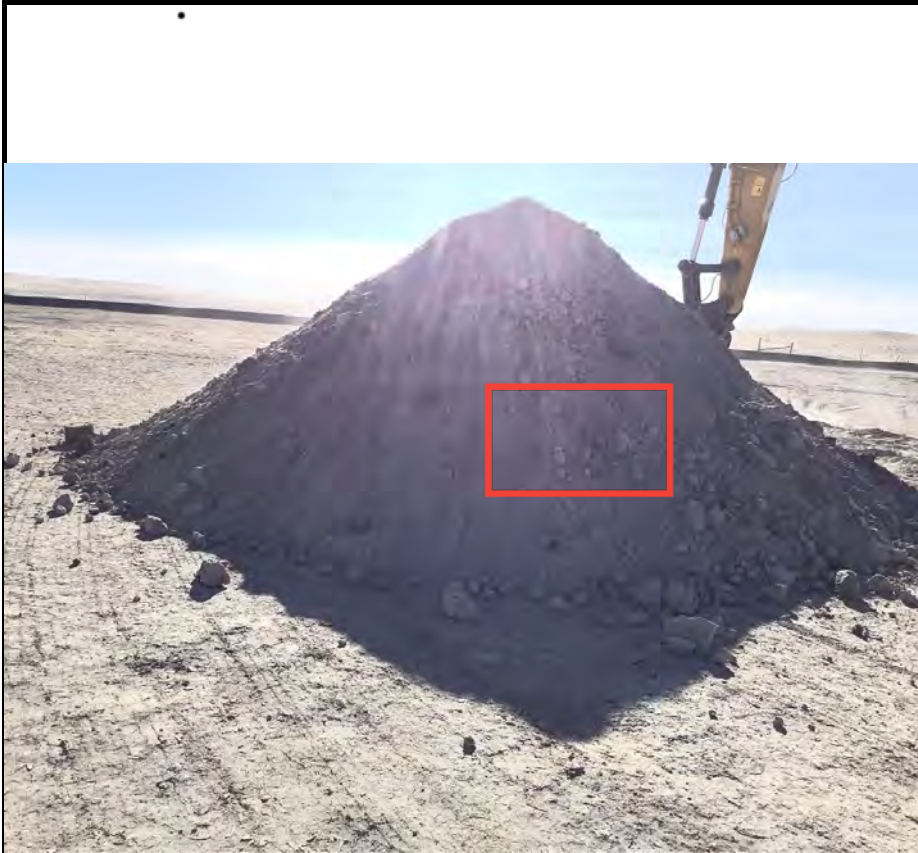
Notes/Conditions: Facing south
Material had elevated PID and was hauled off

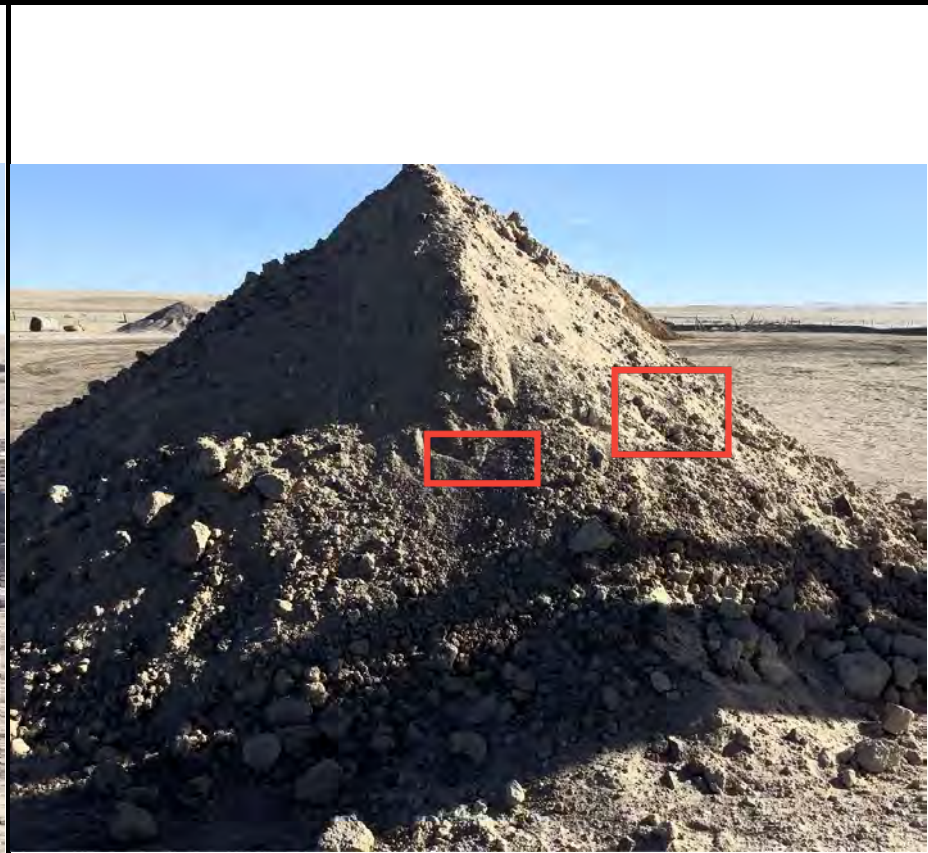
Notes/Conditions: Facing west
 Material had elevated PID and was hauled off

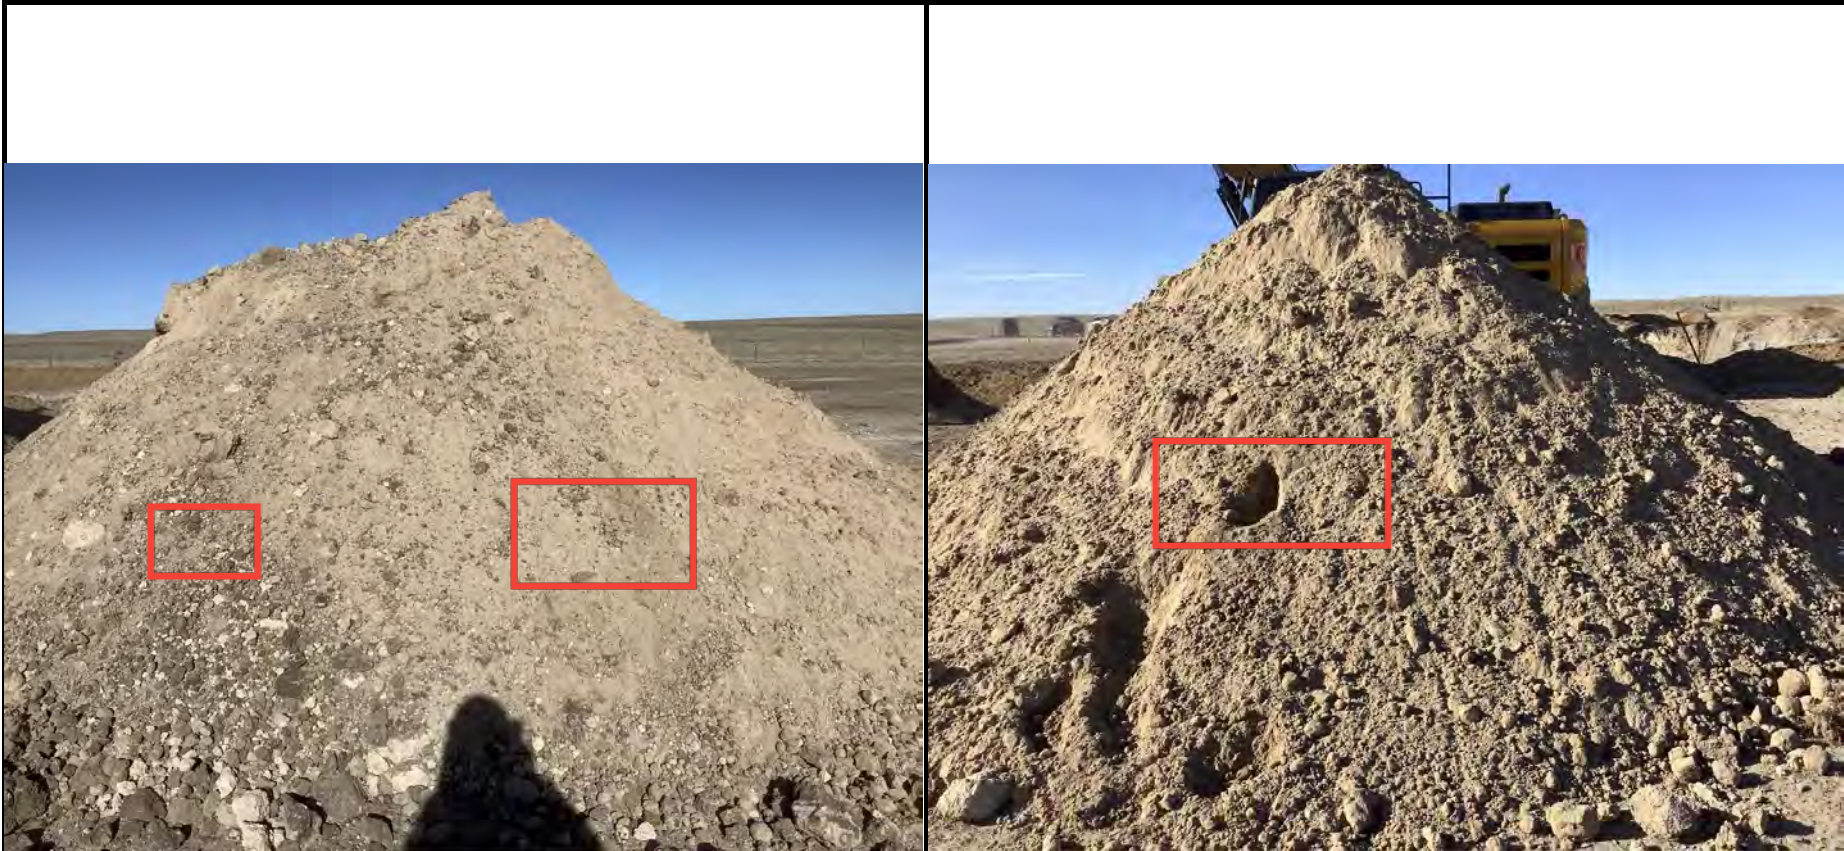
Equipment ID: OB02		Equipment Type:	
Material:	Volume:	Contents:	
Notes/Conditions: Material was stockpiled with the other clean overburden

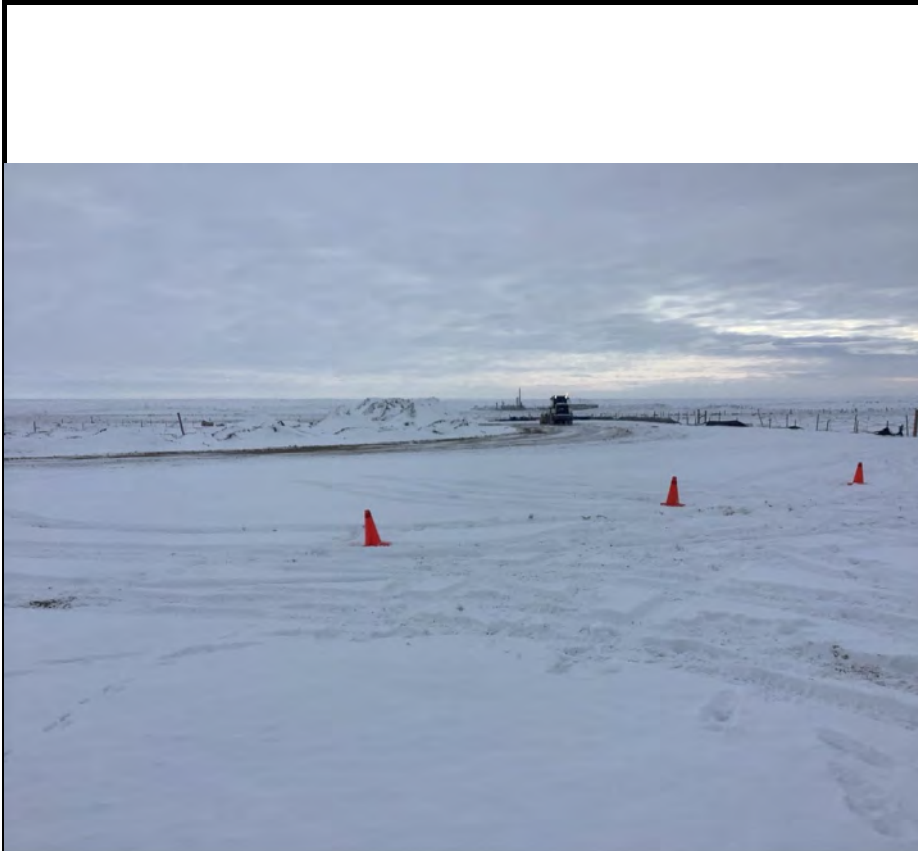
Notes/Conditions: Site photo facing east
Crew working on clearing the site for the trucks so they have a clear path to follow when arrive on site

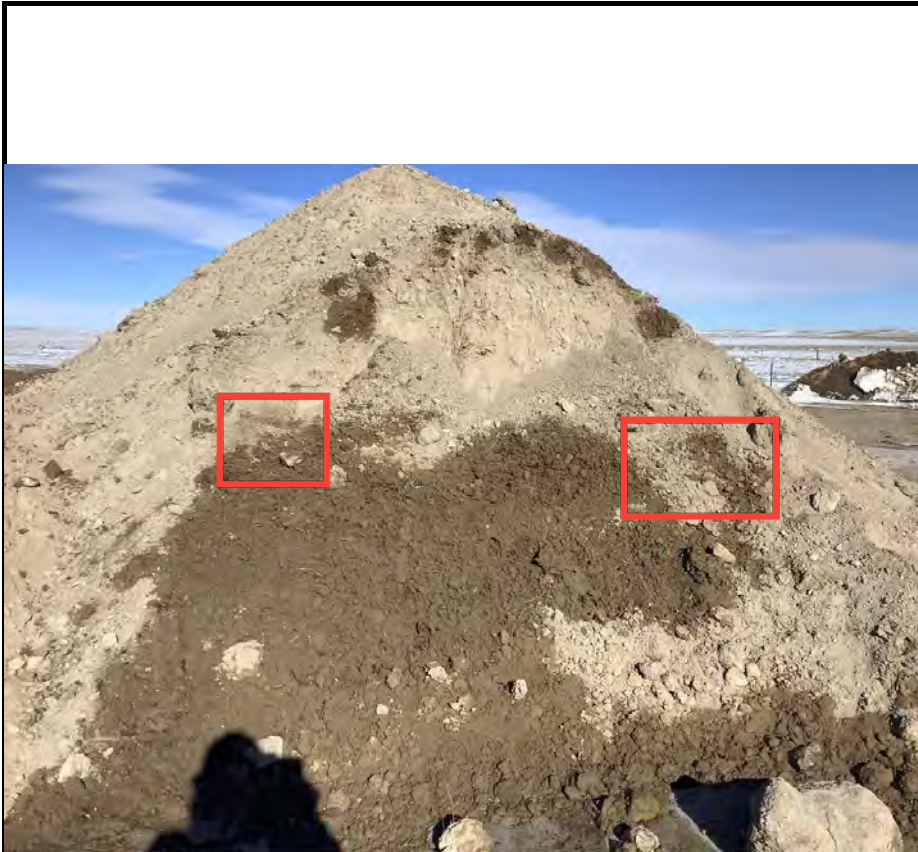
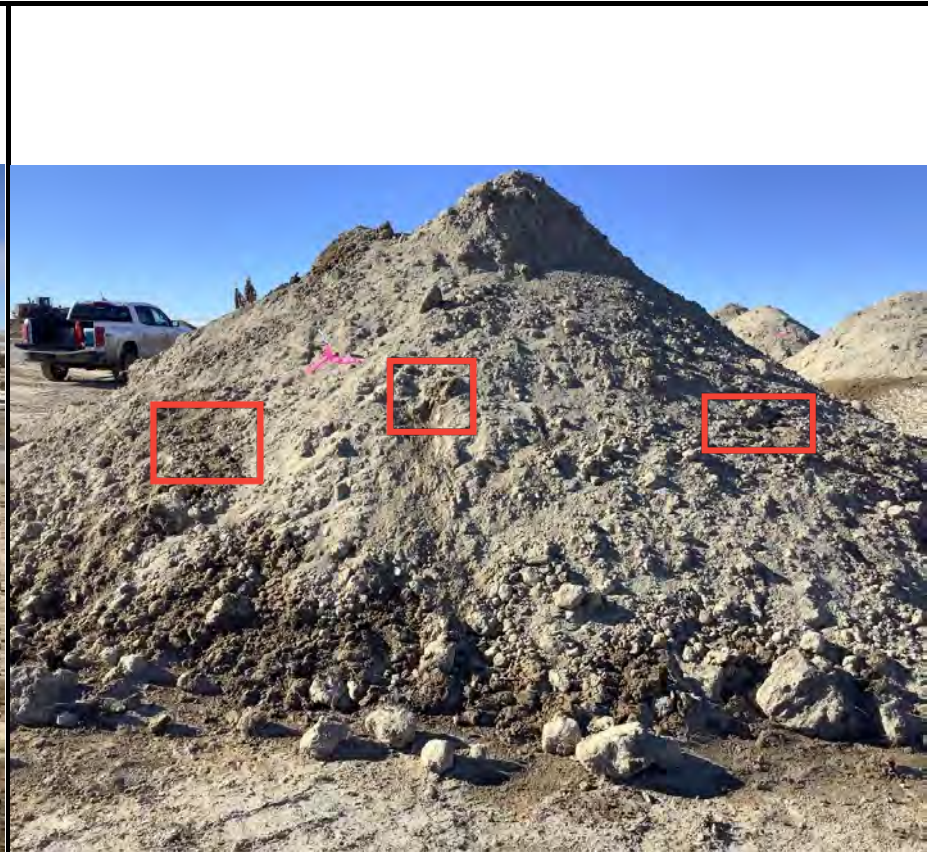
Equipment ID:		Equipment Type:	
Material:	Volume:	Contents:	
Notes/Conditions: Site photo Excavation Facing West

Equipment ID:		Equipment Type:	
Material:	Volume:	Contents:	
Notes/Conditions: Excavation Facing south

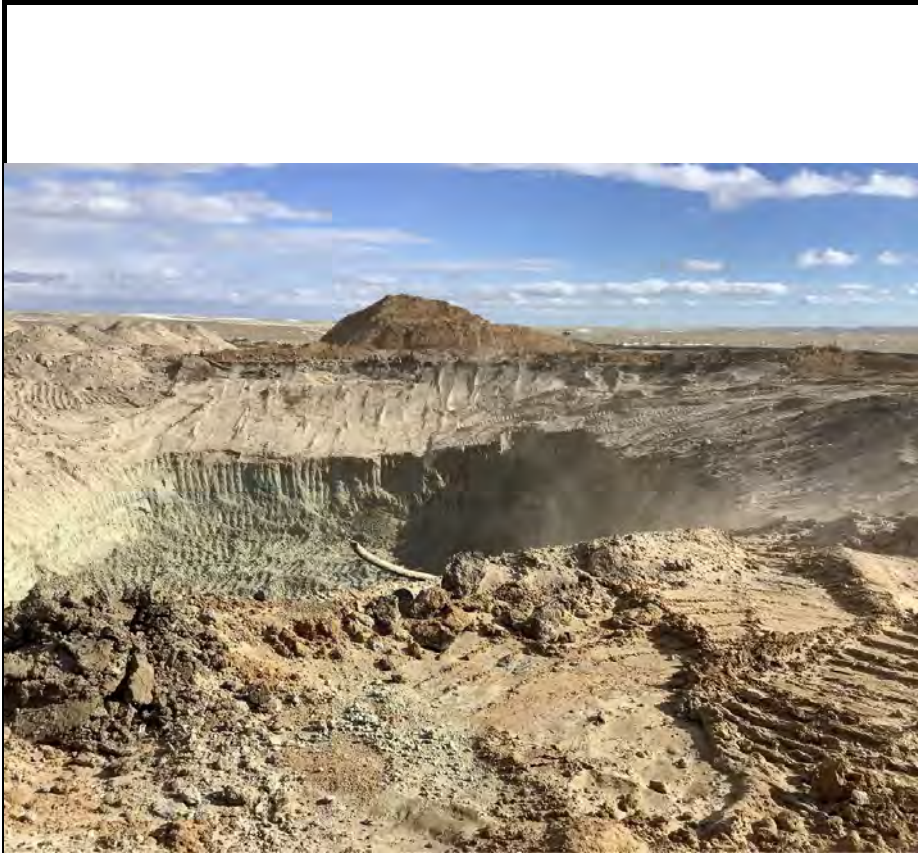
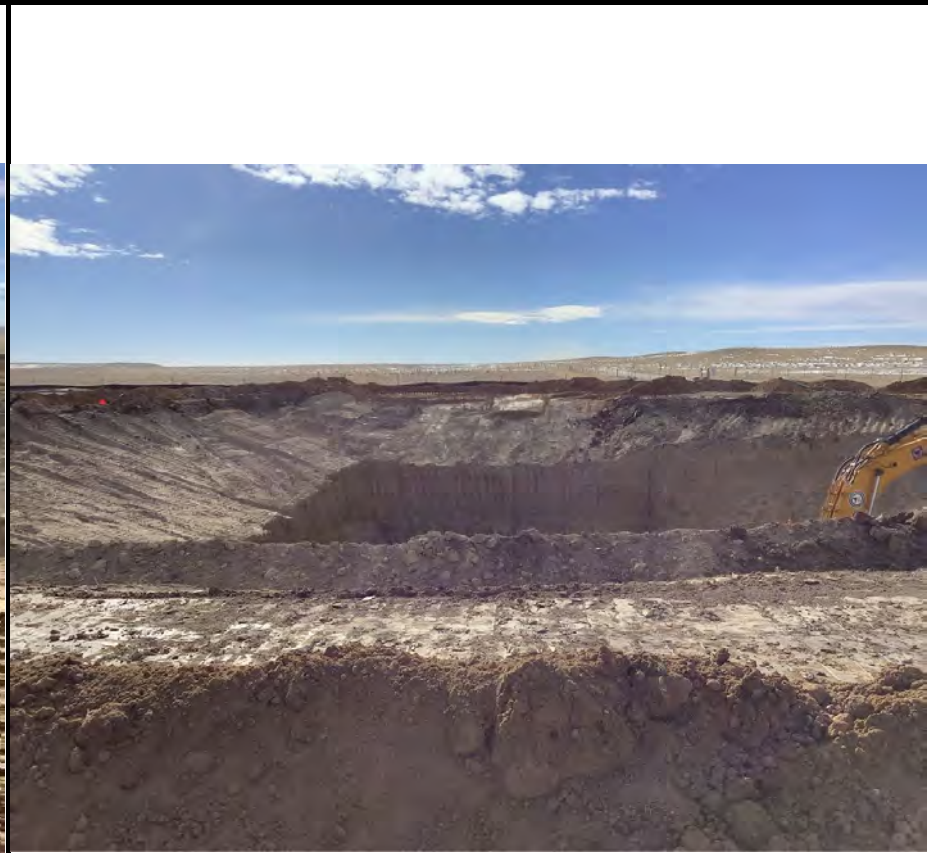
Equipment ID:		Equipment Type:	
Material:	Volume:	Contents:	
Notes/Conditions: Site photo facing east

Equipment ID:		Equipment Type:	
Material:	Volume:	Contents:	
Notes/Conditions: Excavation facing south

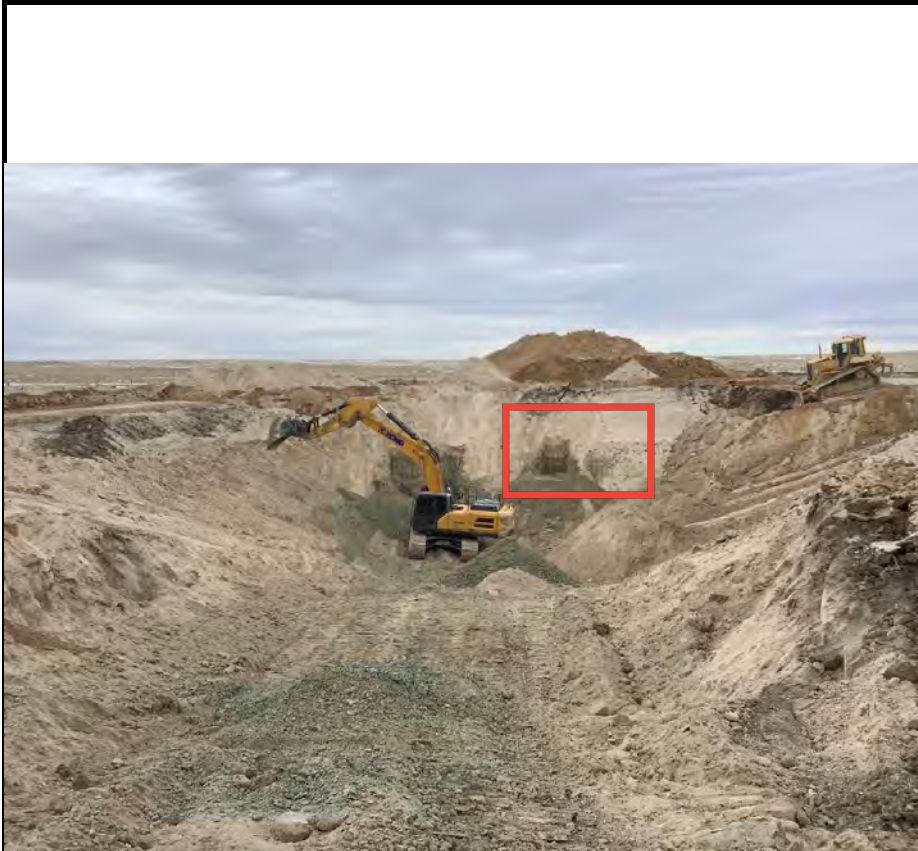
Equipment ID: GS06@20'		Equipment Type:	
Material:	Volume:	Contents:	
Notes/Conditions: Grab sample GS07 was taken to confirm that the contamination we are finding on the north eastern section does not follow the whole sidewall

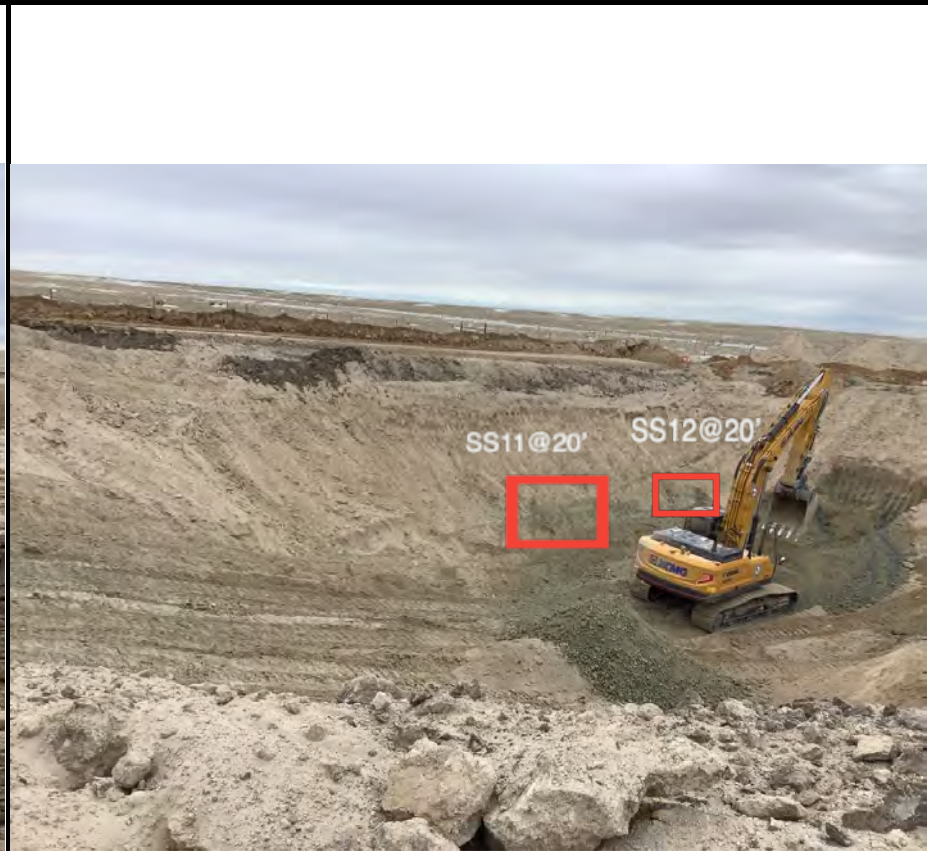
Equipment ID: SS11@20' & SS12@20'		Equipment Type:	
Material:	Volume:	Contents:	
Notes/Conditions: 20' samples were taken on the north wall of the excavation. Sidewall was sloped after samples were taken for safety. So they are kind of hard to see in the picture.

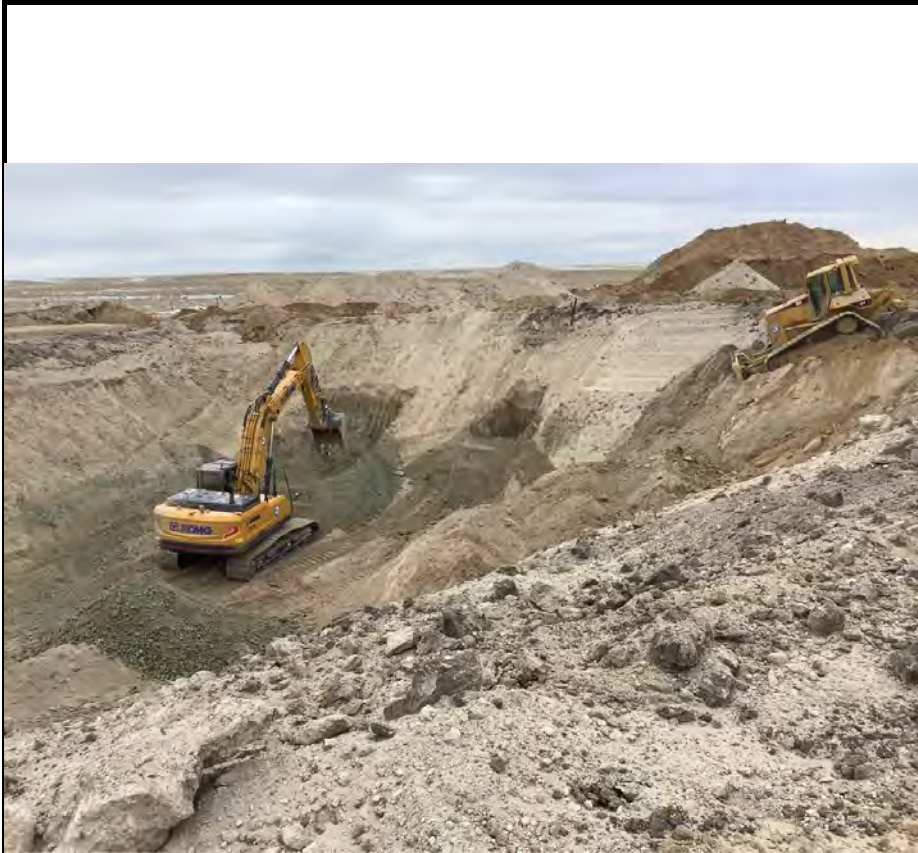
Notes/Conditions: Digging 10' back on the northeastern sidewall to see if the wall will clean up as well as screening samples along the wall.
Site photo facing east

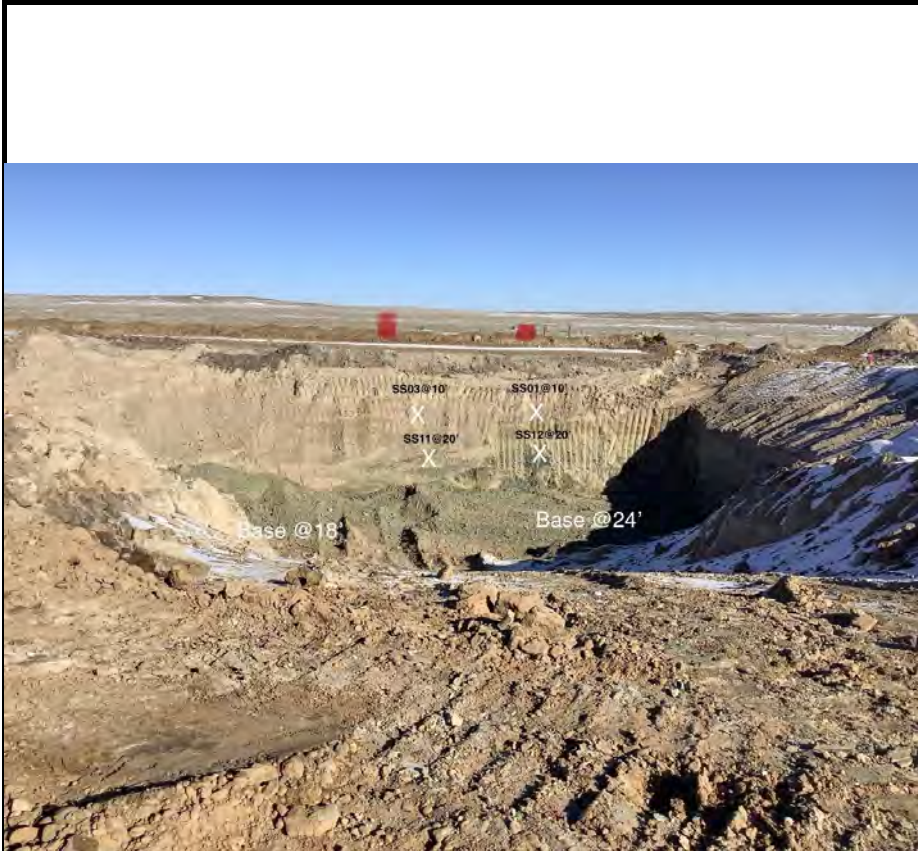
Equipment ID:		Equipment Type:	
Material:	Volume:	Contents:	
Notes/Conditions: Site photo facing north In the photo highlighted in red on stakes in the outer indicating where sidewall samples were taken so as we get deeper we can stay on track The sidewall is moving east due to the impacts we encountered last Friday

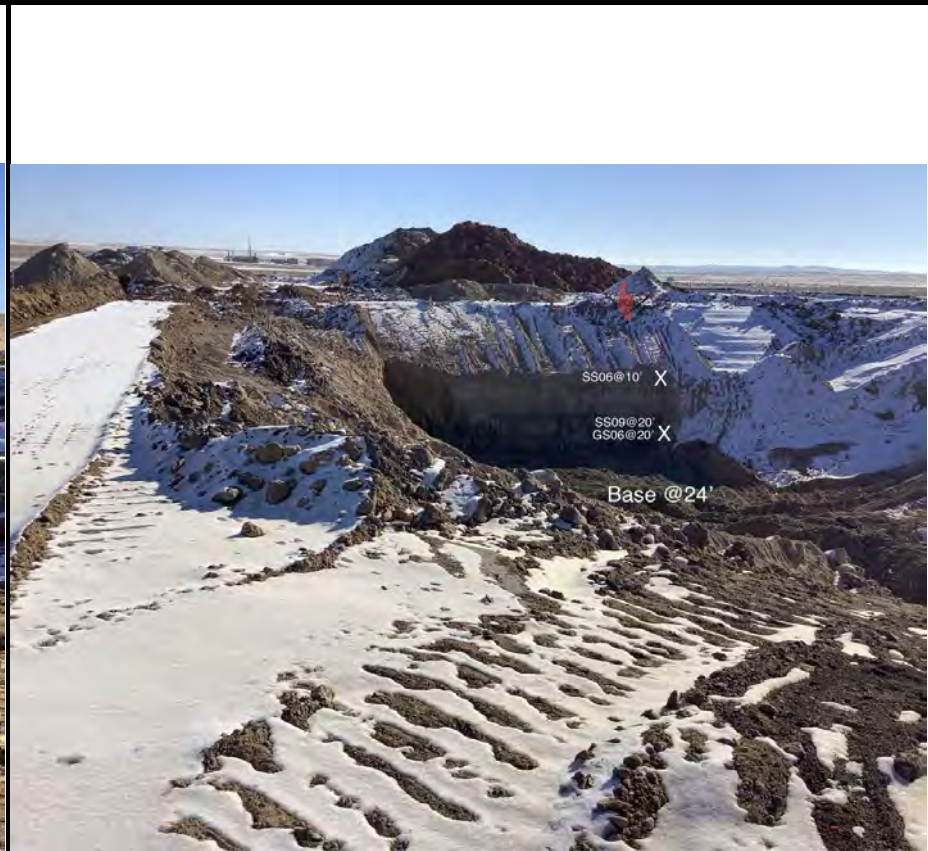
Equipment ID:		Equipment Type:	
Material:	Volume:	Contents:	
Notes/Conditions: Site photo facing east In the photo highlighted in red is the stake that shows where the last sidewall sample was taken GS06 was taken around the same location as SS09 to confirm that it was clean the further we move south

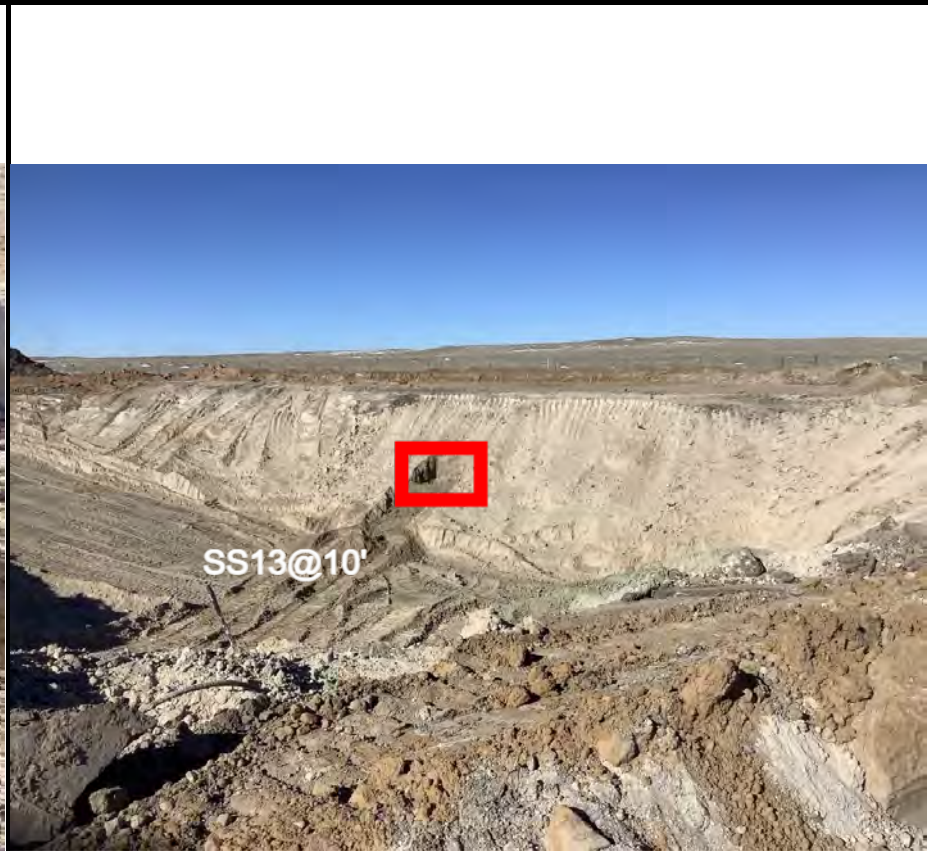
Notes/Conditions: Soil turns from a dark green blue to a tan with some green there is a significant color change as we get deeper
