Noble Energy, Inc. – 100322 – DJ Basin
Lilli Unit N-5 Facility
 SESW, Section 5, Township 8 North, Range 58 West
 Weld County, Colorado

Excavation Soil Sample Location Map - Sidewalls
 (12/06/2024 – 04/08/2025)

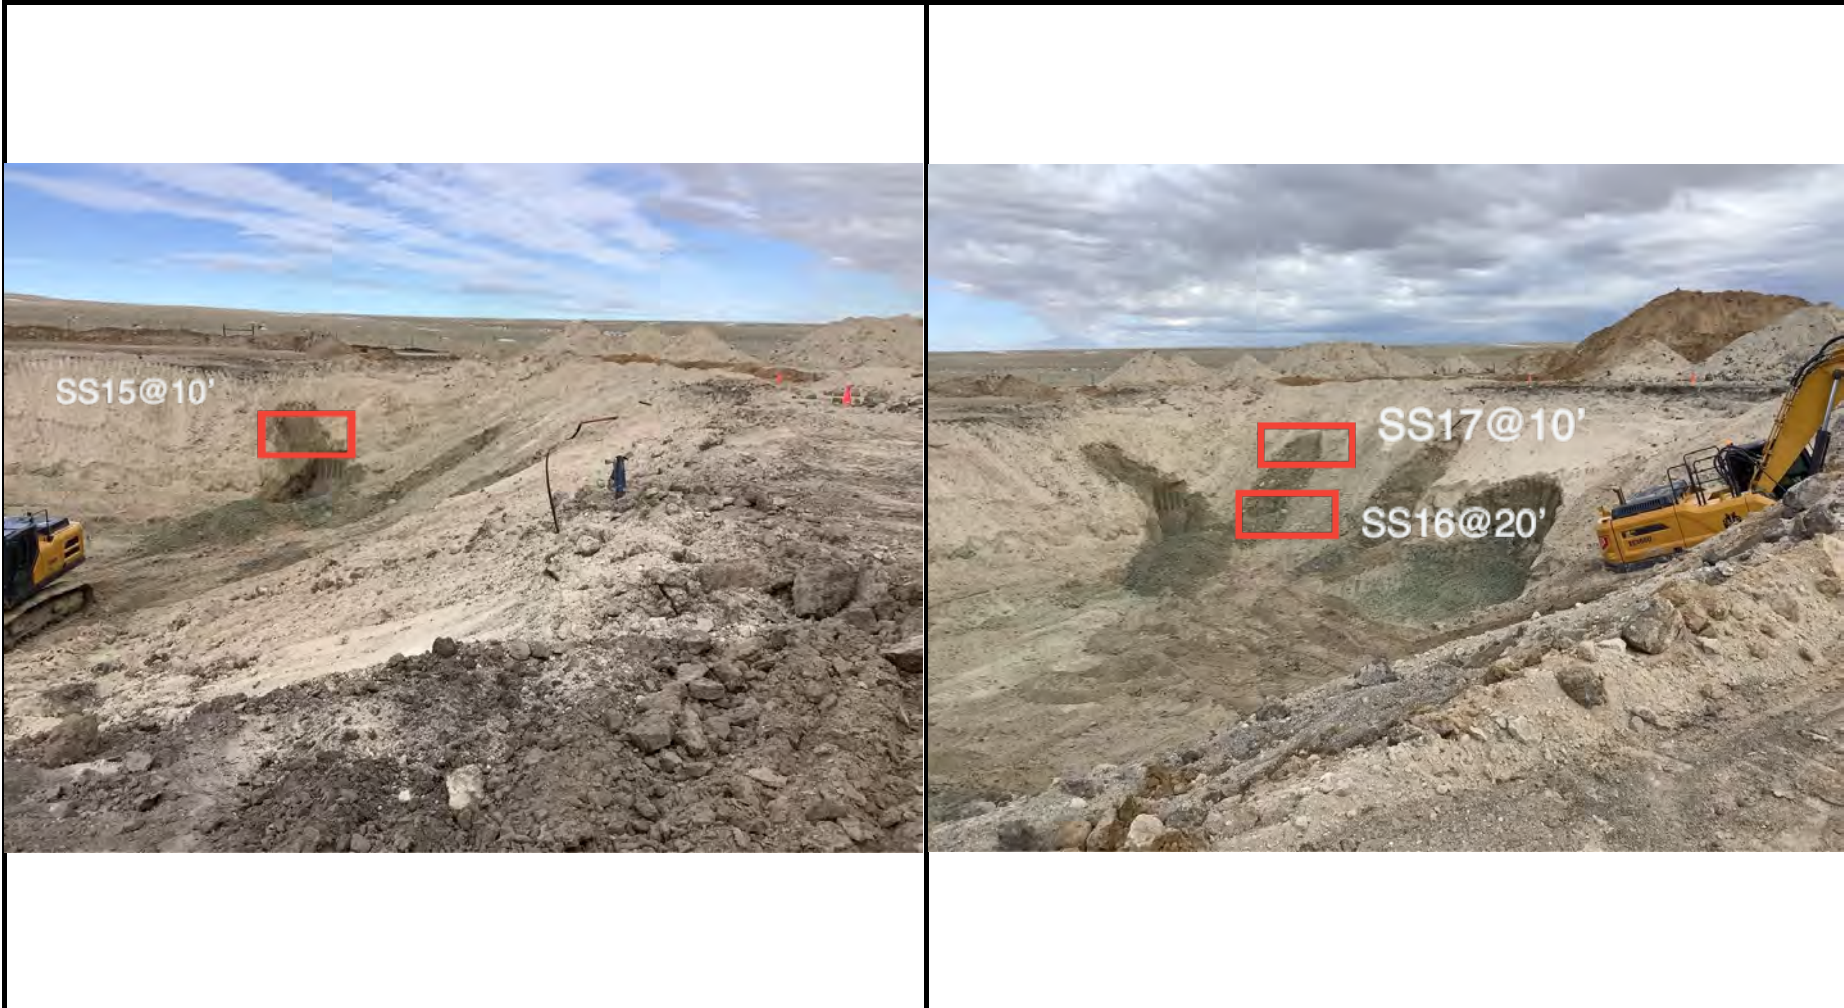
Equipment ID: SS15@0'		Equipment Type:		Equipment ID: SS17@10', SS16@20'		Equipment Type:	
Material:	Volume:	Contents:		Material:	Volume:	Contents:	
Notes/Conditions: Facing north 10' sampled submitted 20' still needs some more material removed before sampling				Notes/Conditions: Facing north east

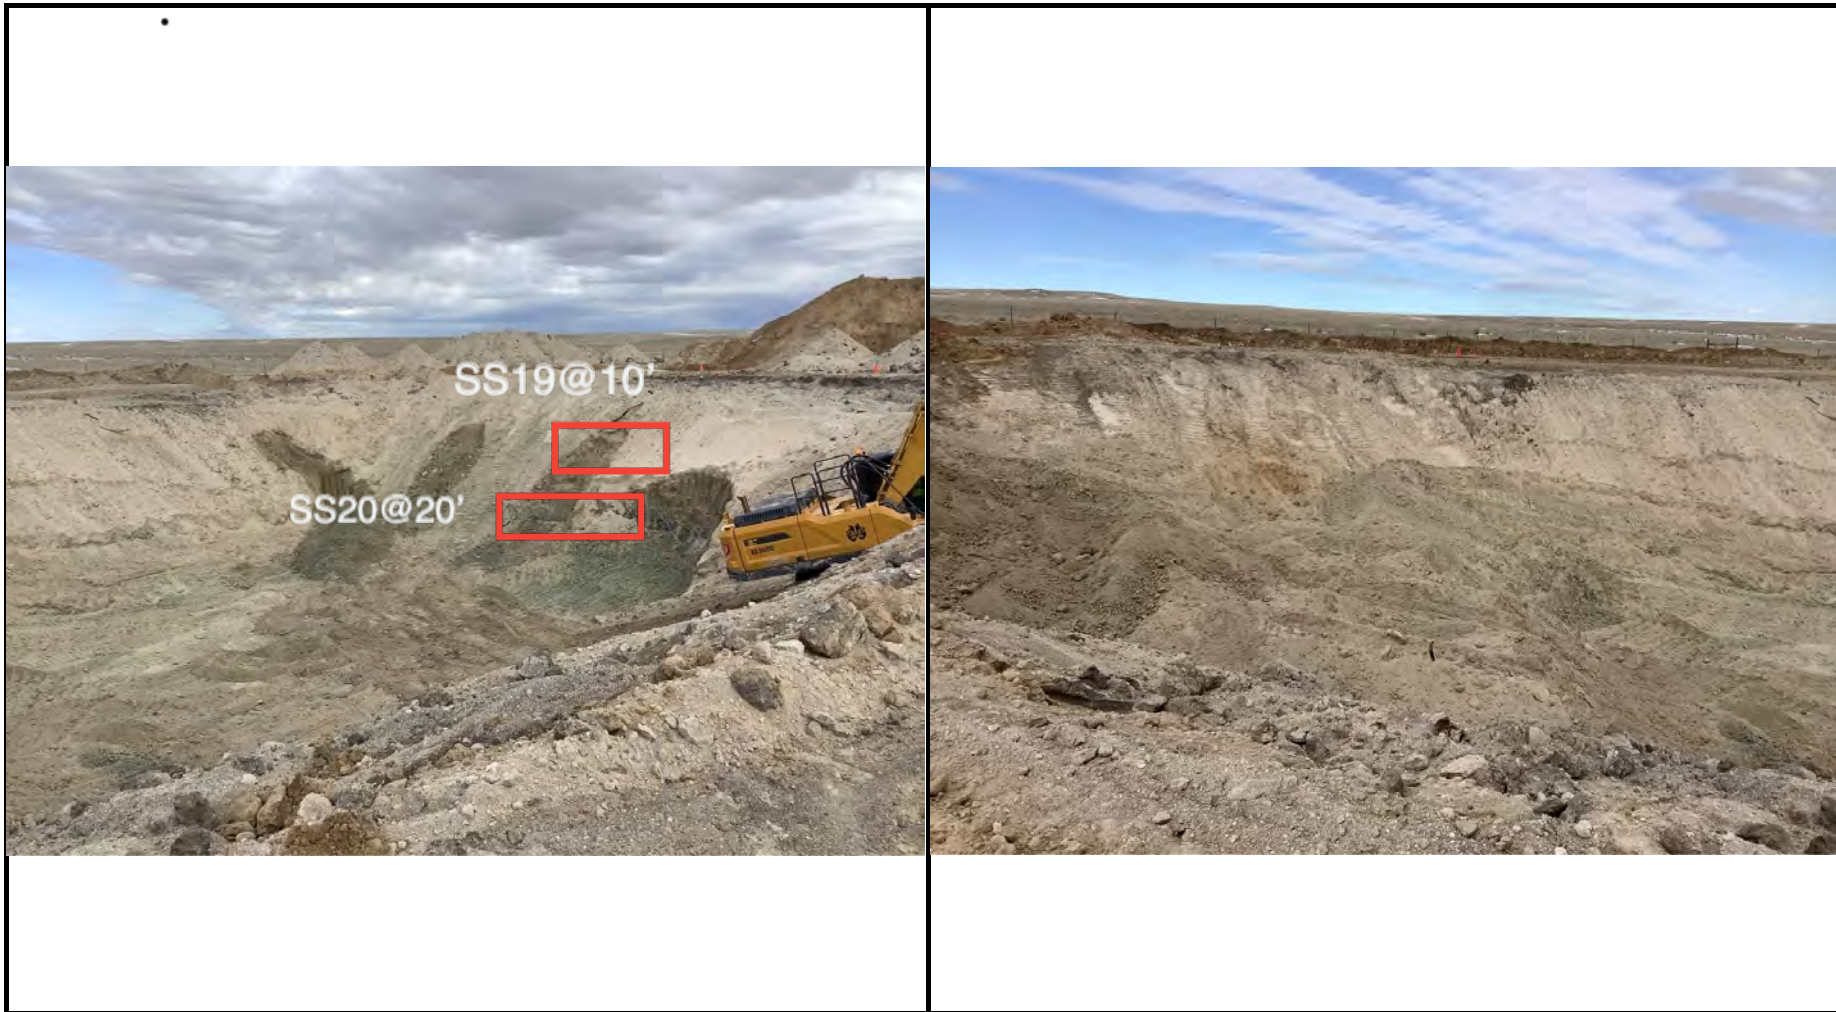
Equipment ID: SS19@10' SS20@20'		Equipment Type:		Equipment ID:		Equipment Type:	
Material:	Volume:	Contents:		Material:	Volume:	Contents:	
Notes/Conditions: facing north east base @24'				Notes/Conditions: Facing northwest section of the excavation with the ramp

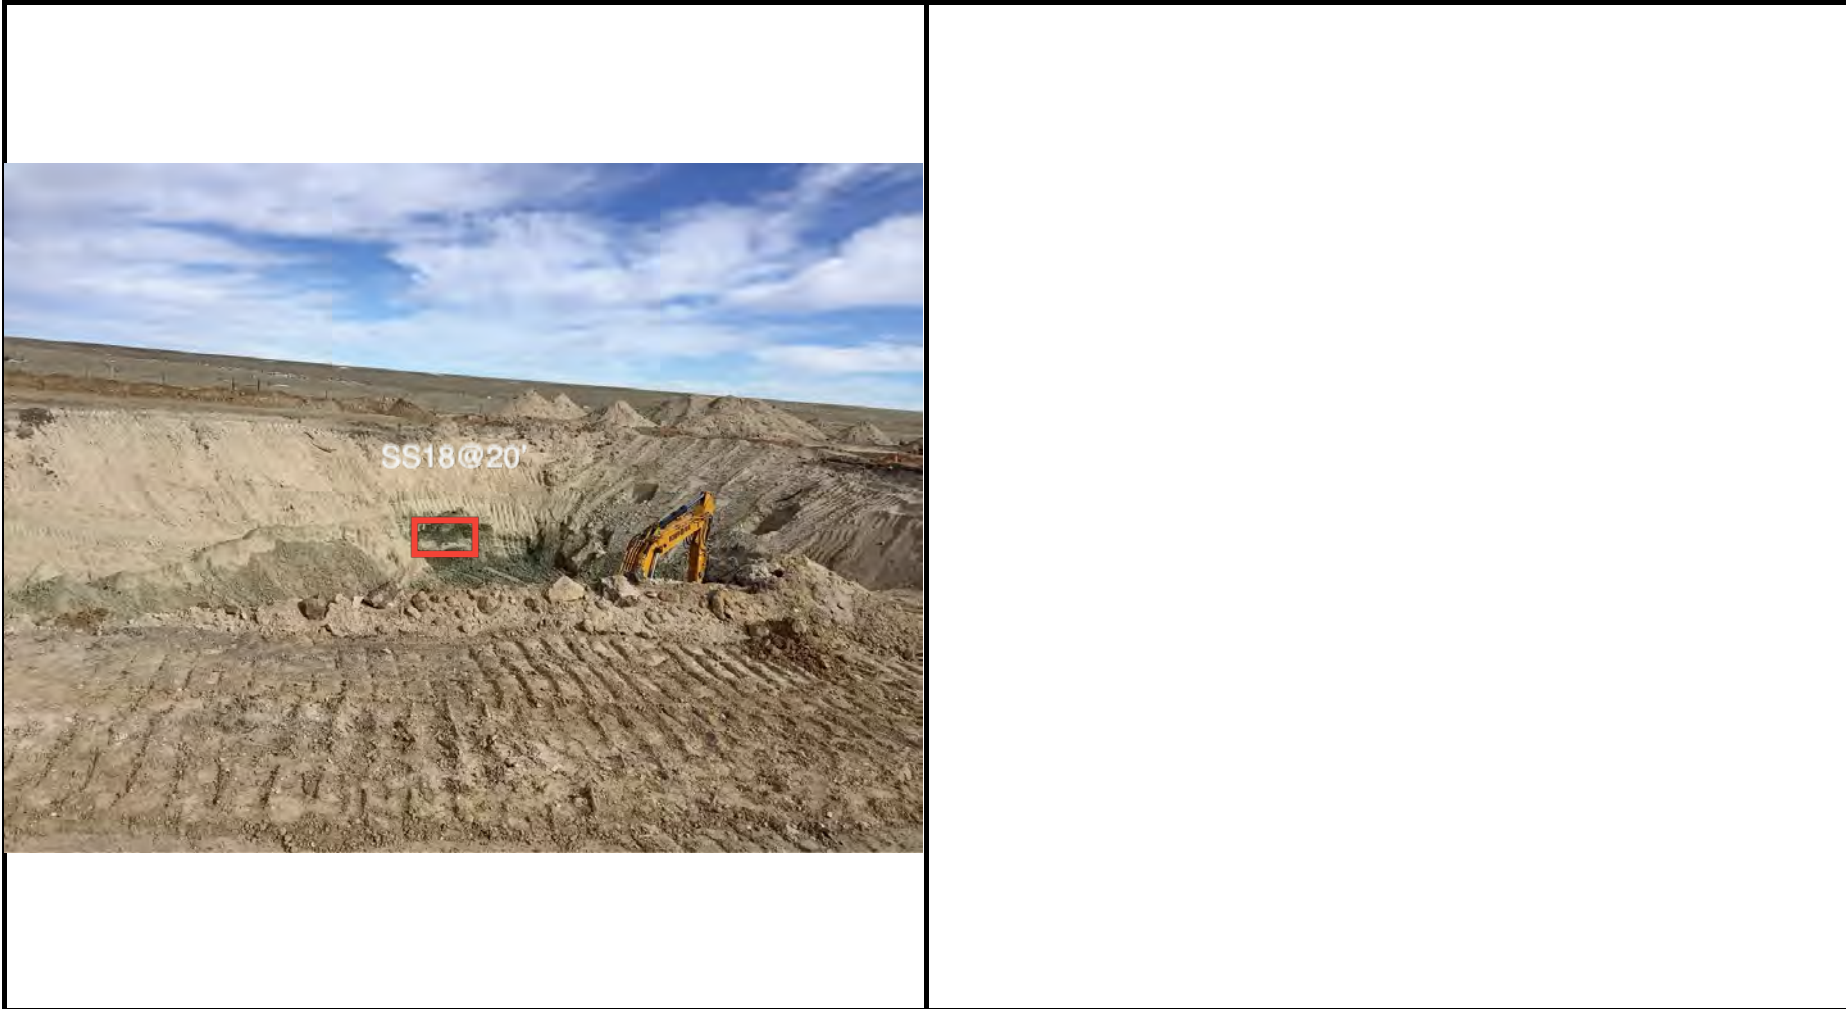
Equipment ID: SS18@20'		Equipment Type:		Equipment ID:		Equipment Type:	
Material:	Volume:	Contents:		Material:	Volume:	Contents:	
Notes/Conditions: Facing northeast				Notes/Conditions:

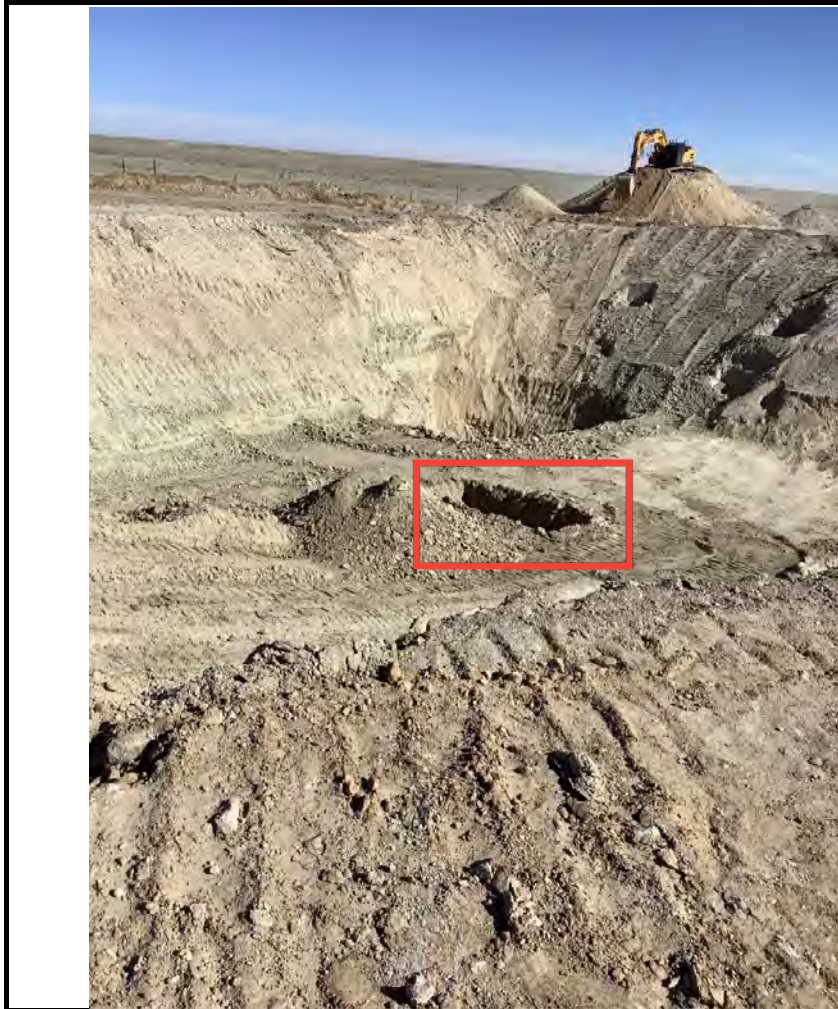
Equipment ID: TP02		Equipment Type:	
Material:	Volume:	Contents:	
Notes/Conditions: Center test pit navigated over to BH01/BH06 to punch down and sample at the following depths TP02 @ 32' TP02 @ 34'

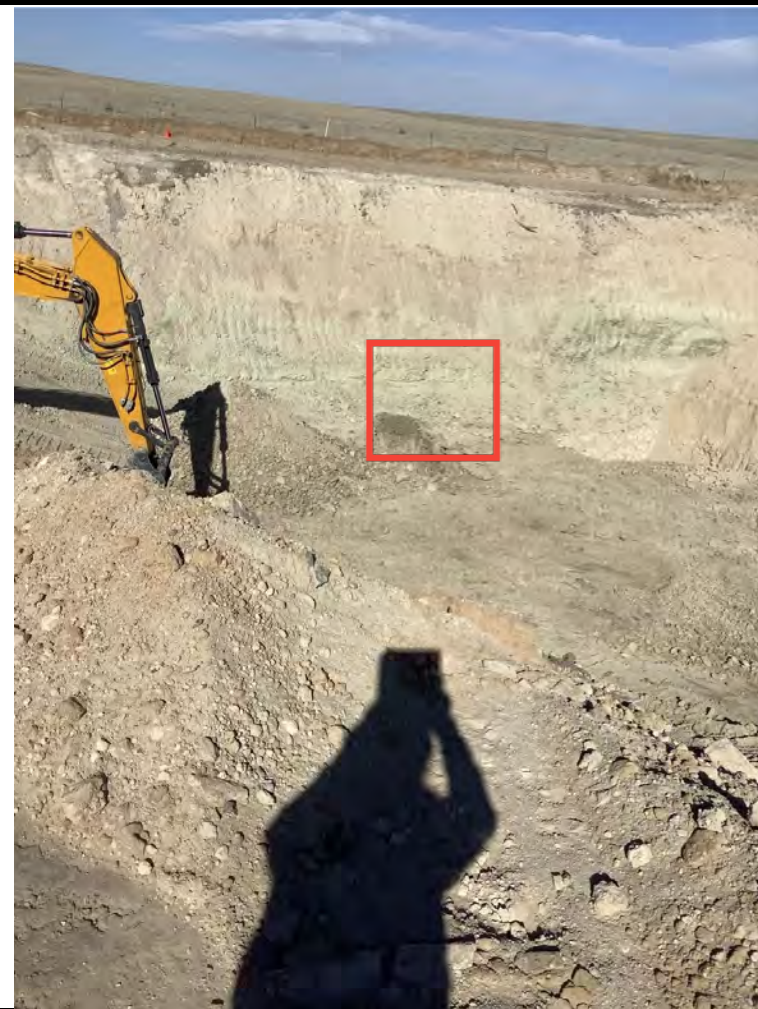
Equipment ID: TP03		Equipment Type:	
Material:	Volume:	Contents:	
Notes/Conditions: Test pit to the north of TP02 TP03 @ 32' TP03 @ 34'

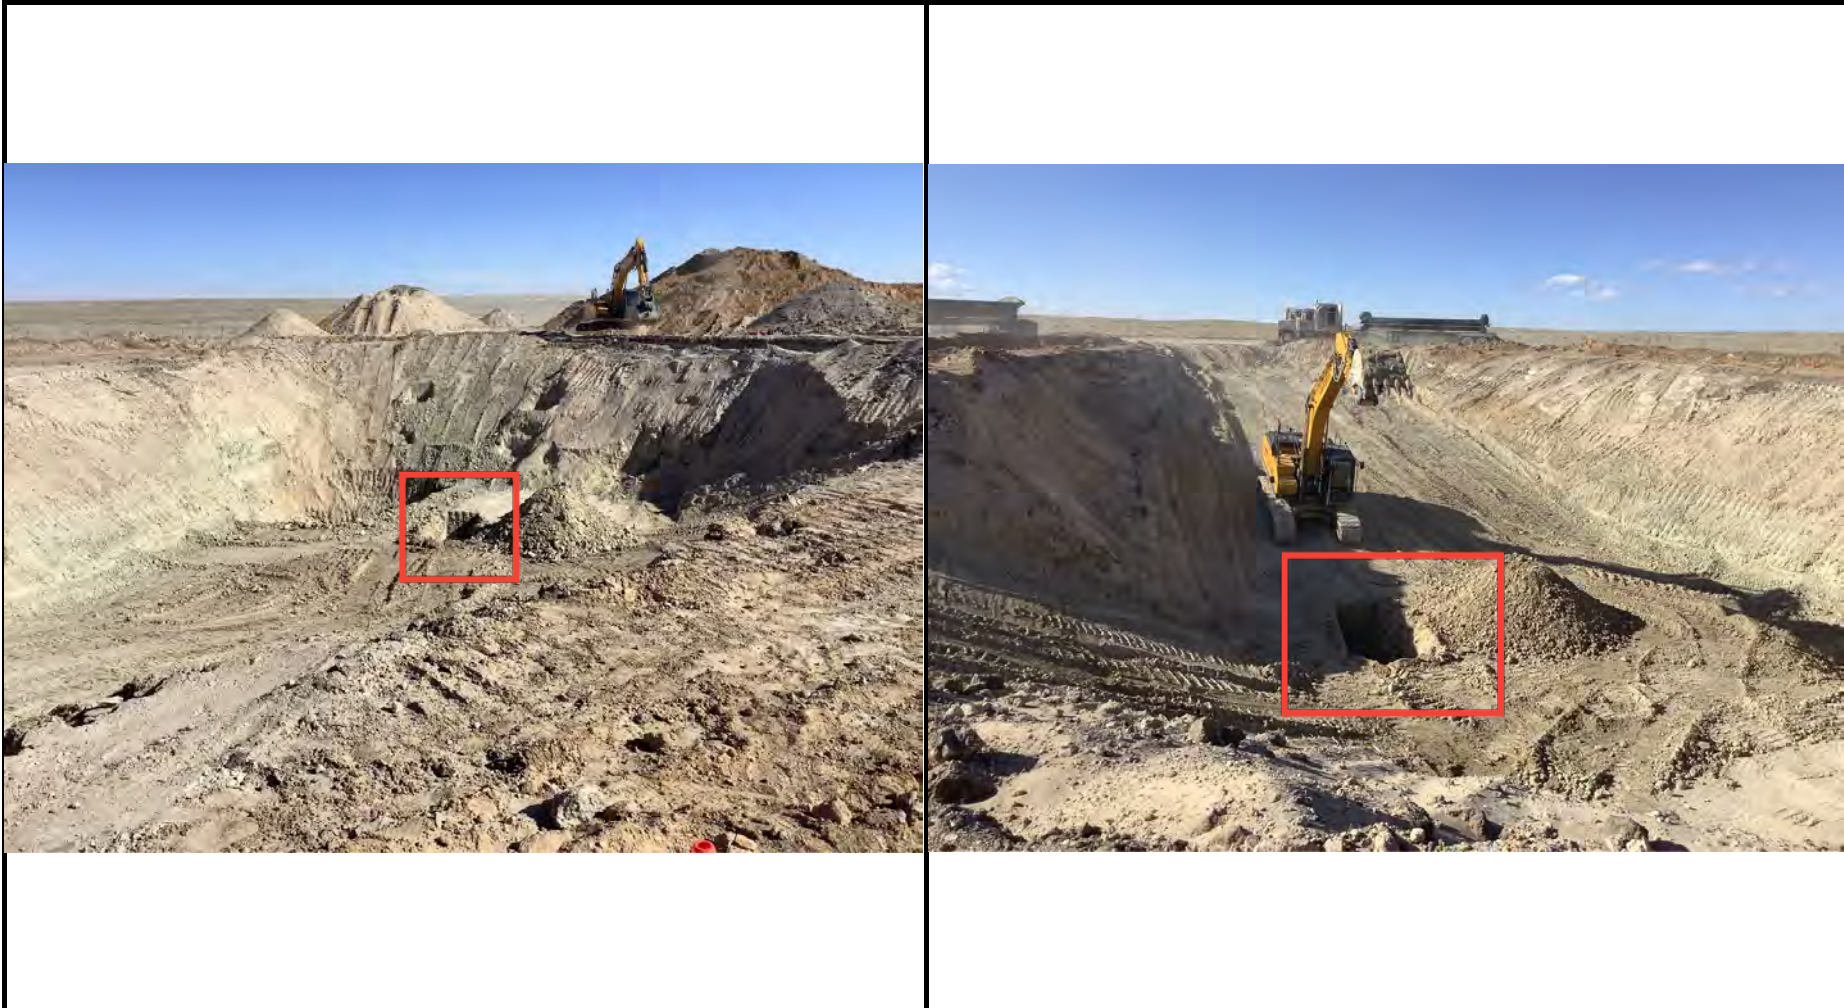
Equipment ID: TP04		Equipment Type:		Equipment ID: TP05		Equipment Type:	
Material:	Volume:	Contents:		Material:	Volume:	Contents:	
Notes/Conditions: West of TP02 TP04@32' TP04@34'				Notes/Conditions: Test pit south of TP02 TP05@32' TP05@34'

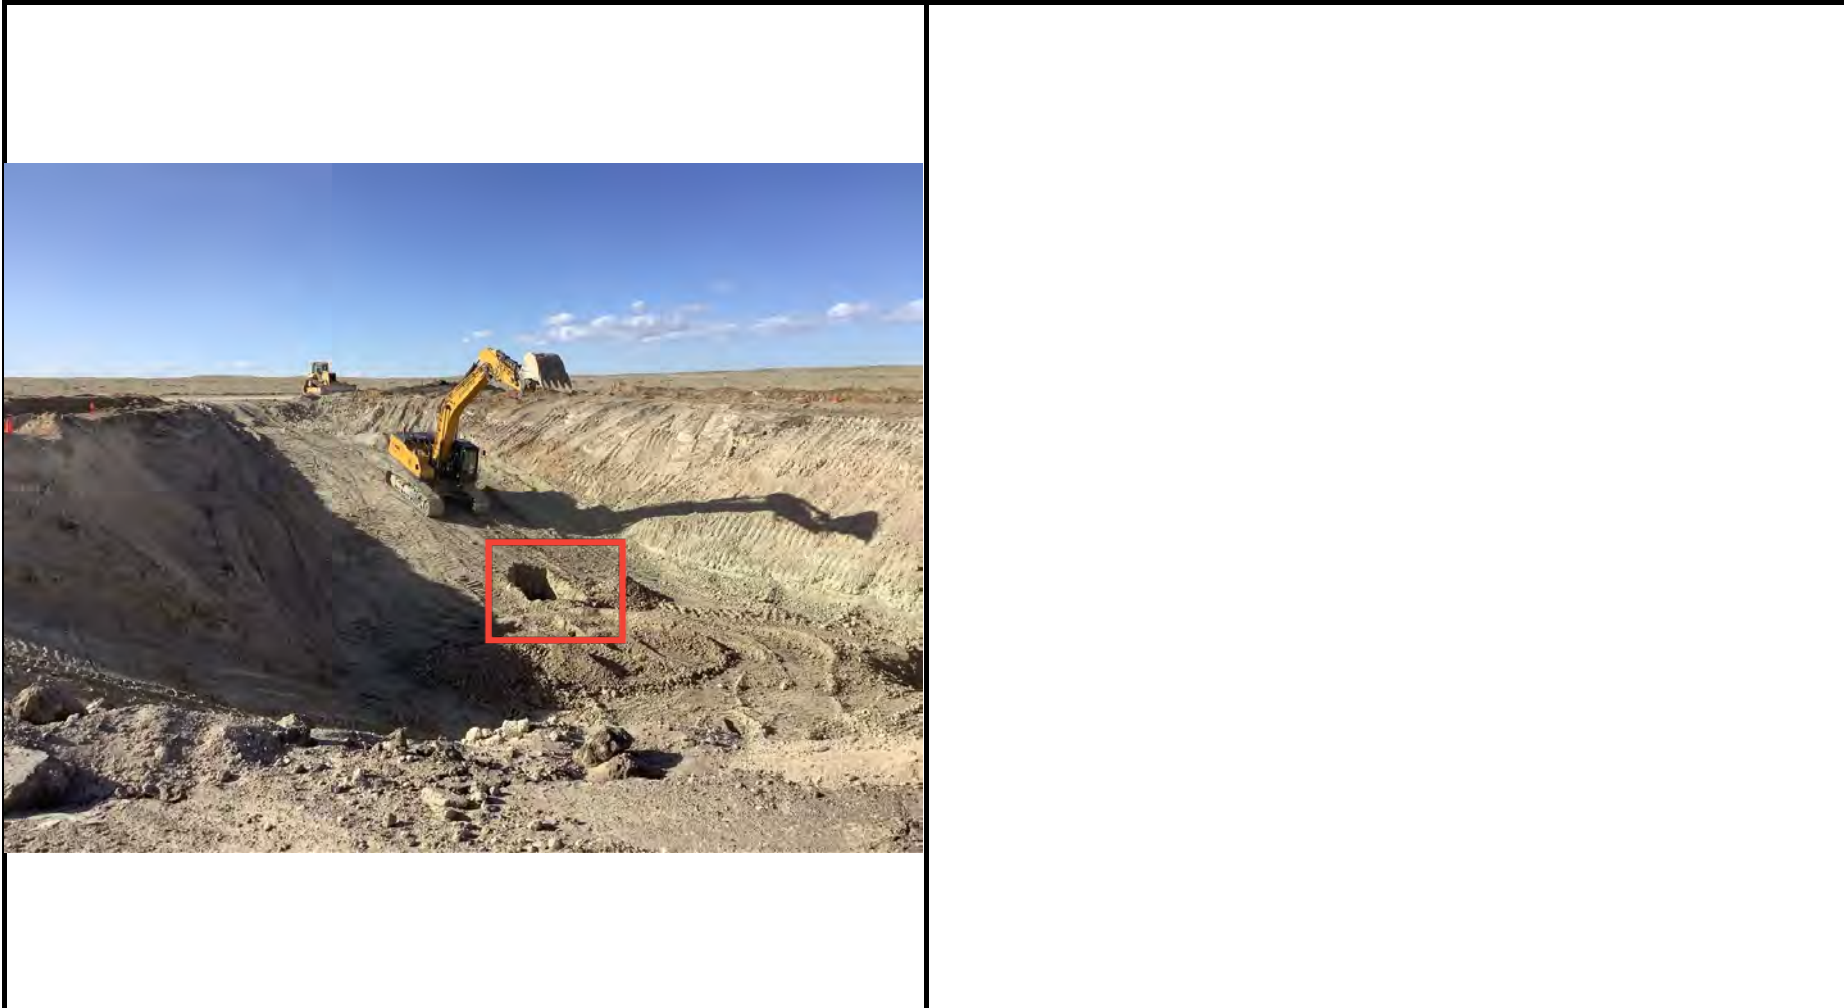
Equipment ID: TP06		Equipment Type:		Equipment ID:		Equipment Type:	
Material:		Volume:		Material:		Volume:	
Contents:				Contents:			
Notes/Conditions: Test pit to the west of TP02 TP06@32' TP06@34'				Notes/Conditions:

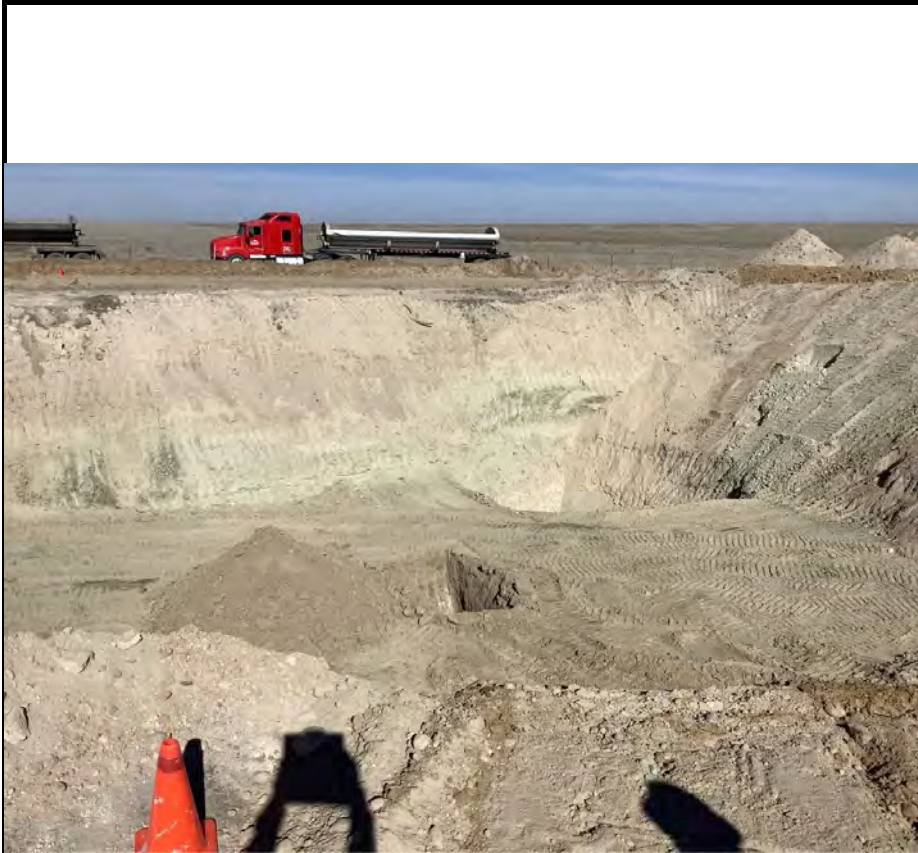
Equipment ID: TP02		Equipment Type:	
Material:	Volume:	Contents:	
Notes/Conditions: Test pit was reopened and dug to a new depth of 36 feet to determine if 36 would be our new base or not

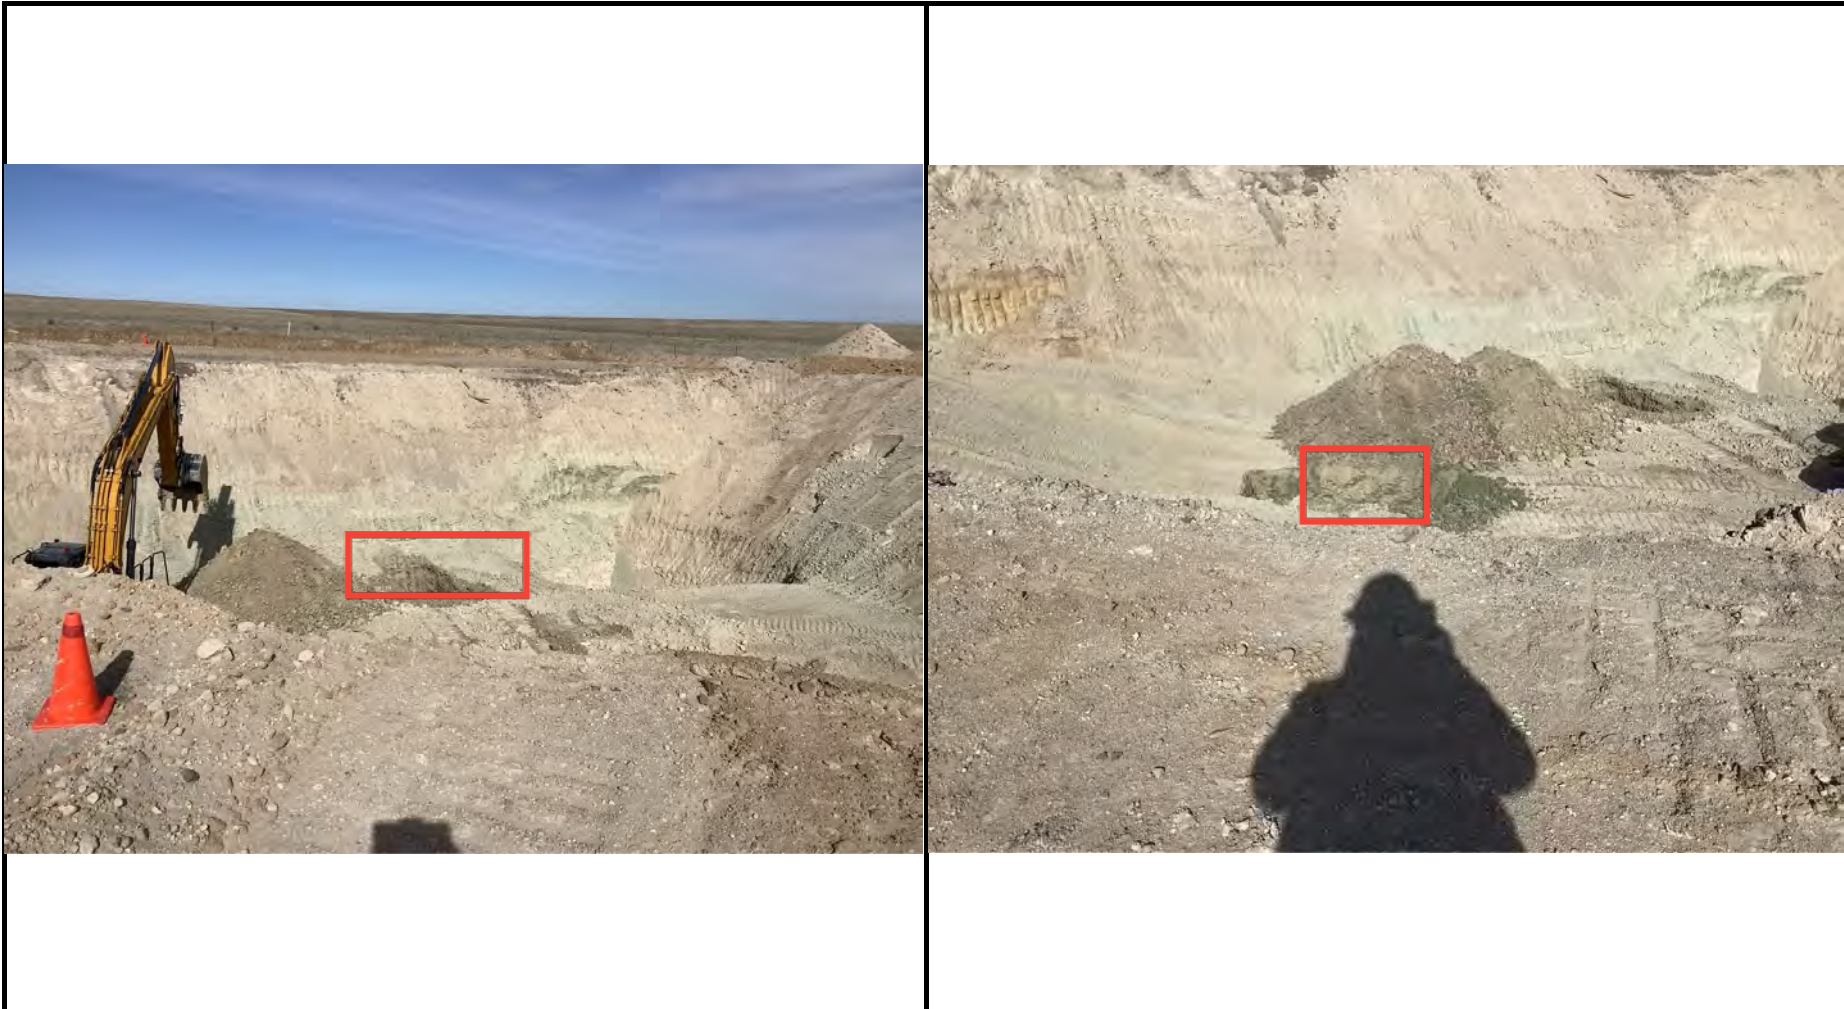
Equipment ID: TP07@36'		Equipment Type:		Equipment ID: TP08@36'		Equipment Type:	
Material:	Volume:	Contents:		Material:	Volume:	Contents:	
Notes/Conditions: Sample taken to the north of pervious dug samples to determine if the contamination moves laterally north				Notes/Conditions: Sample taken to the west of BH06/TP02

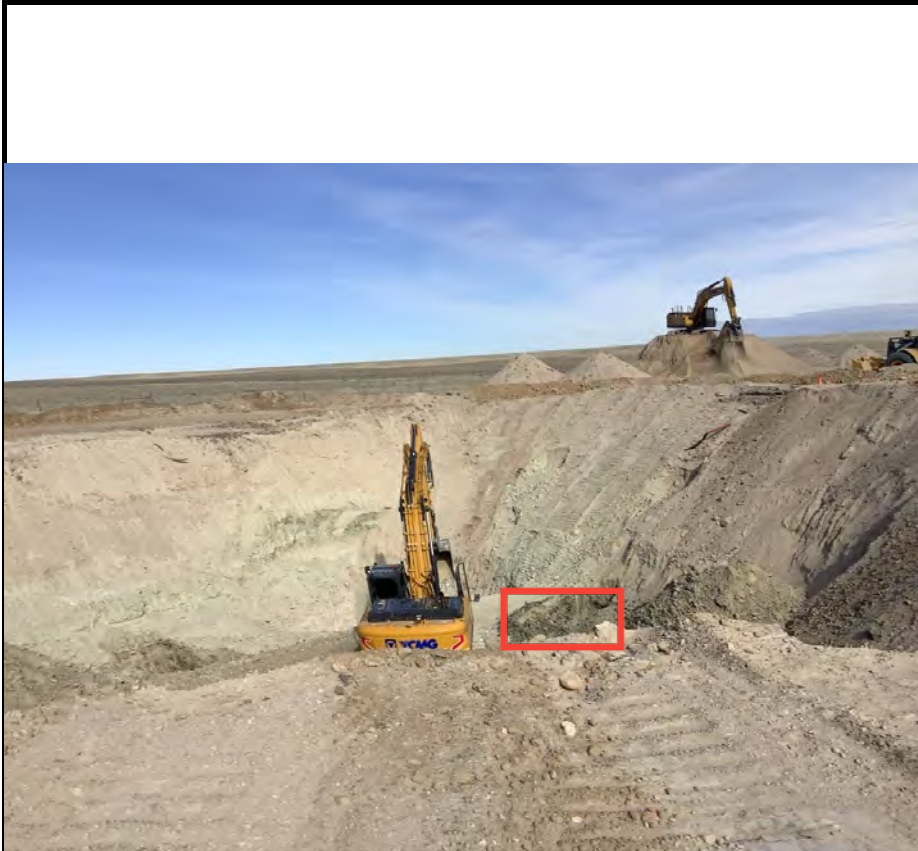
Equipment ID: TP09@36'		Equipment Type:	
Material:	Volume:	Contents:	
Notes/Conditions: Sample taken east of failed locations (BH06, TP02, TP04)

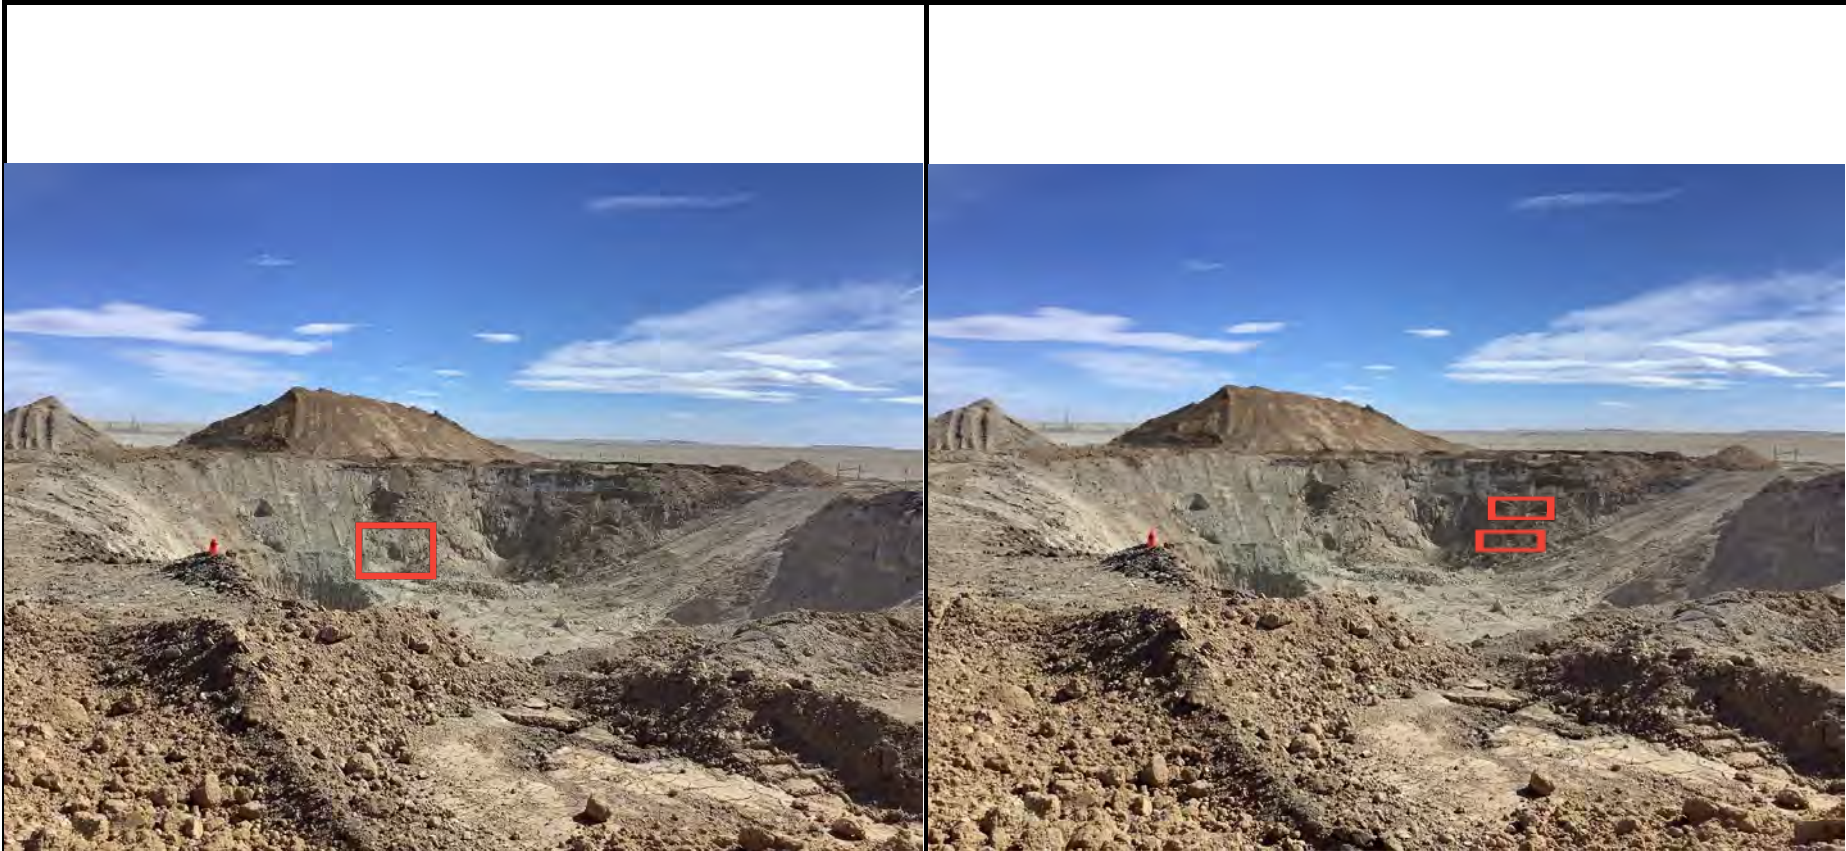
Equipment ID:SS26@20' **Equipment Type:**
Material: **Volume:** **Contents:**
Notes/Conditions: Original sample failed at 20'
 Crew removed on bucket worth of soil and resampled
 Sample had no signs of staining or odor

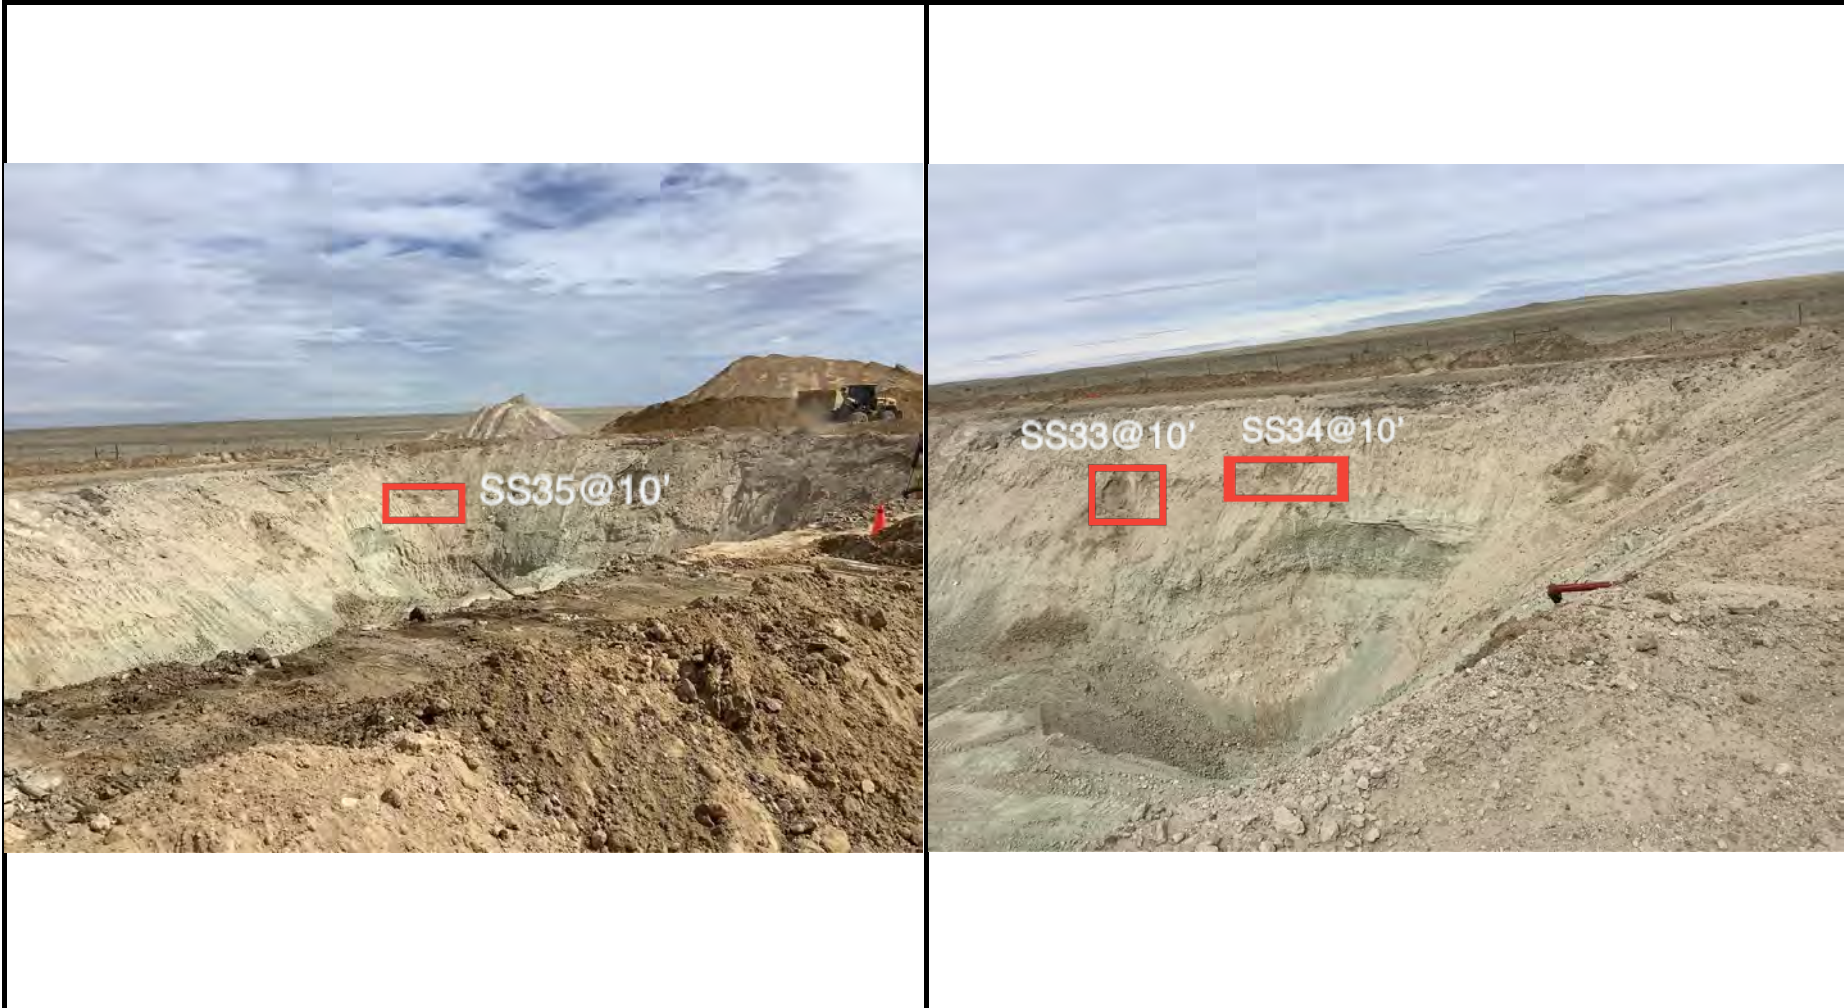
Equipment ID: SS35@10'		Equipment Type:		Equipment ID: SS33@1', SS34@10'		Equipment Type:	
Material:	Volume:	Contents:		Material:	Volume:	Contents:	
Notes/Conditions: Sidewall sample was SP soil light brown with trace iron and no signs of HC odor or staining				Notes/Conditions: These north sidewall samples were taken again due to the original samples being dug out Both samples were SP soil light brown with trace iron and no signs of HC odor or staining

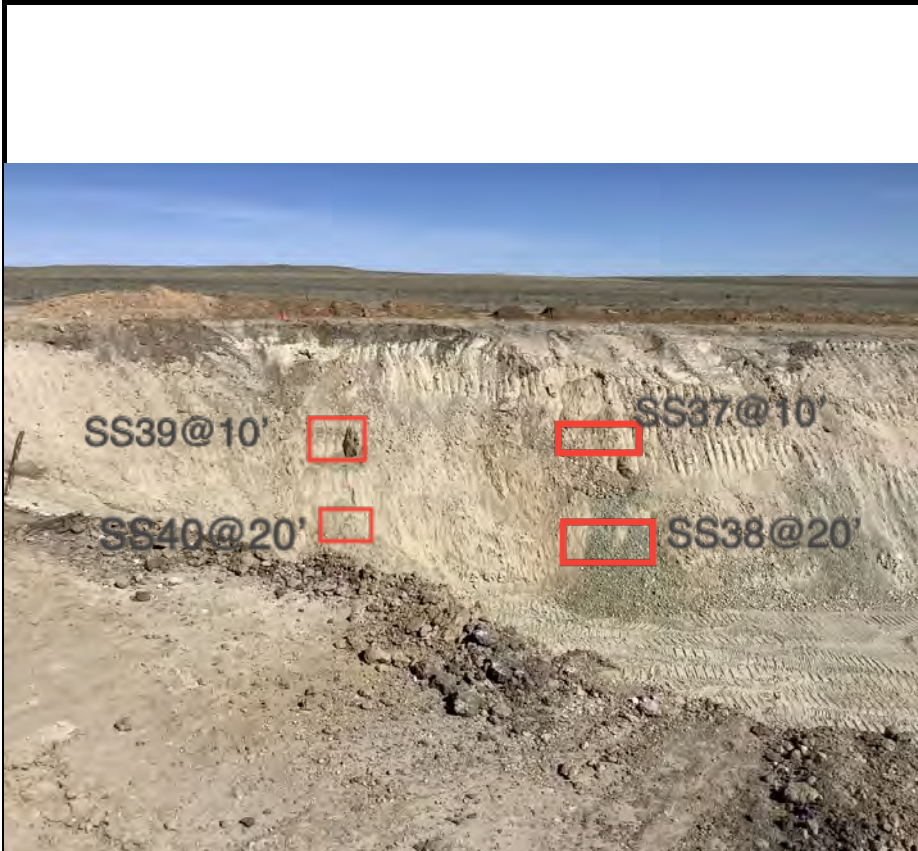
Equipment ID:		Equipment Type:	
Material:	Volume:	Contents:	
Notes/Conditions: SS37@10', SS38@20', SS39@10', S40@20' Facing north

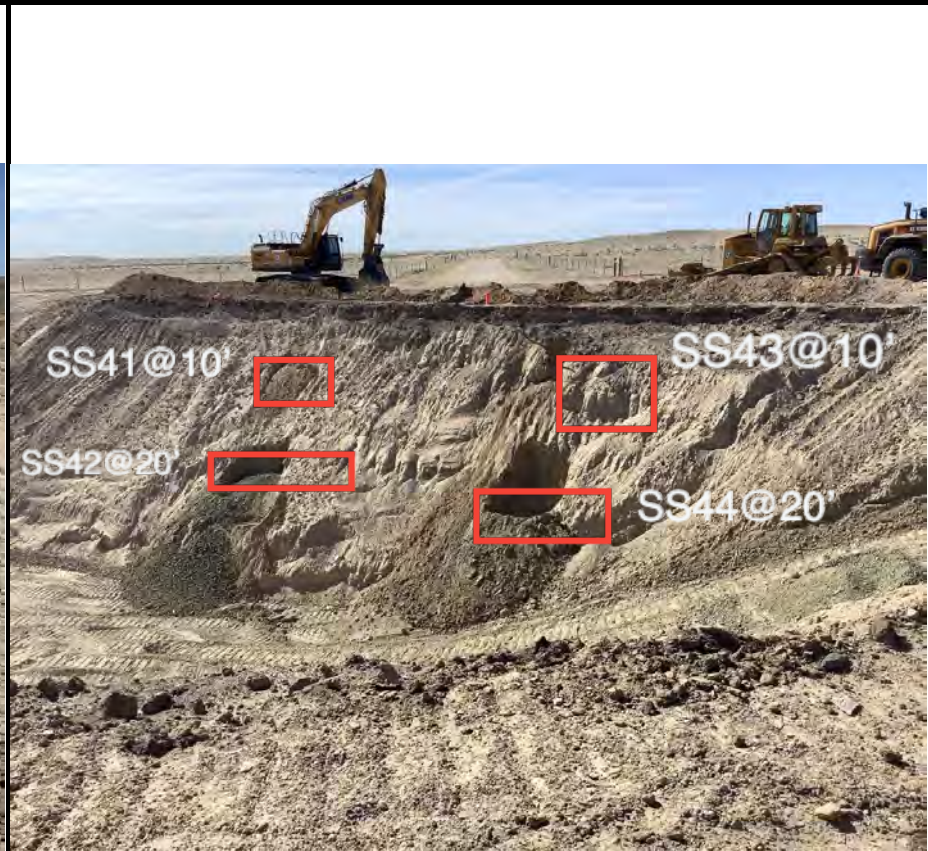
Equipment ID:		Equipment Type:	
Material:	Volume:	Contents:	
Notes/Conditions: SS41@10', SS42@20', SS43@10', SS44@20' Facing south

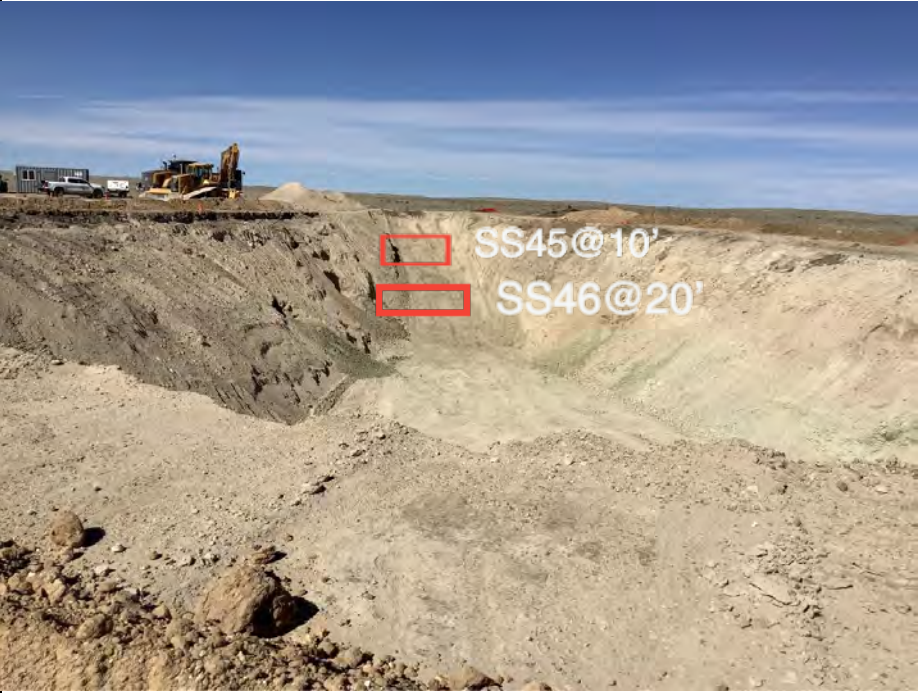
Equipment ID:		Equipment Type:		Equipment ID:		Equipment Type:	
Material:	Volume:	Contents:		Material:	Volume:	Contents:	
Notes/Conditions: SS45@10', SS46@20' Facing west				Notes/Conditions:

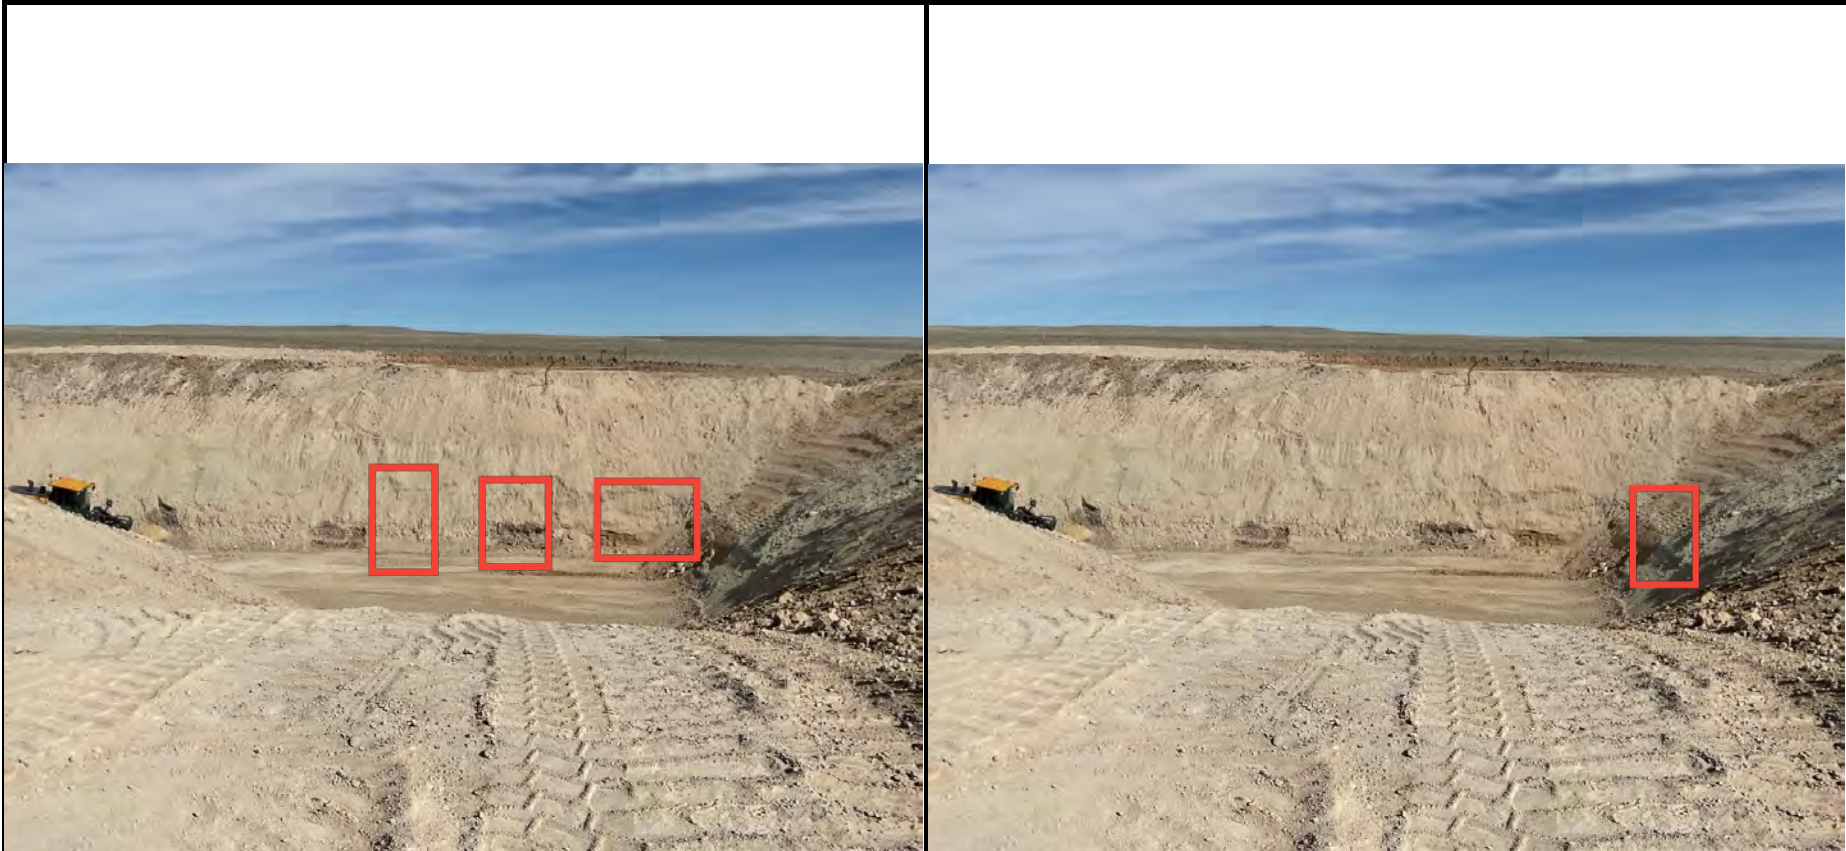
Notes/Conditions: Facing north
In order from left to right (SS41@29', SS42@29', SS43@29')

Notes/Conditions: Facing north
SS44@29' in the corner of the northeast section
