Noble Energy, Inc. – 100322 – DJ Basin
Lilli Unit N-5 Facility
 SESW, Section 5, Township 8 North, Range 58 West
 Weld County, Colorado

Excavation Soil Sample Location Map - Sidewalls
 (12/06/2024 – 04/08/2025)

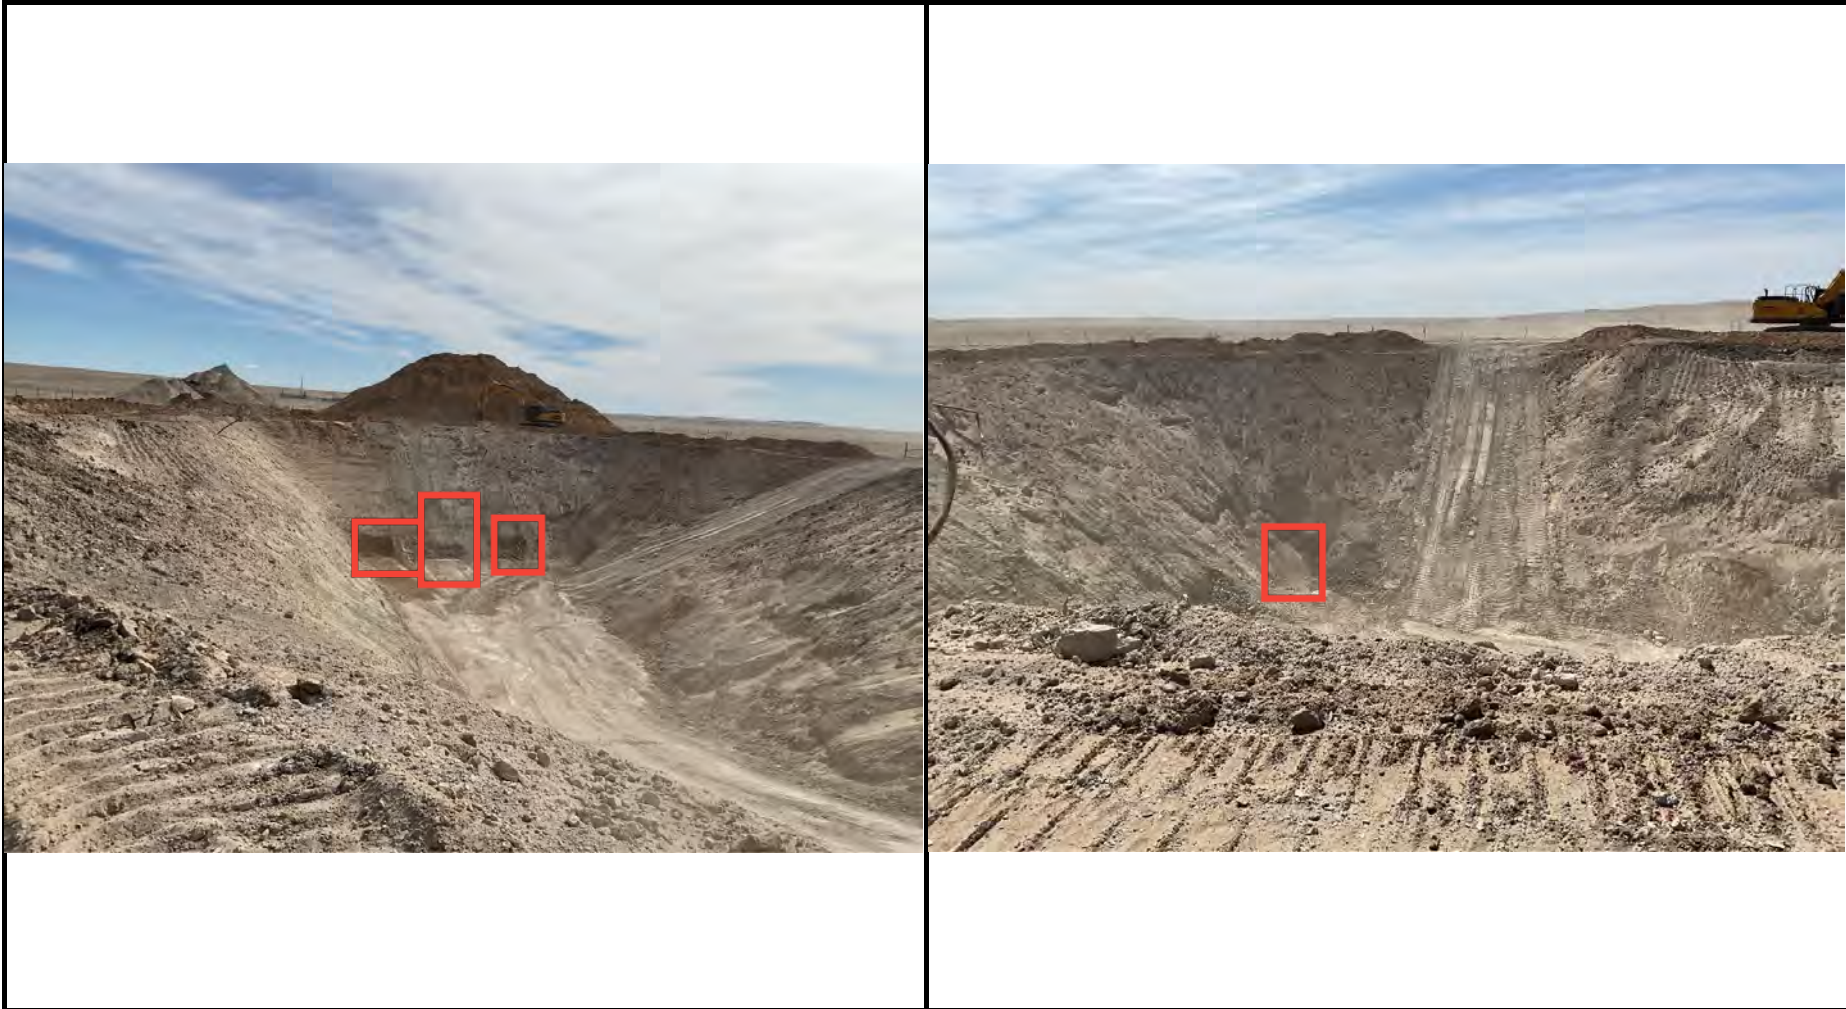
Equipment ID:		Equipment Type:		Equipment ID:		Equipment Type:	
Material:	Volume:	Contents:		Material:	Volume:	Contents:	
Notes/Conditions: Facing east From left to right (SS45@29', SS46@29', SS47@29')				Notes/Conditions: SS48@29' in the southeast corner of Facing south

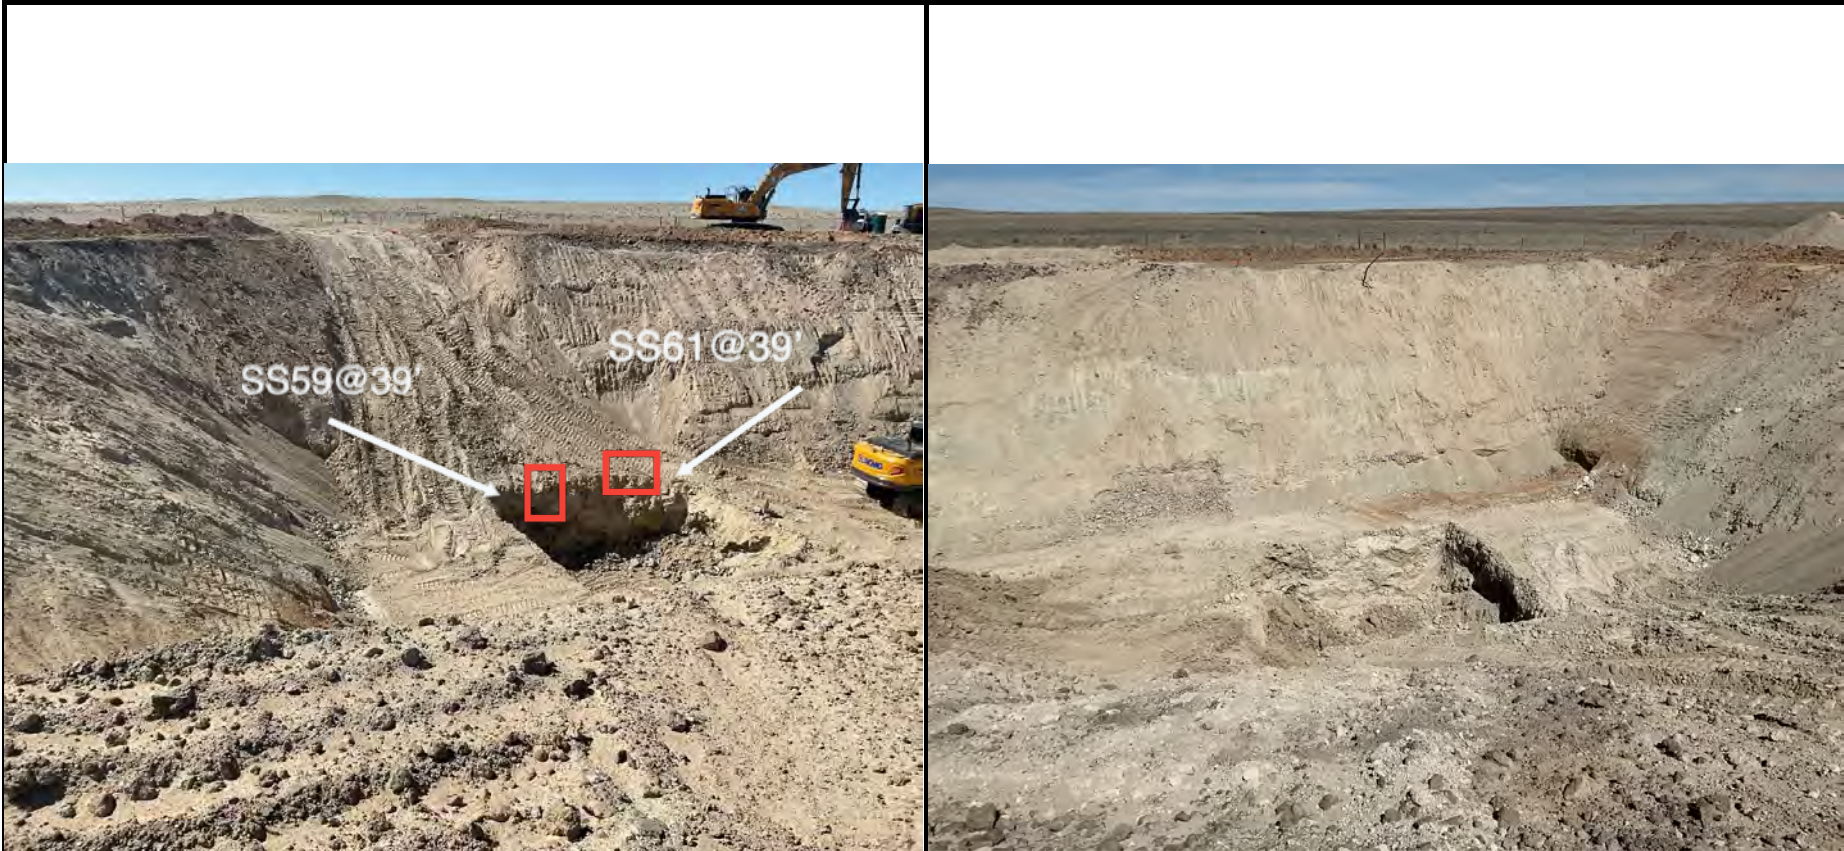
Notes/Conditions: Facing southwest
 SS59@39' and SS61@39' had low PIDs and no signs of staining or odor

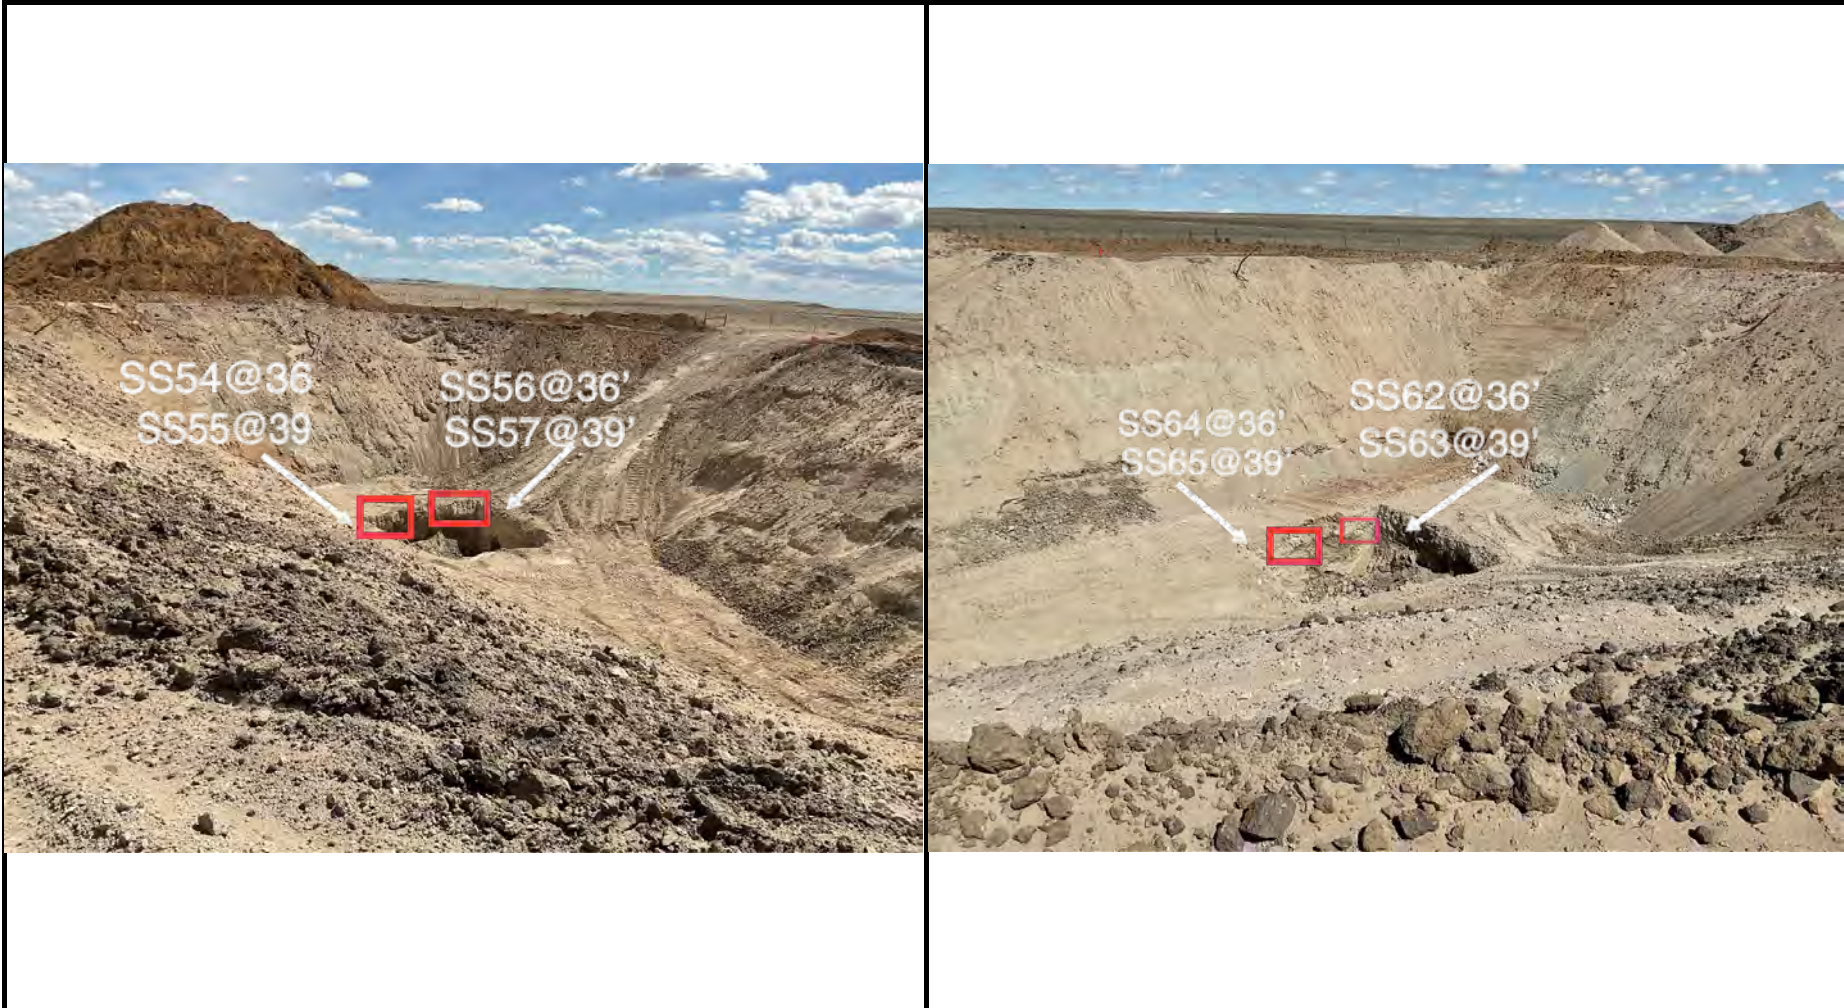
Equipment ID:		Equipment Type:		Equipment ID:		Equipment Type:	
Material:	Volume:	Contents:		Material:	Volume:	Contents:	
Notes/Conditions: Site photo facing east SS54@36', SS55@39', SS56@36', SS57@39' all showed no signs of staining or odor and had low PIDS				Notes/Conditions: Facing north SS62@36', SS63@39', SS64@36', SS65@39' all showed no signs of staining or odor and had low PIDS

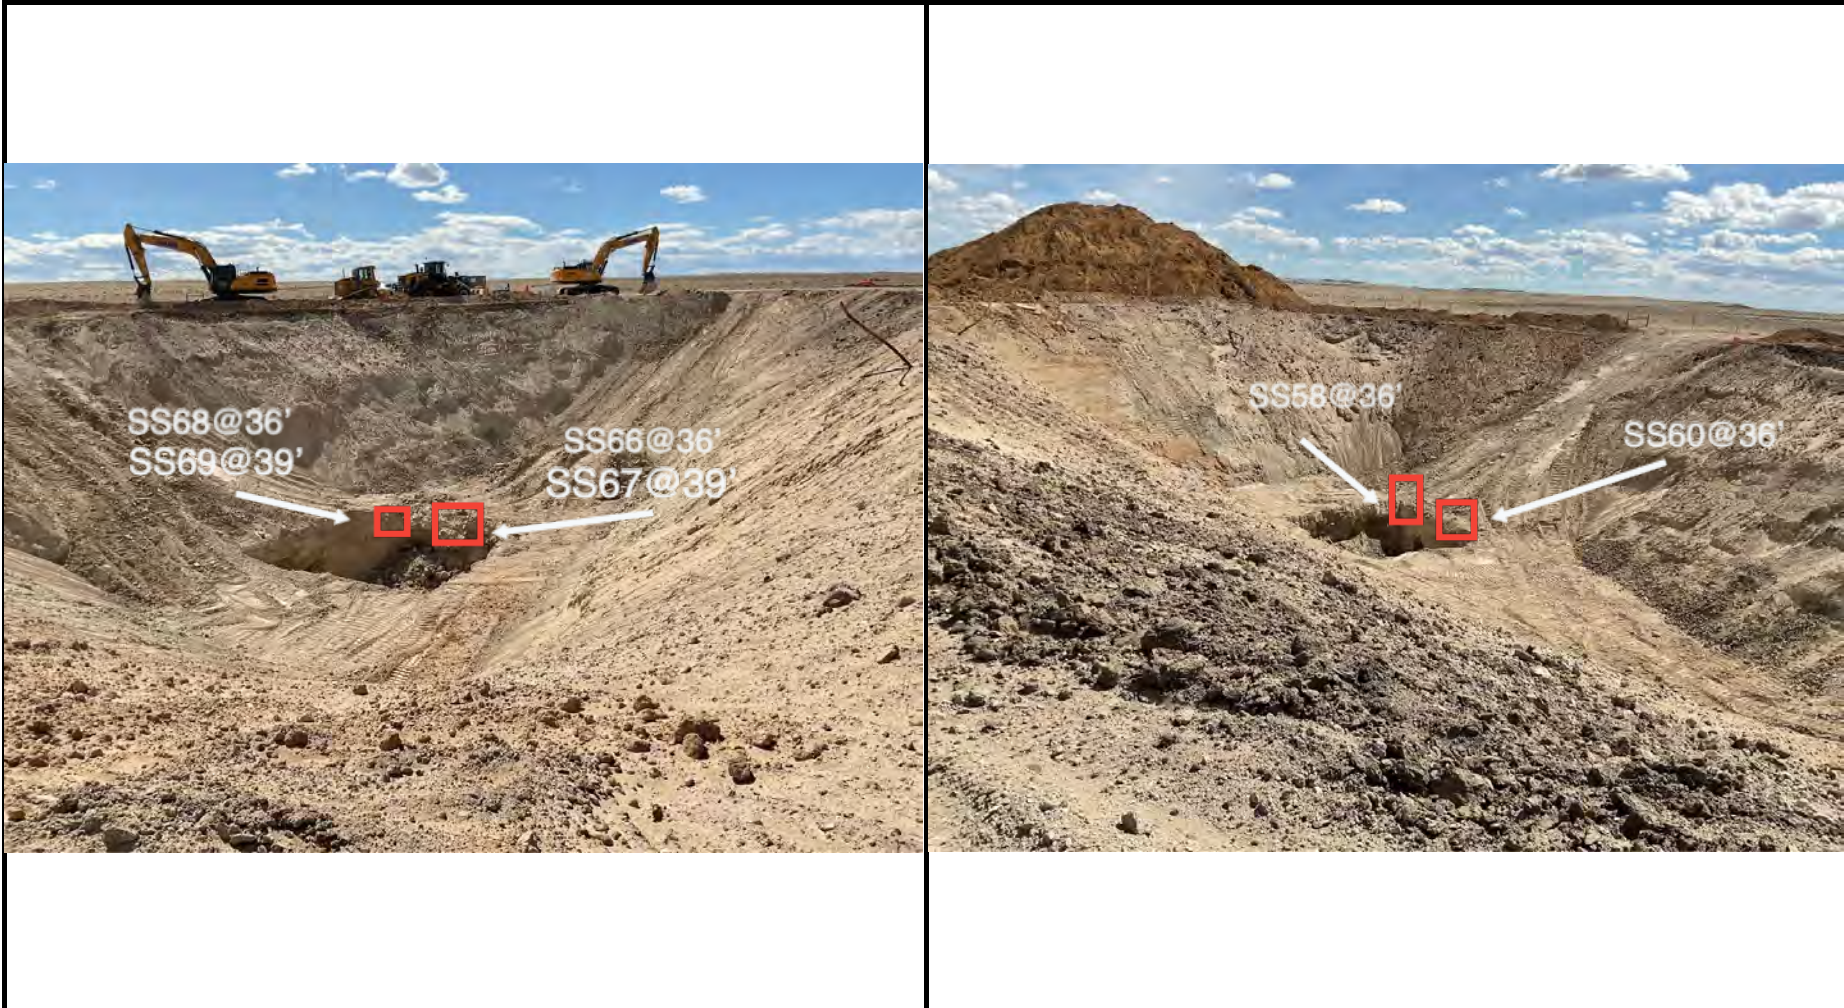
Notes/Conditions: Facing West
 SS66@36', SS67@39', SS68@36', SS69@39' all showed no signs of staining or odor and had low PIDS

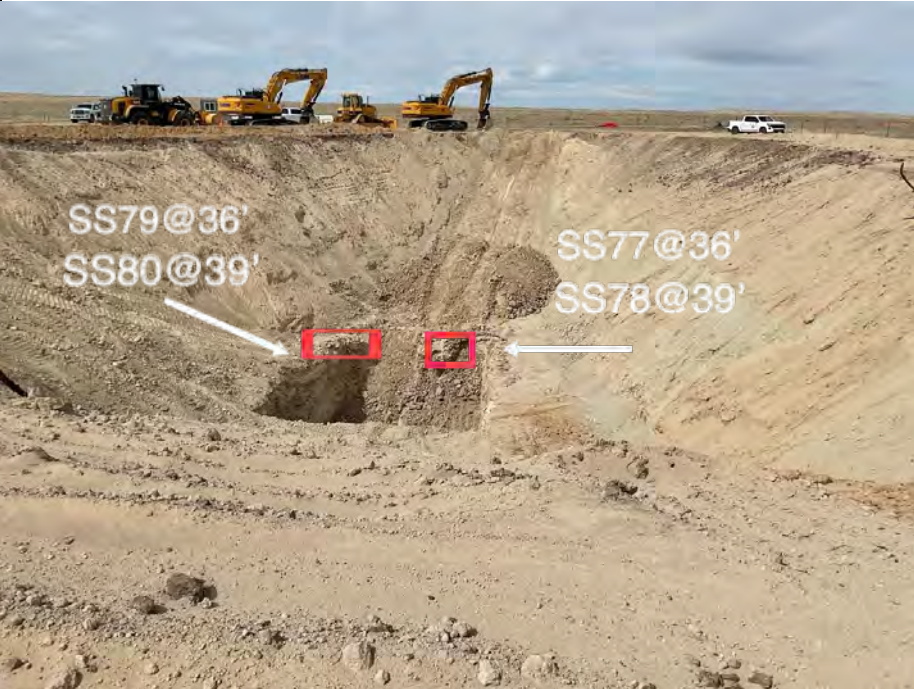
Notes/Conditions: Site photo facing east

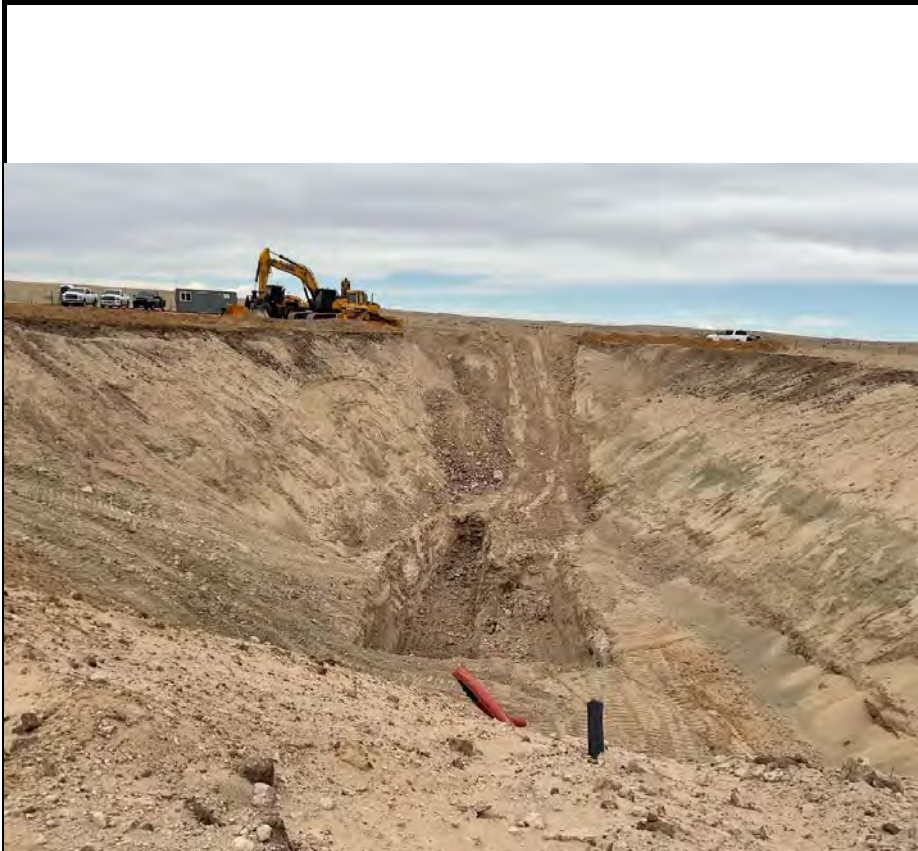
Equipment ID:		Equipment Type:	
Material:	Volume:	Contents:	
Notes/Conditions: Site photo facing north

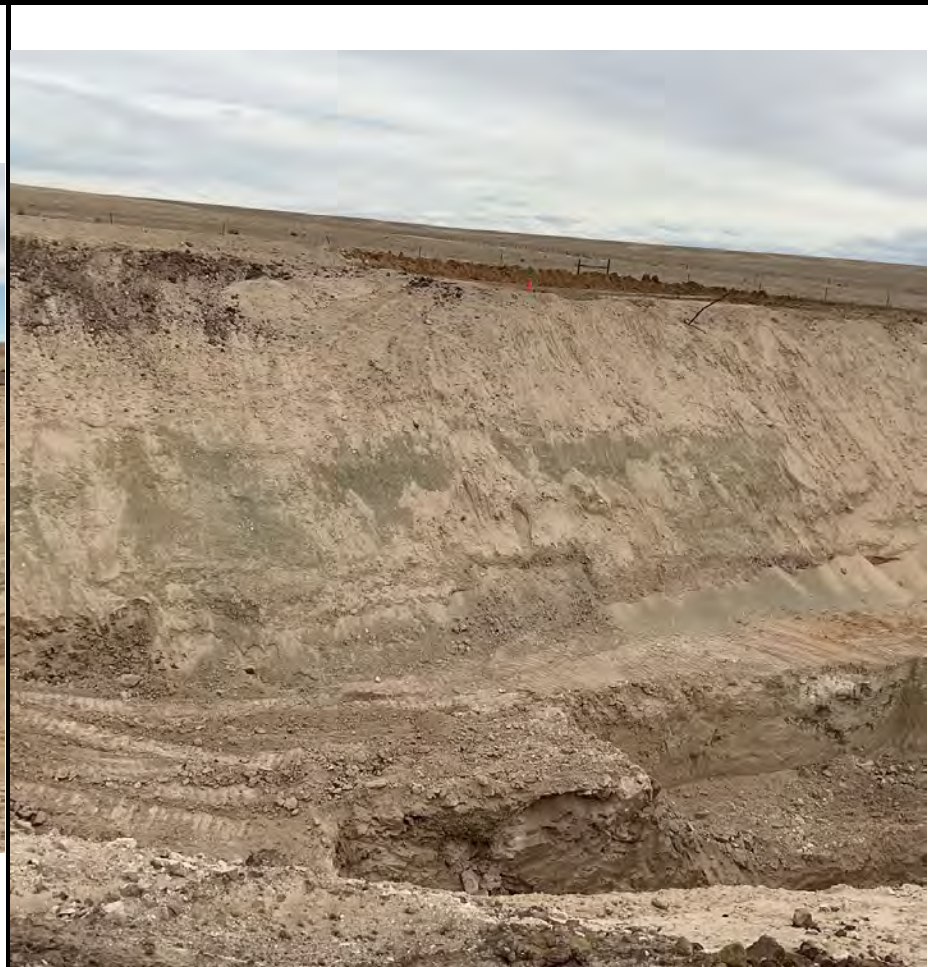
Equipment ID:		Equipment Type:	
Material:	Volume:	Contents:	
Notes/Conditions: Site photo facing north

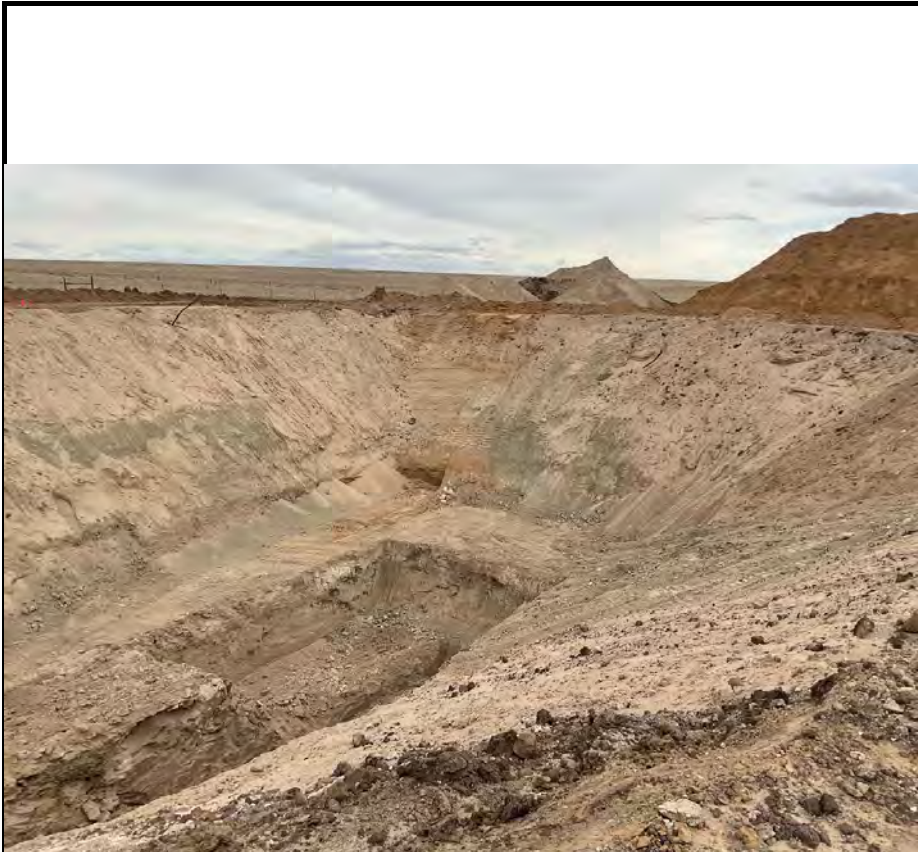
Equipment ID:		Equipment Type:	
Material:	Volume:	Contents:	
Notes/Conditions: Site photo facing northeast

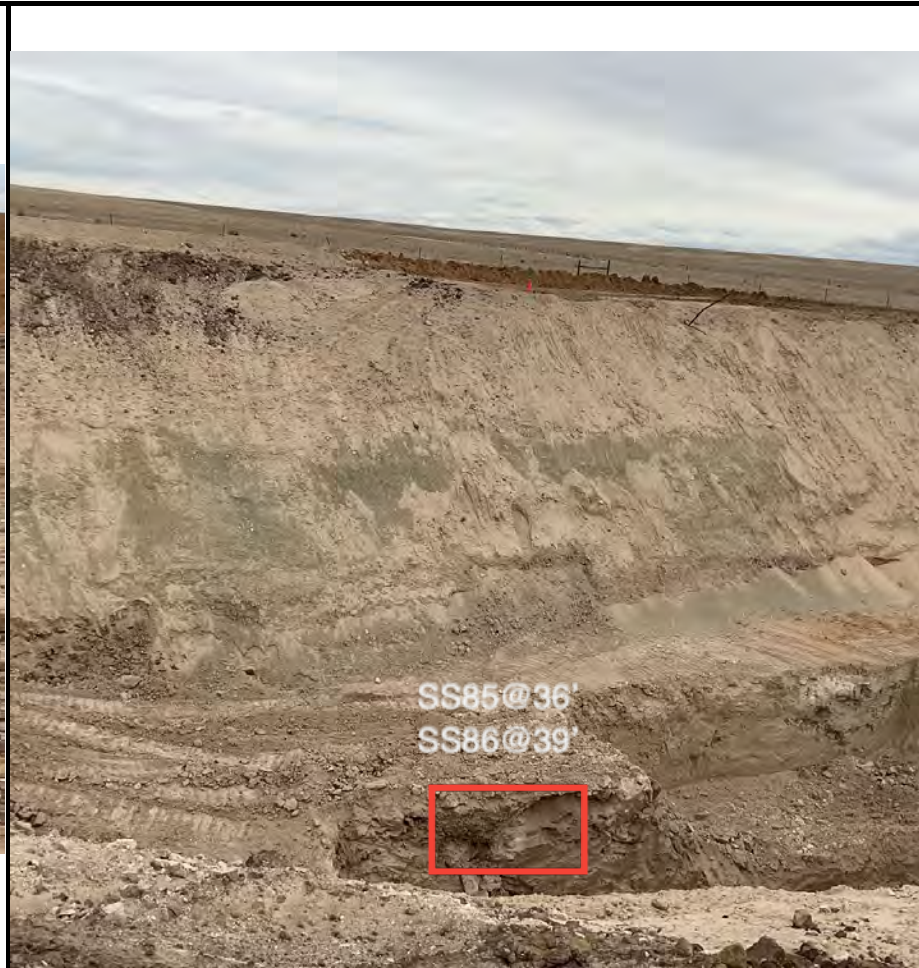
Equipment ID:		Equipment Type:	
Material:	Volume:	Contents:	
Notes/Conditions: Site photo facing north

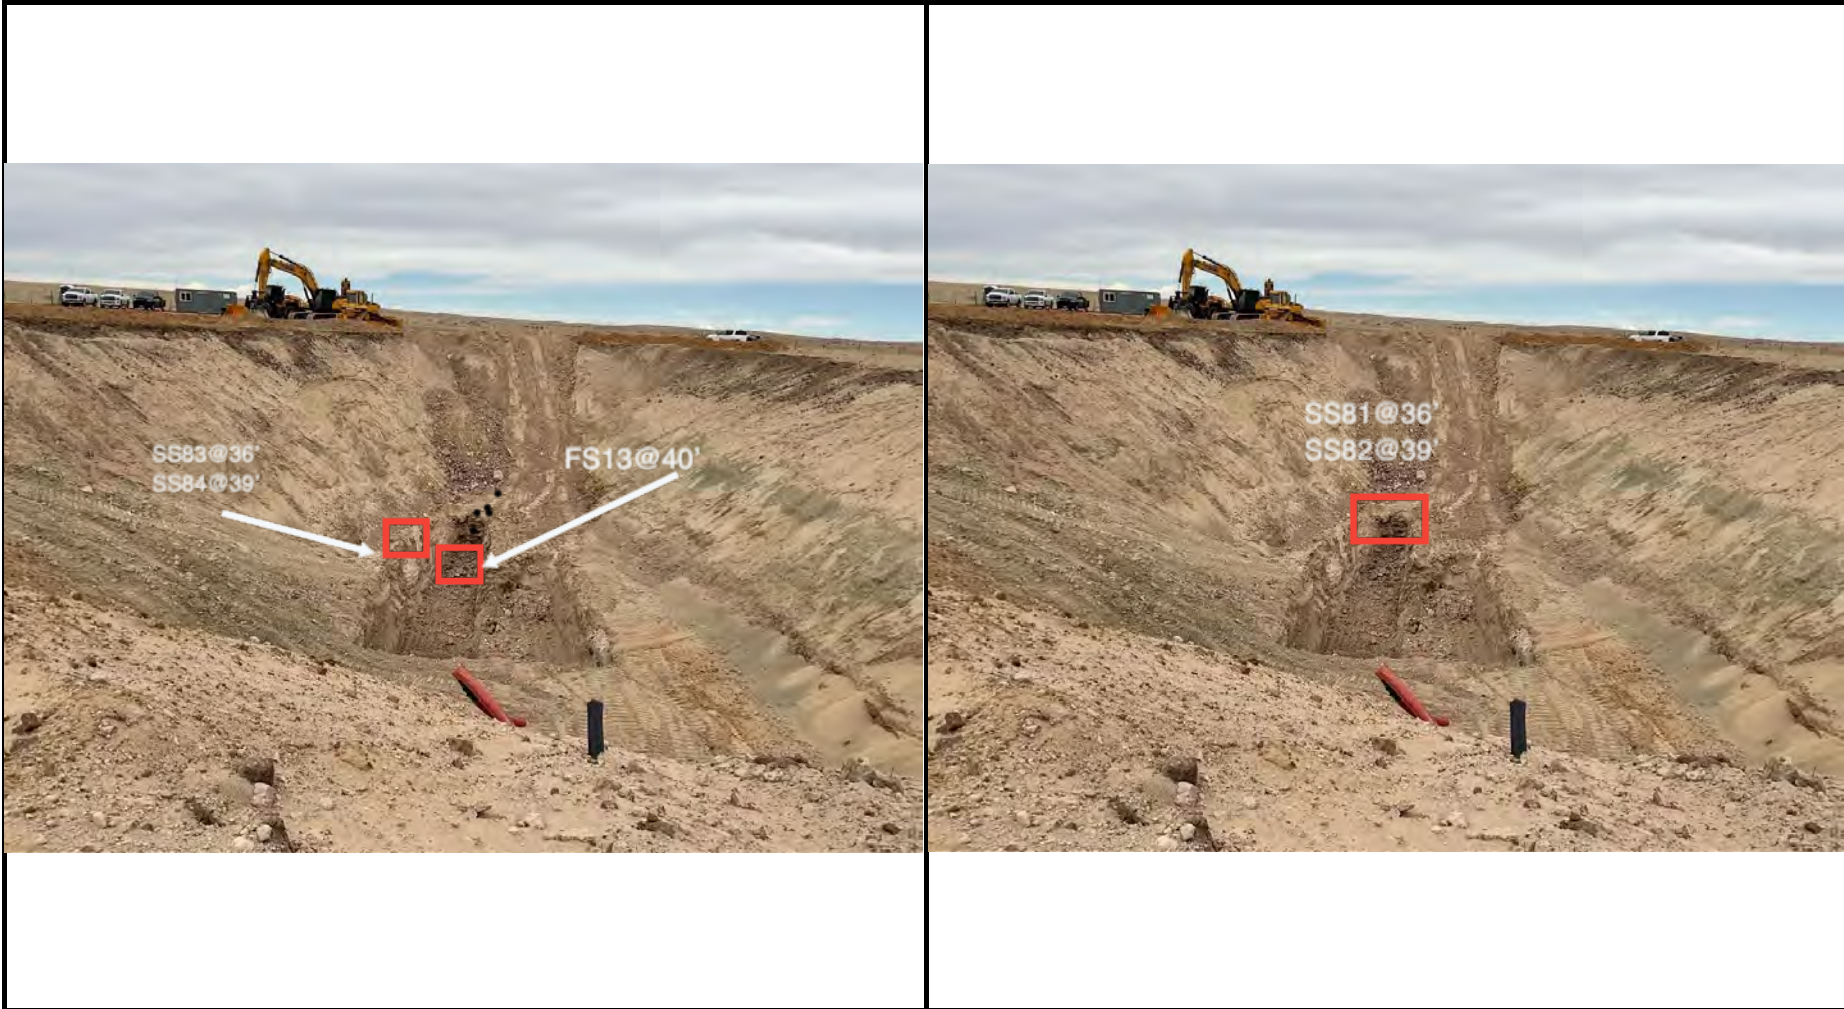
Equipment ID:		Equipment Type:	
Material:	Volume:	Contents:	
Notes/Conditions: Facing west

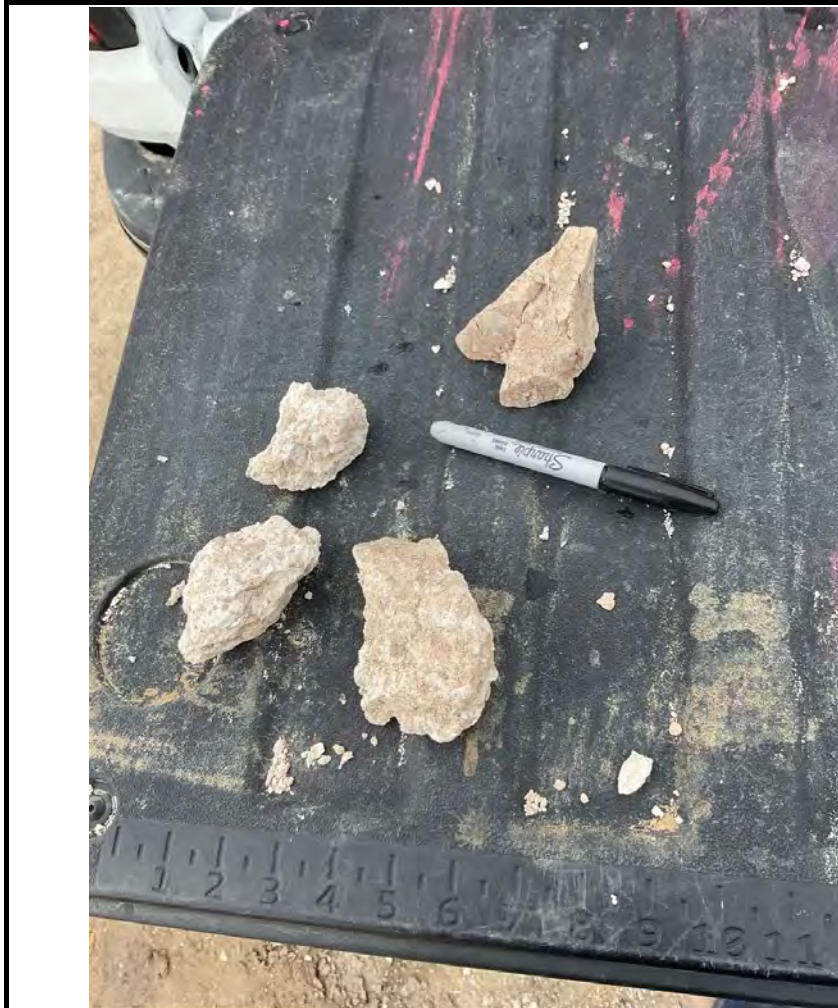
Equipment ID:		Equipment Type:		Equipment ID:		Equipment Type:	
Material:	Volume:	Contents:		Material:	Volume:	Contents:	
Notes/Conditions: Soil was a SC clayey sand brown/white medium plasticity, dry, no staining or odor				Notes/Conditions:

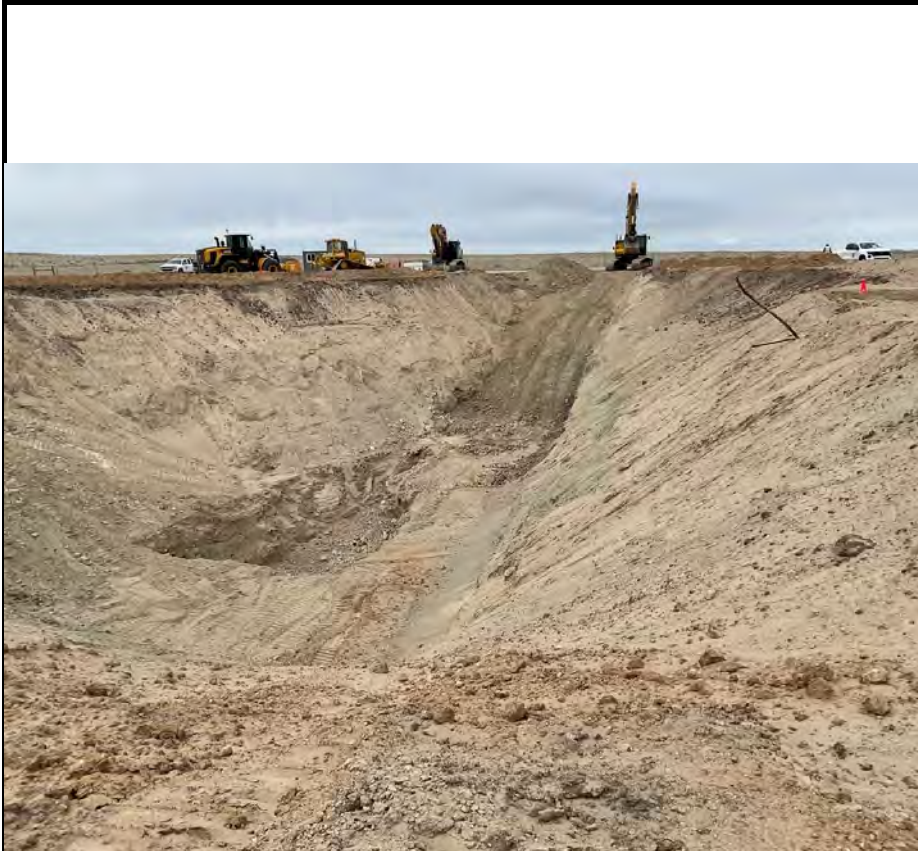
Equipment ID:		Equipment Type:	
Material:	Volume:	Contents:	
Notes/Conditions: Site photo facing west

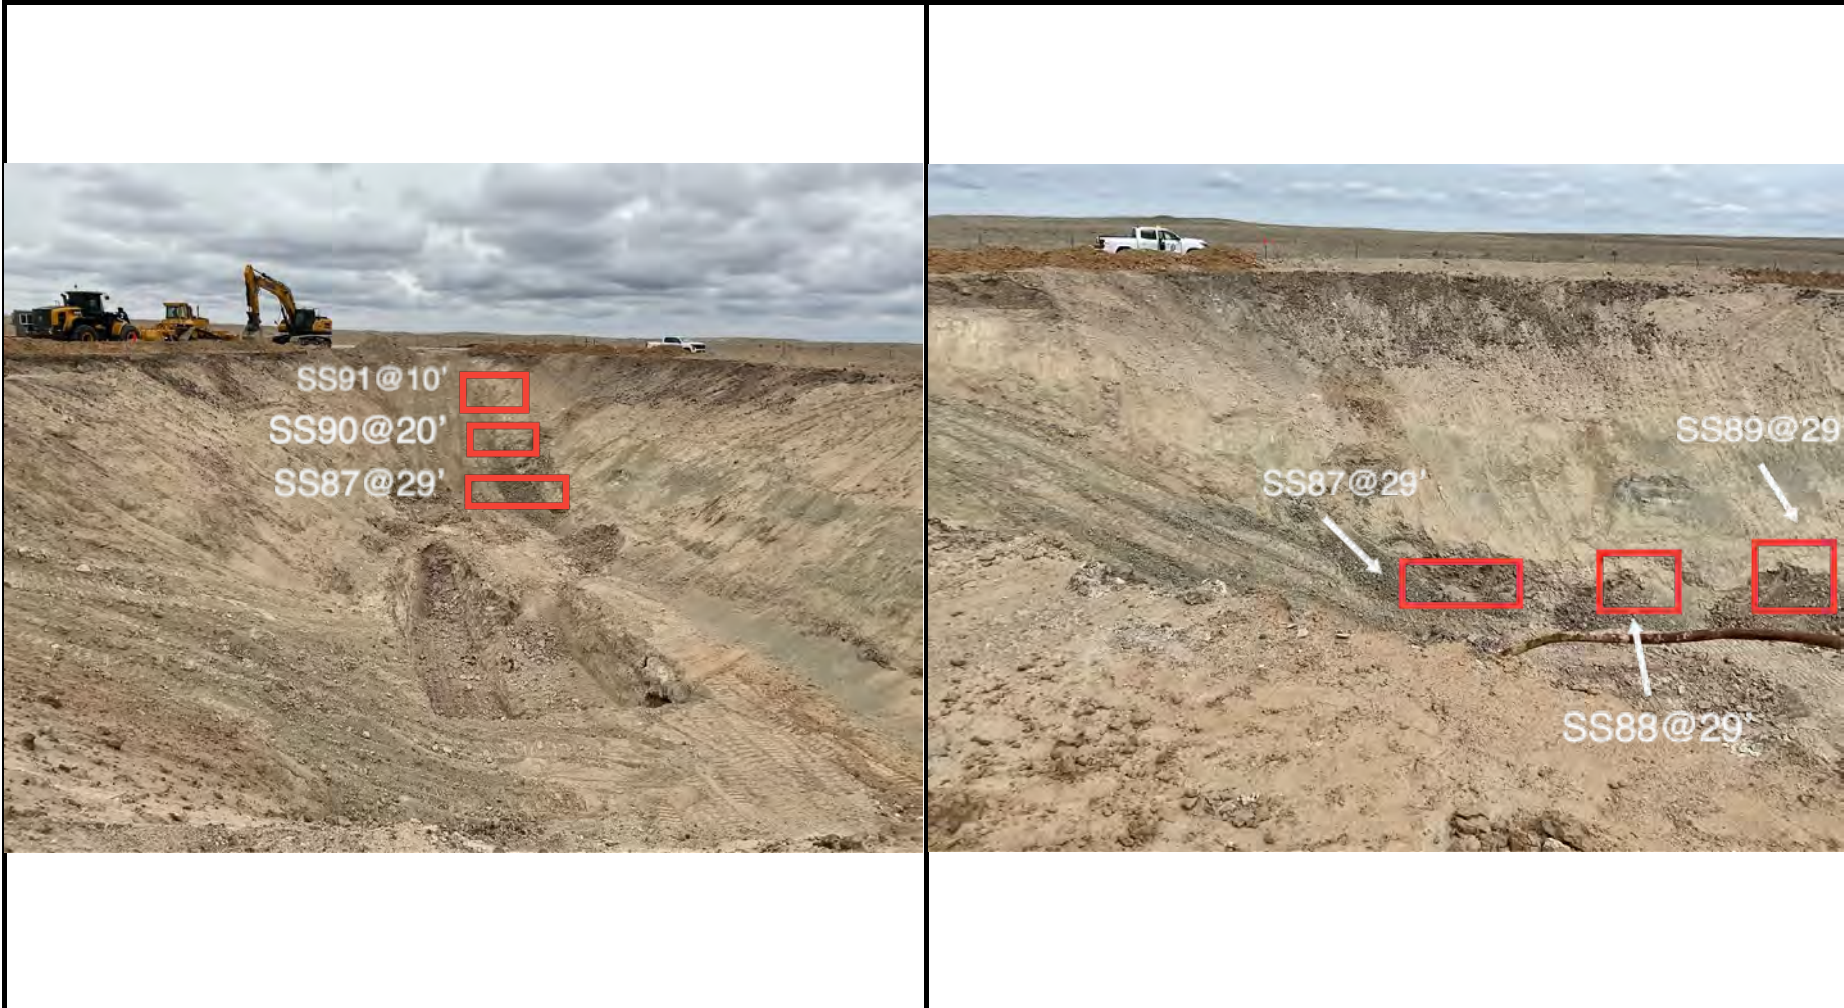
Notes/Conditions: Facing west
All soil samples had low PIDS and no signs of staining or odor

Notes/Conditions: Facing north
All soil samples had low PIDS and no signs of staining or odor

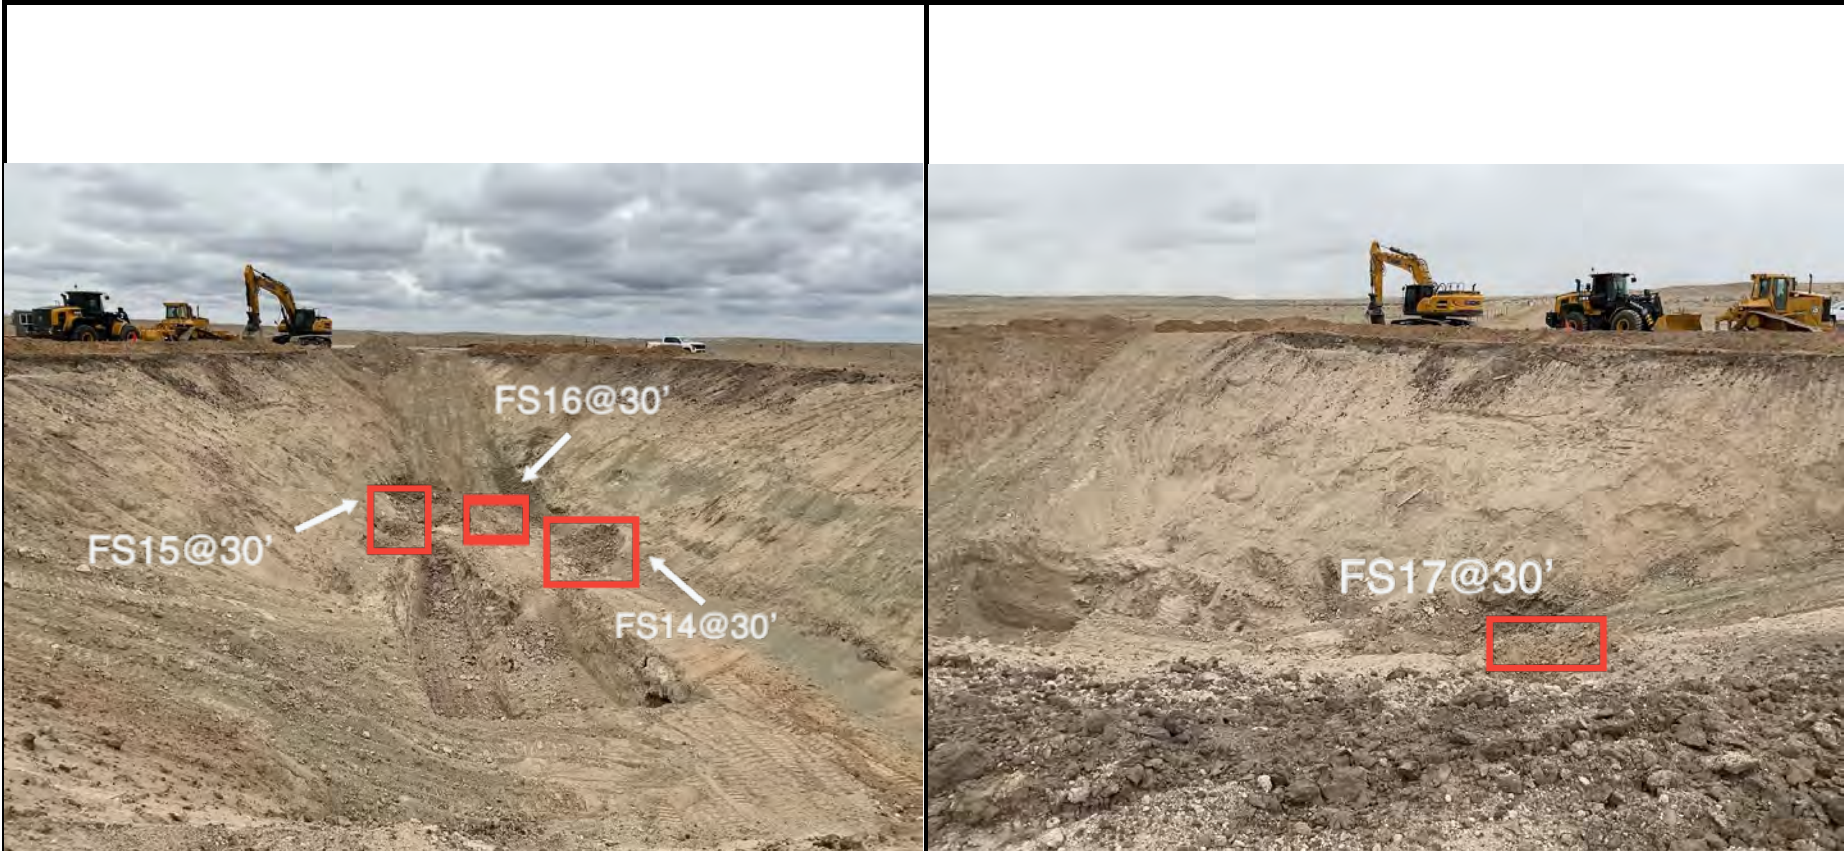
Notes/Conditions: Facing west
 Had to take the floor sample in this view due to being able to get a photo in another direction to show the base samples due to safety concerns
