Inspection Photos

Operator: Caerus Piceance LLC #10456

Location ID: 398469

Inspection Doc: 719200084

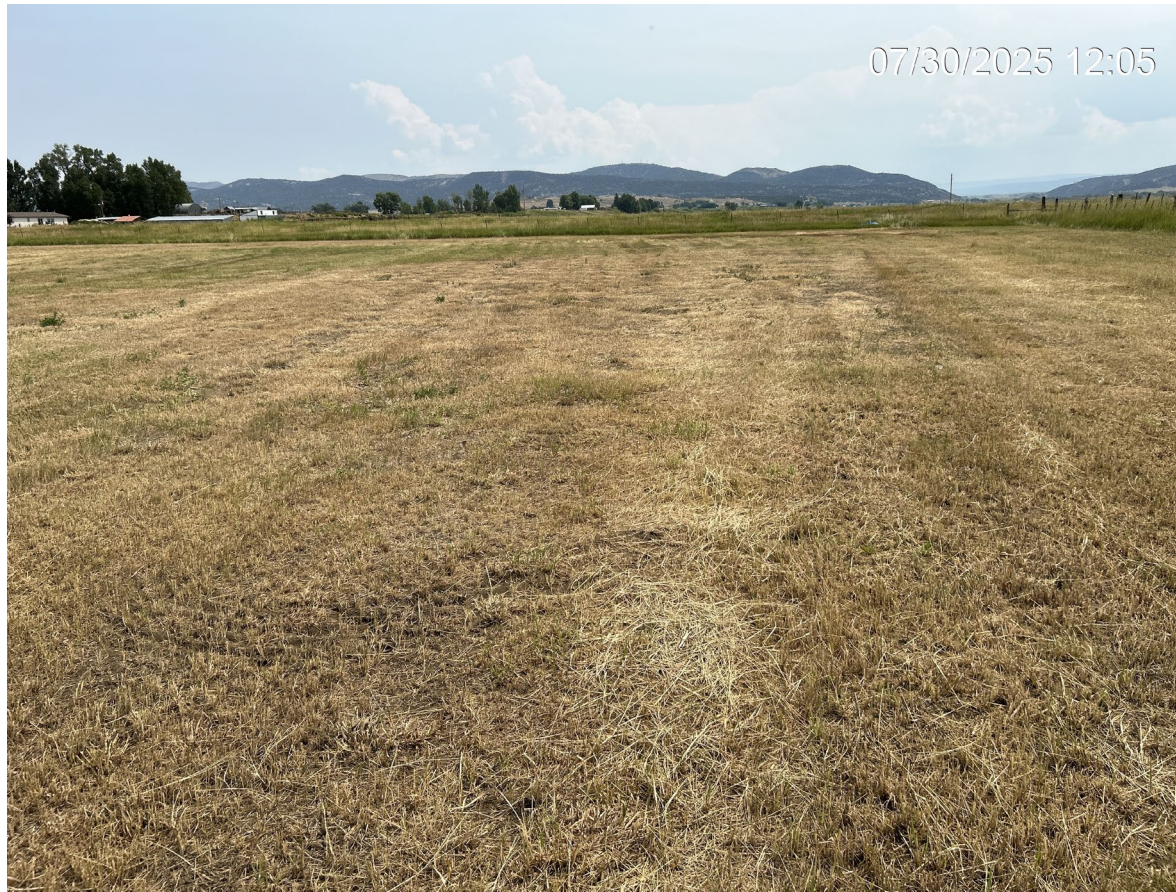
Photo 1: Photo taken showing an overview of the Location looking east. Bare patches and undesirable plant species appear to be present.

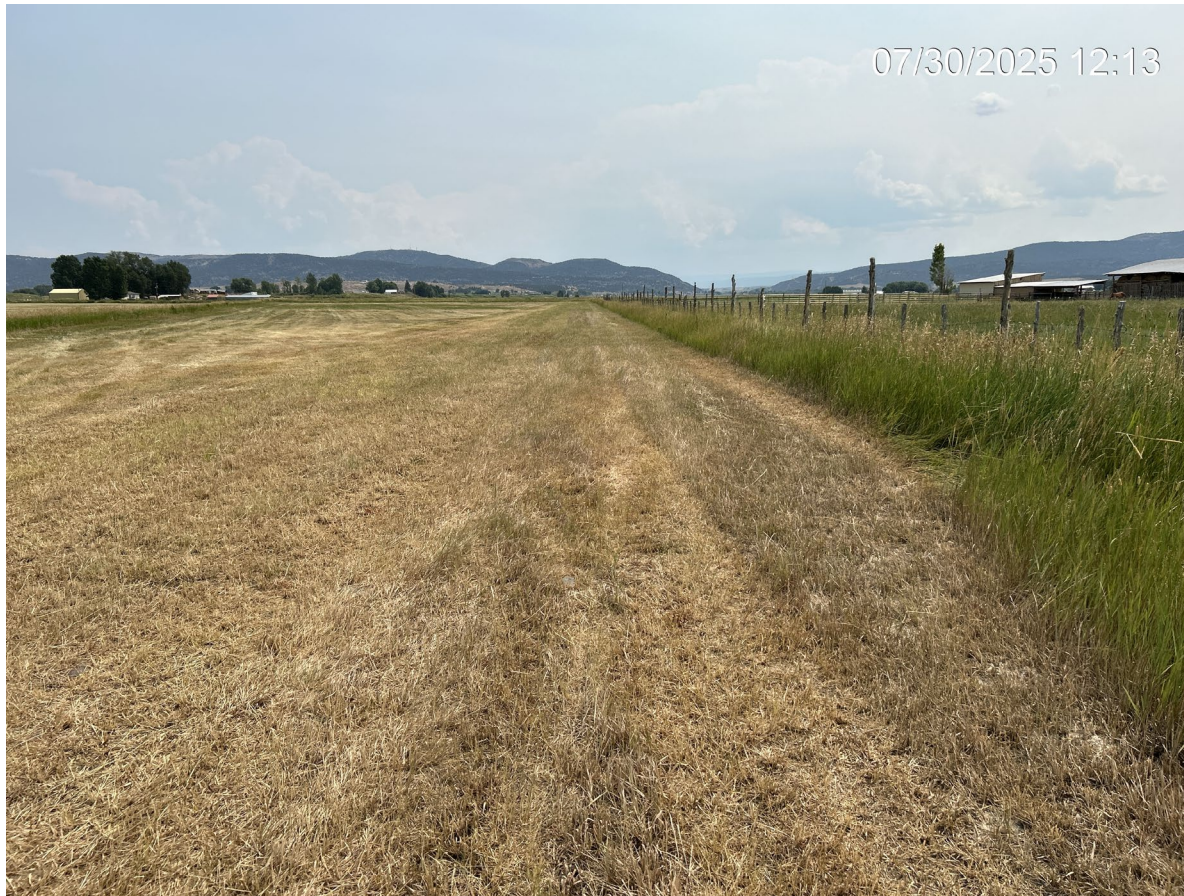
Photo 2: Photo taken of the access to the Location looking east. The access road has been reclaimed.

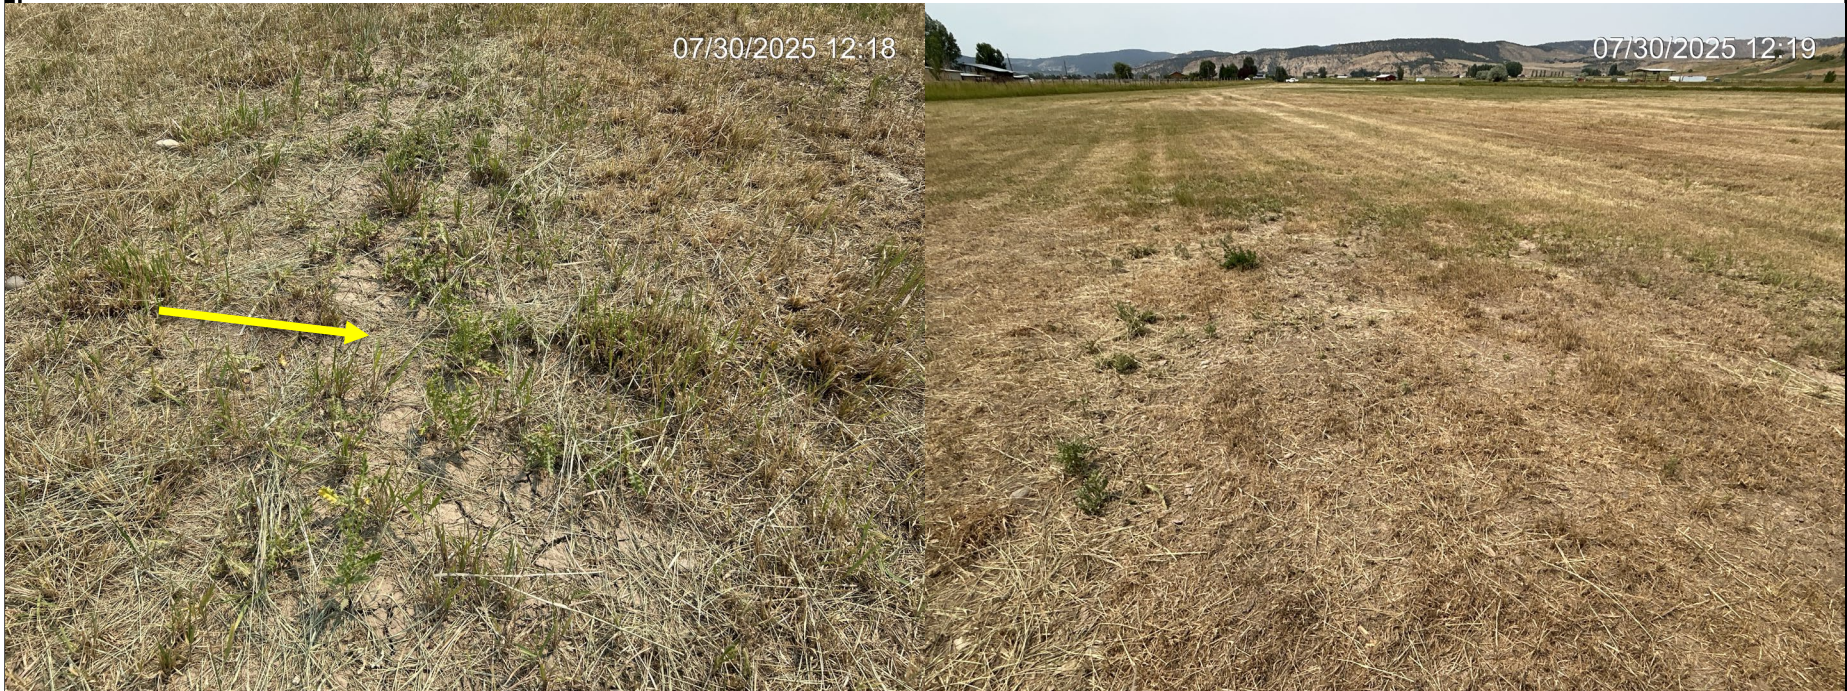
Photo 3: Photos showing an example of Canada thistle growing throughout the Location. Comply with Rules 606.c. and 1004.a.
