Final Reclamation Inspection

Operator: PDC ENERGY INC - 69175

Location ID: 419100

Inspection Photos
Location Name: RICH #3-28
Location ID: 419100

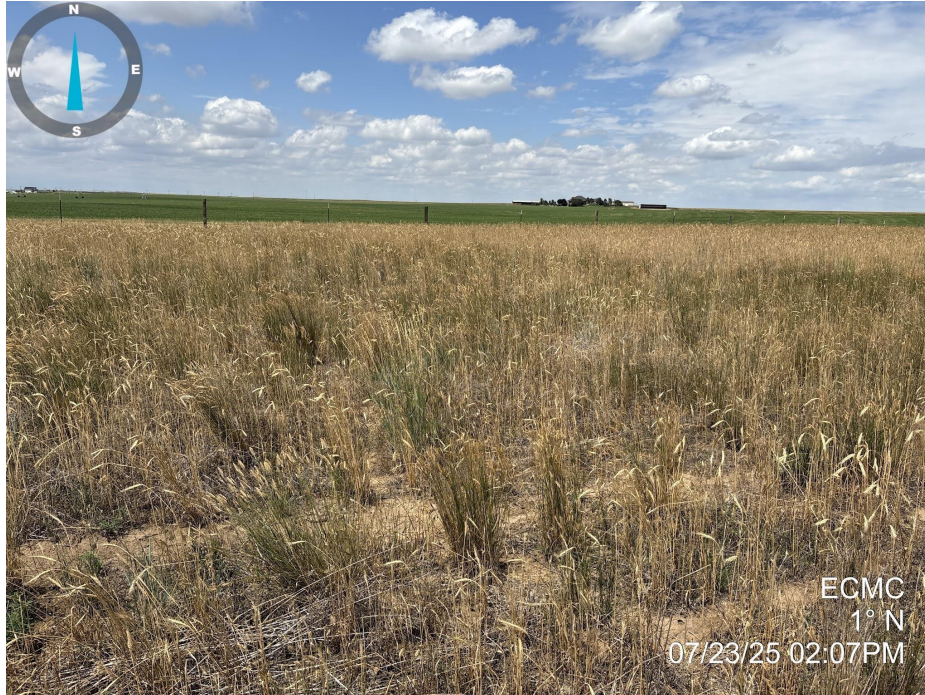
Photo 1. Photo taken from the well location, facing North. Photo illustrates that vegetation has not established to Rule 1004 standards and subsidence was observed at the location.

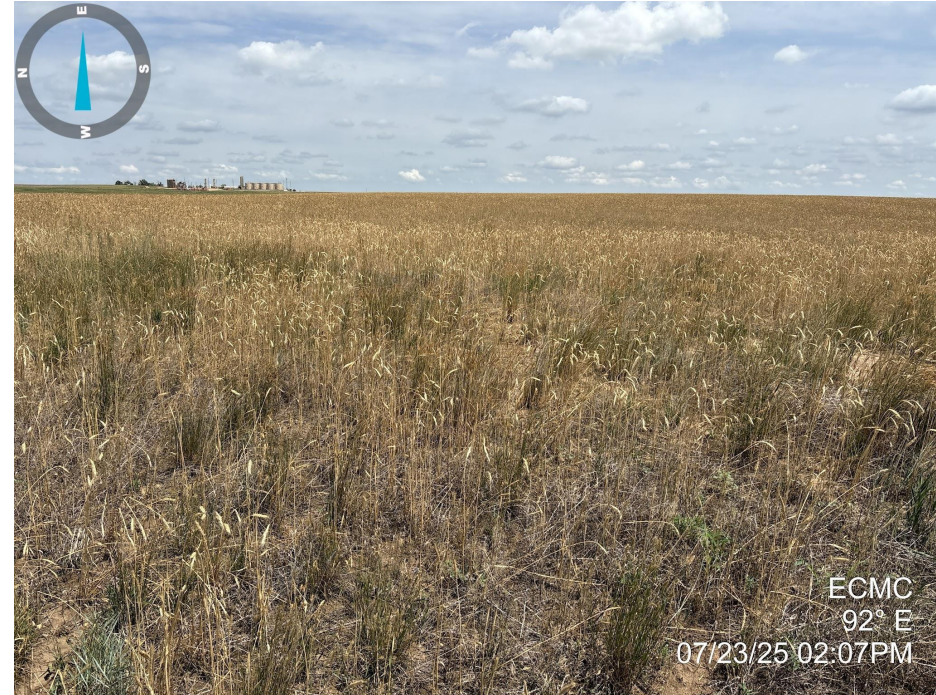
Photo 2. Photo taken from the well location, facing East. See comments under Photo 1.

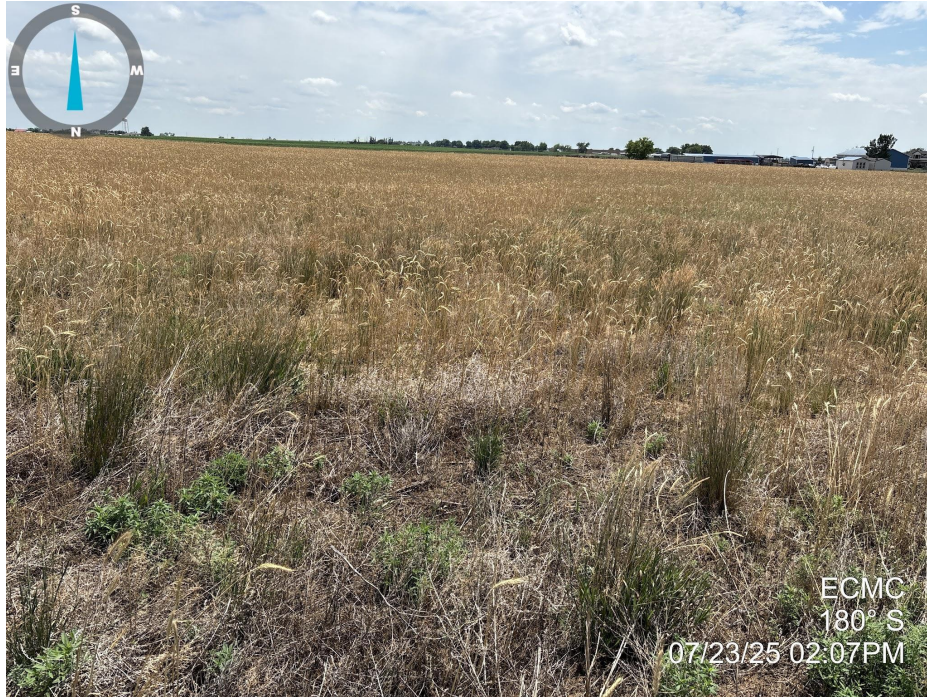
Photo 3. Photo taken from the well location, facing South. See comments under Photo 1.

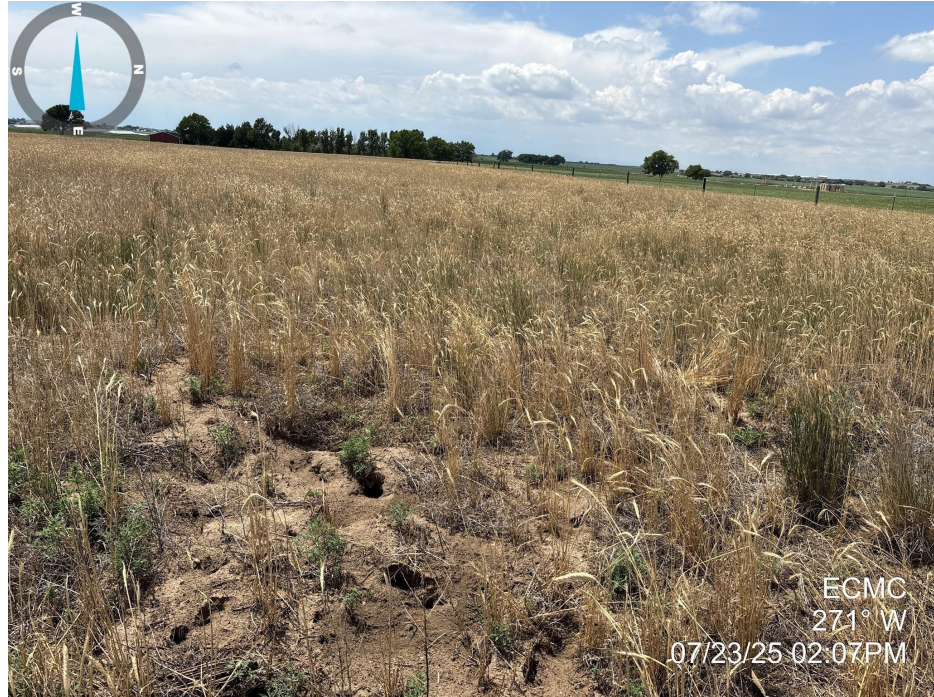
Photo 4. Photo taken from the well location, facing West. See comments under Photo 1. Photo illustrates subsidence that was observed at the location.

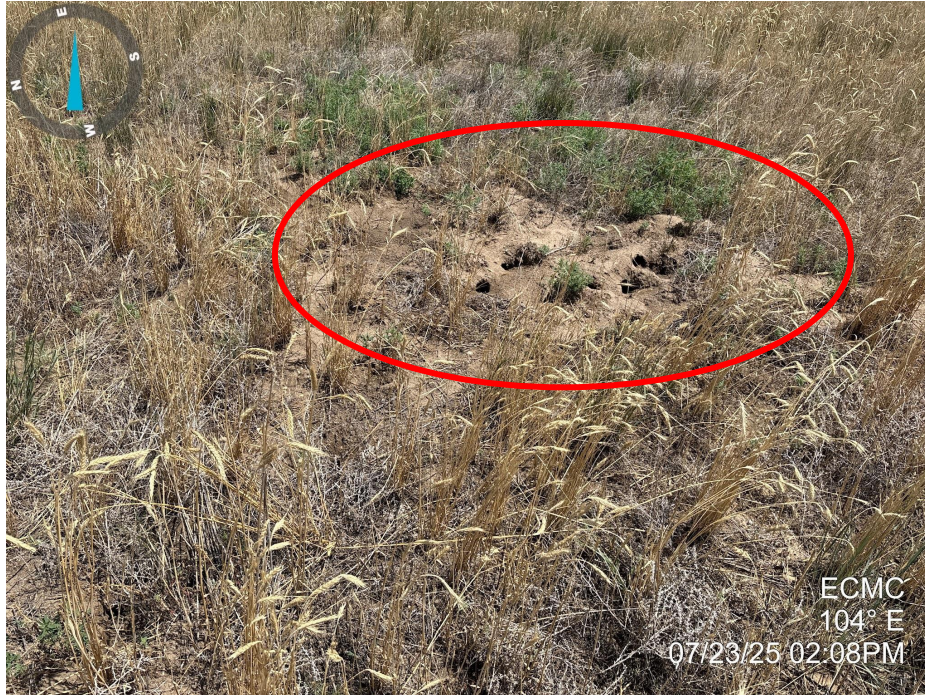
Photo 5. Photo taken of ground cover at the well location. Photo illustrates subsidence at the location, highlighted in red.

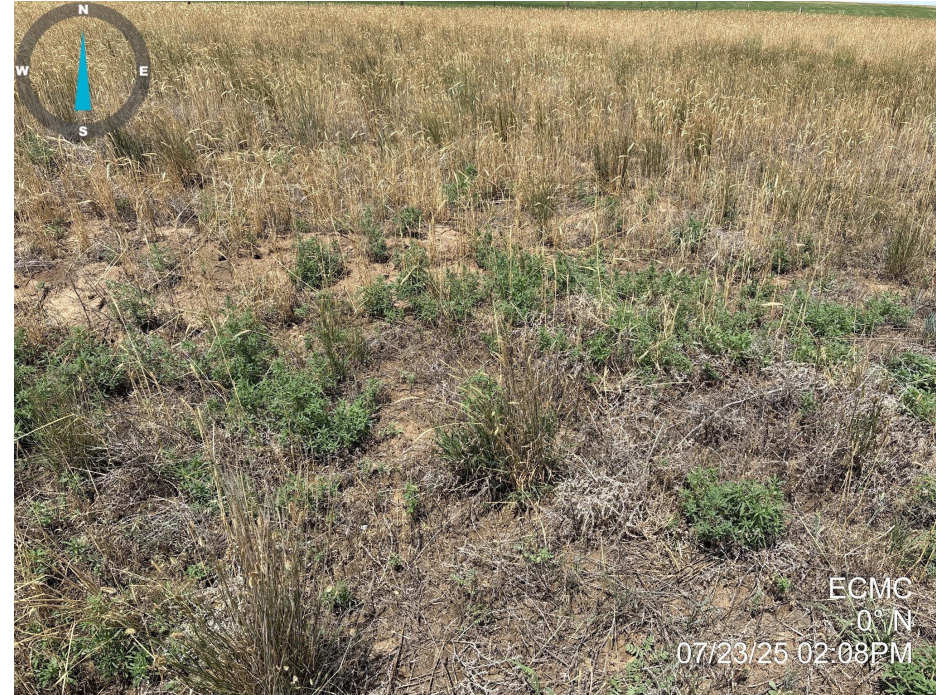
Photo 6. Photo taken of the well location, facing north. Photo illustrates weedy annual vegetation was observed across the location including kochia (*Bassia scoparia*) and russian thistle (*Salsola tragus*).

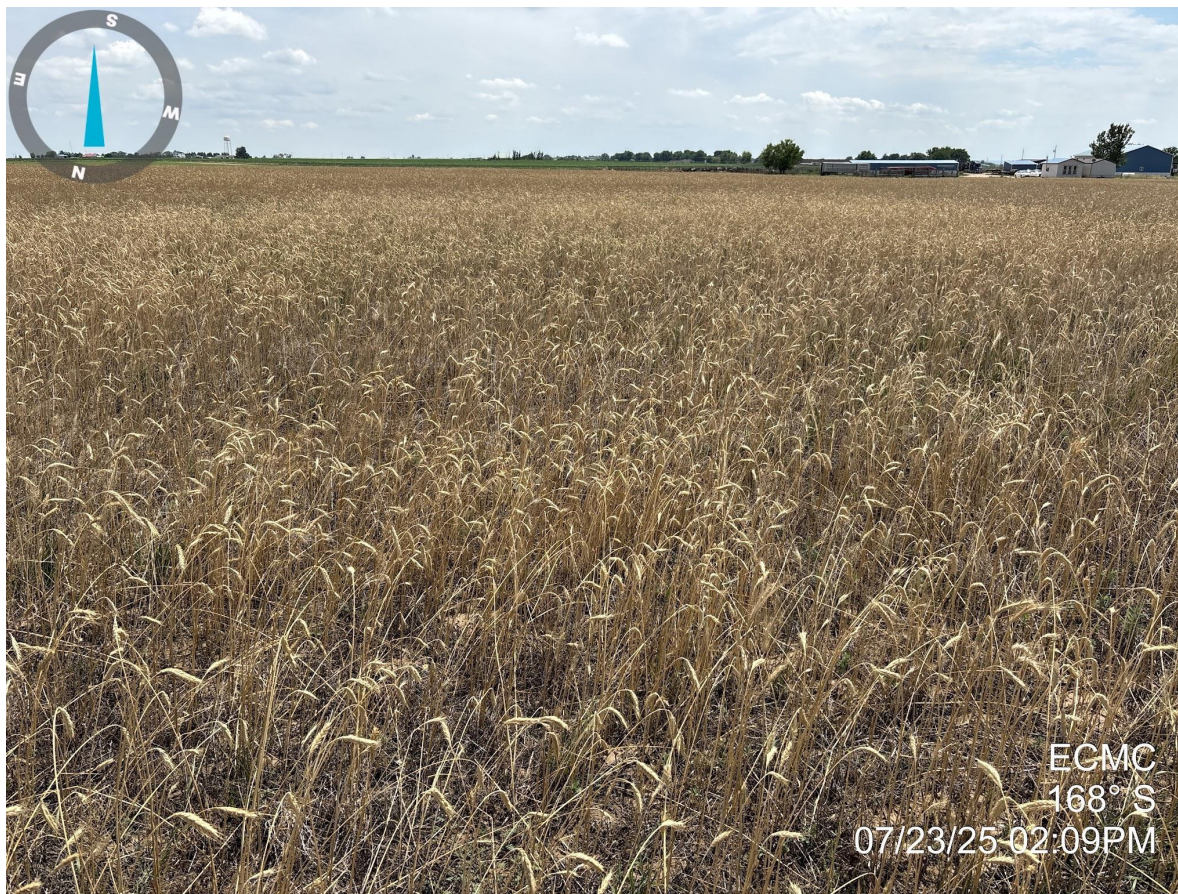
Photo 7. Photo taken of the reference area to the location, east of the location, facing south. Photo illustrates rye cropland.
