FREMONT ENVIRONMENTAL INC.

Subject: **Facility Closure Data Submittal**
Ewing Robert Fed T4N-R66W-S14 L01
NWNE Sec. 14, T4N, R66W
Weld County, Colorado
Fremont Project No. C024-109
Facility # 332527, Remediation #32879

Tank Battery Closure Checklist

Buried or Partially Buried Vessel Closure Checklist

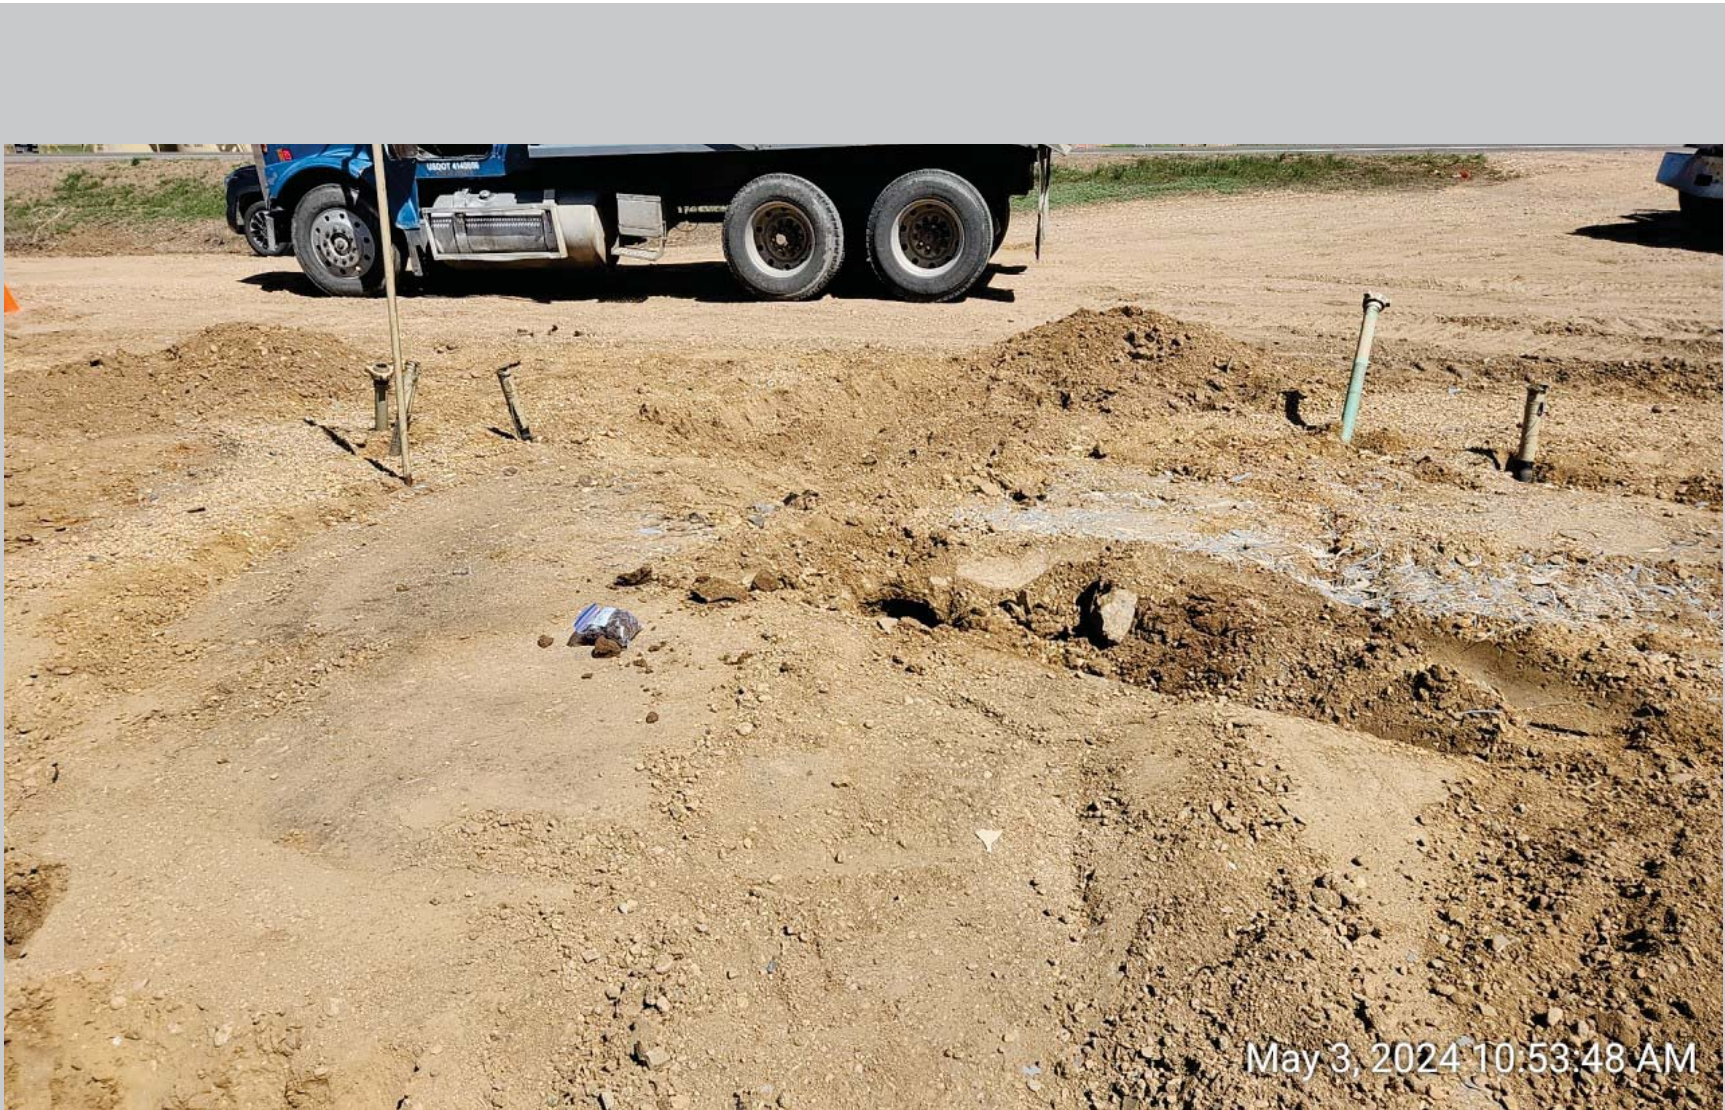
#1A - Ewing Robert Fed T4N-R66W-S14 L01 - 1st Above Ground Storage Tank (Oil) - AST01@6.0" - No Impacts Noted - PID: 0.2ppm

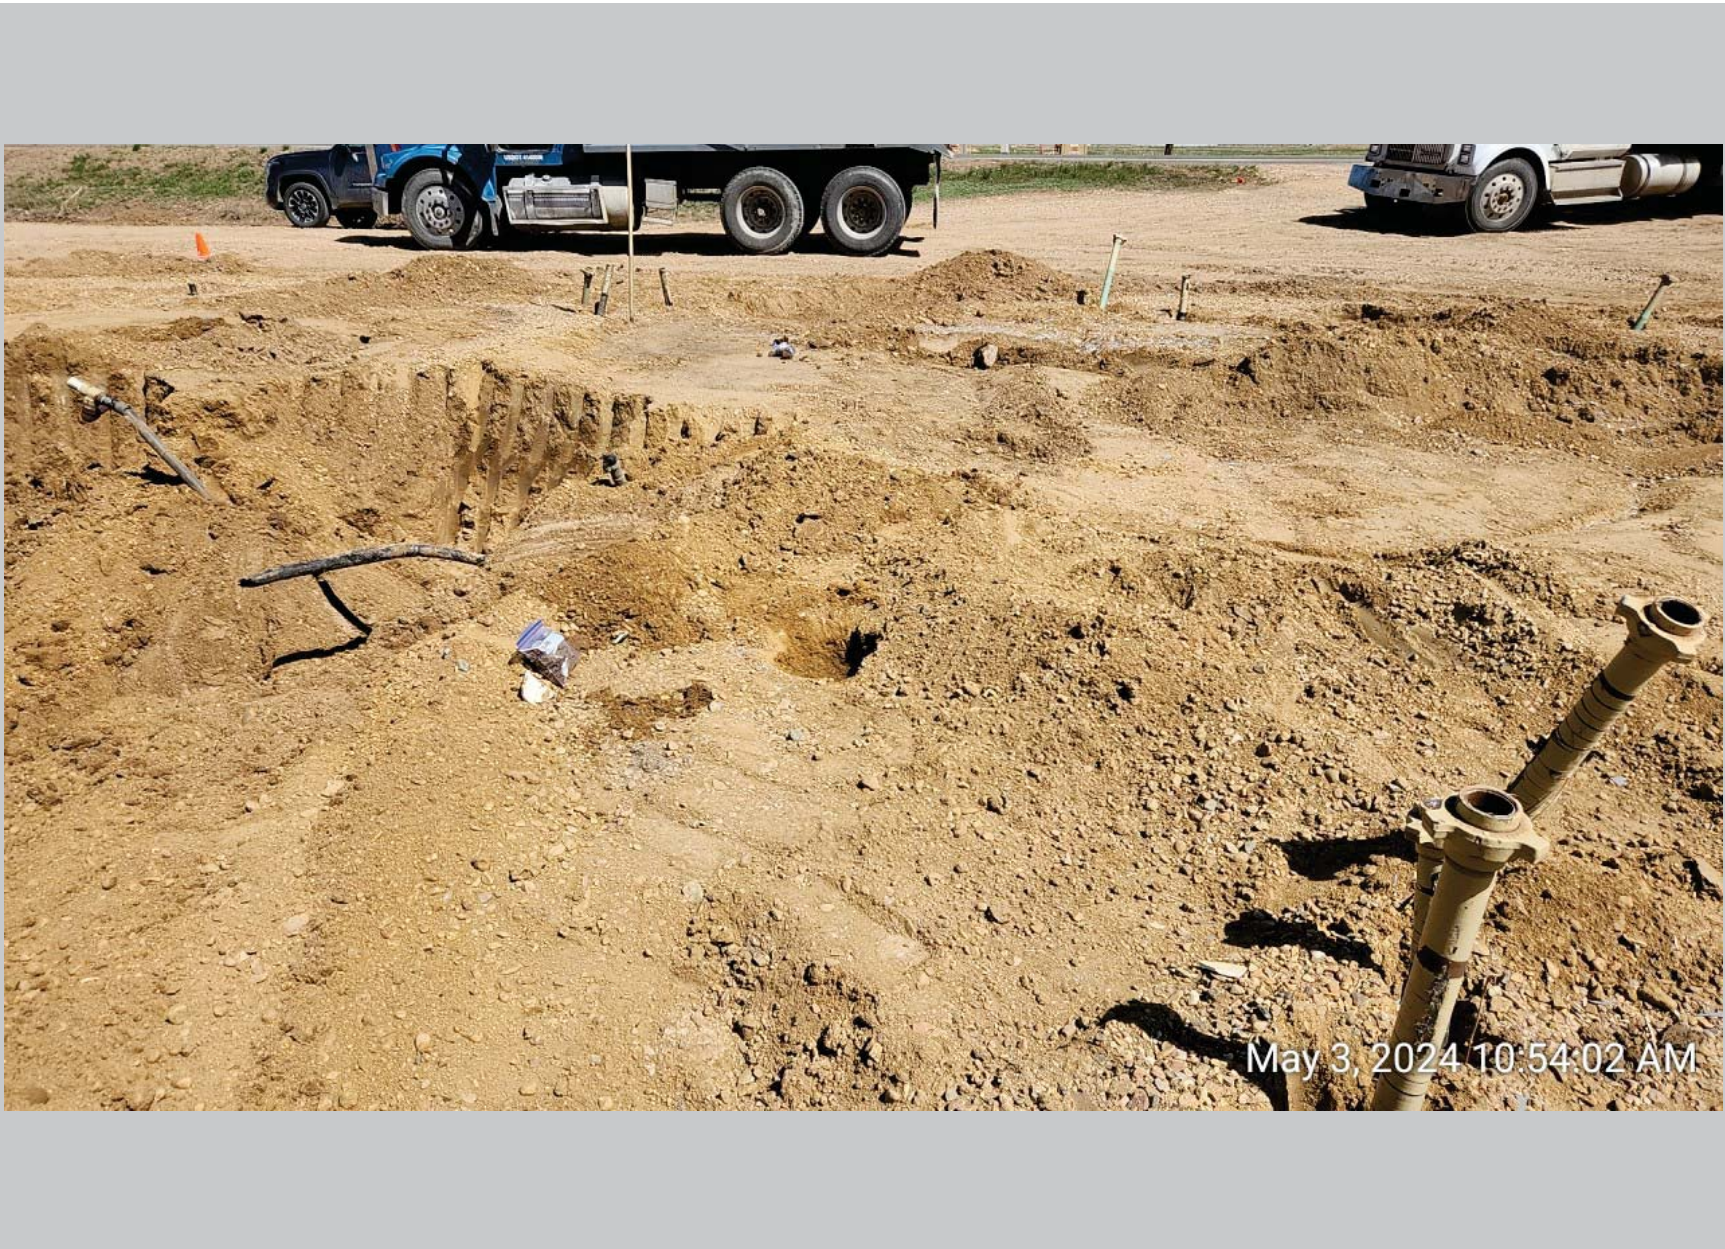
#2A - Ewing Robert Fed T4N-R66W-S14 L01 - 2nd Above Ground Storage Tank (Oil) - AST02@6.0" - No Impacts Noted - PID: 0.0ppm

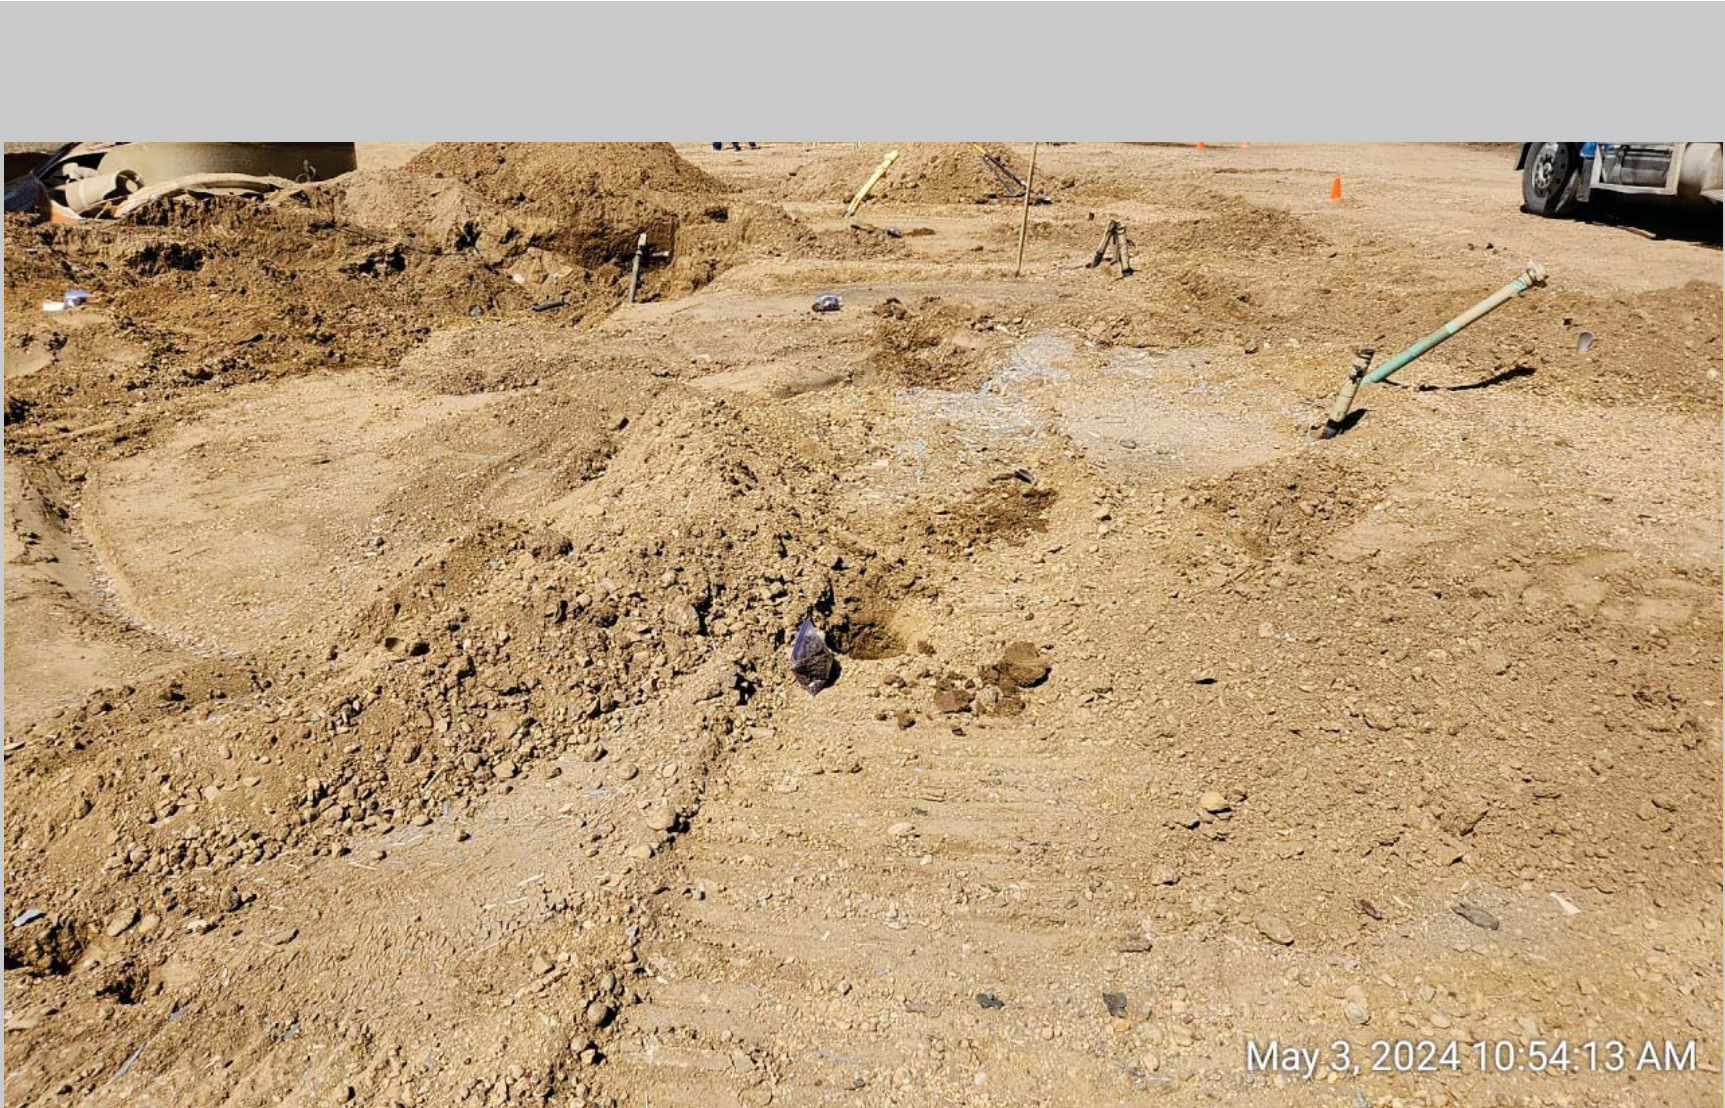
Other observations regarding tanks: Tanks removed prior to sampling event. An exceedance in pH and barium was discovered at the above ground storage tank sample location AST03@6.0", and exceedances in arsenic were discovered at all AST sample locations. Furthermore, several local background samples were found exceeding in pH and barium, and all local background samples were found exceeding in arsenic. Thus, it is proposed that these exceedances be contributed to native soil conditions. Refer to the soil suitability for reclamation chemistry table (Table 4) and metals in soil chemistry table (Table 5) for reference.

#3A - Ewing Robert Fed T4N-R66W-S14 L01 - 3rd Above Ground Storage Tank (Oil) - AST03@6.0" - No Impacts Noted - PID: 0.0ppm

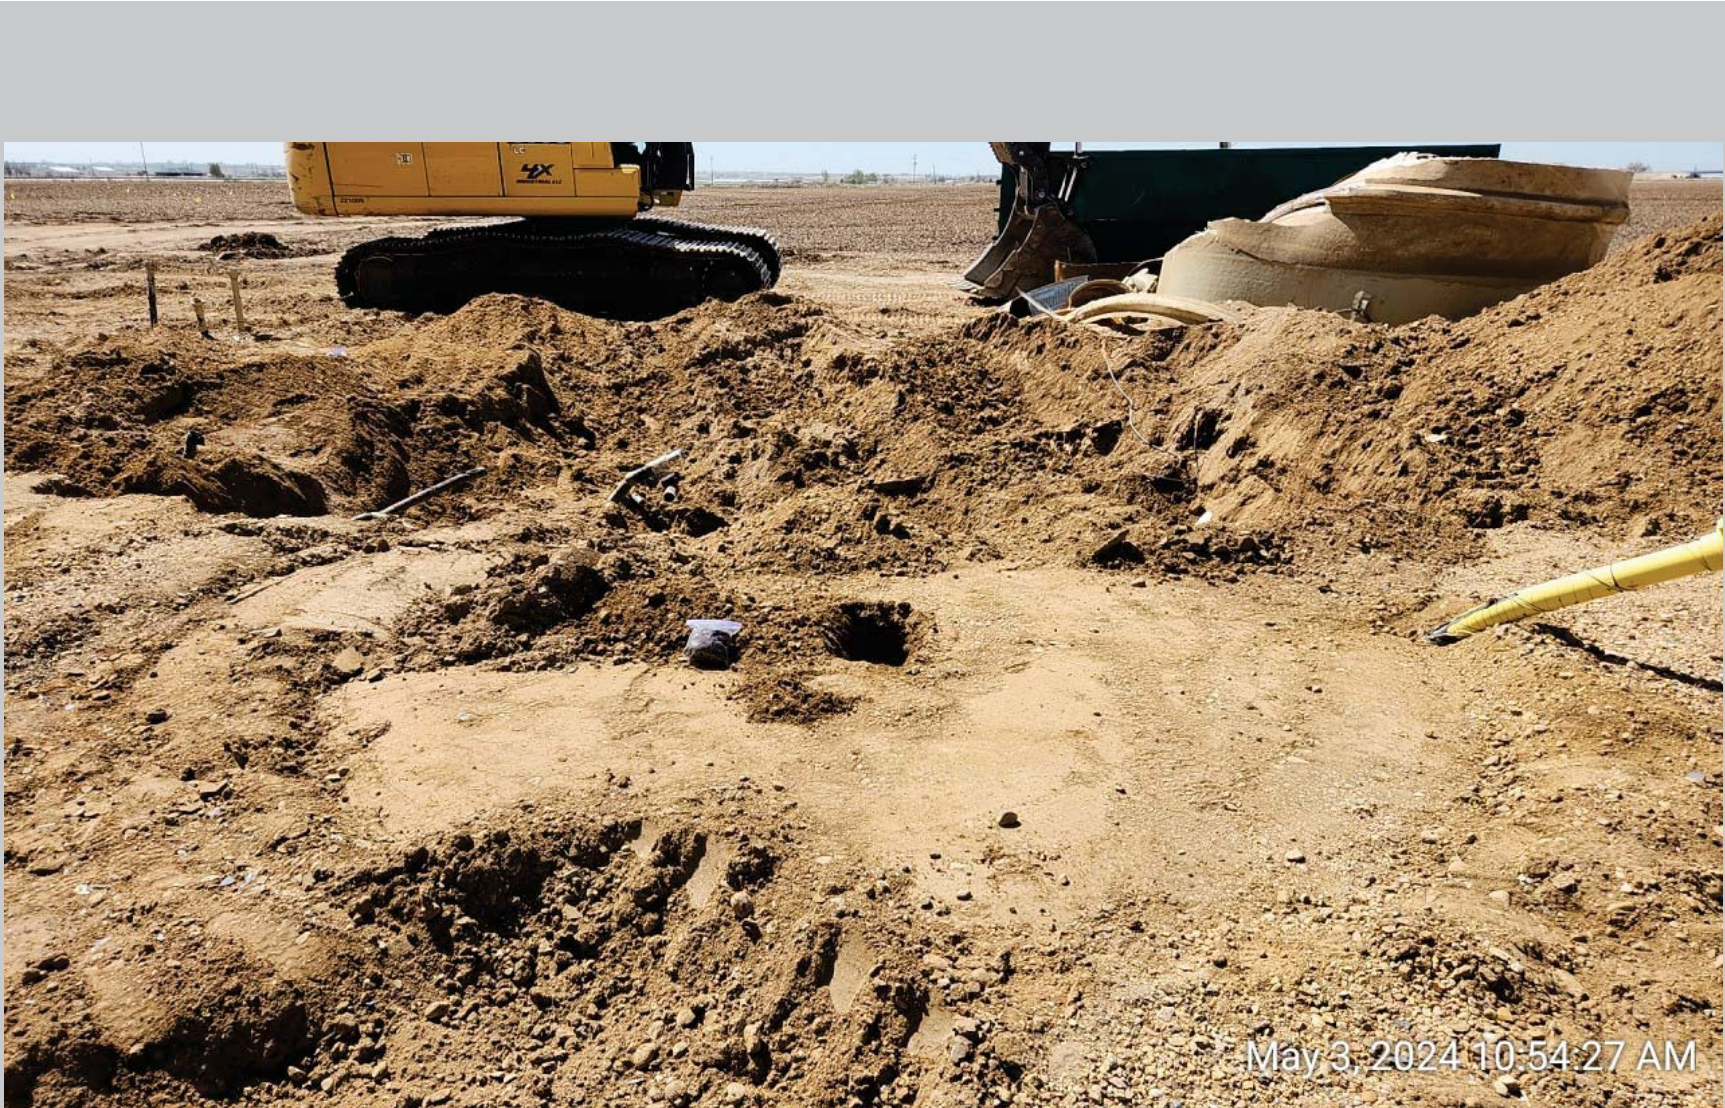
#4A - Ewing Robert Fed T4N-R66W-S14 L01 - 4th Above Ground Storage Tank (Oil) - AST04@6.0" - No Impacts Noted - PID: 0.0ppm

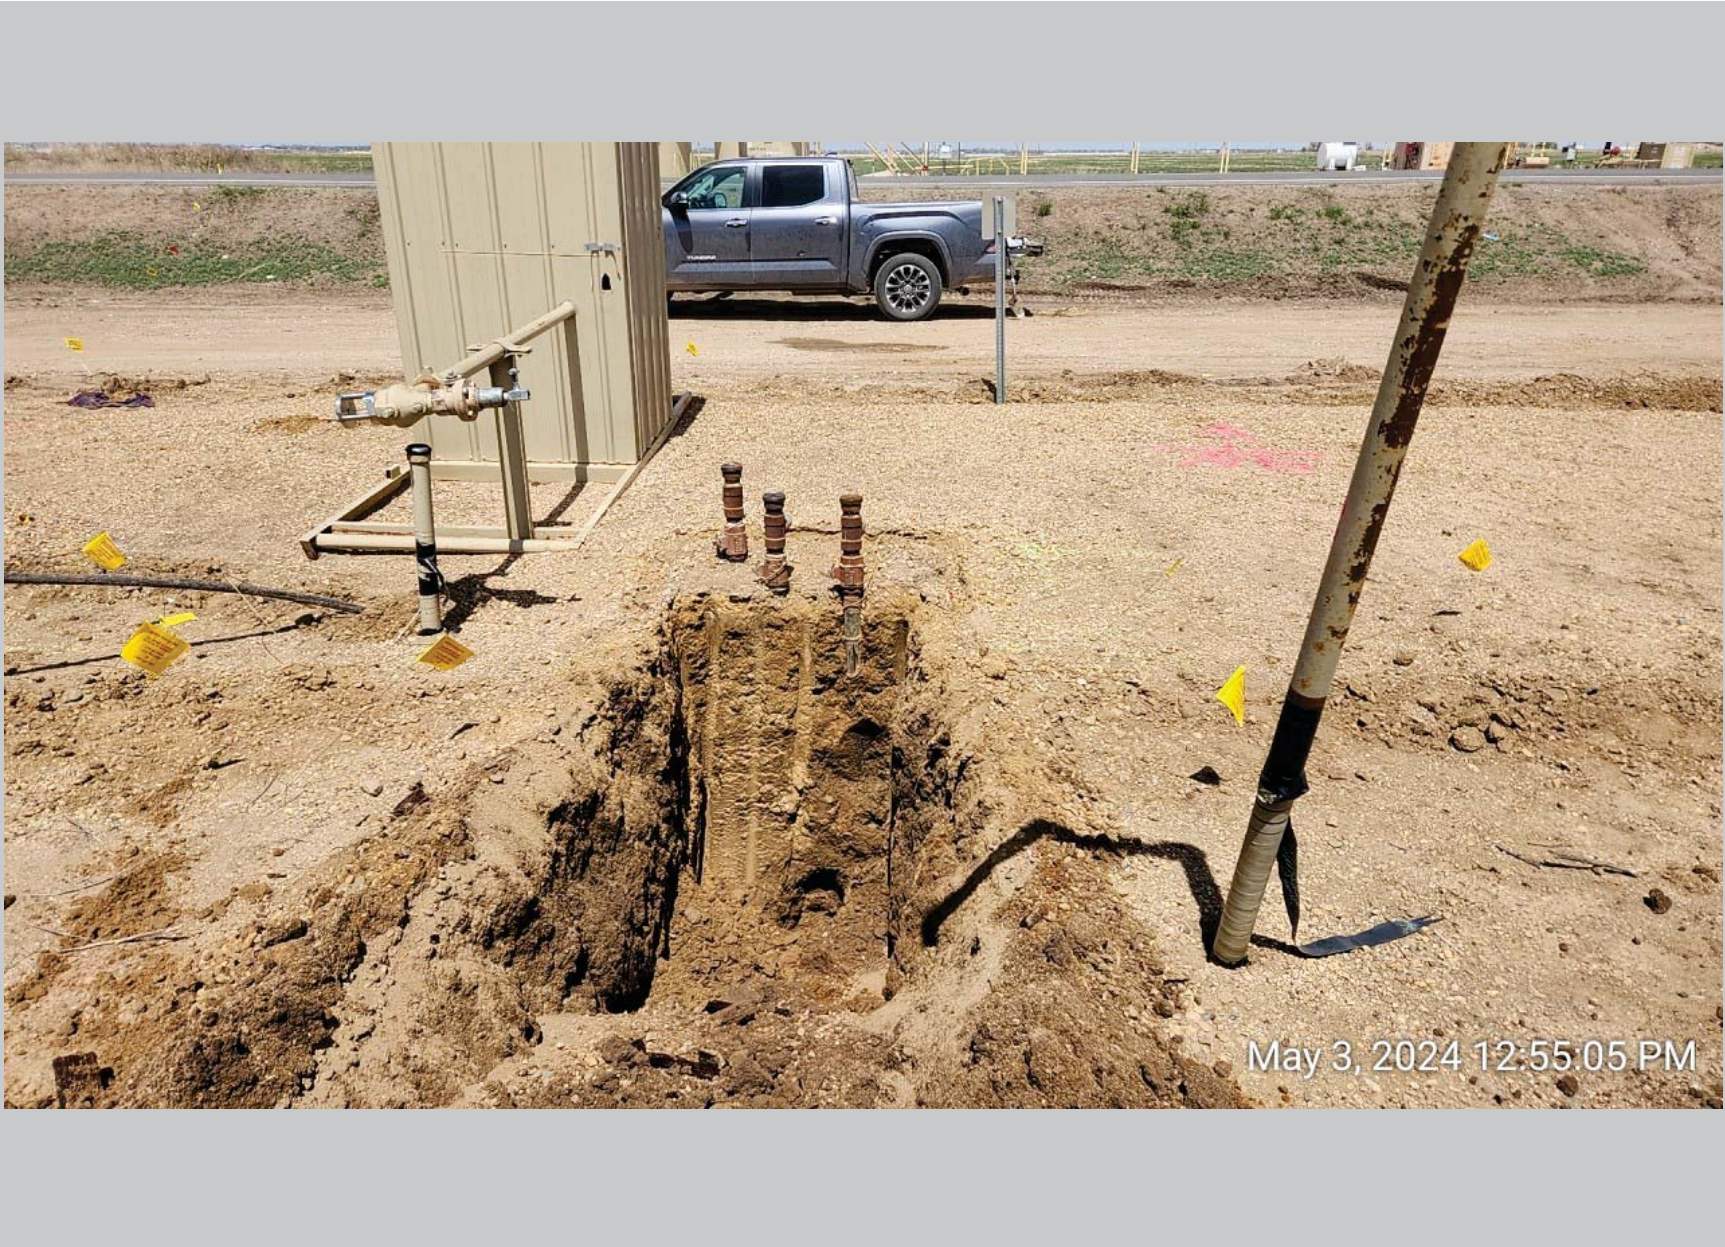
Other observations regarding separators: Separators removed prior to sampling event. An exceedance in pH was discovered at separator sample locations SEP01@5.0' and SEP04@5.0', and exceedances in arsenic were discovered at all separator sample locations. Furthermore, several local background samples were found exceeding in pH and all local background samples were found exceeding in arsenic. Thus, it is proposed that these exceedances be contributed to native soil conditions. Refer to the soil suitability for reclamation chemistry table (Table 4) and metals in soil chemistry table (Table 5) for reference.

#5A - Ewing Robert Fed T4N-R66W-S14 L01 - 1st Separator - SEP01@5.0' - No Impacts Noted - PID: 0.0ppm

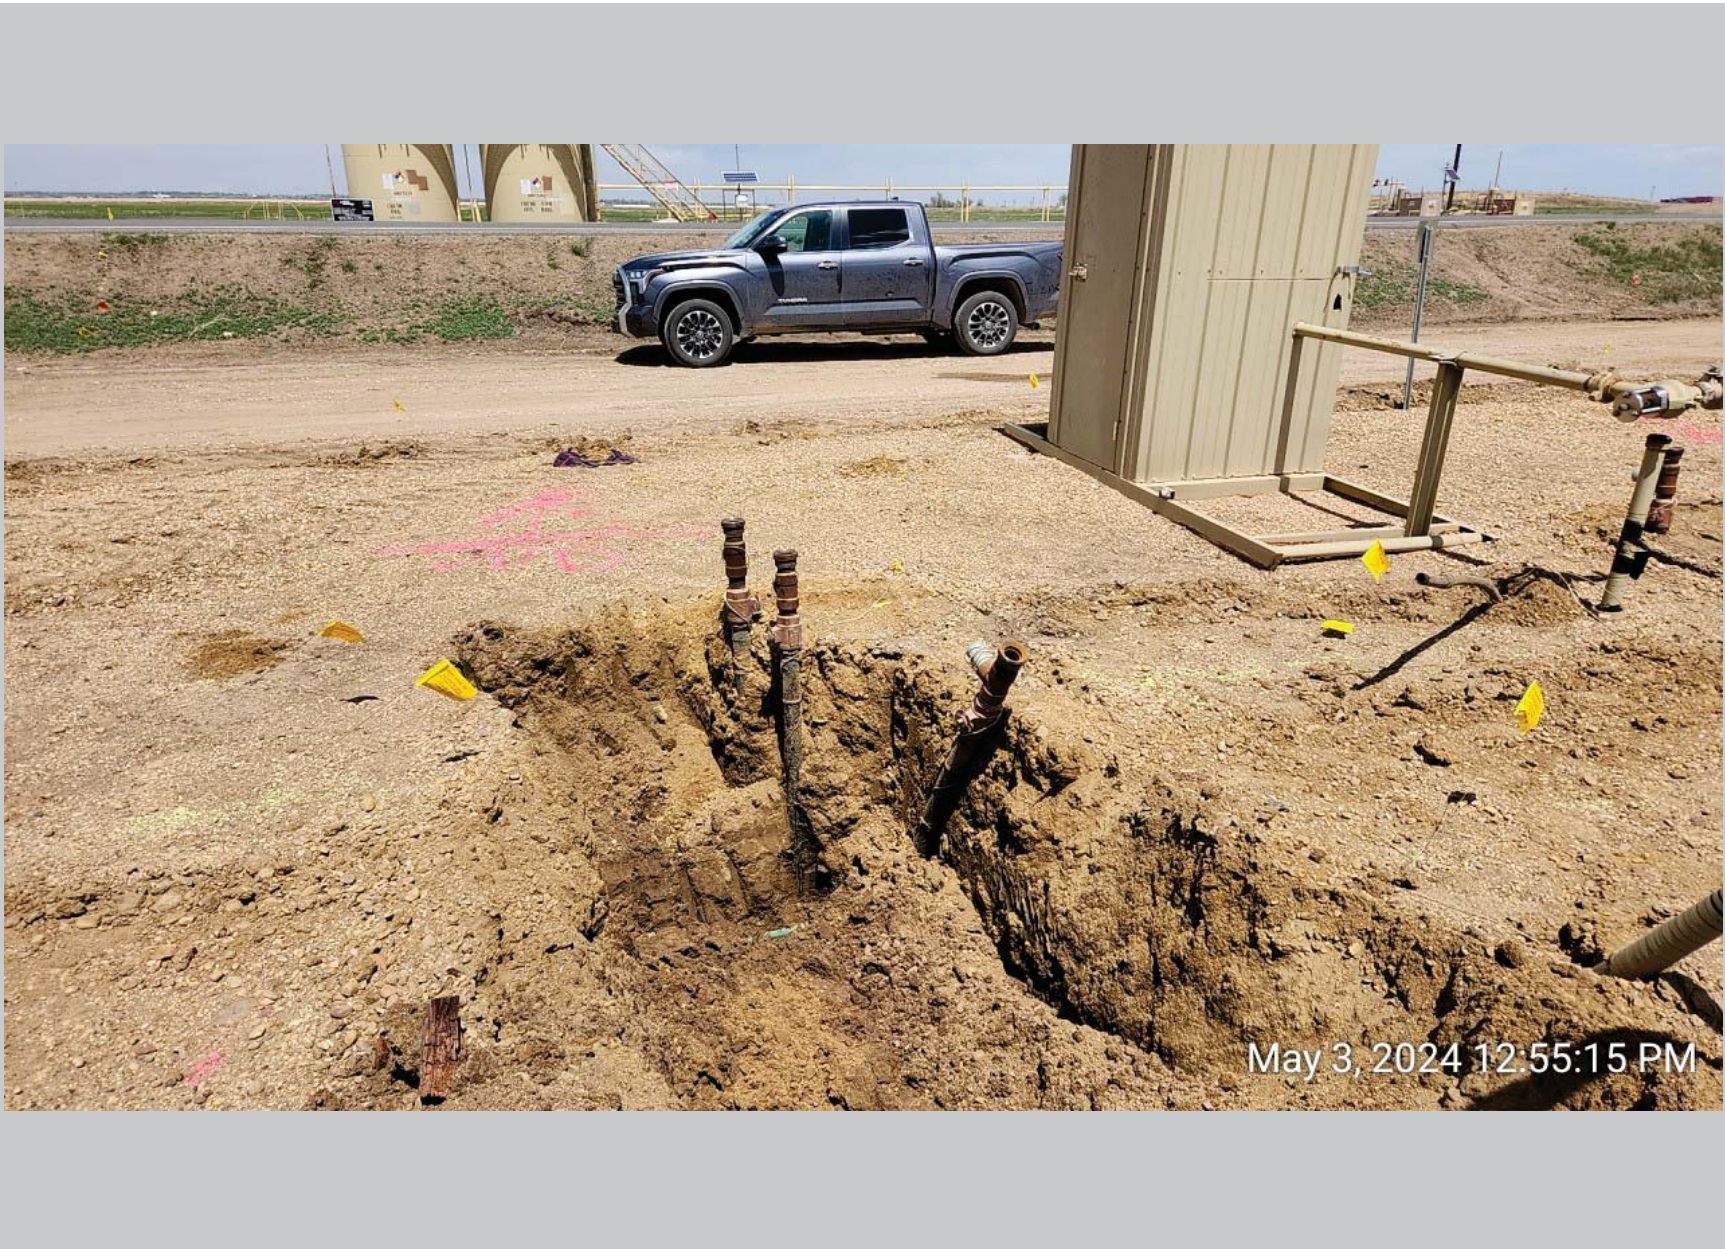
#6A - Ewing Robert Fed T4N-R66W-S14 L01 - 2nd Separator - SEP02@5.0' - No Impacts Noted - PID: 0.0ppm

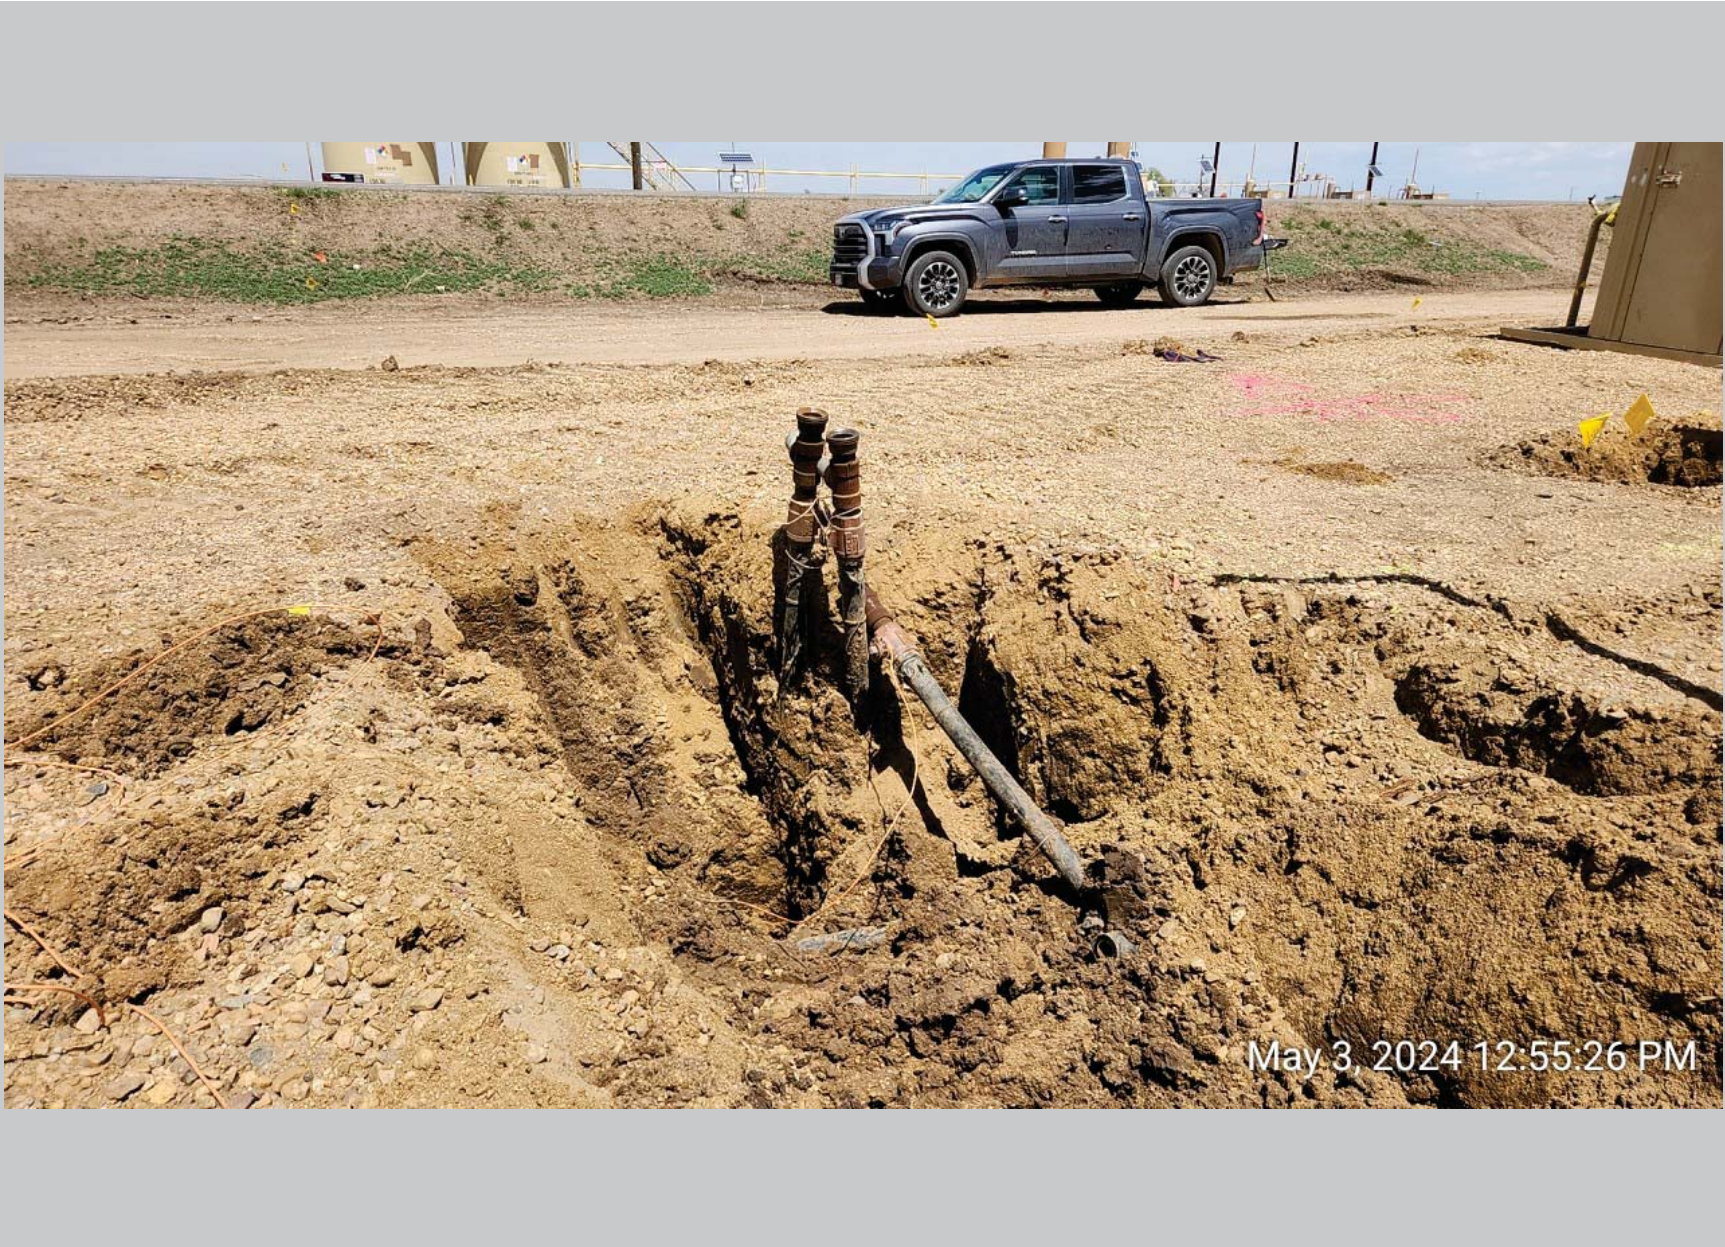
#7A - Ewing Robert Fed T4N-R66W-S14 L01 - 3rd Separator - SEP03@5.0' - No Impacts Noted - PID: 0.0ppm

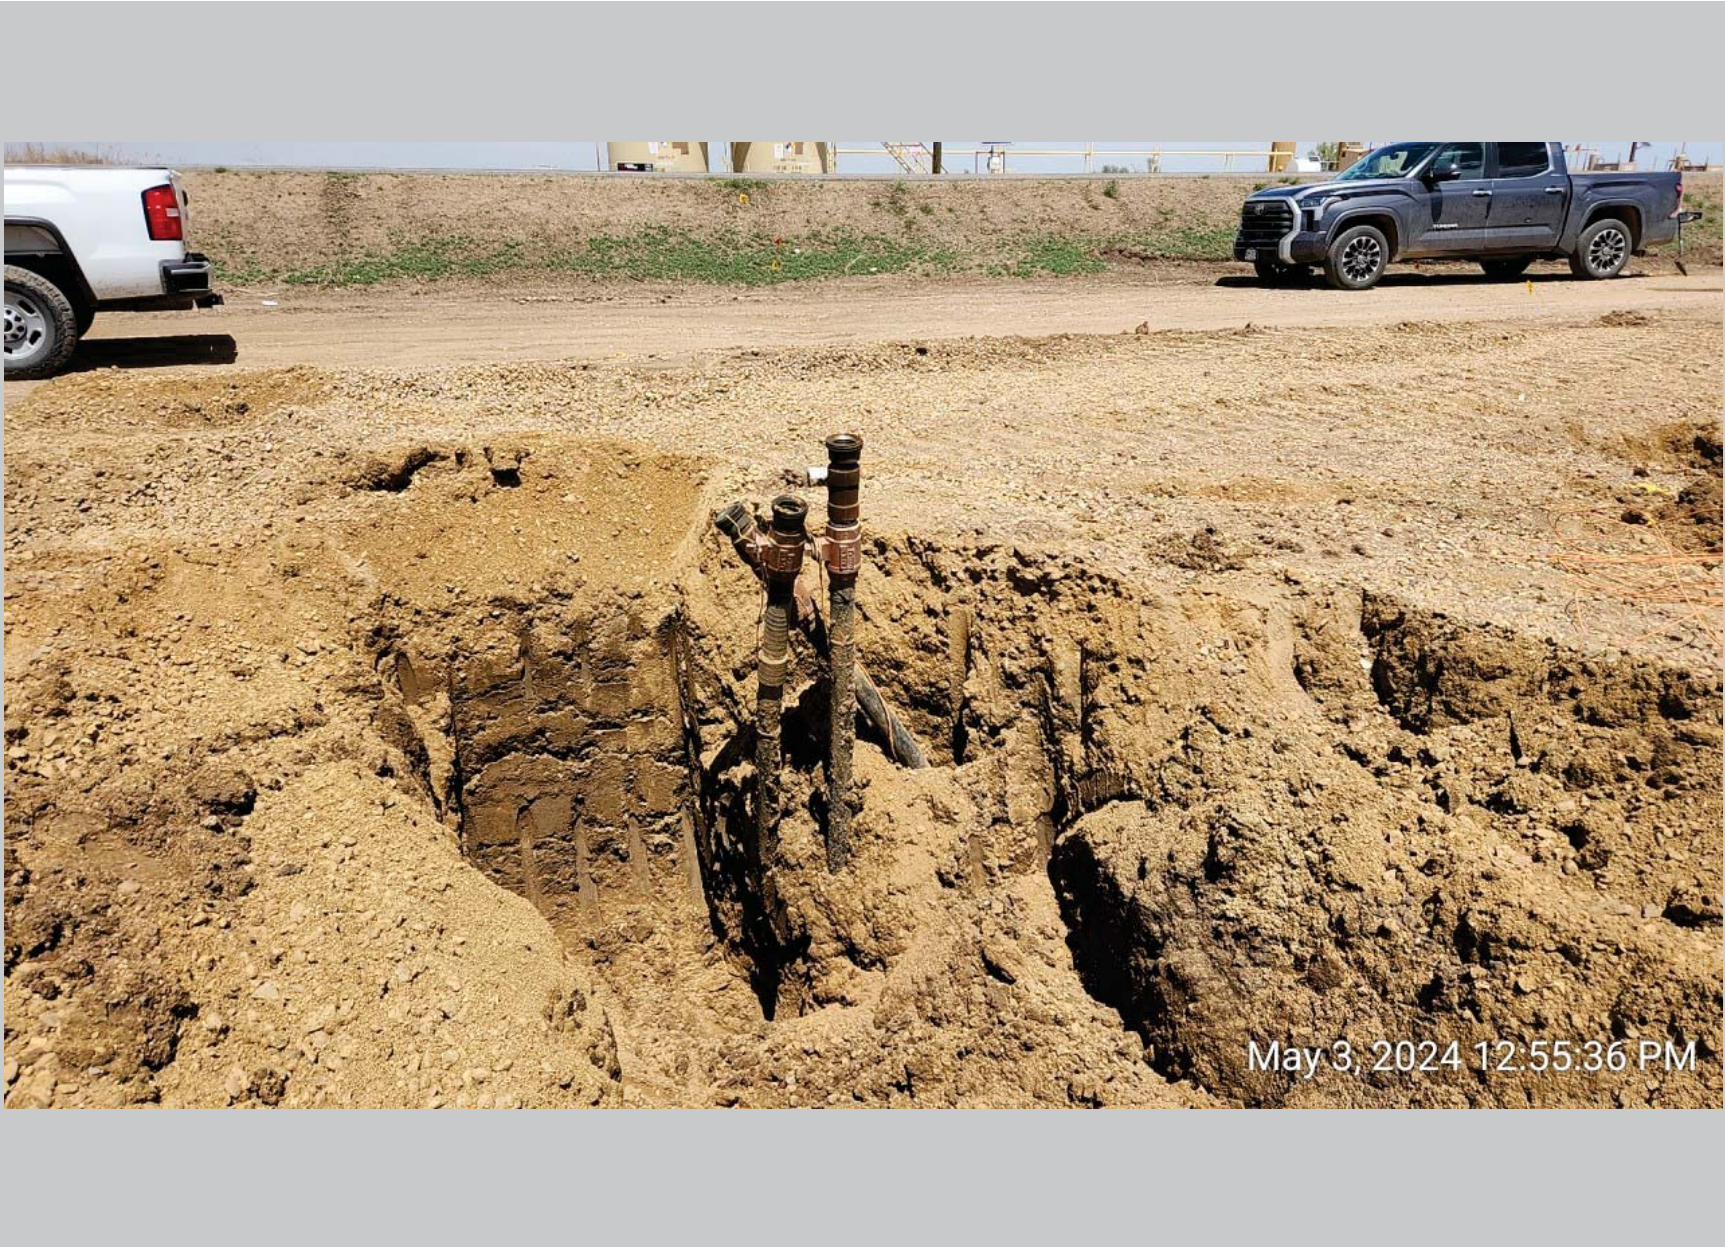
#8A - Ewing Robert Fed T4N-R66W-S14 L01 - 4th Separator - SEP04@5.0' - No Impacts Noted - PID: 0.0ppm

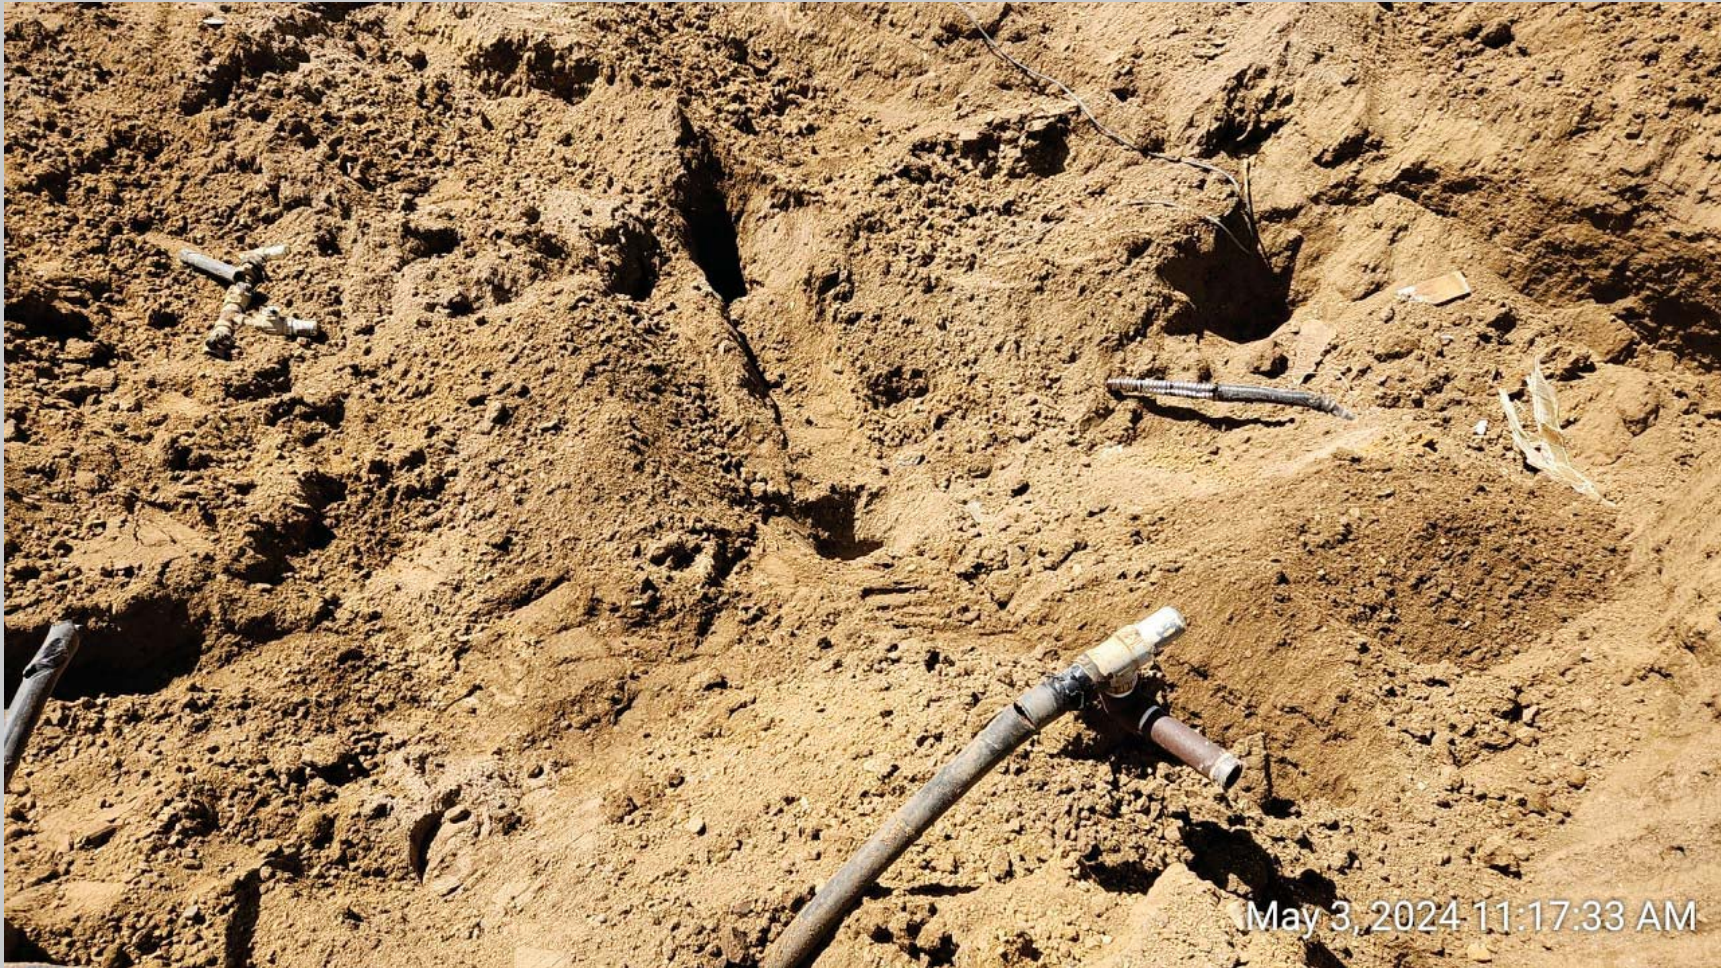
Other observations regarding partially buried vessels: Dumplines were not trenched. The dumpline tie-in points were at all separator sample locations and sample location PWVE01@4.0'. An exceedance in pH was discovered at sample location PWVE01@4.0', and exceedances in arsenic were discovered at both samples taken from the PWV excavation. Furthermore, several local background samples were found exceeding in pH and all local background samples were found exceeding in arsenic. Thus, it is proposed that these exceedances be contributed to native soil conditions. Refer to the soil suitability for reclamation chemistry table (Table 4) and metals in soil chemistry table (Table 5) for reference

#9A - Ewing Robert Fed T4N-R66W-S14 L01 - Floor of Produced Water Vault (PWV) Excavation - PWVB01@5.0' - No Impacts Noted - PID: 0.0ppm

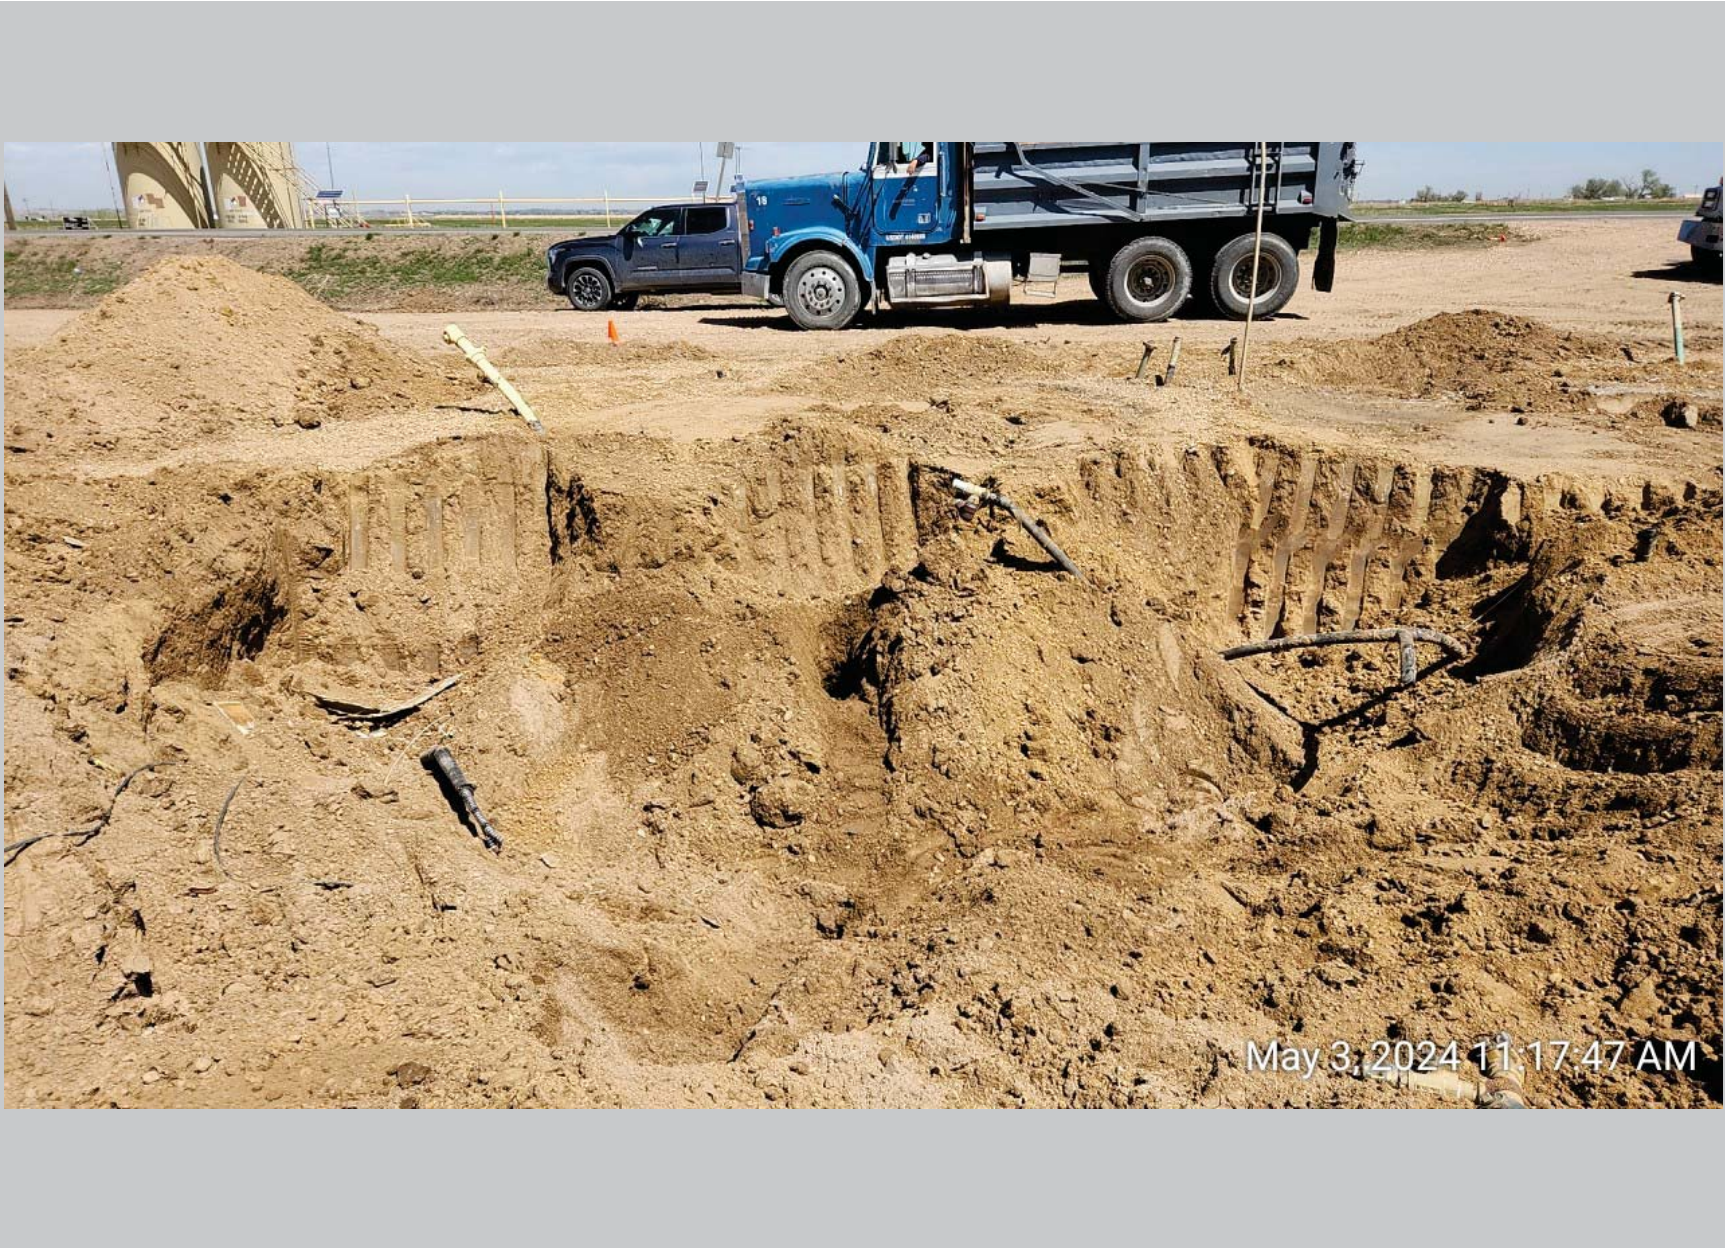
#9B - Ewing Robert Fed T4N-R66W-S14 L01 - North Sidewall of PWV Excavation - PWVN01@4.0' - No Impacts Noted - PID: 0.0ppm

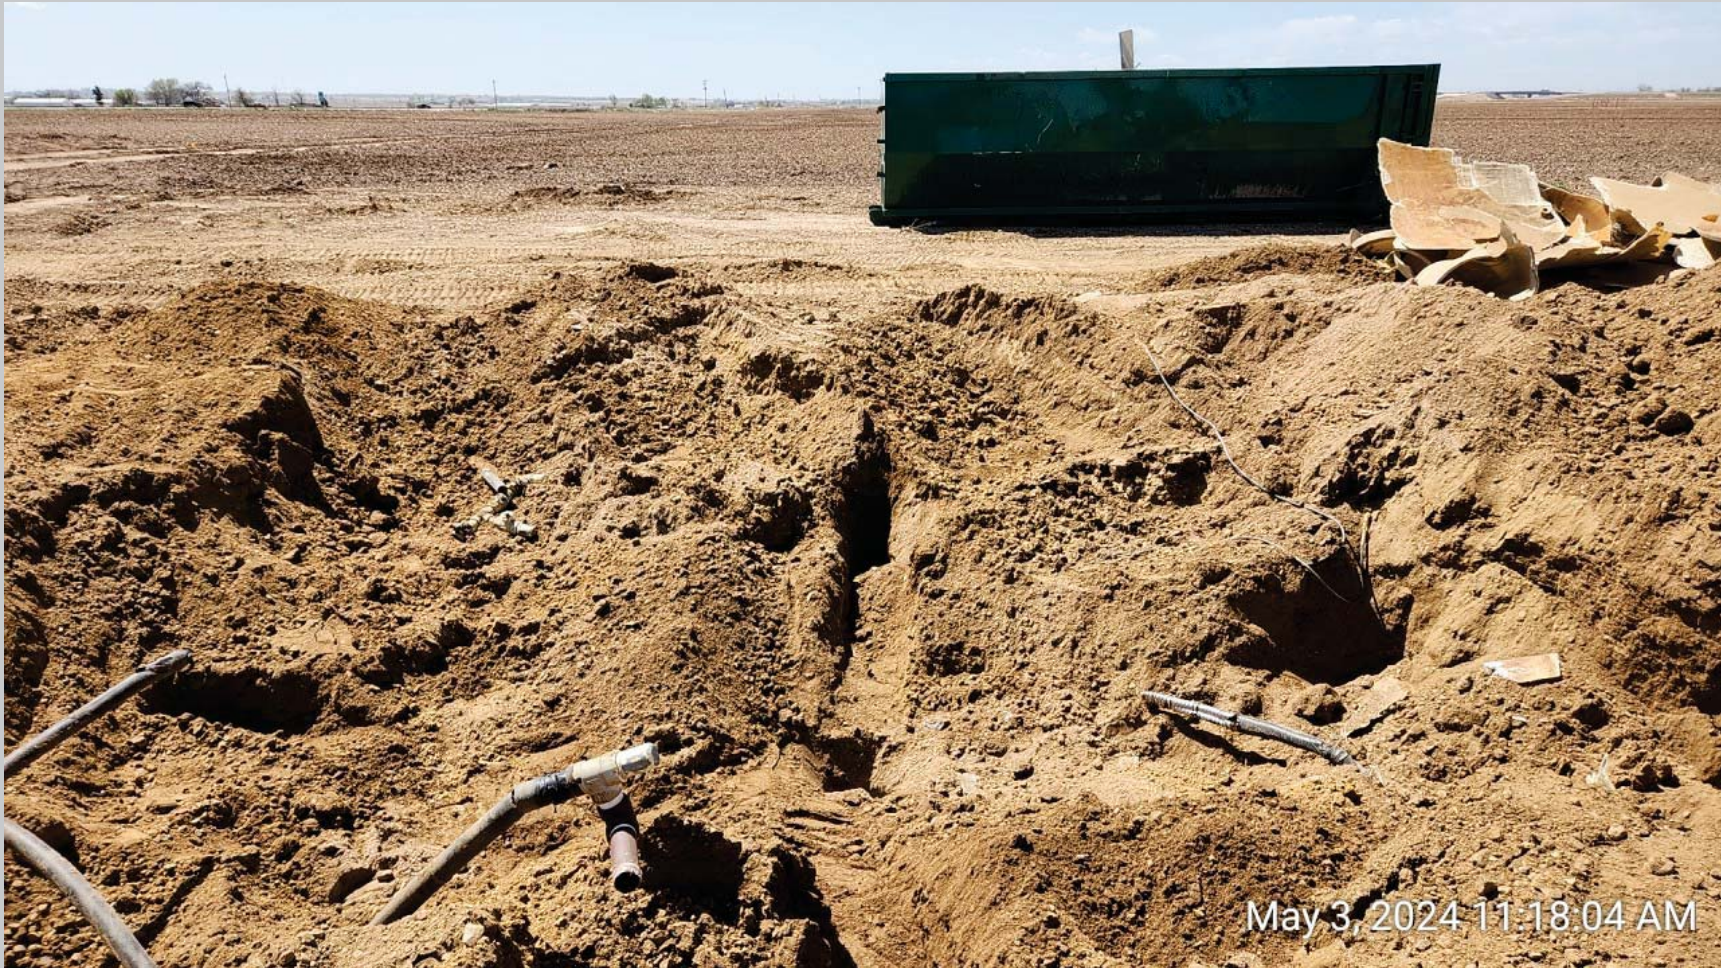
#9C - Ewing Robert Fed T4N-R66W-S14 L01 - South Sidewall of PWV Excavation - PWVS01@4.0' - No Impacts Noted - PID: 0.0ppm
