FREMONT ENVIRONMENTAL INC.

Subject: **Facility Closure Data Submittal**
Ewing Robert Fed T4N-R66W-S14 L01
NWNE Sec. 14, T4N, R66W
Weld County, Colorado
Fremont Project No. C024-109
Facility # 332527, Remediation #32879

Tank Battery Closure Checklist

Buried or Partially Buried Vessel Closure Checklist

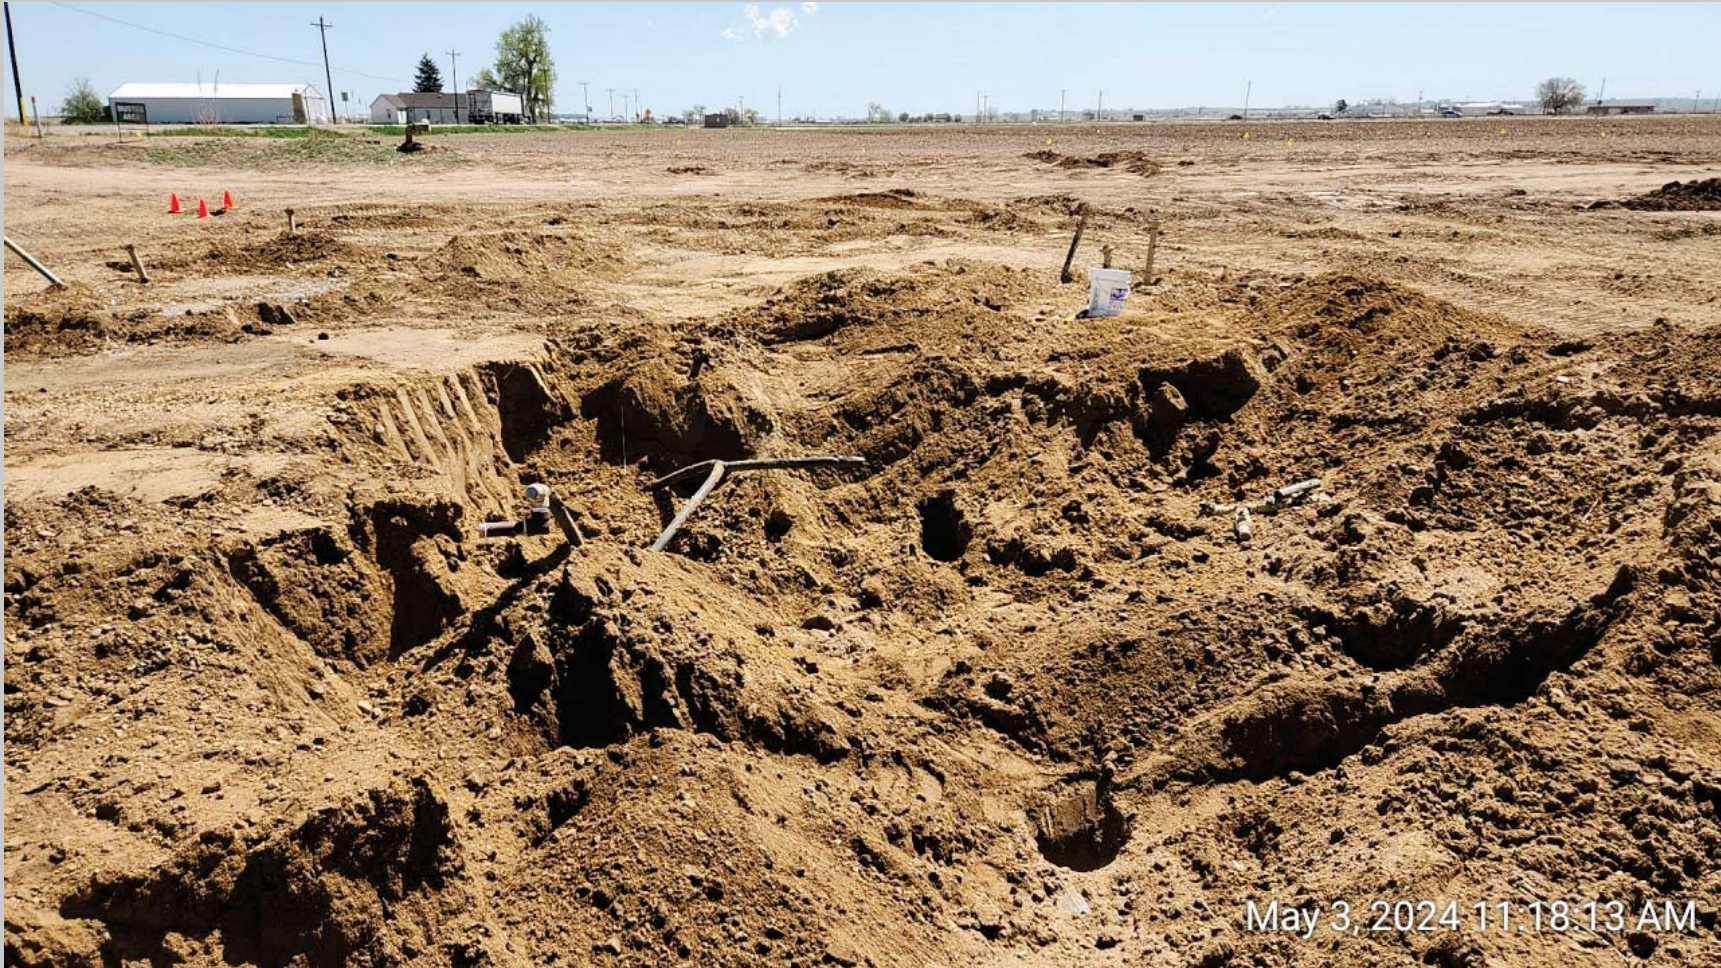
#9D - Ewing Robert Fed T4N-R66W-S14 L01 - East Sidewall of PWV Excavation - PWVE01@4.0' - No Impacts Noted - PID: 0.0ppm

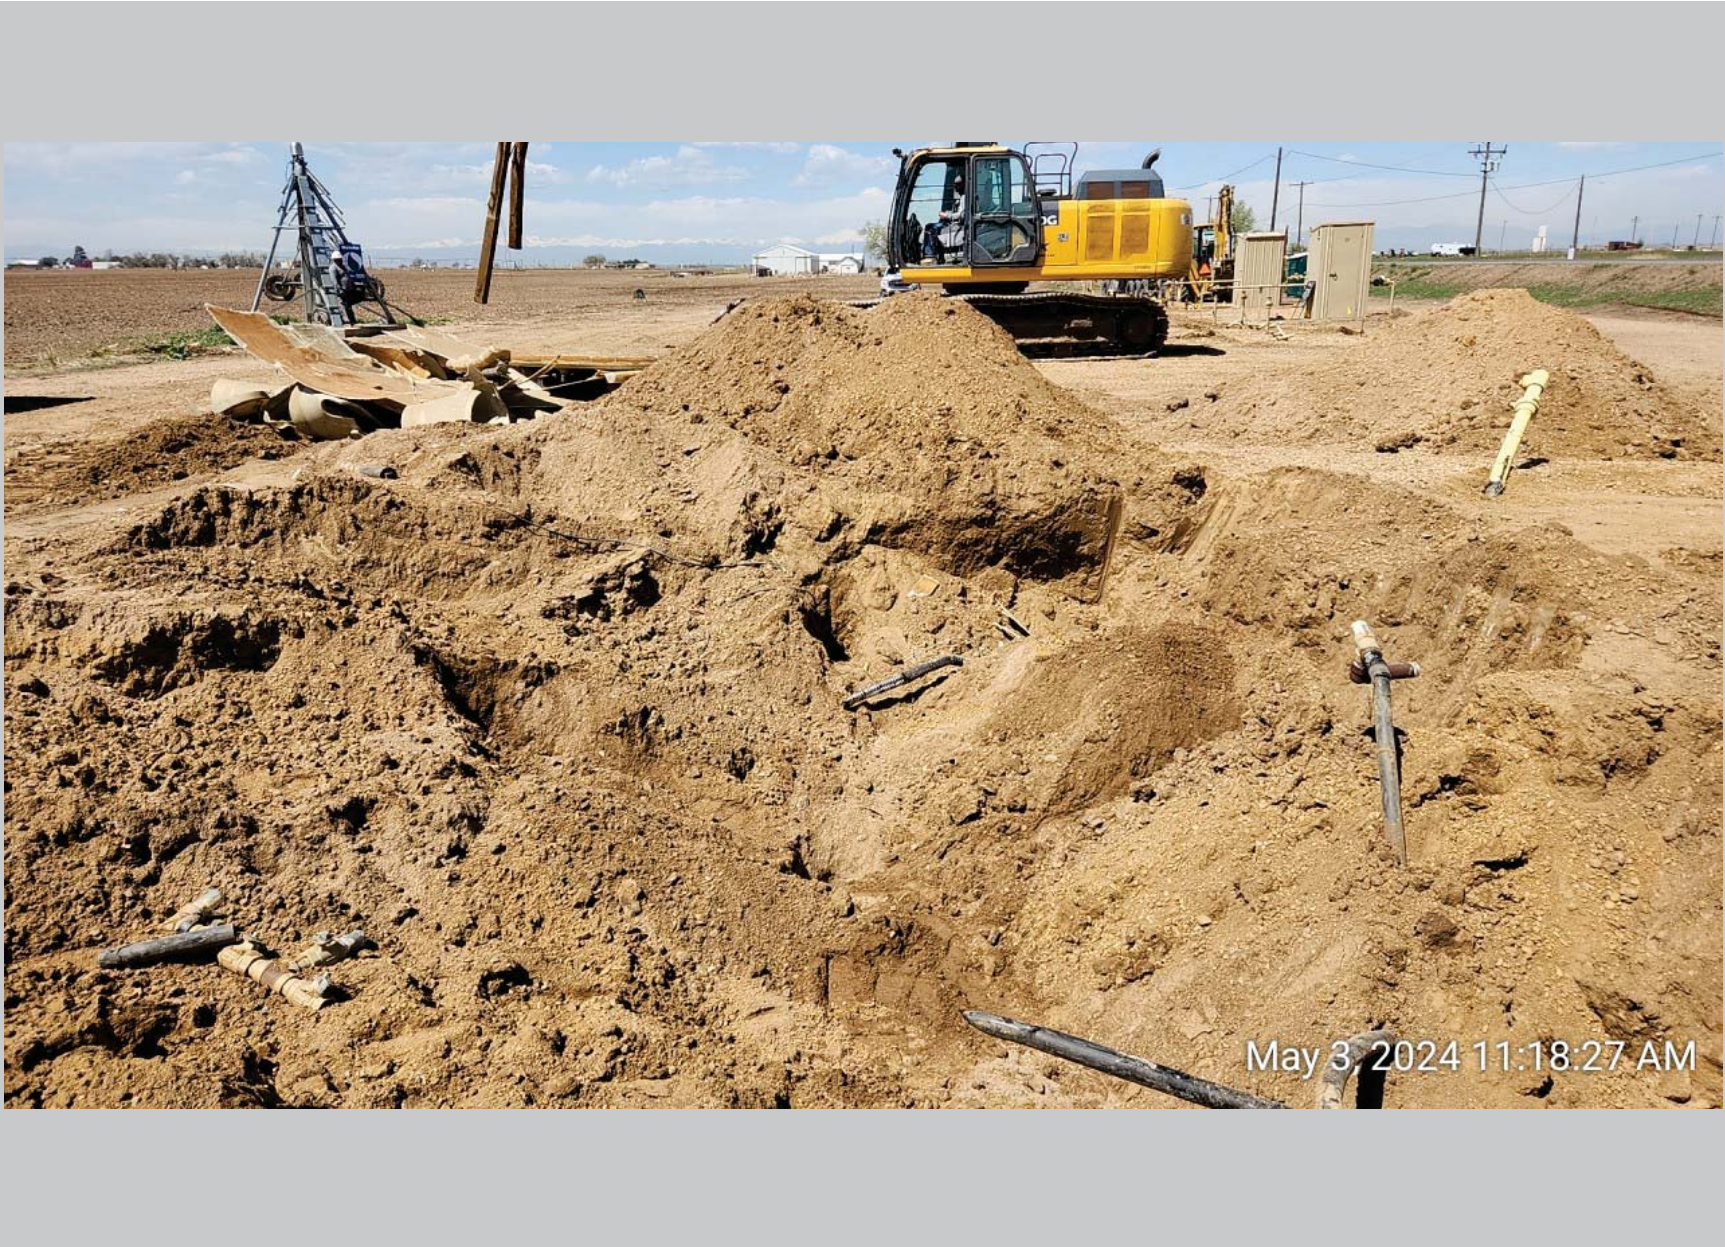
#9E - Ewing Robert Fed T4N-R66W-S14 L01 - West Sidewall of PWV Excavation - PWVW01@4.0' - No Impacts Noted - PID: 0.0ppm

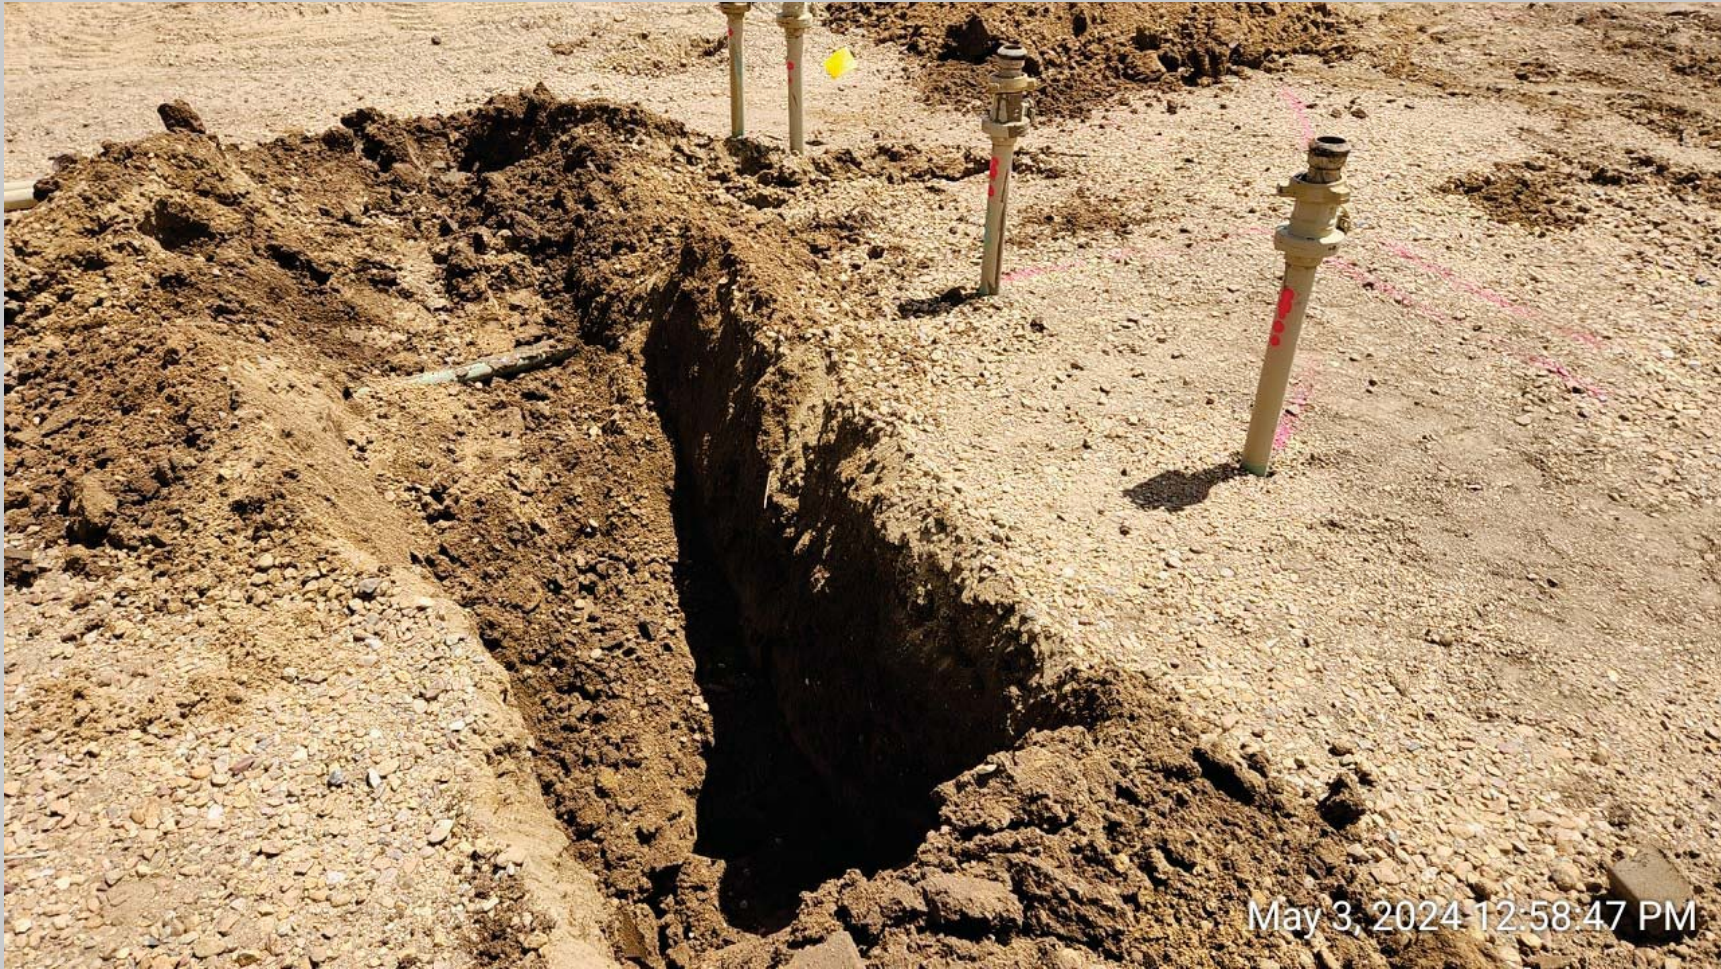
Combustion Unit removed prior to sampling event. GL01 @5.0' was the riser tie-in point for gas from separators to third party meter sheds

#10A - Ewing Robert Fed T4N-R66W-S14 L01 - Gas Lines Tie-in from Separators - GL01@5.0' - No Impacts Noted - PID: 0.0ppm

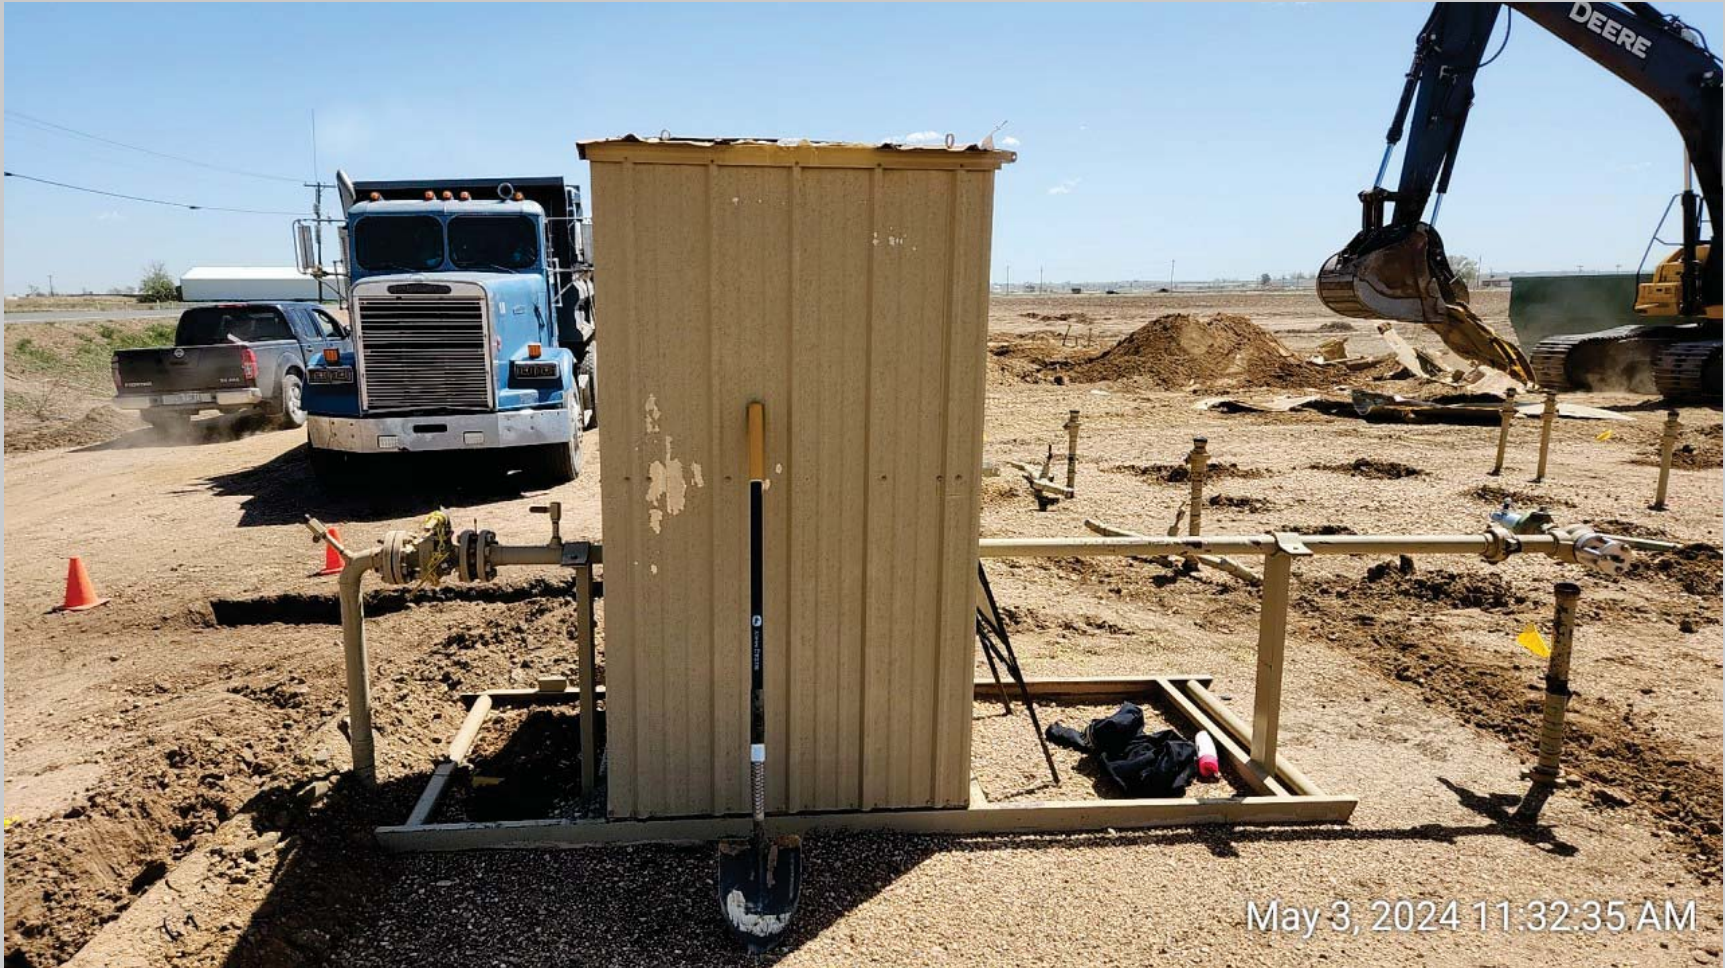
#11A - Ewing Robert Fed T4N-R66W-S14 L01 - 1st Third Party Meter Shed - MET01@6.0" - No Impacts Noted - PID: 0.0ppm

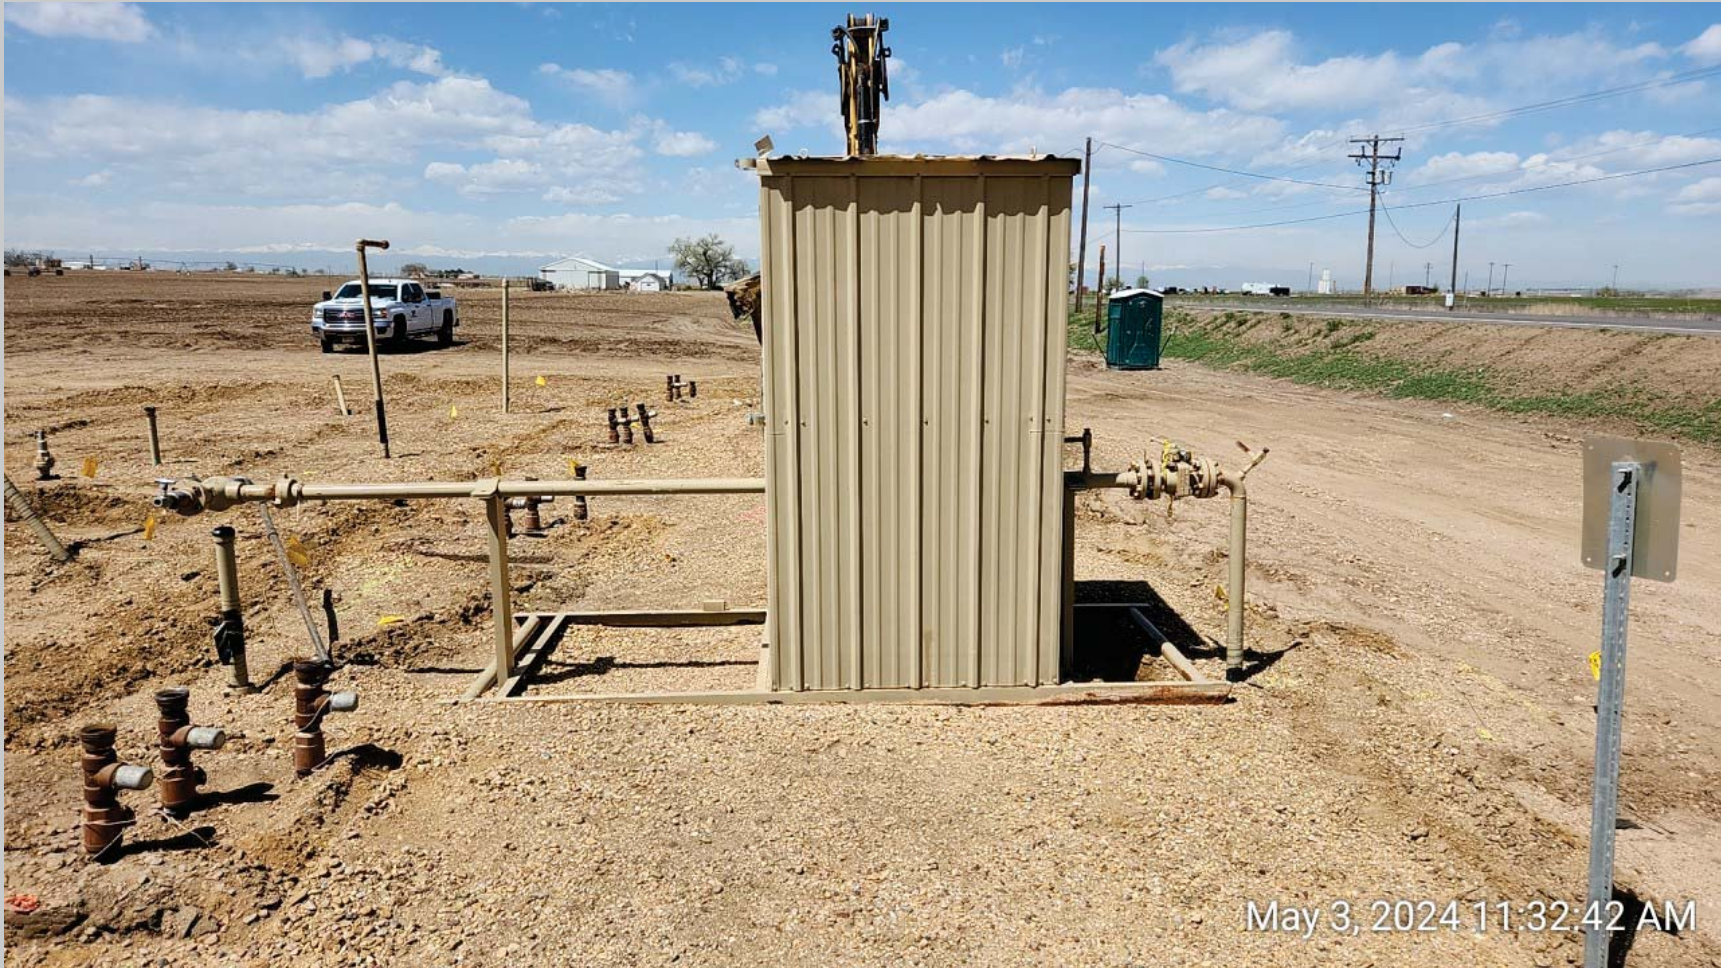
#12A - Ewing Robert Fed T4N-R66W-S14 L01 - 2nd Third Party Meter Shed - MET02@6.0" - No Impacts Noted - PID: 0.0ppm

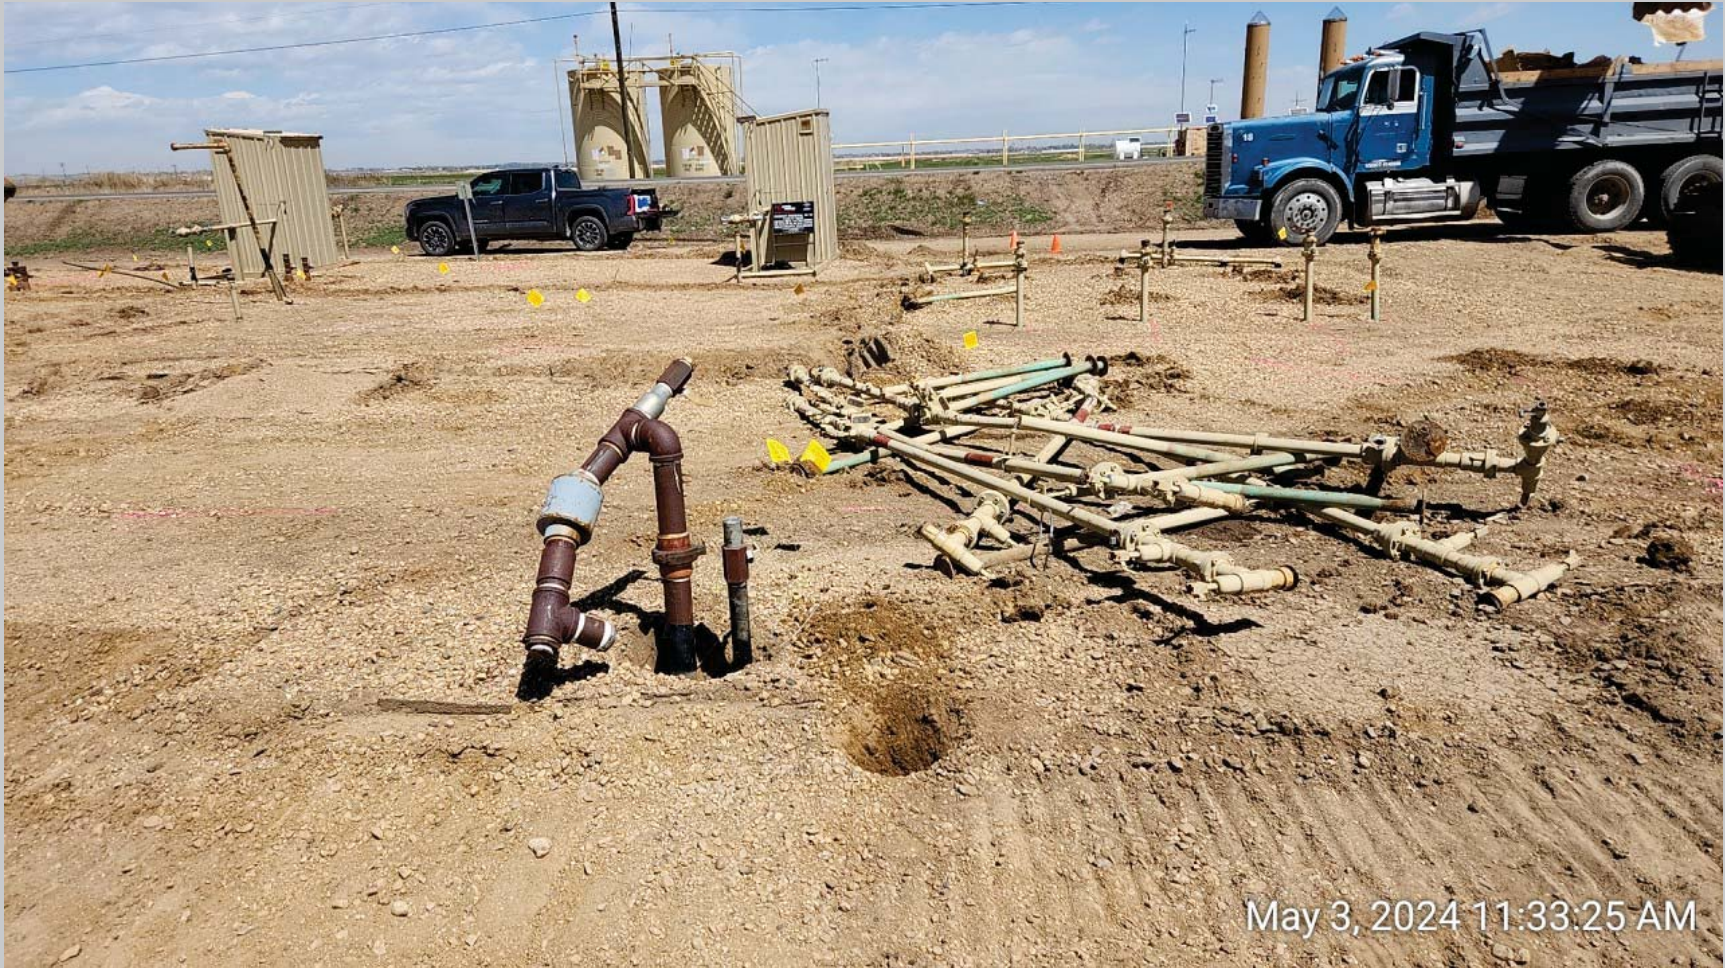
#13A - Ewing Robert Fed T4N-R66W-S14 L01 - Combustion Unit - ECD01@6.0" - No Impacts Noted - PID: 0.0ppm

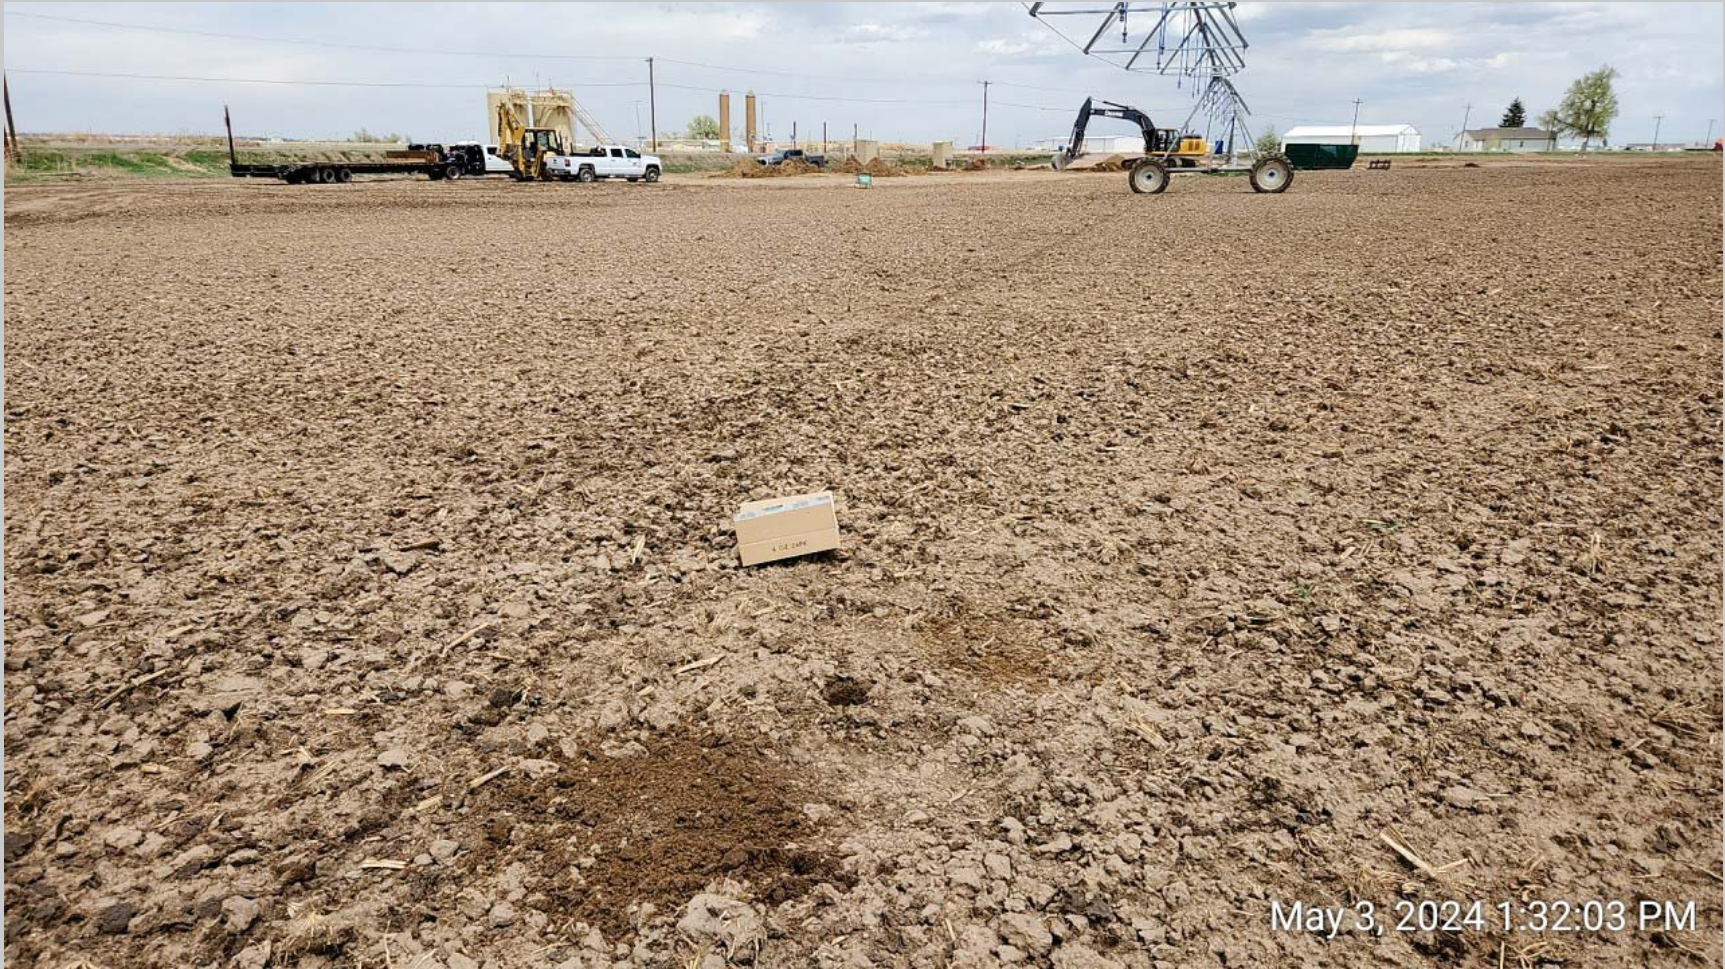
#14A - Ewing Robert Fed T4N-R66W-S14 L01 - 1st local Background Sample Bore - BKG01 - Samples Collected at 0.5ft, 4.0ft and 5.0ft

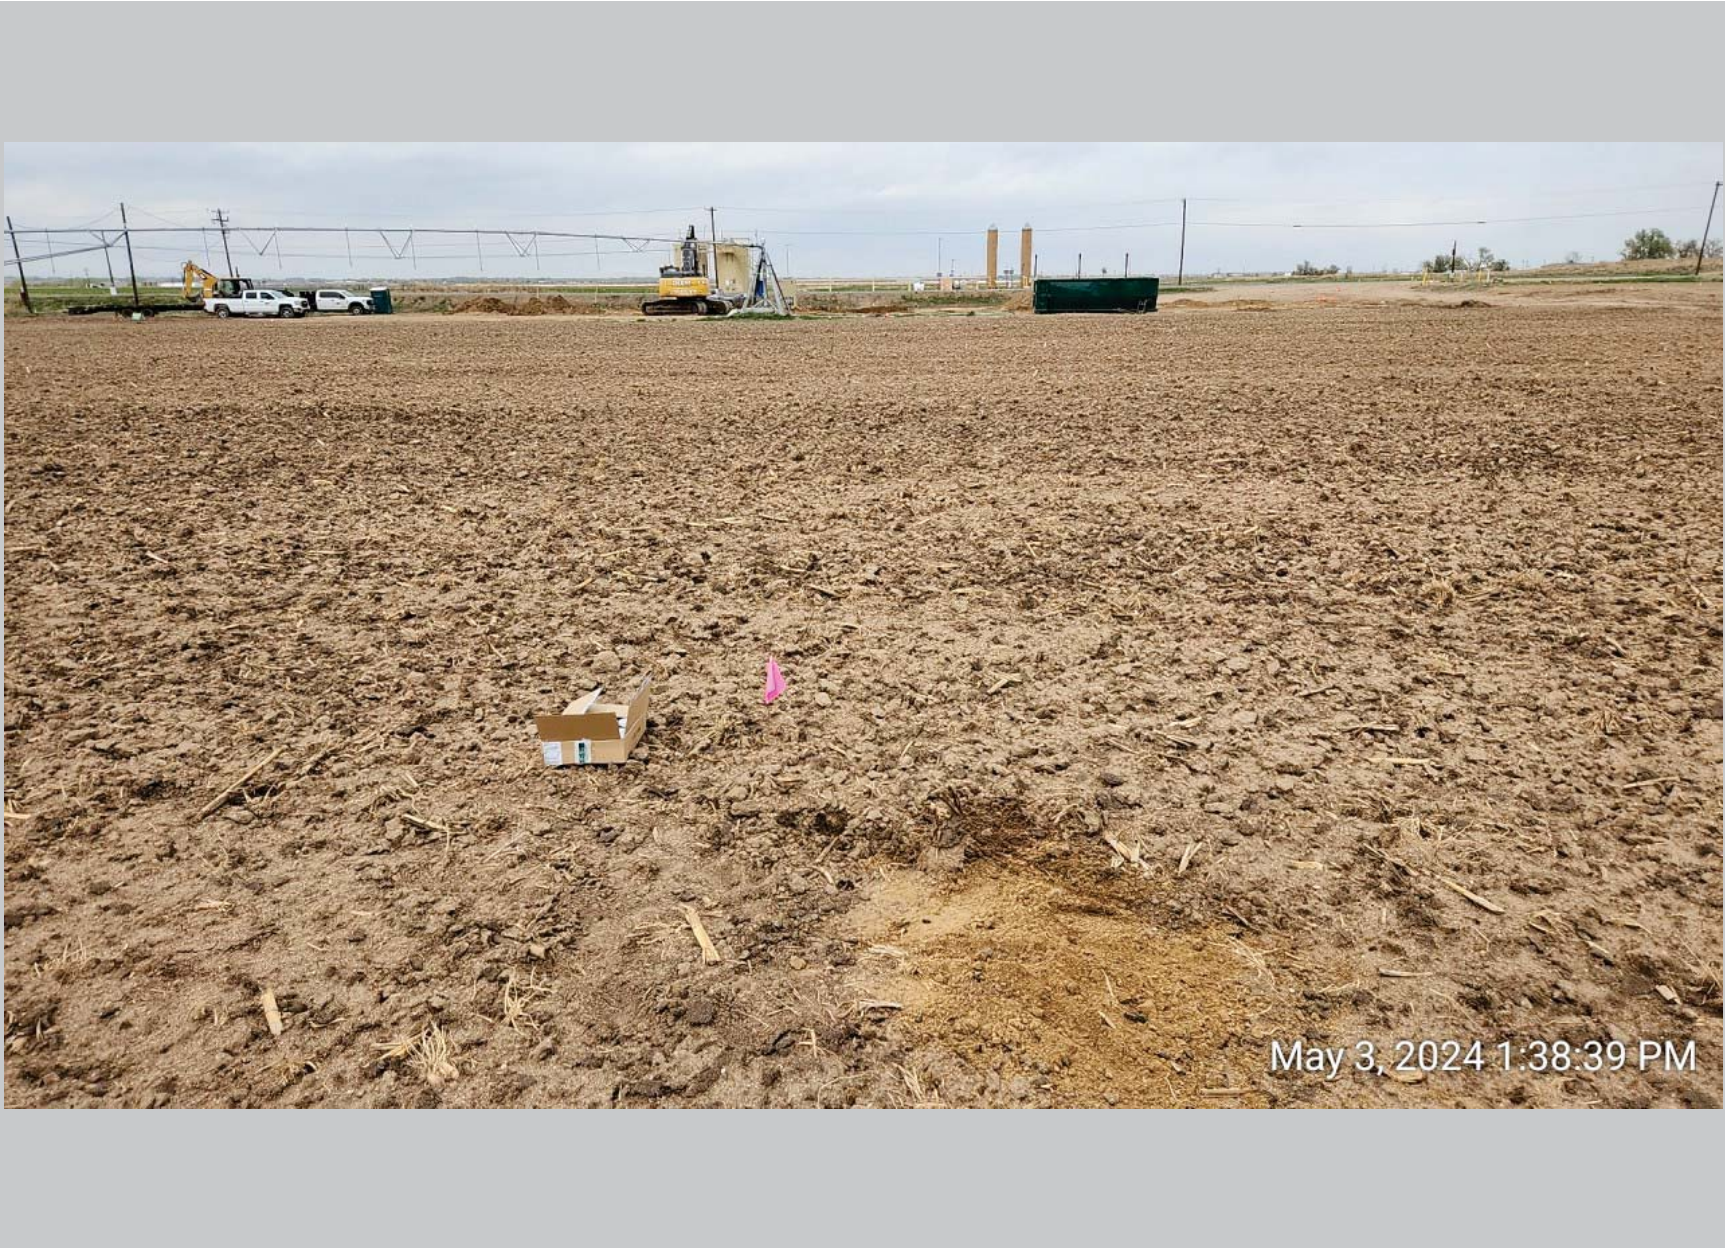
#14B - Ewing Robert Fed T4N-R66W-S14 L01 - 2nd local Background Sample Bore - BKG02 - Samples Collected at 0.5ft, 4.0ft and 5.0ft

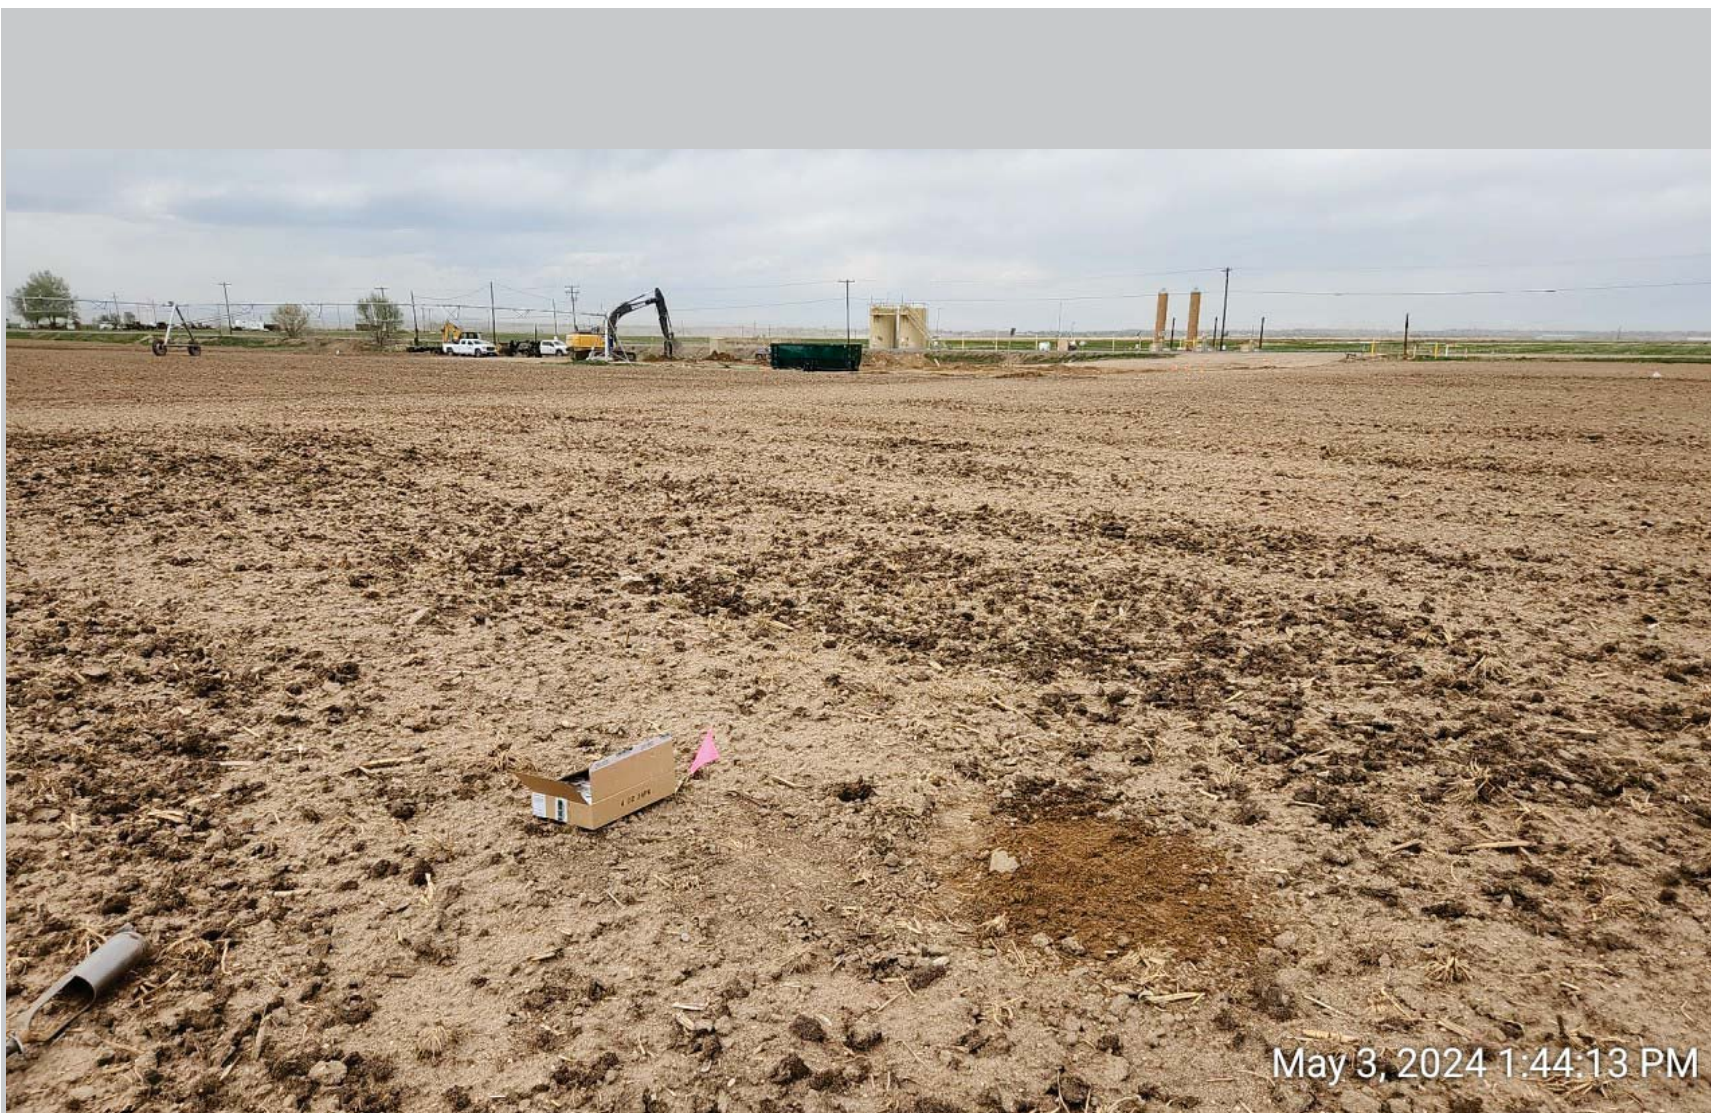
#14C - Ewing Robert Fed T4N-R66W-S14 L01 - 3rd local Background Sample Bore - BKG03 - Samples Collected at 0.5ft, 4.0ft and 5.0ft

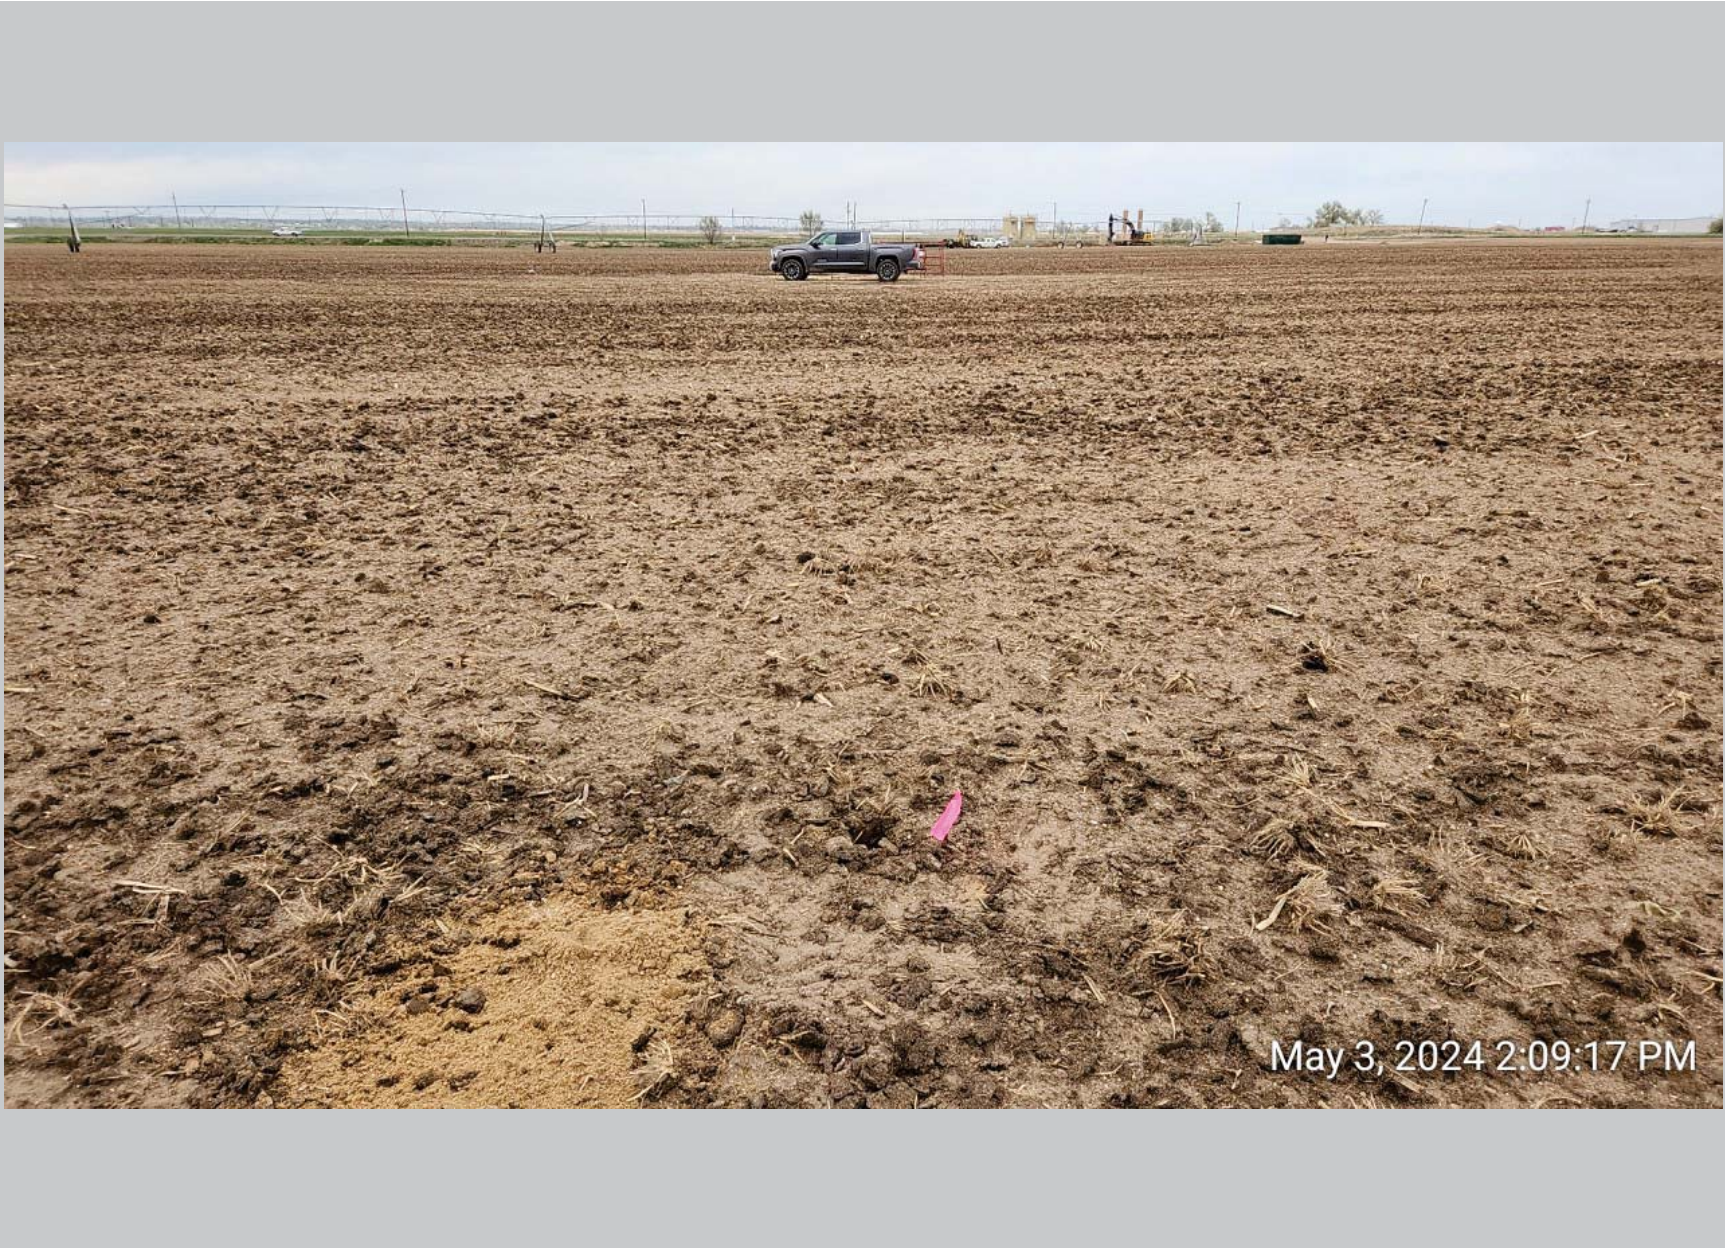
#14D - Ewing Robert Fed T4N-R66W-S14 L01 - 4th local Background Sample Bore - BKG04 - Samples Collected at 0.5ft, 4.0ft and 5.0ft

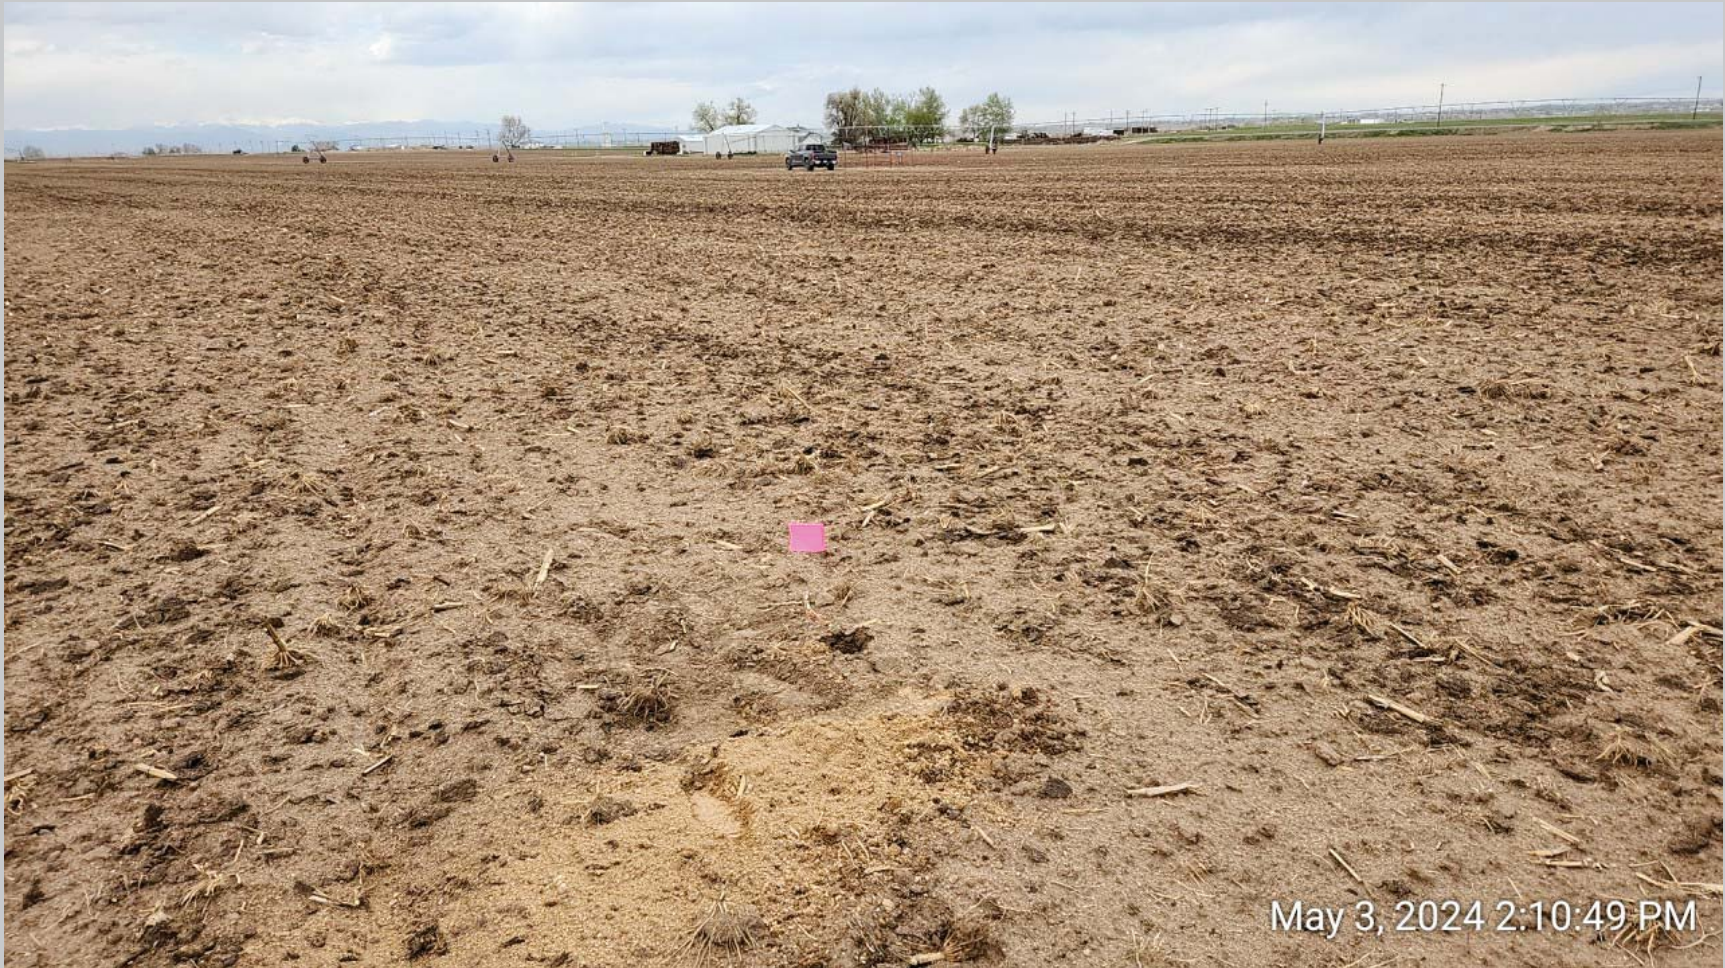
#14E - Ewing Robert Fed T4N-R66W-S14 L01 - 5th local Background Sample Bore - BKG05 - Samples Collected at 0.5ft, 4.0ft and 5.0ft
