Final Reclamation and Stormwater Inspection

Location ID: 320378

Well Name: FOSTER #1-22

Inspection Document #: 718600882

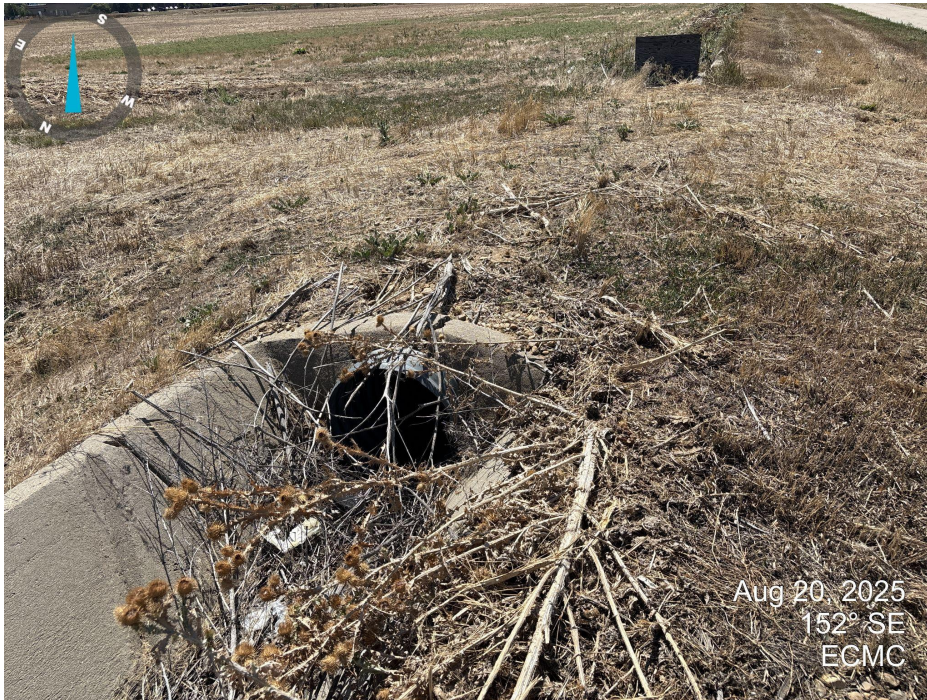
Photo 1. Picture taken at the center of the access road. Culvert is part of the irrigation system and appears to be used for landowner access to the field. List B noxious weed scotch thistle is present on the access road.

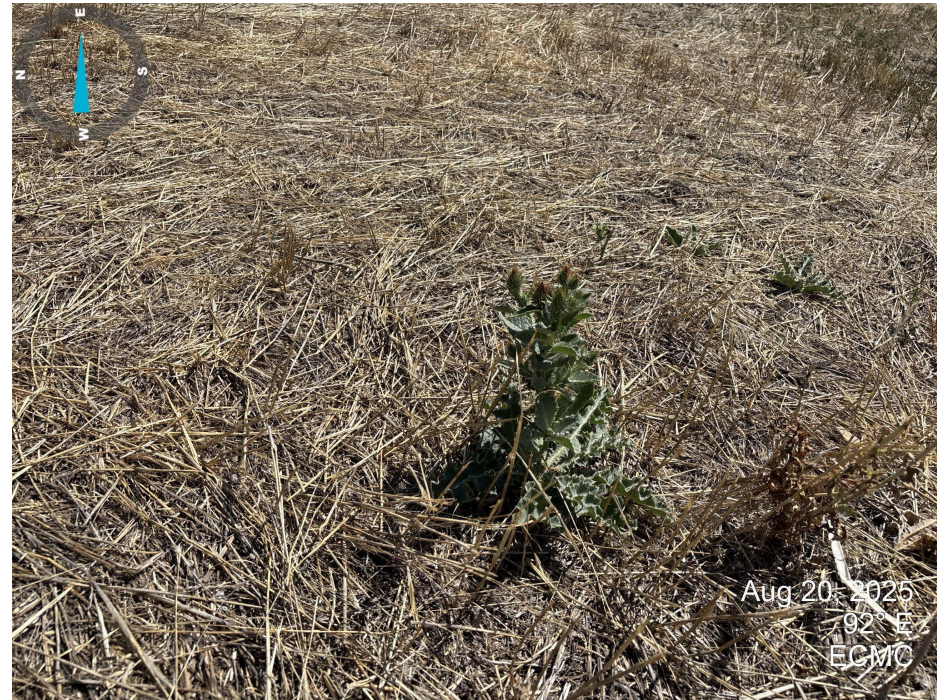
Photo 2. Picture taken near the entrance of the access road. List B noxious weed scotch thistle. Scotch thistle rosettes were observed on the length of the access road.

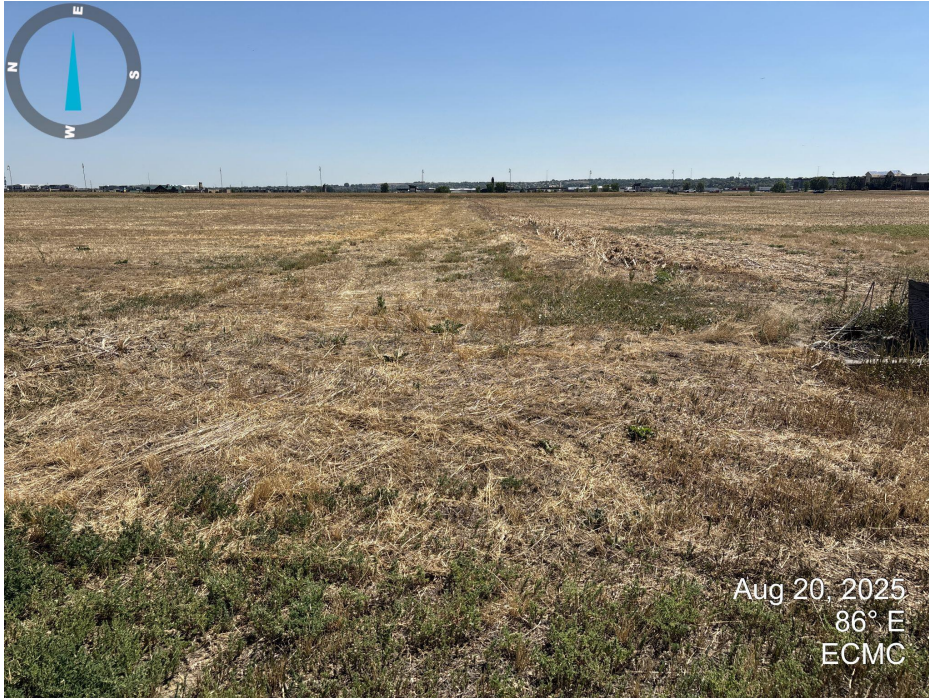
Photo 3. Looking east down the access road towards the well location. The location and access road are located within a mowed field. It appears that desirable vegetation has established on the access road.

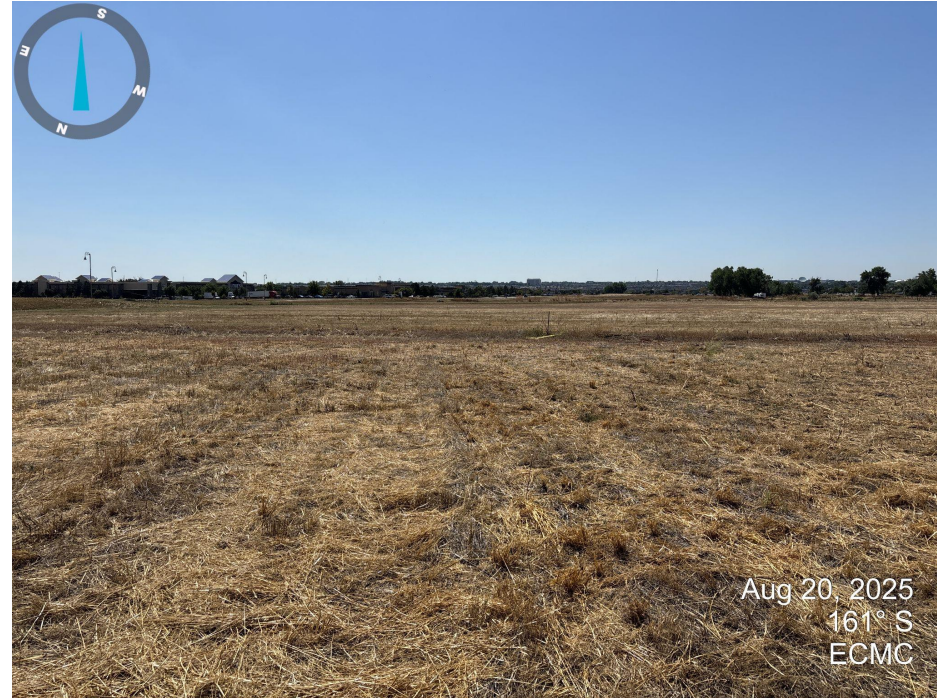
Photo 4. Looking south from the wellbore. the well location has been mowed. No oil and gas equipment remains on location. List B noxious weed scotch thistle rosettes were observed on the well location along with other undesirable weeds such as kochia. It appears that desirable vegetation has established on location and is progressing towards 80% coverage of the reference area.

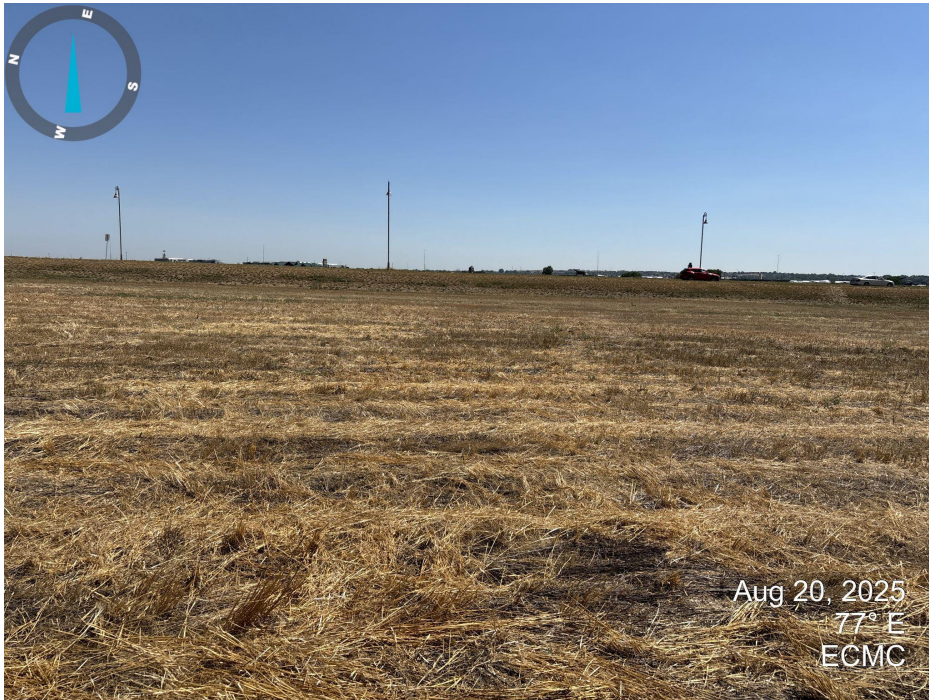
Photo 5. Looking east from wellbore. See photo 4 comments.

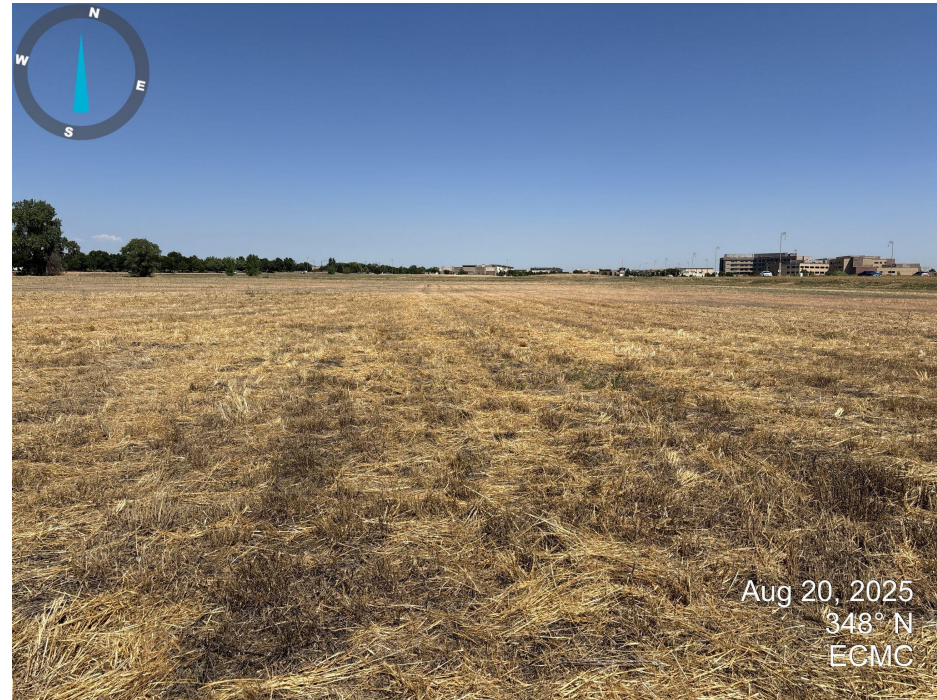
Photo 6. Looking north from wellbore. See photo 4 comments.

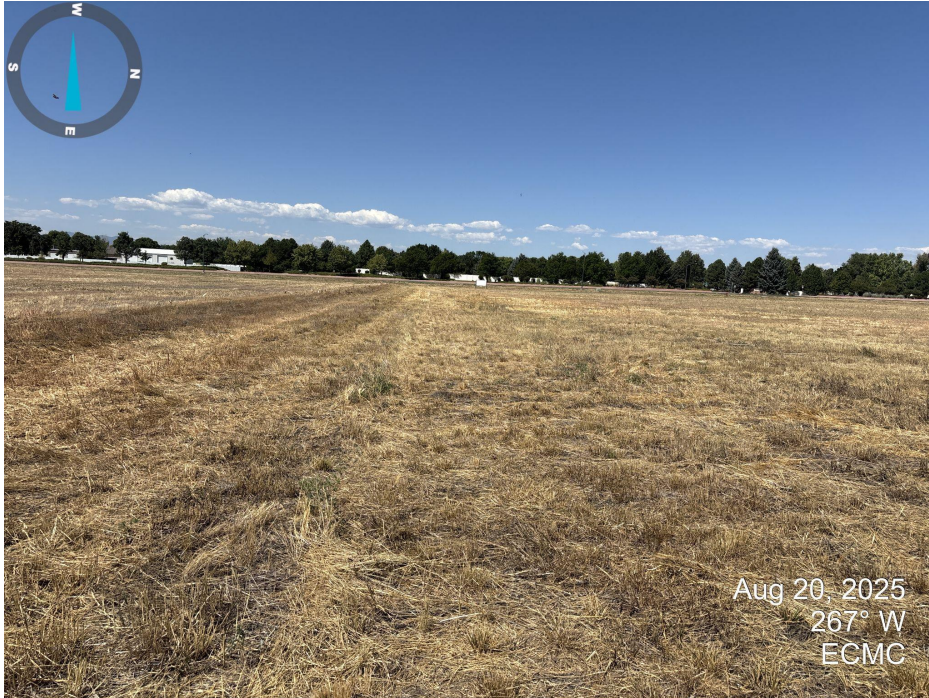
Photo 7. Looking west from wellbore. See photo 4 comments.

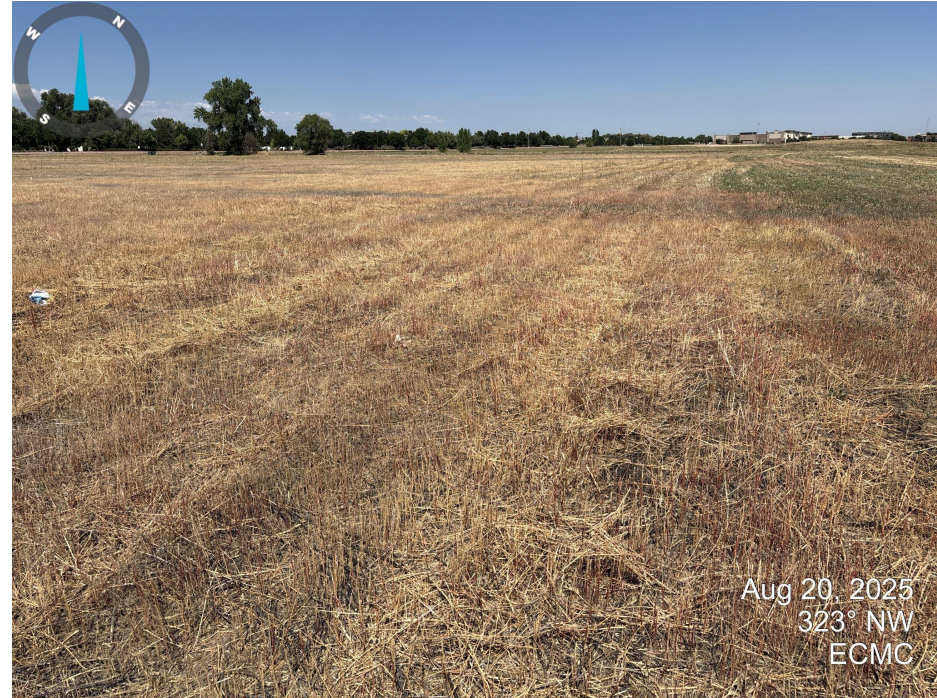
Photo 8. Reference vegetation to the south of well location. Reference vegetation appears to be poor.
