Final Reclamation and Stormwater Inspection

Location ID: 320204

Well Name: POITZ #1-22

Inspection Document #: 718600884

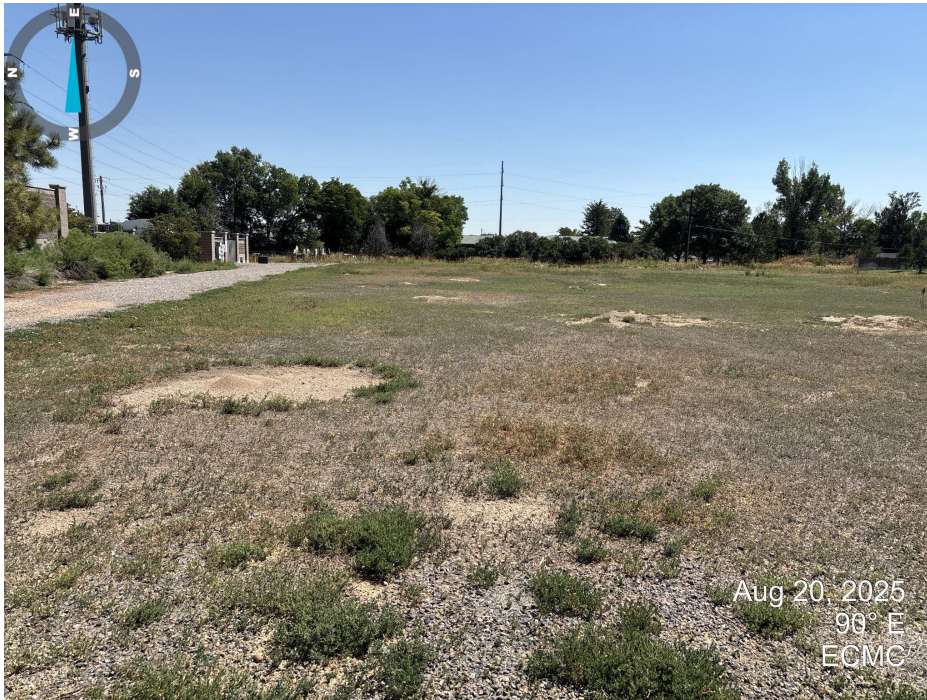
Photo 1. Looking east down the former access road to the wellhead. No oil and gas equipment is present on location. Desirable vegetation was not observed on location. Vegetation consists of undesirable weedy species such as kochia and list C noxious weed field bindweed. A prairie dog colony is present on location.

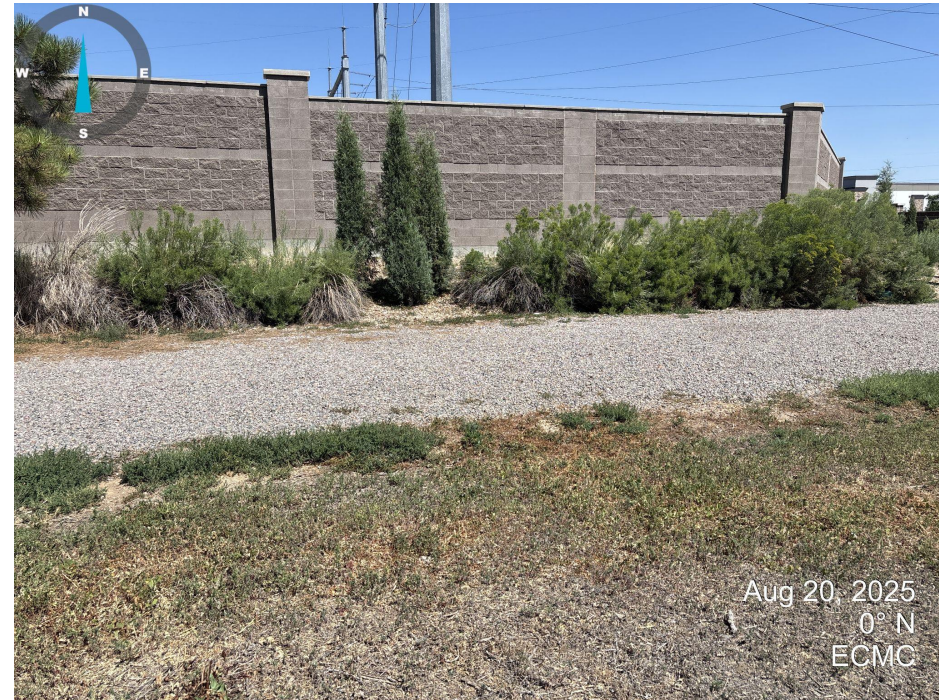
Photo 2. Looking north from the wellhead. This location was surrounded by gravel and abortion remains as an access road to a power substation.

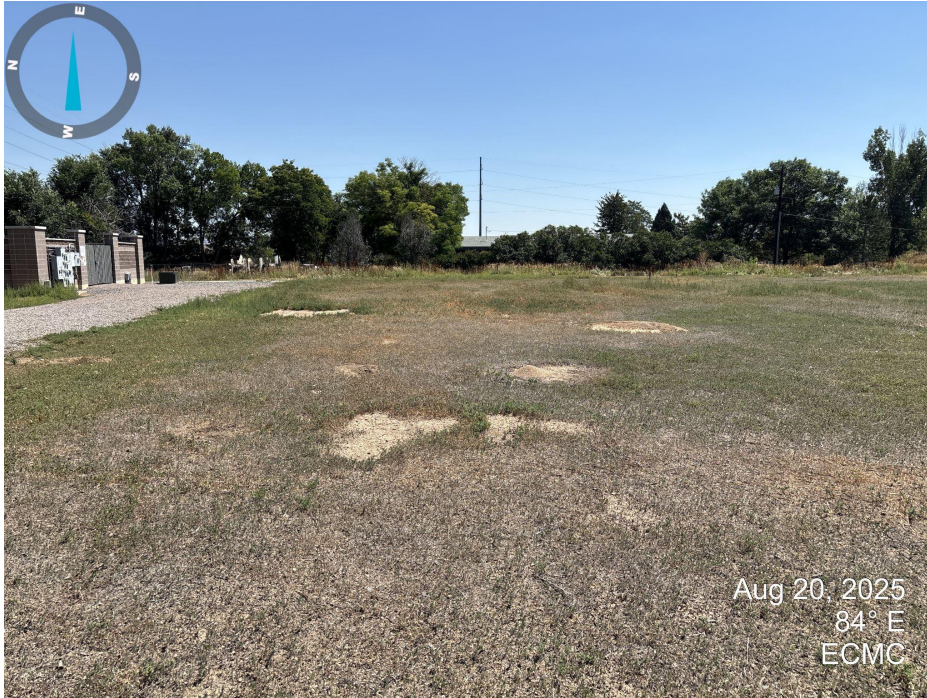
Photo 3. Looking east from the well location. See photo 1 comments.

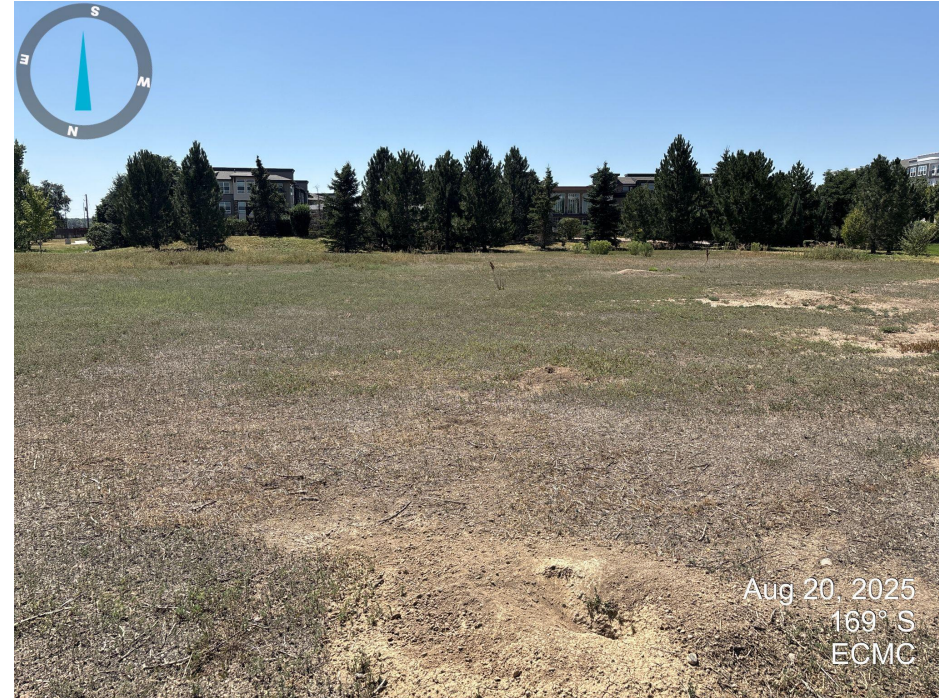
Photo 4. Looking east from the well location. See photo 1 comments.

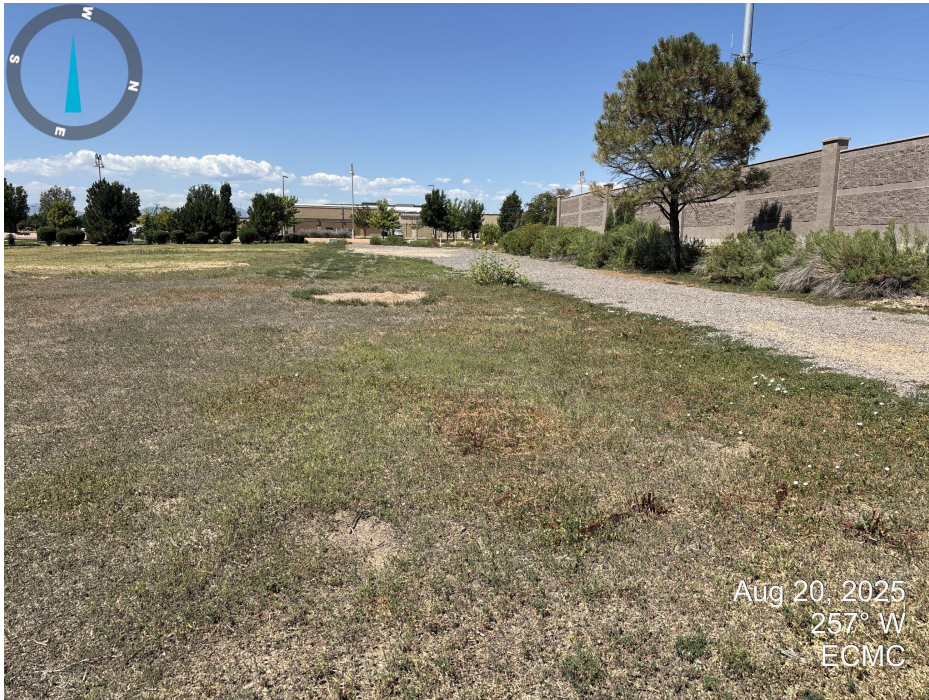
Photo 5. Looking west from the well location. See photo 1 comments.

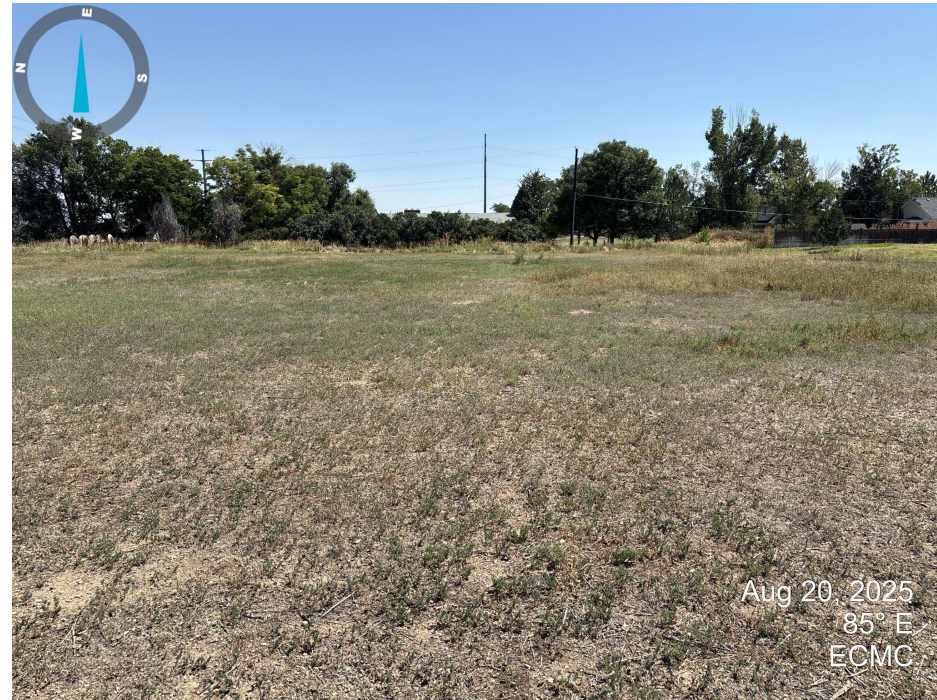
Photo 6. Looking east across the former tank battery. No equipment remains. Vegetation consists of undesirable weedy species such as kochia and list C noxious weed field bindweed.

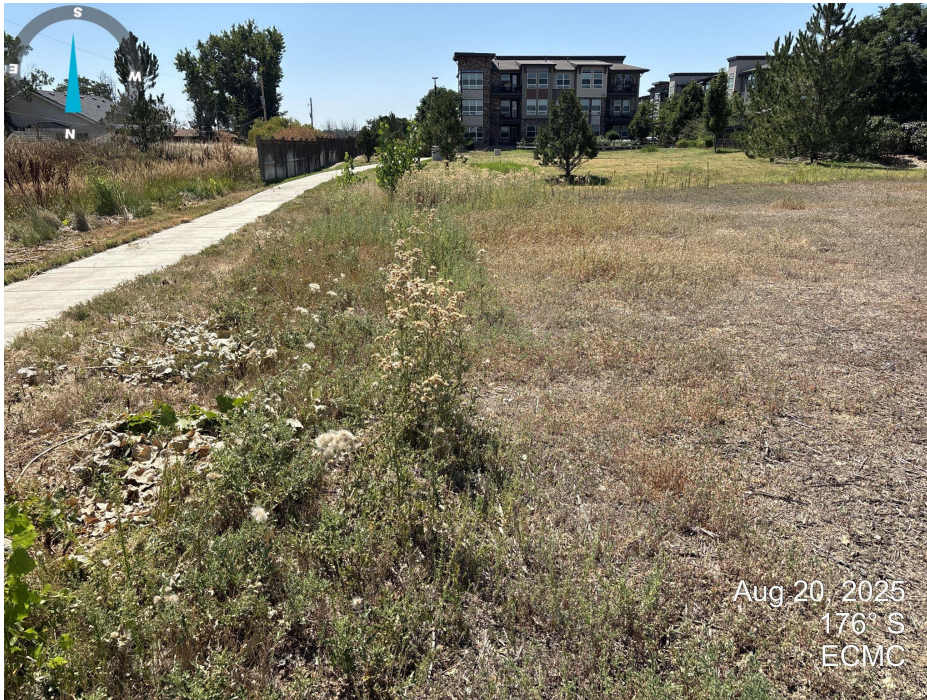
Photo 7. Picture taken at the east side of the location looking south. List B noxious weed Canada thistle was observed just outside the location. Noxious weeds were not observed on location at the time of inspection and appear to have been controlled on location.

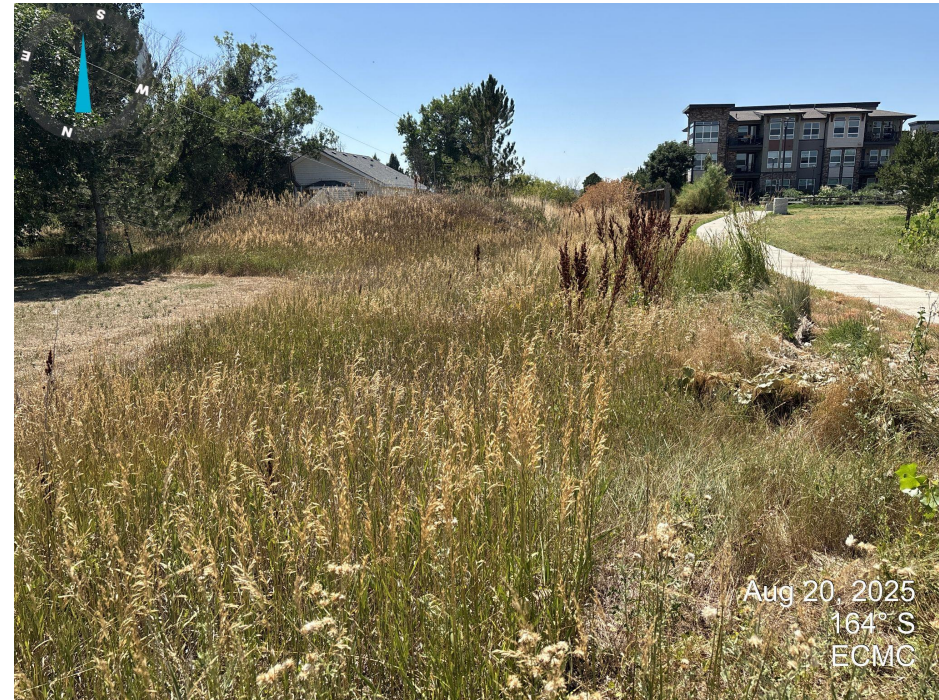
Photo 8. Reference vegetation to the east of the location.
