Final Reclamation Inspection

Operator: NOBLE ENERGY INC - 100322

Location ID: 330864

Inspection Photos
Location Name: STATE-TINCUP #13-16
Location ID: 330864

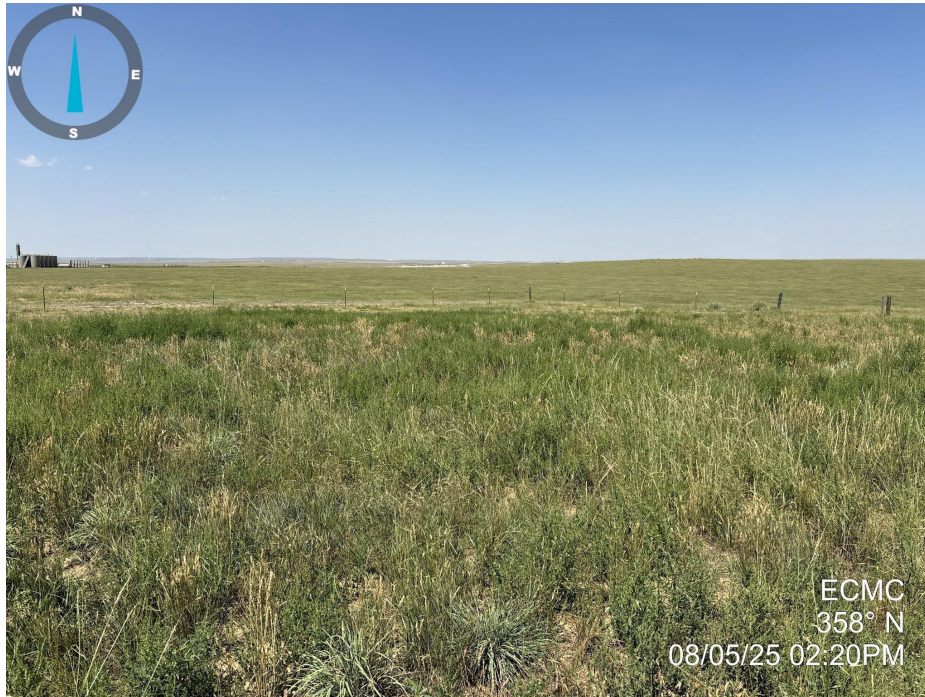
Photo 1. Photo taken of the well location, facing north. Photo illustrates that final reclamation activities have taken place, but the location does not meet Rule 1004 standards and weedy annual vegetation, including kochia (*Bassia scoparia*), was observed across the location.

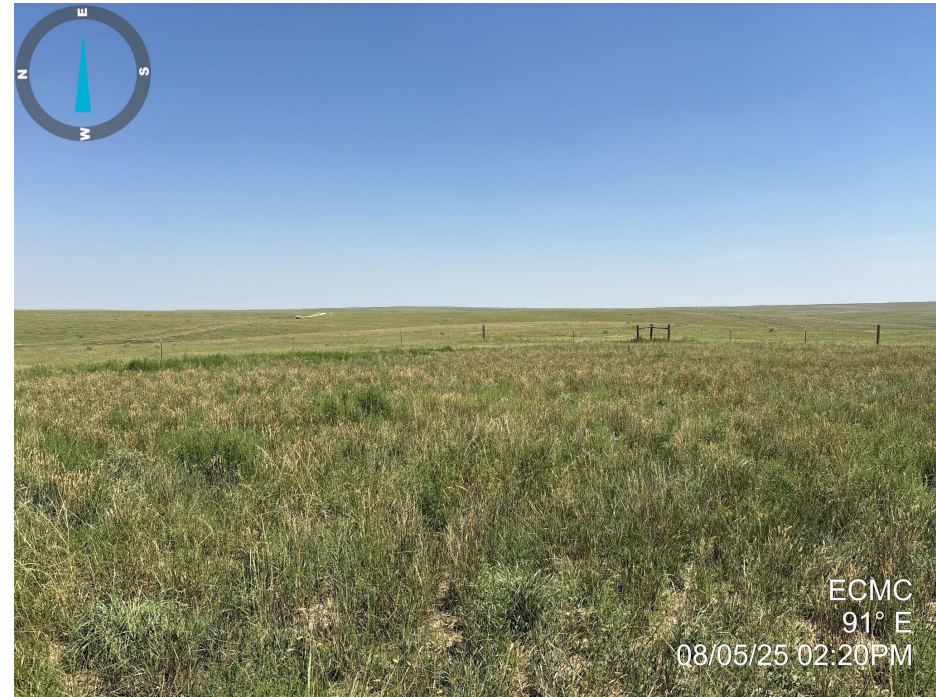
Photo 2. Photo taken of the well location, facing East. See comments under Photo 1.

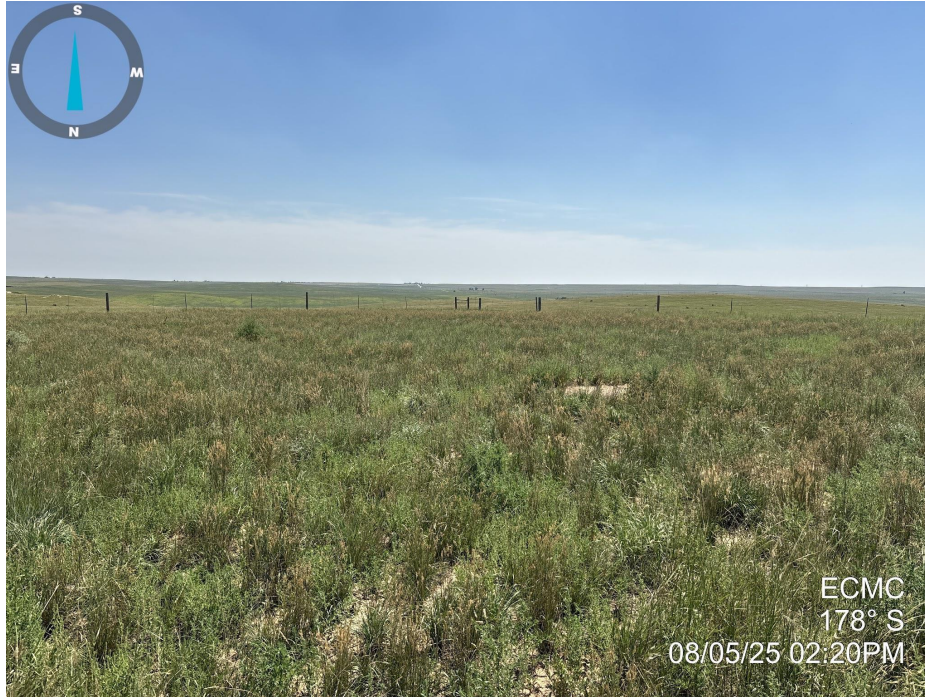
Photo 3. Photo taken of the well location, facing South. See comments under Photo 1.

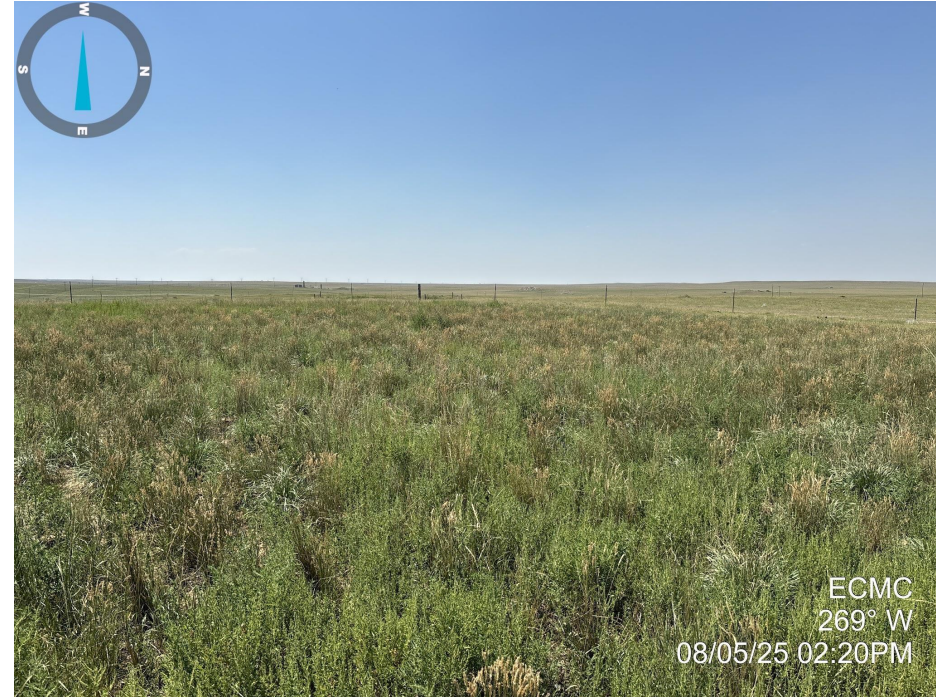
Photo 4. Photo taken of the well location, facing West. See comments under Photo 1.

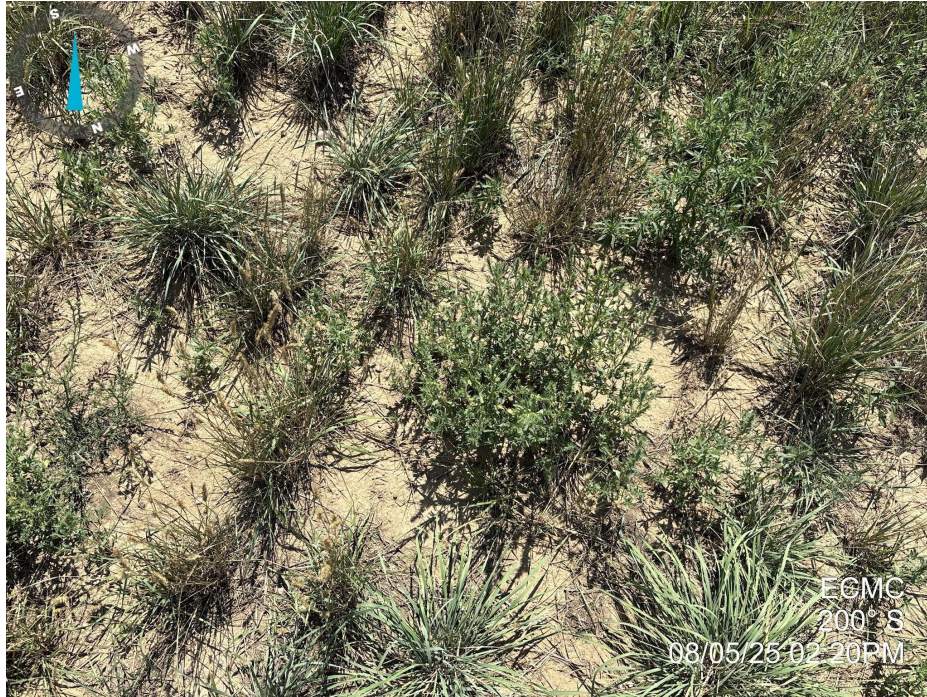
Photo 5. Photo taken of ground cover at the well location. Photo illustrates kochia (*Bassia scoparia*), perennial grass, and patches of bare ground.

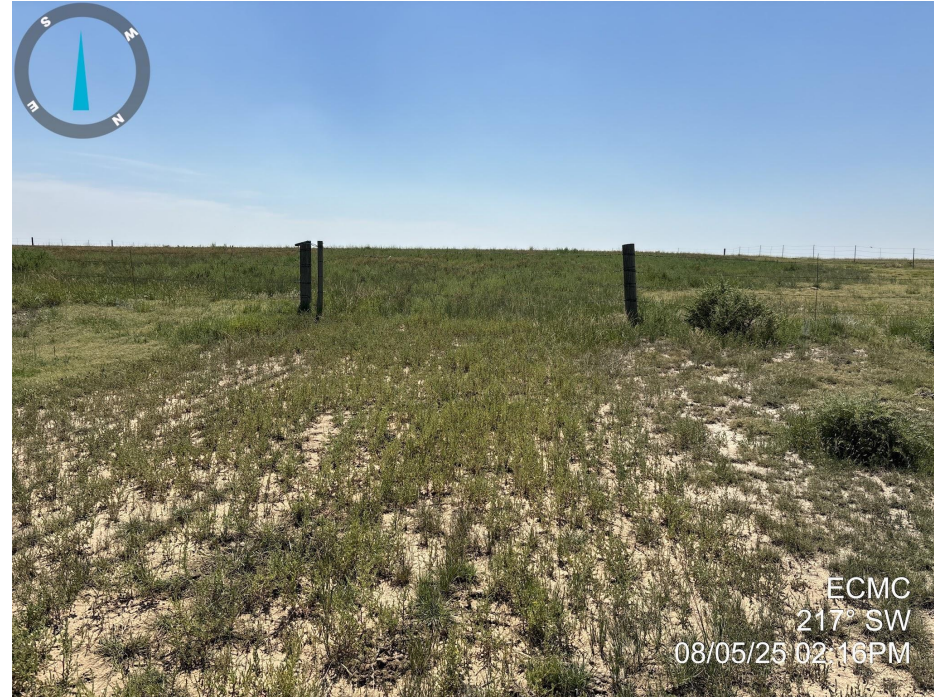
Photo 6. Photo taken of the access road to the well location, facing southwest, towards the location. Photo illustrates that final reclamation activities have taken place, with evidence of drill row seeding, but vegetation does not meet Rule 1004 standards.

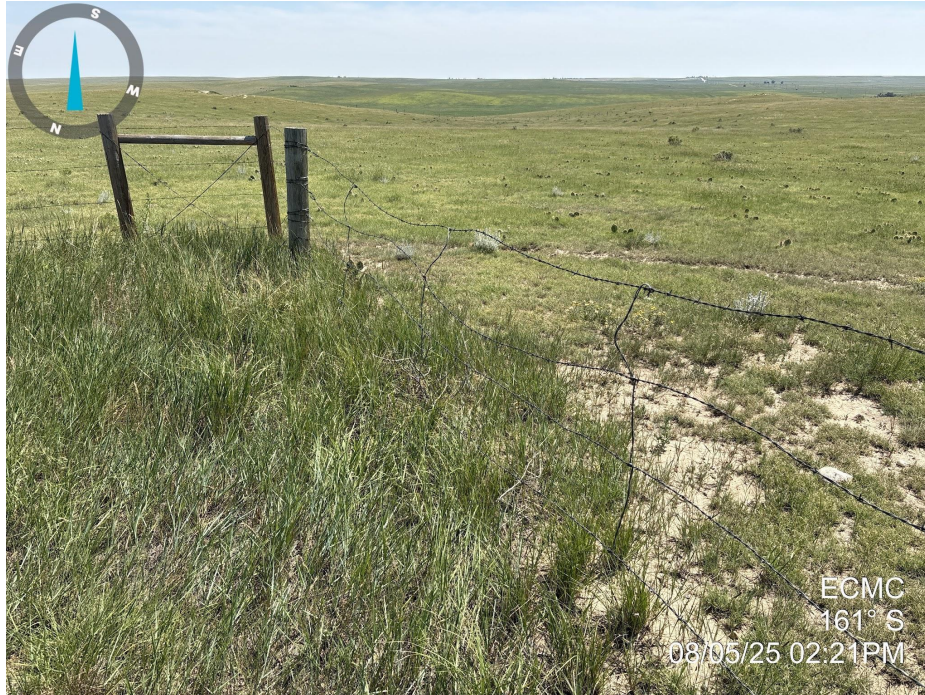
Photo 7. Photo taken of the entrance to the location, facing south. Photo illustrates that fencing remains surrounding the location.

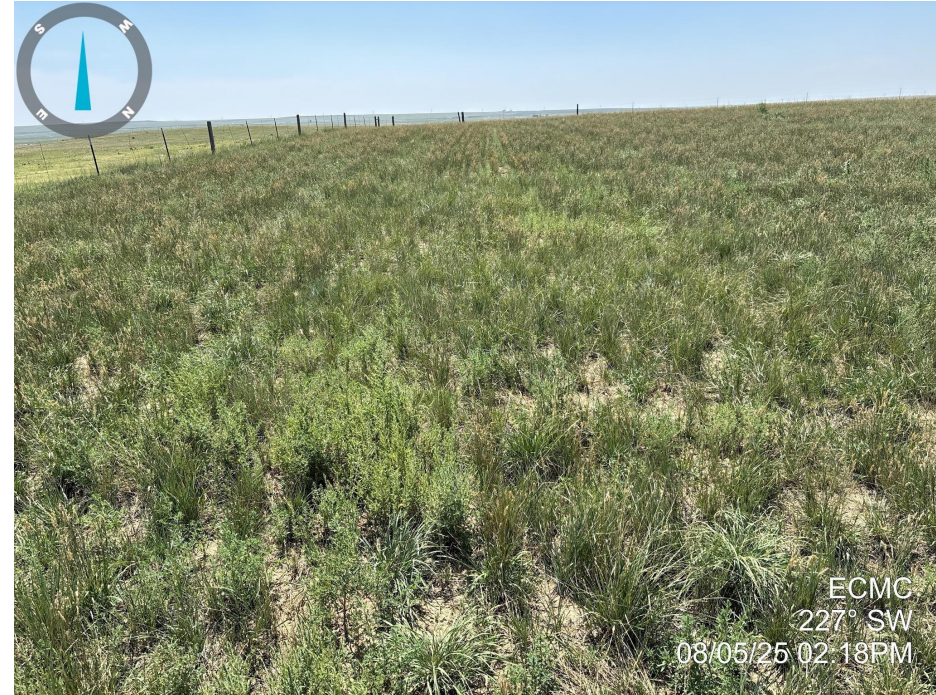
Photo 8. Photo taken of the tank battery location, facing southwest. Photo illustrates that final reclamation activities have taken place, but vegetation has not established to Rule 1004 standards.

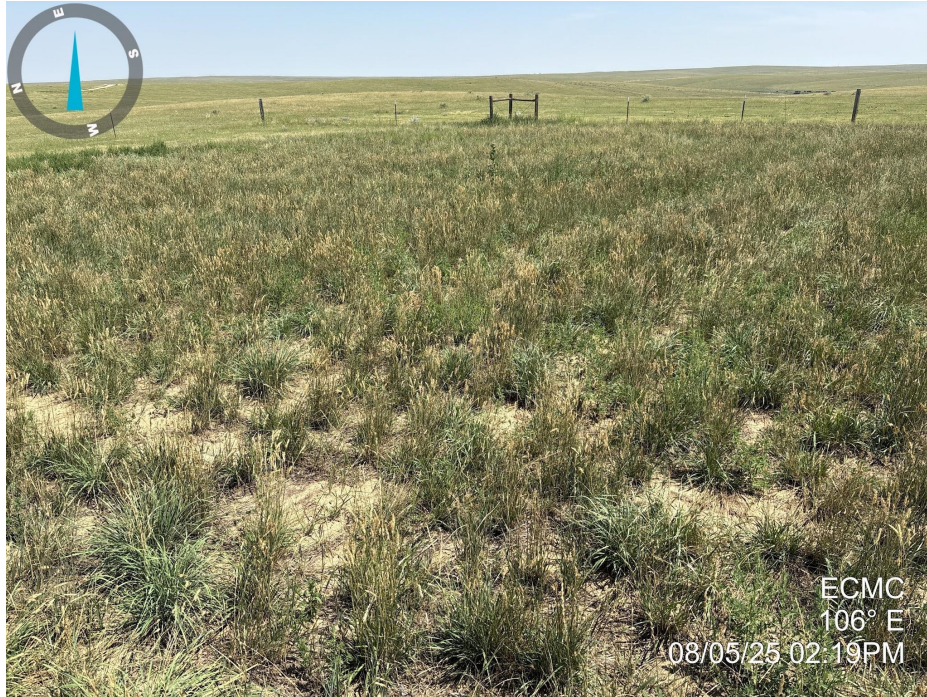
Photo 9. Photo taken of the tank battery location, facing east. See comments under Photo 8.

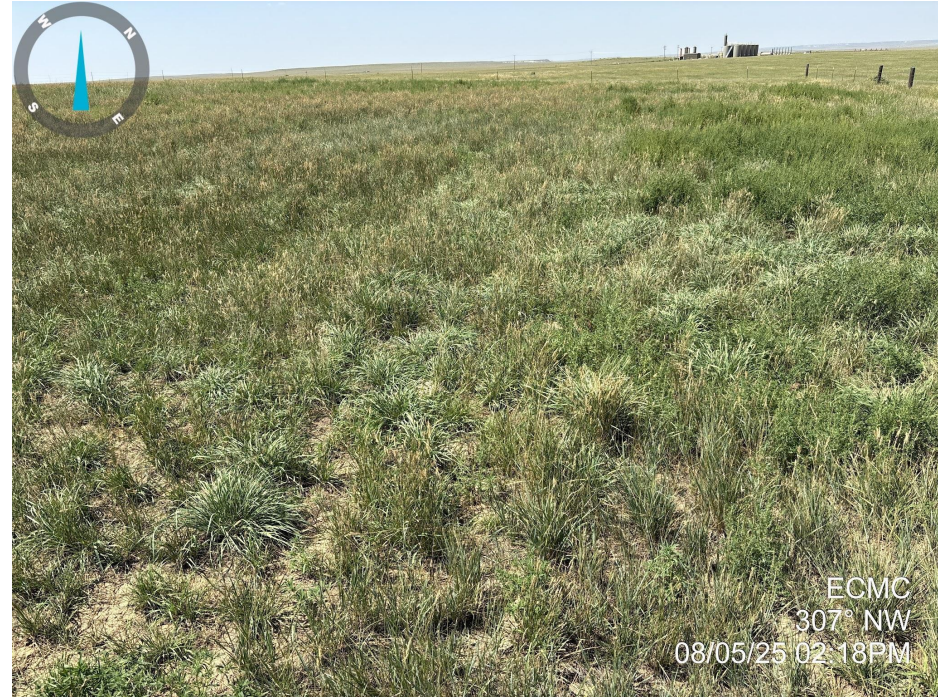
Photo 10. Photo taken of the tank battery location, facing northwest. See comments under Photo 8.

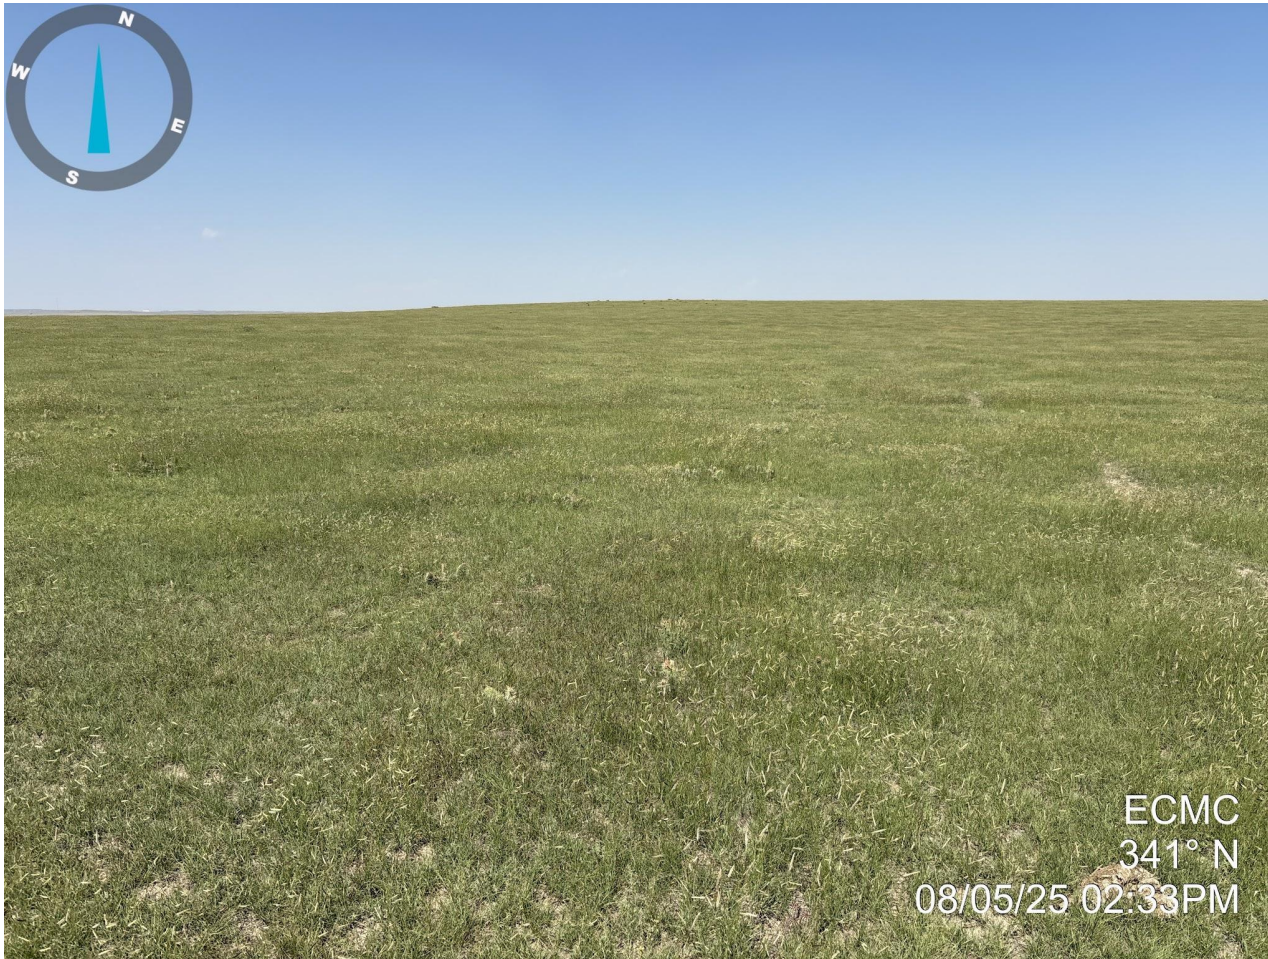
Photo 11. Photo taken of the reference area to the location, north of the location, facing north. Photo illustrates perennial grass vegetation.
