# Final Reclamation Inspection

Operator: PRAIRIE OPERATING CO LLC - 10819

Location ID: 409567

Inspection Photos  
Location Name: SHOWERS #32-11  
Location ID: 409567

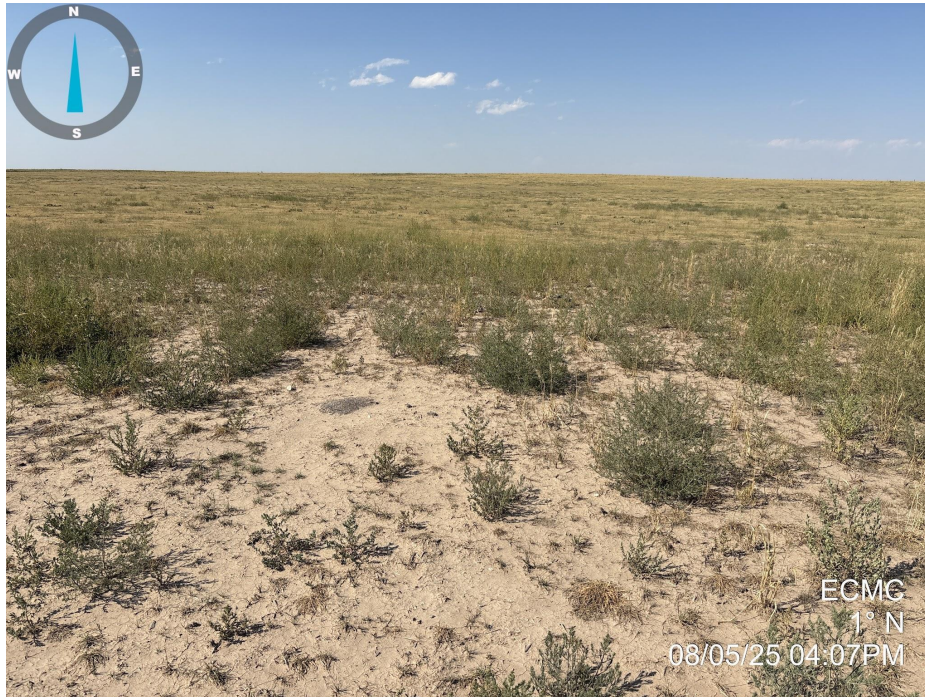
**Photo 1.** Photo taken of the well location, facing north. Photo illustrates that final reclamation activities have taken place, with evidence of drill row seeding, but vegetation establishment does not meet Rule 1004 standards. Bare ground and weedy annual vegetation, including kochia (*Bassia scoparia*) were observed across the location.

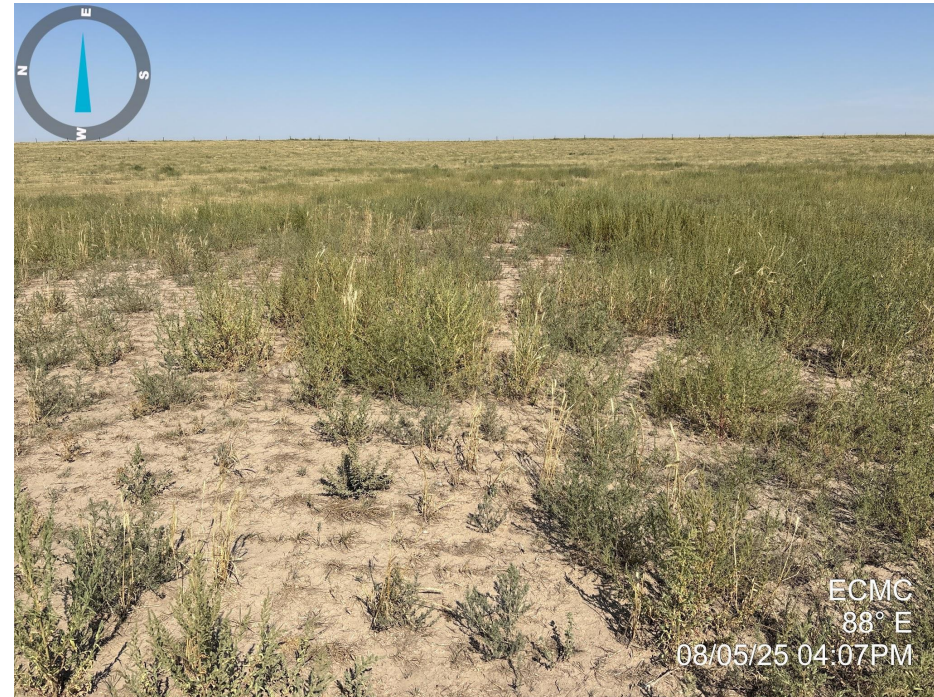
**Photo 2.** Photo taken of the well location, facing East. See comments under Photo 1.

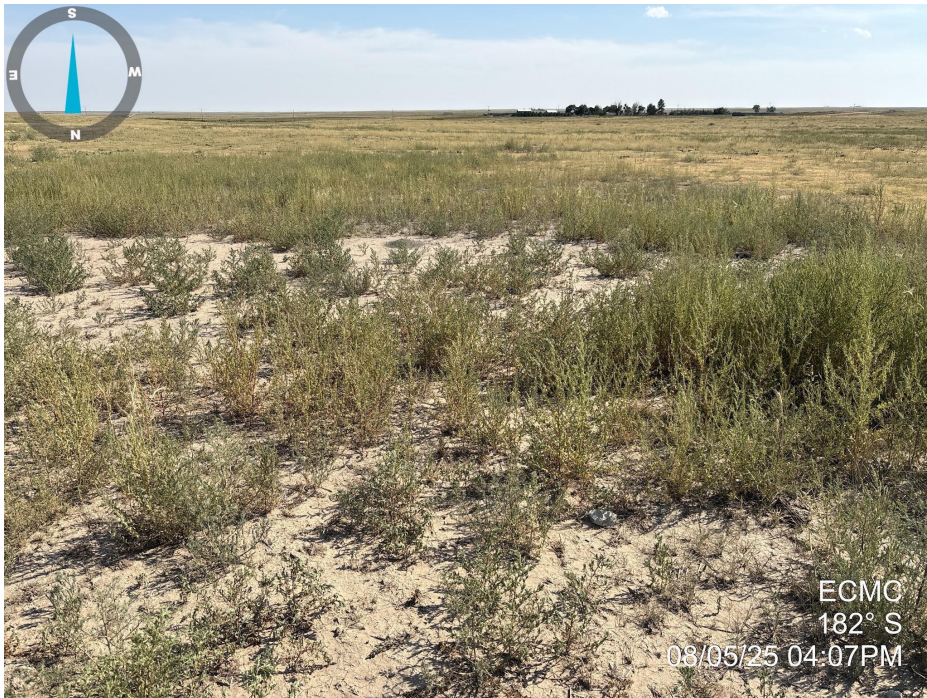
**Photo 3.** Photo taken of the well location, facing South. See comments under Photo 1.

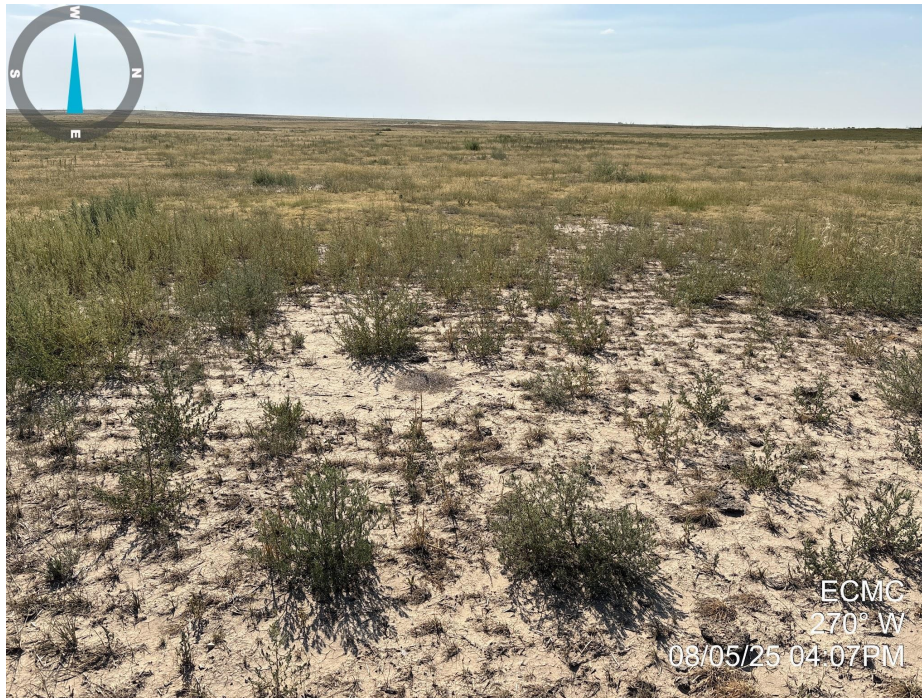
**Photo 4.** Photo taken of the well location, facing West. See comments under Photo 1.

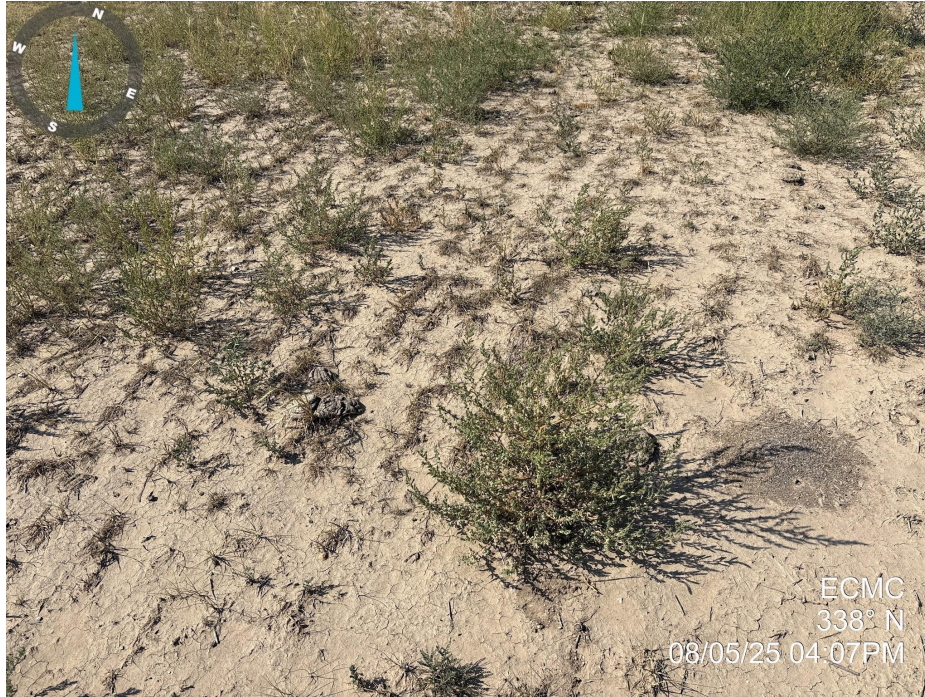
**Photo 5.** Photo taken of ground cover at the well location. Photo illustrates kochia (*Bassia scoparia*) and evidence of drill rows from seeding.

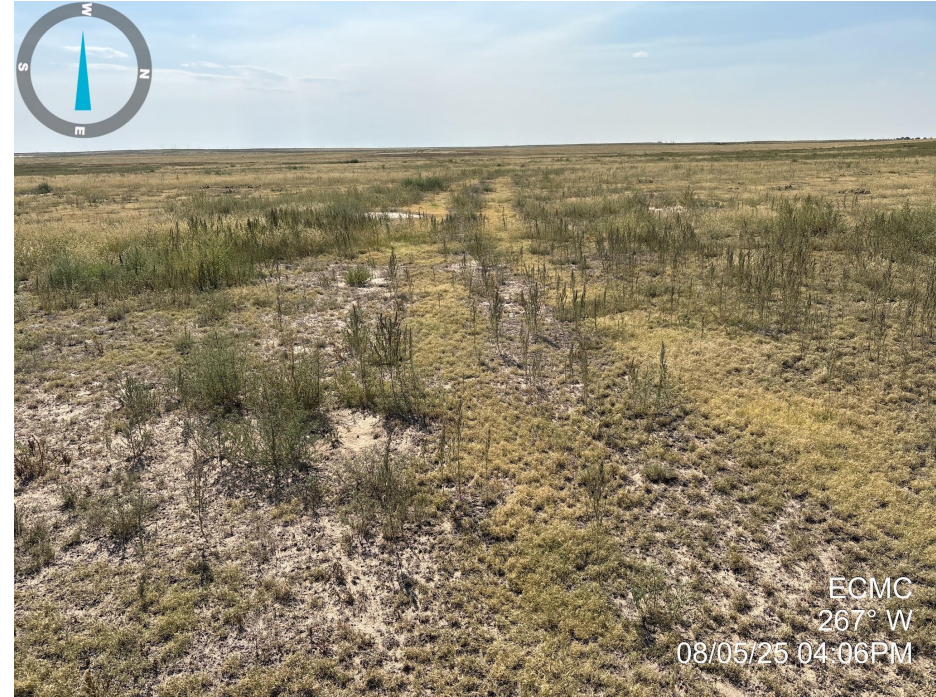
**Photo 6.** Photo taken of the access road to the well location, facing west, towards the location. Photo illustrates that final reclamation activities have taken place, but vegetation has not yet established to Rule 1004 standards.

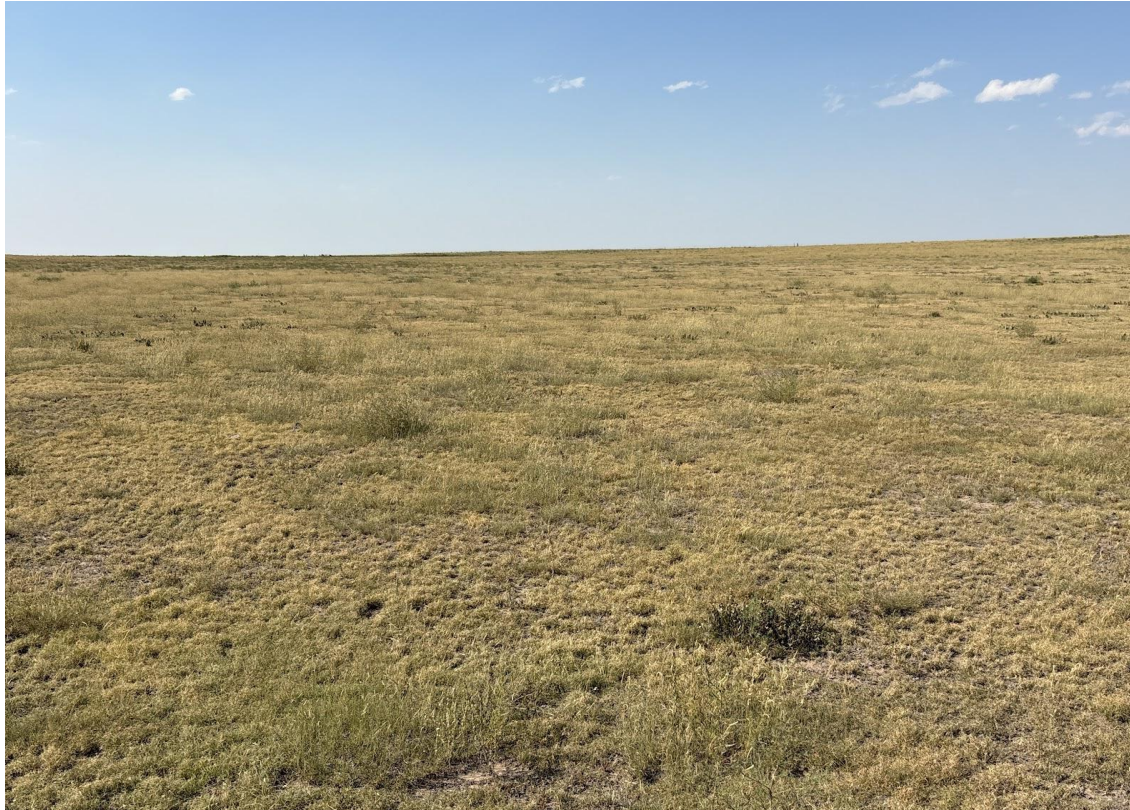
**Photo 7.** Photo taken of the reference area to the location, north of the location, facing north. Photo illustrates perennial grass vegetation.
