**Operator: AXIS EXPLORATION**

**Location Name: HSR-WHITEHEAD-66S62W 9SESW**

**Loc ID: 322209**

**Inspection: 713602313**

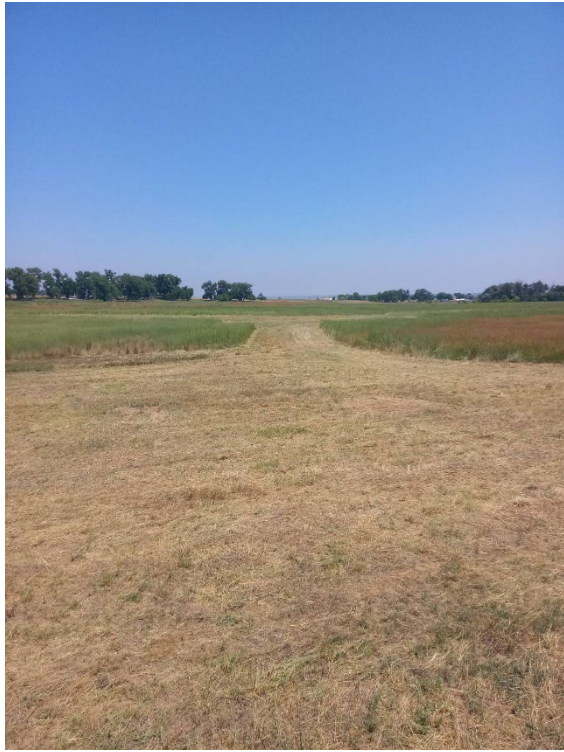
**Exhibit B**

**CA:** The location has not established sufficient perennial vegetation and will need to be reseeded. There are undesirable and noxious weeds that need to be controlled. The associated tank battery location was not inspected but that area will also need to be monitored and maintained. Comply with 1004 Rules.

**CA Resolution:** Operator has addressed the vegetation issue in order to comply with Rule 1004.
