Report of Work Completed – Facility Closure Investigation

ECMC Location Name (ID)	SHELTON R G-64N65W/26SENE (323270)
ECMC Well Name (API)	SHELTON R G #26-8 (05-123-12791)
Client Location Name	Shelton RG 26-08 FL
ECMC Remediation Project	29038
Legal Description	SENE Sec. 26 T4N-R66W
Coordinates (Lat, Long)	40.285020, -104.623510
County	Weld County, Colorado

Facility Closure Investigation
SHELTON R G #26-8 (API: 05-123-12791)

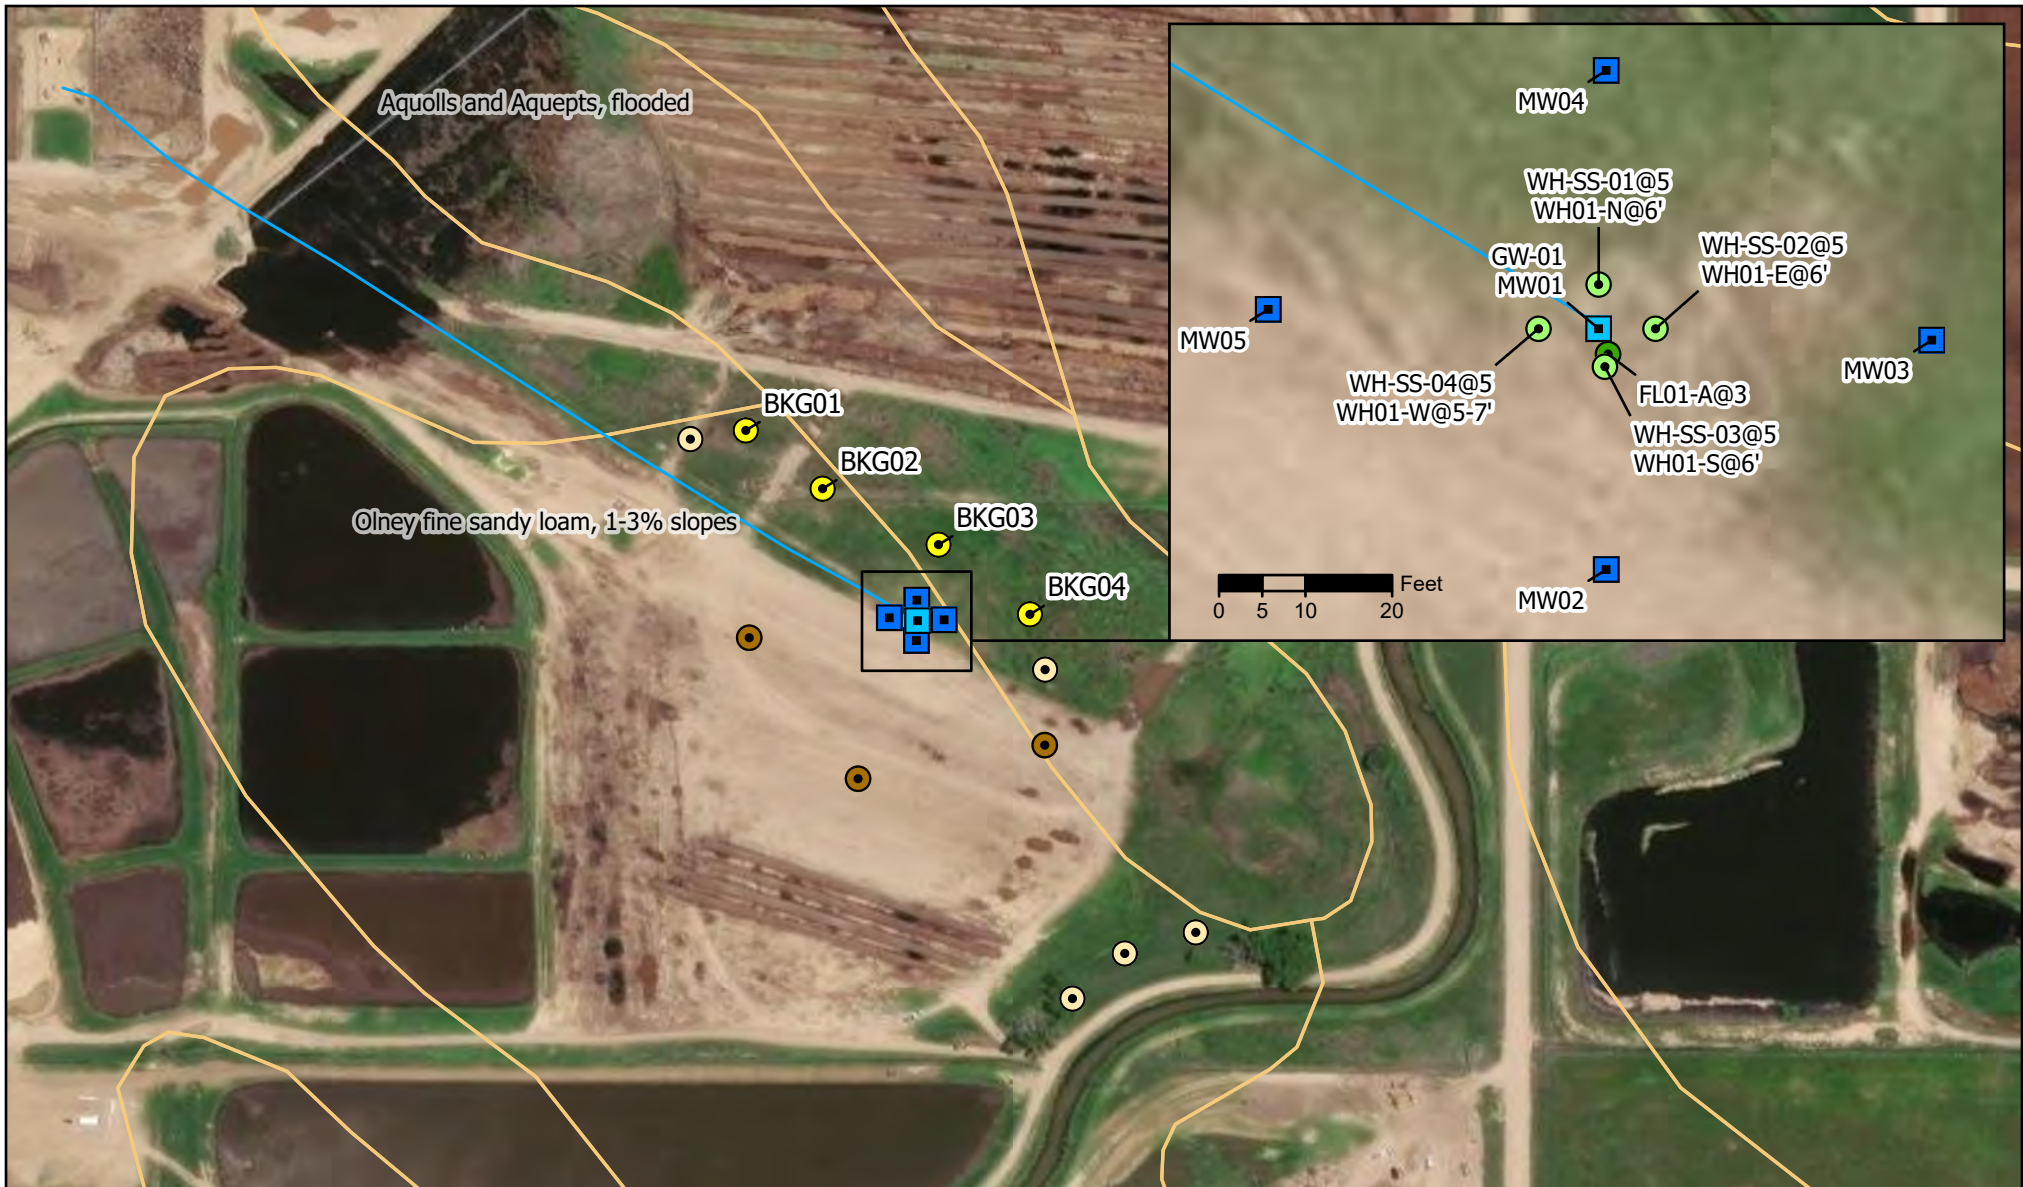
Site Diagram - Project Overview

- Soil Sample: Collected by Eagle (6/30/2023); Recharacterized by Confluence (6/23/2025)
- Soil Sample: Collected by Tasman (8/14/2023)
- Groundwater Grab Sample: Collected by Eagle (6/30/2023); Groundwater Monitoring Well Installed by Confluence (6/23/2025)
- Soil Boring / Groundwater Well
- Background Soil Sample: Collected by Confluence (6/23/2025)
- Proposed Background Soil Sample
- Proposed Manure Characterization / Background Soil Sample
- Approximate Flowline (Abandoned in Place)
- NRSC Soil Survey: Map Unit Boundary

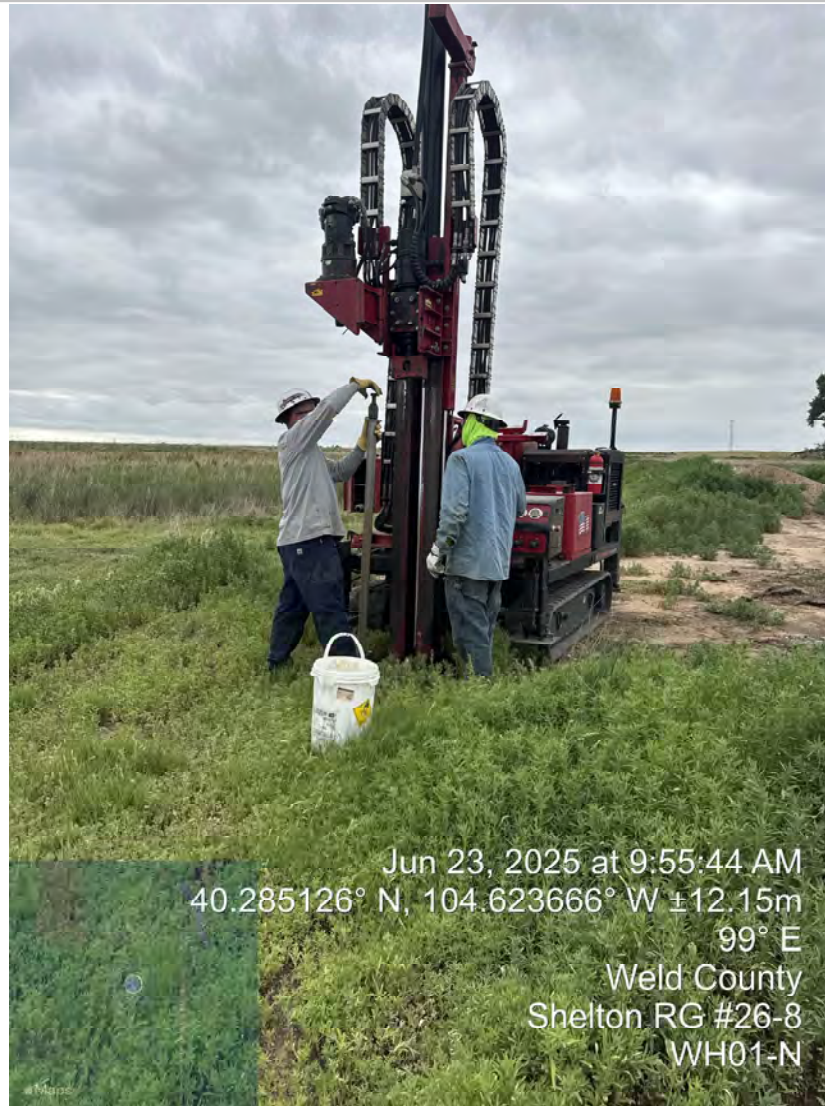
WH01-N Location: View East

Field-screening did not indicate the presence of hydrocarbon impacts. Analytical results of recharacterization soil samples indicate pH values above the SSR standard in all but the western sidewall sample with values ranging from 8.36 to 11.6 and sodium adsorption ratio (SAR) values above the SSR standard within the north and east sidewall samples at 7.08 and 9.57, respectively. All recharacterization soil samples exceed the PGSSL for arsenic with values ranging from 2.06 to 2.53 milligrams per kilogram (mg/kg). Concentrations of hexavalent chromium above the PGSSL were

observed in all but the north sidewall recharacterization sample and range from 0.13 to 0.22 milligrams per kilogram (mg/kg). Values of lead exceeding the PGSSL were observed within the south and west sidewall recharacterization samples at concentrations of 17.0 and 28.7 mg/kg, respectively.

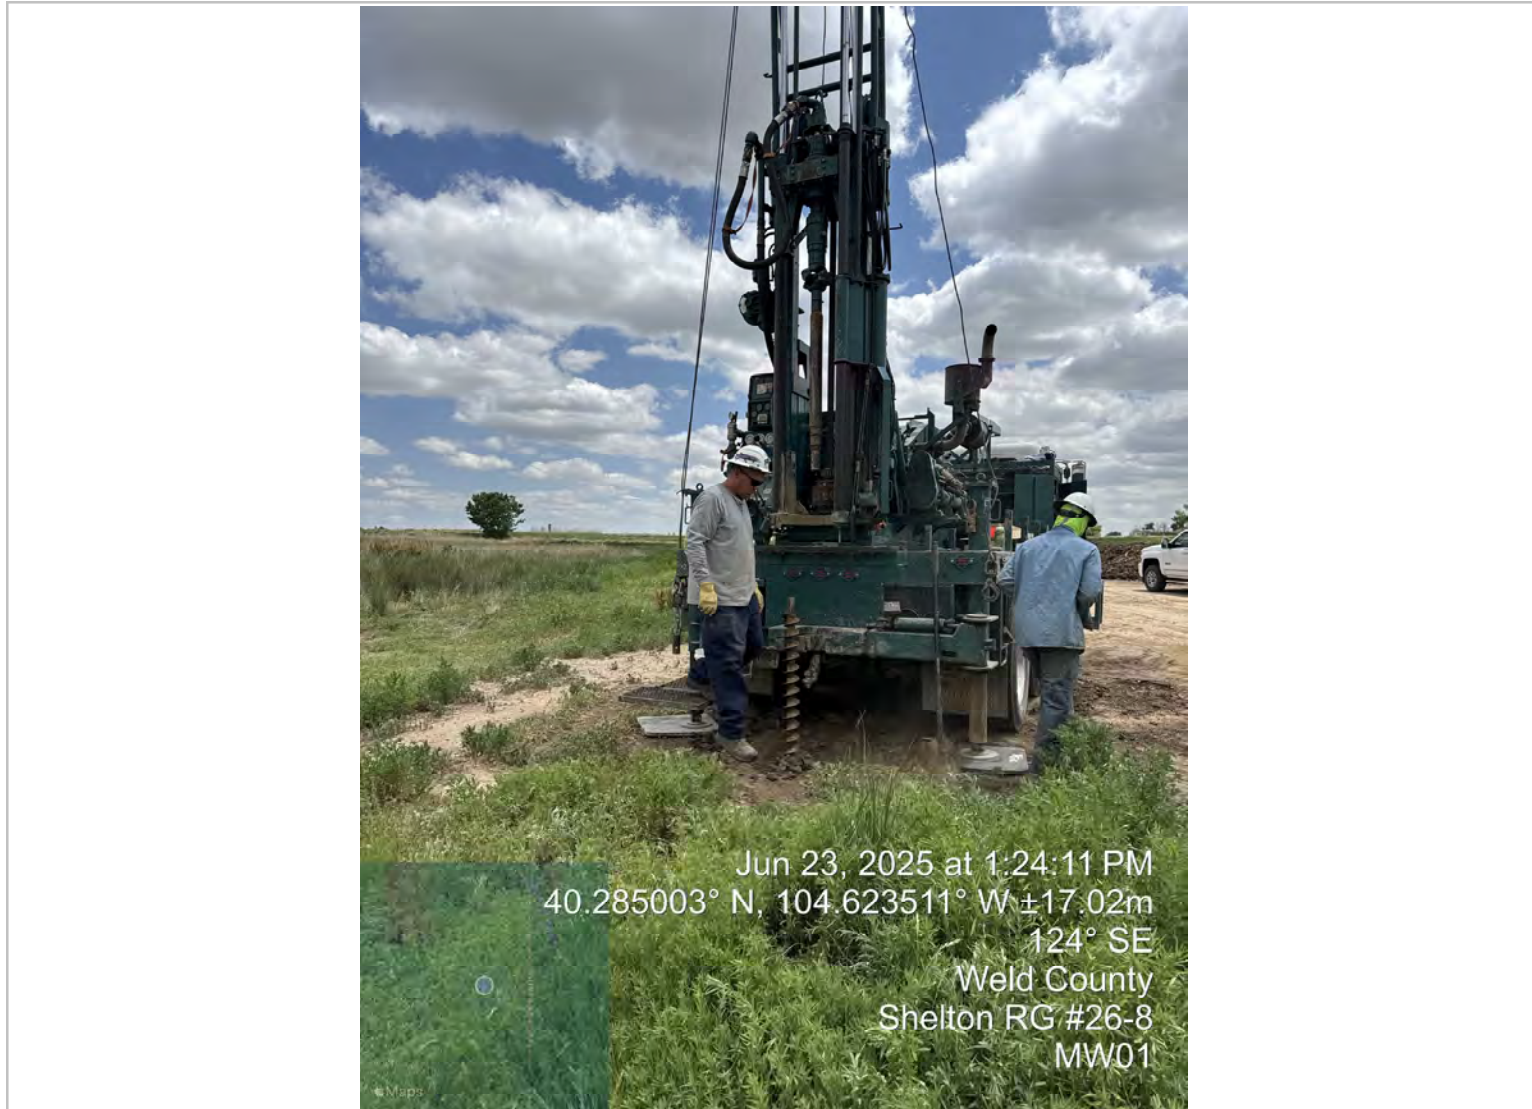
MW01 Location: View Southeast

Field-screening did not indicate the presence of hydrocarbon impacts. Analytical results of soil boring samples indicate SAR values above the SSR standard within all but the MW01 sample with values ranging from 8.20 to 12.2. All soil boring samples exceed the PGSSL for arsenic with values ranging from 2.07 to 4.17 mg/kg. MW02 -MW04 exceeded the PGSSL for barium with concentrations ranging from 82.4 to 161 mg/kg, MW02 and MW05 indicated exceedances of hexavalent chromium at values of 0.08 and 0.15 mg/kg, respectively, and MW01 had a lead exceedance of 26.9 mg/kg.

Boring Number: MW-01				Lat/Long: 40.285025, -104.623537		
Scope: Characterization Soil Sampling & GMMW Install				Drilling Equipment: Power Probe 9500 / HSA		
Drilling Method: SSA		Drilling Contractor: Alpine Remediation		Driller: Tom Morris		
Date: 06/23/2025	Start Time: 1020	Finish Time: 1035	DTW: 3.9'	Total Depth of Boring: 10'		
Geologist: Holly Tignac						
Depth (ft)	Time	Recovery	Standard Penetration Test Results	USCS Symbol	Material Description	PID Reading (ppm)
0 - 5	1020	10%	NA	CL	Brown, Sandy Clay Loam, Moist, Medium Plasticity. No Odor or Staining.	0.5
5 - 10	1030	80%	NA	CL	Brown with Black Streaks, Sandy Clay Loam, Moist, Medium Plasticity, Light Odor. Wet at 7'	2.0
<p style="text-align: center;">5 feet Screen 5 feet Riser 2 feet Sand Above Screen 3 feet Bentonite plug Flush Mount 2-Inch PVC</p>						
Samples Collected: 6' (3 jars)				Comments:

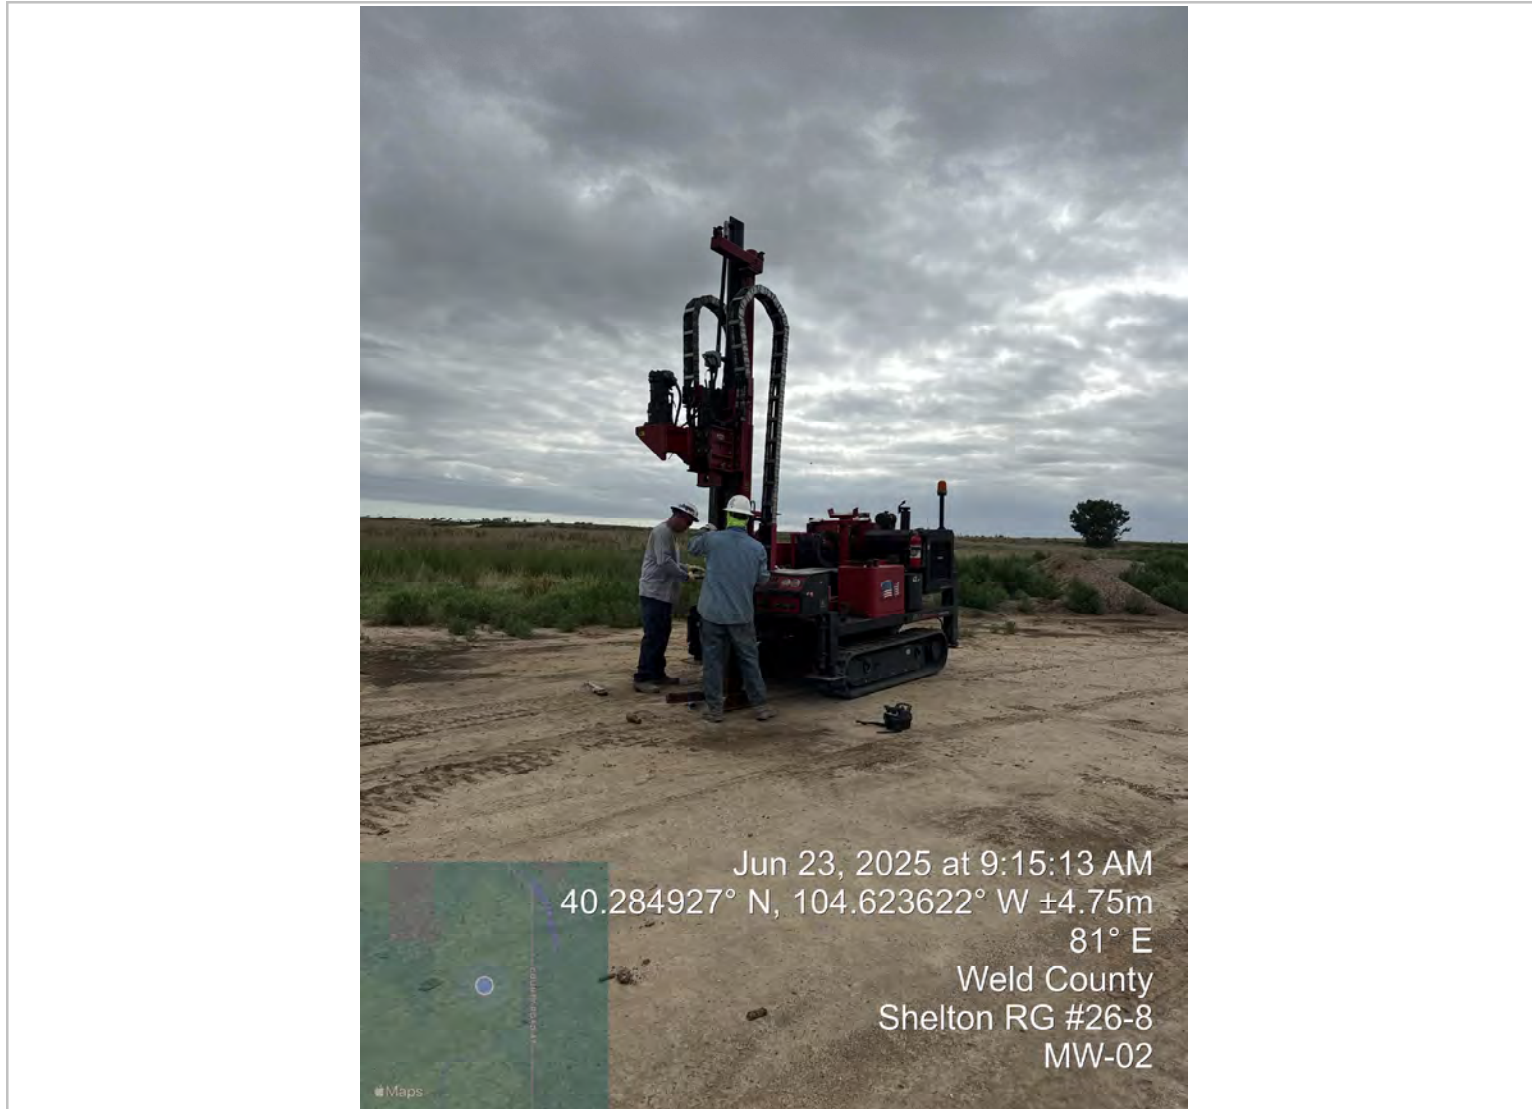
MW02 Location (Pre-Monitoring Well Borehole): View East

Boring Number: MW-02			Lat/Long: 40.284945, -104.623542			
Scope: Characterization Soil Sampling & GMMW Install			Drilling Equipment: Power Probe 9500 / HSA			
Drilling Method: SSA		Drilling Contractor: Alpine Remediation		Driller: Tom Morris		
Date: 06/23/2025	Start Time: 0915	Finish Time: 0925	DTW: 2.8'	Total Depth of Boring: 10'		
Geologist: Holly Tignac						
Depth (ft)	Time	Recovery	Standard Penetration Test Results	USCS Symbol	Material Description	PID Reading (ppm)
0 - 2	0920	60%	NA	CL	Brown, Sandy Clay, Dry, Low Plasticity. No Odor or Staining.	0.3
2 - 5	0920	60%	NA	CL	Brown, Sandy Clay Loam, Moist, Medium Plasticity. No Odor or Staining.	0.2
5 - 10	0925	80%	NA	CL	Tan, Sandy Clay, Moist, Medium Plasticity. No Odor or Staining. Wet at 6' bgs. 6 feet Screen 4 feet Riser 1 foot Sand Above Screen 3 feet Bentonite plug Flush Mount 2-Inch PVC	0.2
Samples Collected: 5' (3 jars)				Comments:

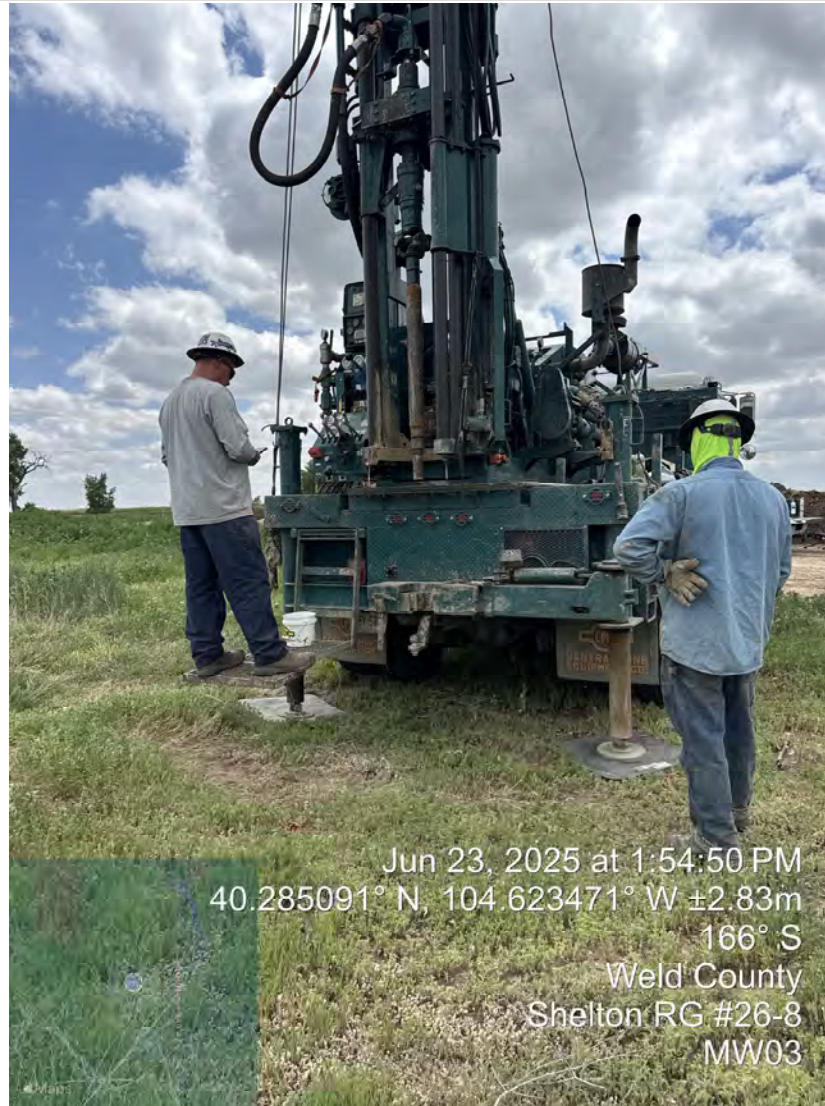
MW03 Location: View South

Boring Number: MW-03				Lat/Long: 40.285029, -104.623430		
Scope: Characterization Soil Sampling & GMMW Install				Drilling Equipment: Power Probe 9500 / HSA		
Drilling Method: SSA		Drilling Contractor: Alpine Remediation		Driller: Tom Morris		
Date: 06/23/2025	Start Time: 1040	Finish Time: 1050	DTW: 2.4'	Total Depth of Boring: 10'		
Geologist: Holly Tignac						
Depth (ft)	Time	Recovery	Standard Penetration Test Results	USCS Symbol	Material Description	PID Reading (ppm)
0 - 5	1040	80%	NA	CL	Brown with Orange Streaks, Sandy Clay Loam, Moist, Medium Plasticity. No Odor or Staining.	0.0
5 - 10	1050	85%	NA	CL	Brown with Orange Streaks, Sandy Clay Loam, Moist, Medium Plasticity. No Odor or Staining. Wet at 6' 6 feet Screen 4 feet Riser 1 foot Sand Above Screen 3 feet Bentonite plug J-Plug 2-Inch PVC	0.0
Samples Collected: 5' (3 jars)				Comments:

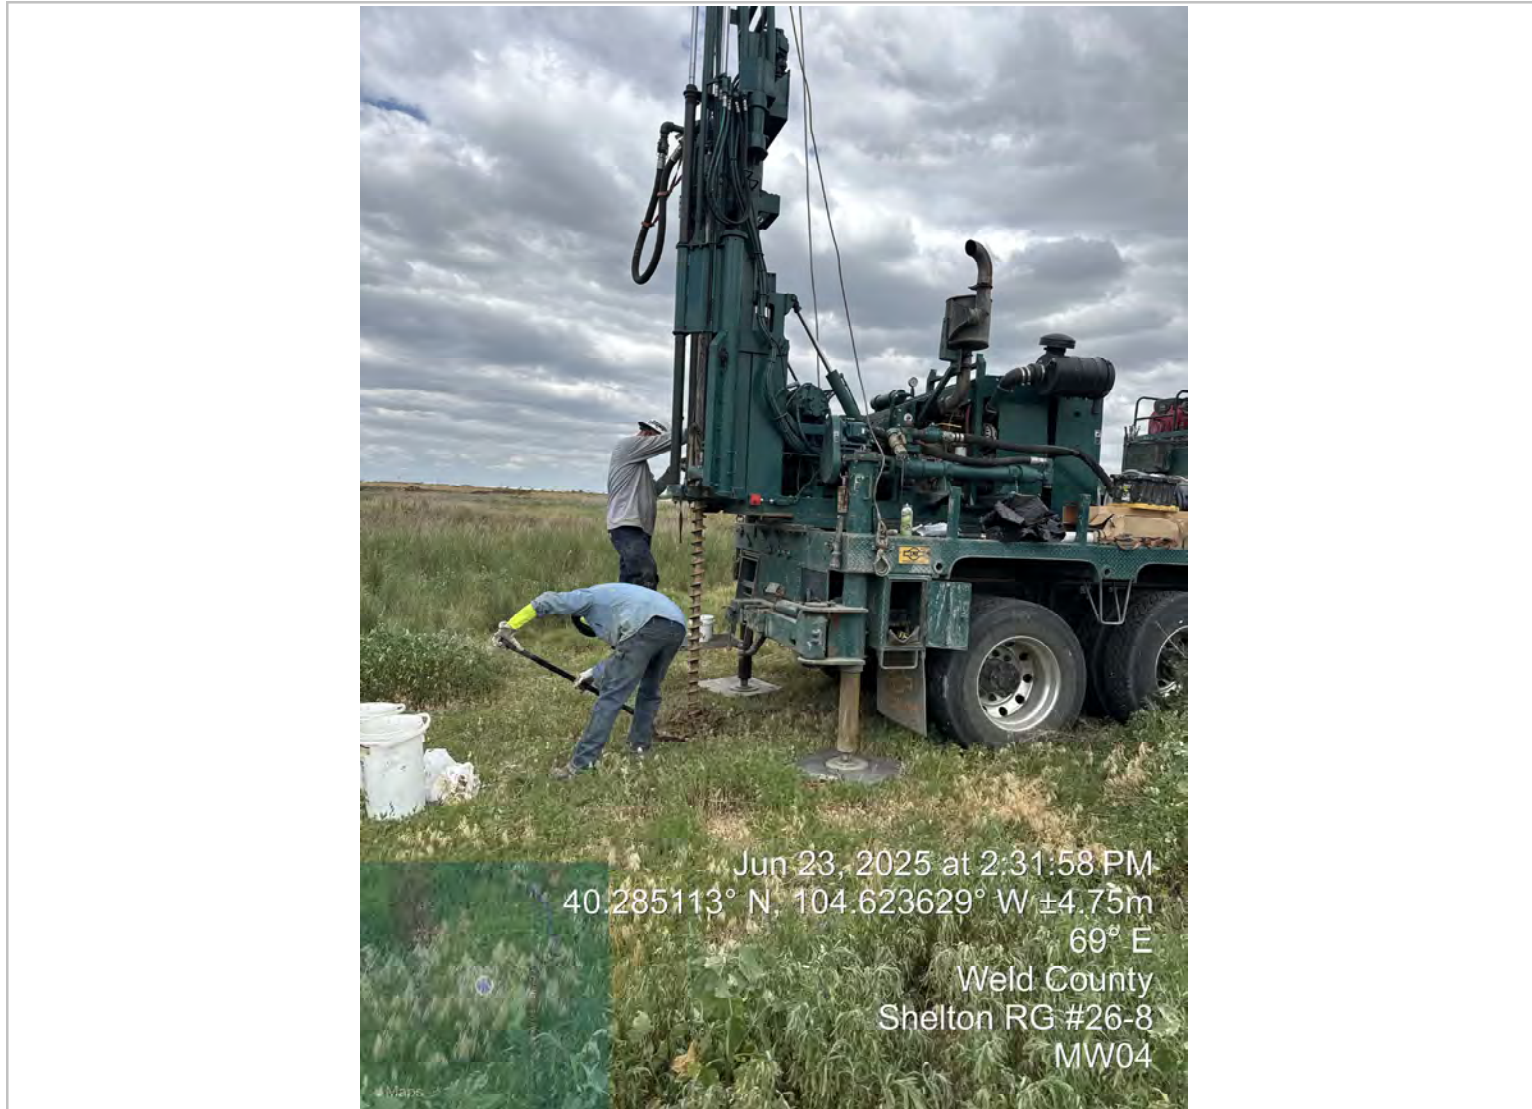
MW04 Location: View Northeast

Boring Number: MW-04			Lat/Long: 40.285108, -104.623540			
Scope: Characterization Soil Sampling & GMMW Install			Drilling Equipment: Power Probe 9500 / HSA			
Drilling Method: SSA		Drilling Contractor: Alpine Remediation		Driller: Tom Morris		
Date: 06/23/2025	Start Time: 1050	Finish Time: 1055	DTW: 2.7'	Total Depth of Boring: 10'		
Geologist: Holly Tignac						
Depth (ft)	Time	Recovery	Standard Penetration Test Results	USCS Symbol	Material Description	PID Reading (ppm)
0 - 5	1050	70%	NA	CL	Brown with Orange Streaks, Sandy Clay Loam, Moist, Medium to High Plasticity. No Odor or Staining.	0.2
5 - 10	1055	50%	NA	CL	Brown with Orange Streaks, Sandy Clay Loam, Moist, Medium to High Plasticity. No Odor or Staining Wet at 6' 6 feet Screen 4 feet Riser 1 foot Sand Above Screen 3 feet Bentonite plug Flush Mount 2-Inch PVC	0.0
Samples Collected: 5' (3 jars)				Comments:

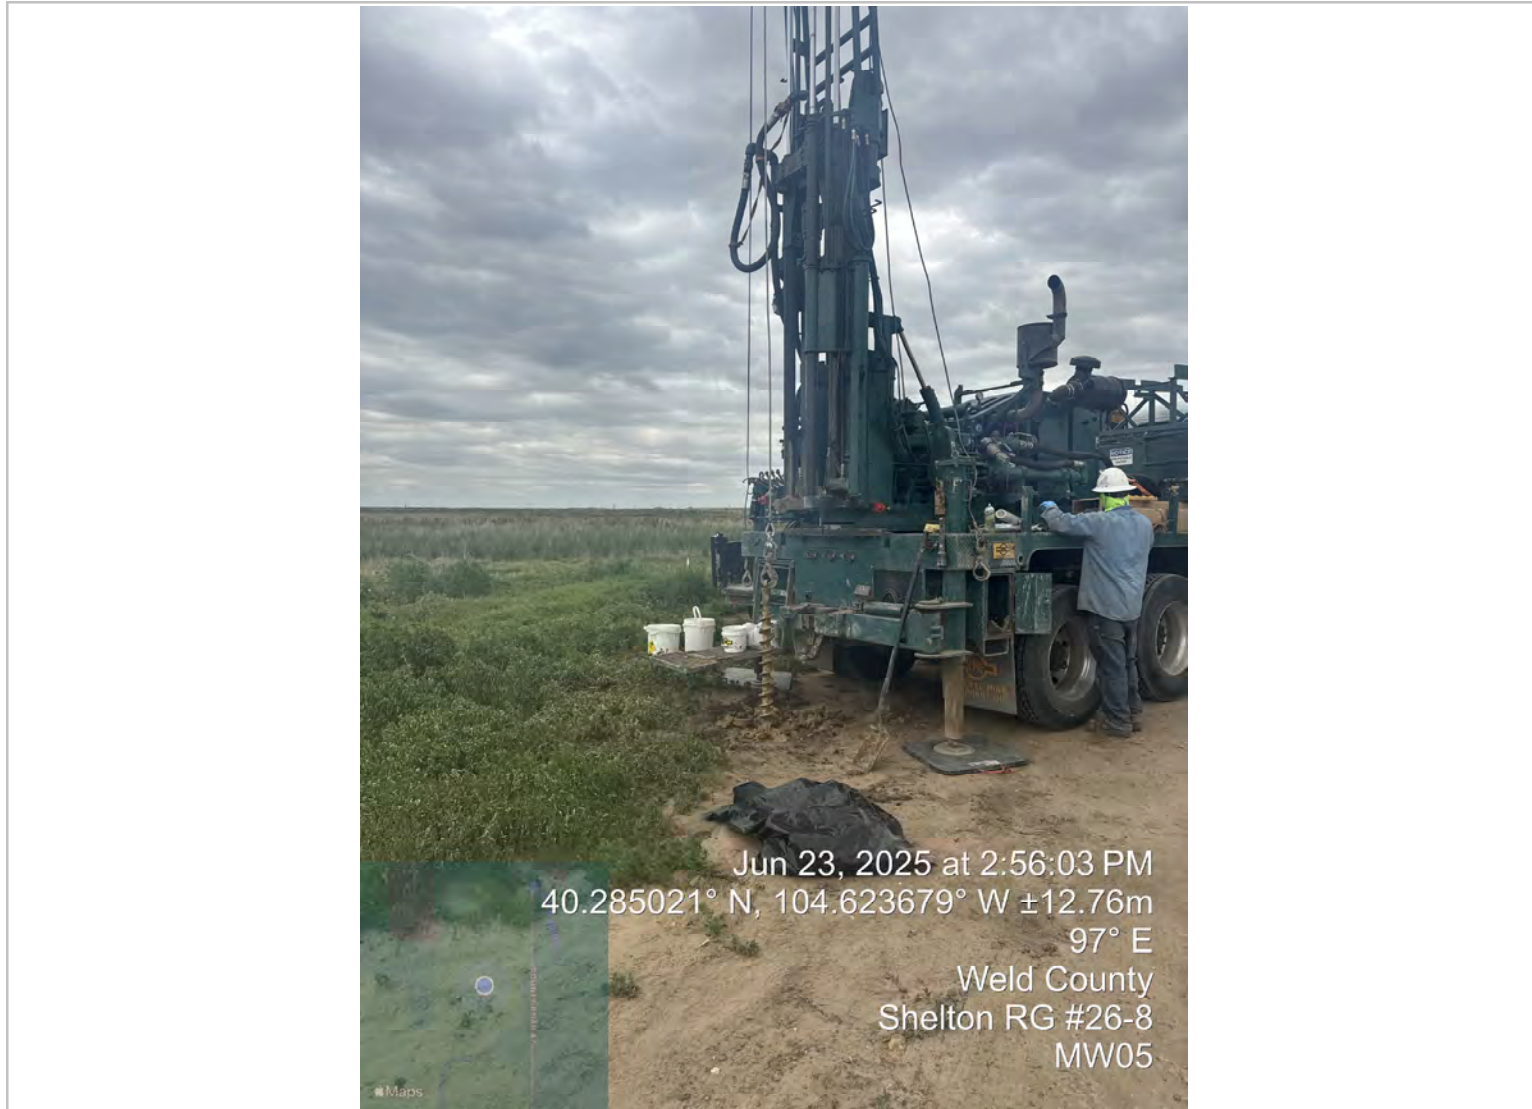
MW05 Location: View Northeast

Boring Number: MW-05				Lat/Long: 40.285037, -104.623651		
Scope: Characterization Soil Sampling & GMMW Install				Drilling Equipment: Power Probe 9500 / HSA		
Drilling Method: SSA		Drilling Contractor: Alpine Remediation		Driller: Tom Morris		
Date: 06/23/2025	Start Time: 1100	Finish Time: 1110	DTW: 3.1'	Total Depth of Boring: 10'		
Geologist: Holly Tignac						
Depth (ft)	Time	Recovery	Standard Penetration Test Results	USCS Symbol	Material Description	PID Reading (ppm)
0 - 5	1105	80%	NA	CL	Brown, Sandy Clay Loam, Moist, Medium Plasticity. No Odor or Staining.	0.5
5 - 10	1110	80%	NA	CL	Brown/Gray, Sandy Clay Loam, Moist, Medium Plasticity, Light Odor. Wet at 7' 5 feet Screen 5 feet Riser 2 feet Sand Above Screen 3 feet Bentonite plug Flush Mount 2-Inch PVC	0.5
Samples Collected: 6' (3 jars)				Comments:

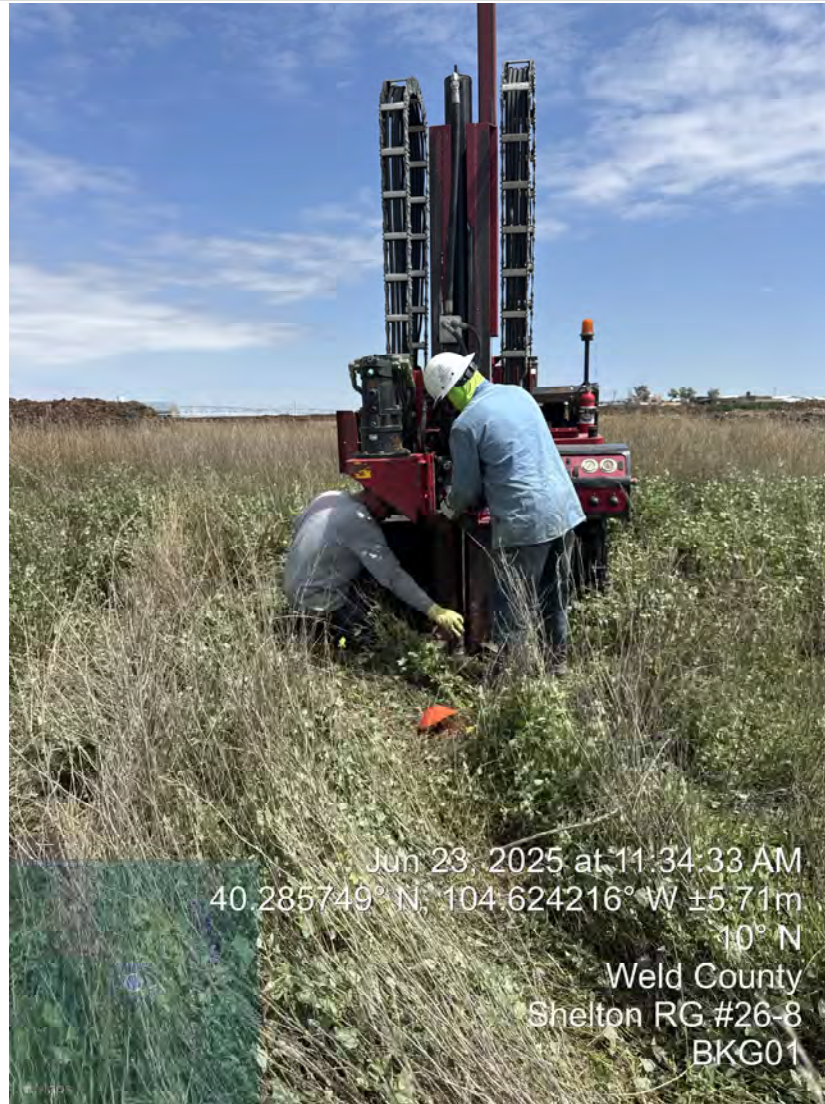
BKG01 Location: View North

Boring Number: BKG01				Lat/Long: 40.285794, -104.624231		
Scope: Background Soil Sampling				Drilling Equipment: Power Probe 9500		
Drilling Method: Direct Push		Drilling Contractor: Alpine Remediation		Driller: Tom Morris		
Date: 06/23/2025		Start Time: 1135	Finish Time: 1145	DTW: NA	Total Depth of Boring: 10'	
Geologist: Holly Tignac						
Depth (ft)	Time	Recovery	Standard Penetration Test Results	USCS Symbol	Material Description	PID Reading (ppm)
0 - 5	1140	60%	NA	CL	Tan to Brown with Orange Streaks, Sandy Clay Loam, Moist, Medium Plasticity. No Odor or Staining.	0.0
5 - 10	1145	90%	NA	CL	Sandy Loam, Low Plasticity. No Odor, Iron Oxide Staining at 8' Wet at 6'	1.4
Samples Collected: 5' (2 jars)				Comments: Backfilled with bentonite chips

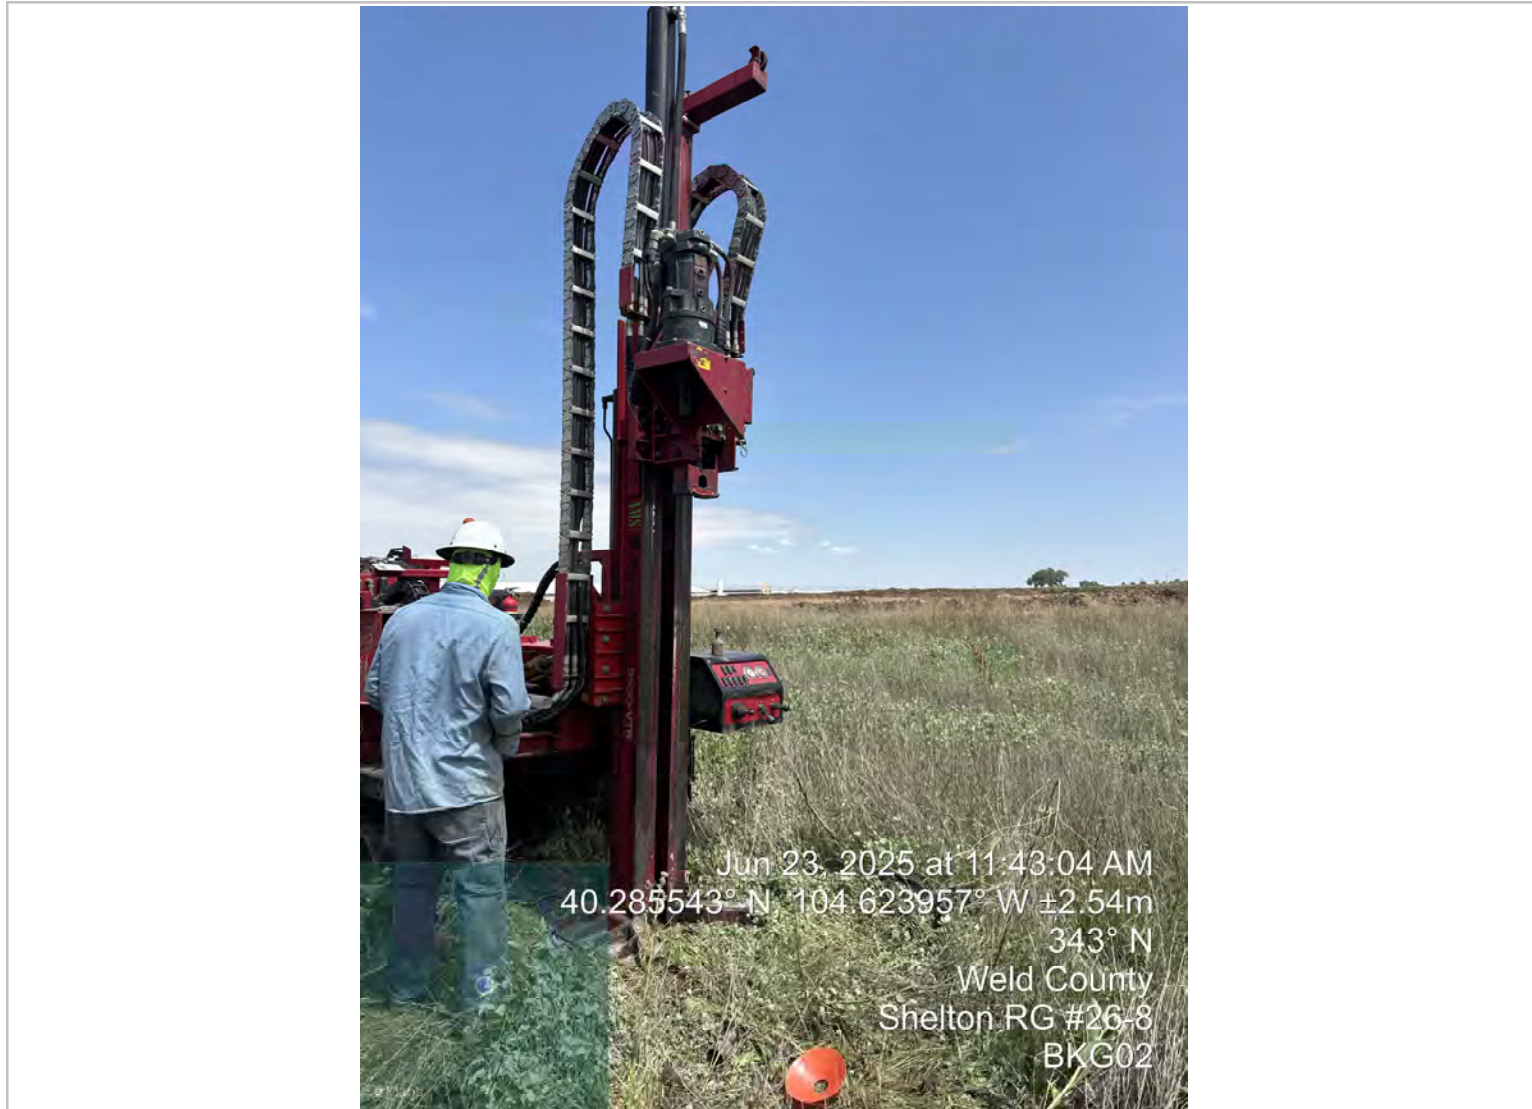
BKG02 Location: View North

Boring Number: BKG02				Lat/Long: 40.285559, -104.623921		
Scope: Background Soil Sampling & GMMW Install				Drilling Equipment: Power Probe 9500 / HSA		
Drilling Method: SSA		Drilling Contractor: Alpine Remediation		Driller: Tom Morris		
Date: 06/23/2025	Start Time: 1150	Finish Time: 1200	DTW: 1.5'	Total Depth of Boring: 10'		
Geologist: Holly Tignac						
Depth (ft)	Time	Recovery	Standard Penetration Test Results	USCS Symbol	Material Description	PID Reading (ppm)
0 - 5	1150	85%	NA	CL	Tan with Orange Streaks, Sandy Clay Loam, Moist, Medium Plasticity. No Odor or Staining.	0.0
5 - 10	1155	95%	NA	CL	Tan with Orange Streaks, Sandy Clay Loam, Wet, Medium Plasticity. No Odor or Staining. Wet at 6' 6 feet Screen 4 feet Riser 1 foot Sand Above Screen 3 feet Bentonite plug Flush Mount 2-Inch PVC	0.0
Samples Collected: 5' (2 jars)				Comments:

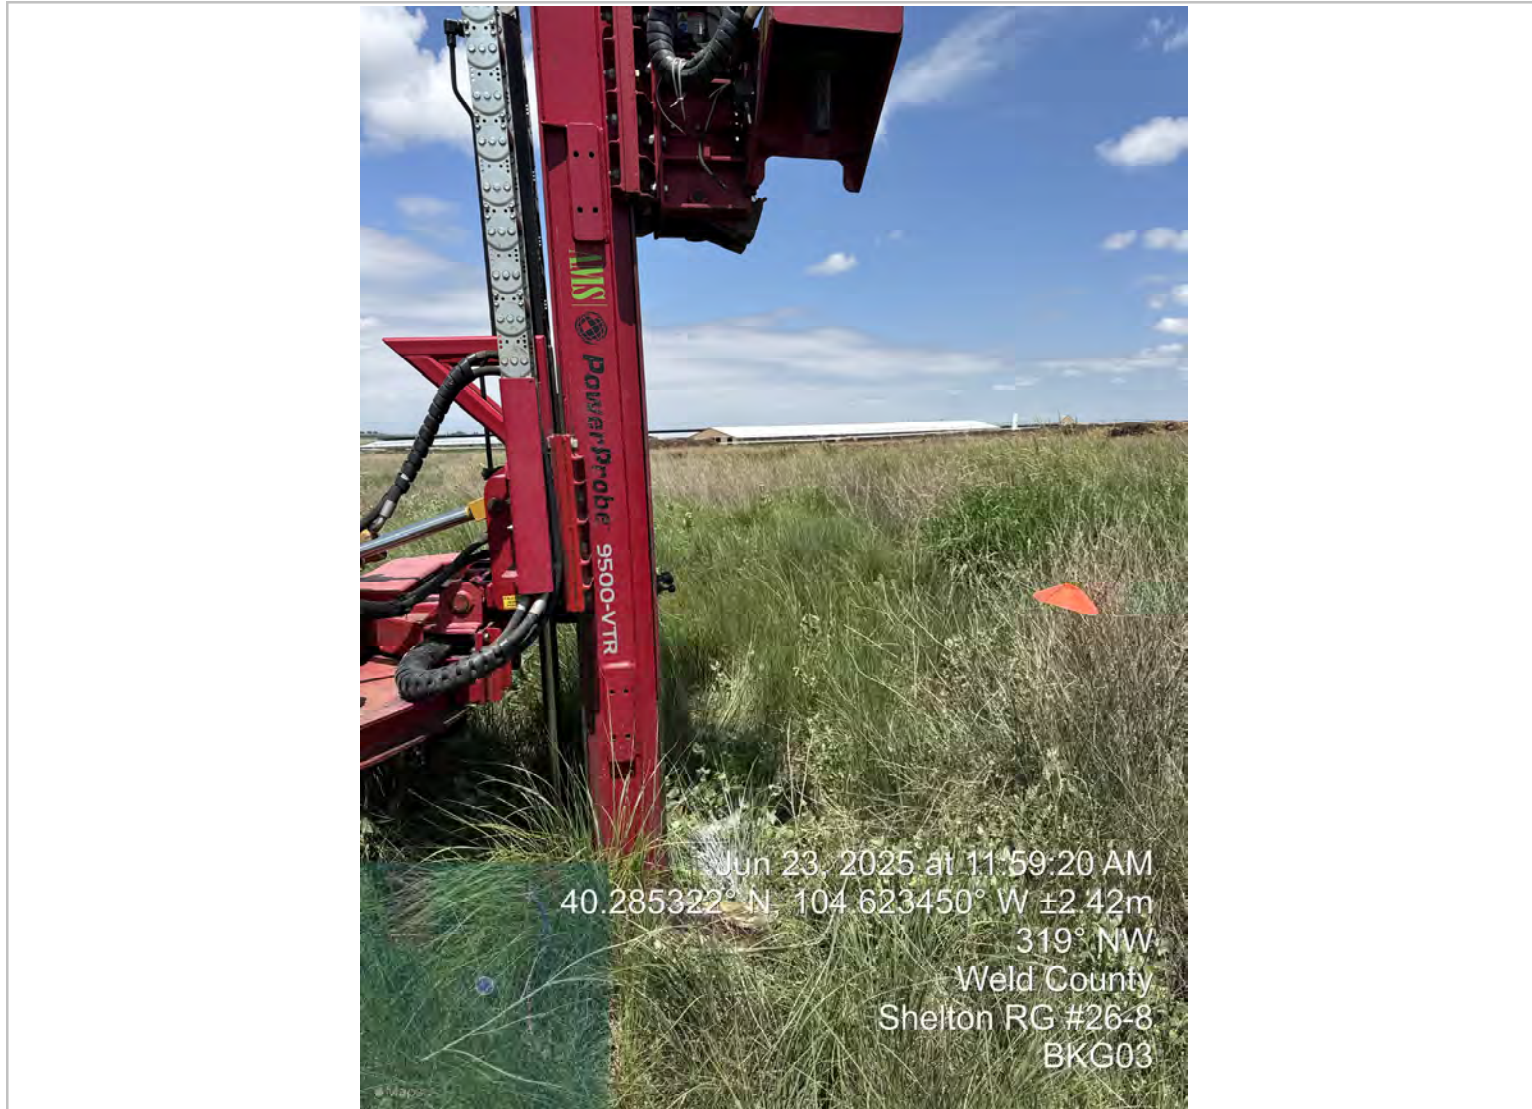
BKG03 Location: View Northwest

Boring Number: BKG03				Lat/Long: 40.285332, -104.623452		
Scope: Background Soil Sampling				Drilling Equipment: Power Probe 9500		
Drilling Method: Direct Push		Drilling Contractor: Alpine Remediation		Driller: Tom Morris		
Date: 06/23/2025		Start Time: 1230	Finish Time: 1245	DTW: NA	Total Depth of Boring: 10'	
Geologist: Holly Tignac						
Depth (ft)	Time	Recovery	Standard Penetration Test Results	USCS Symbol	Material Description	PID Reading (ppm)
0 - 5	1235	75%	NA	CL	Tan with Orange Streaks, Sandy Clay Loam, Moist, Medium Plasticity. No Odor or Staining.	1.6
5 - 10	1240	80%	NA	CL	Tan with Orange Streaks, Sandy Clay Loam, Moist, Medium Plasticity. No Odor or Staining. Wet at 6'	1.7
Samples Collected: 5' (2 jars)				Comments: Backfilled with bentonite chips
