**Inspection Photos**  
**Final Reclamation**  
**06/18/2025**

**Operator:** WEXPRO COMPANY- #95960

**Location ID:** 415715

Location Name: Sugarloaf Government #18 Pad

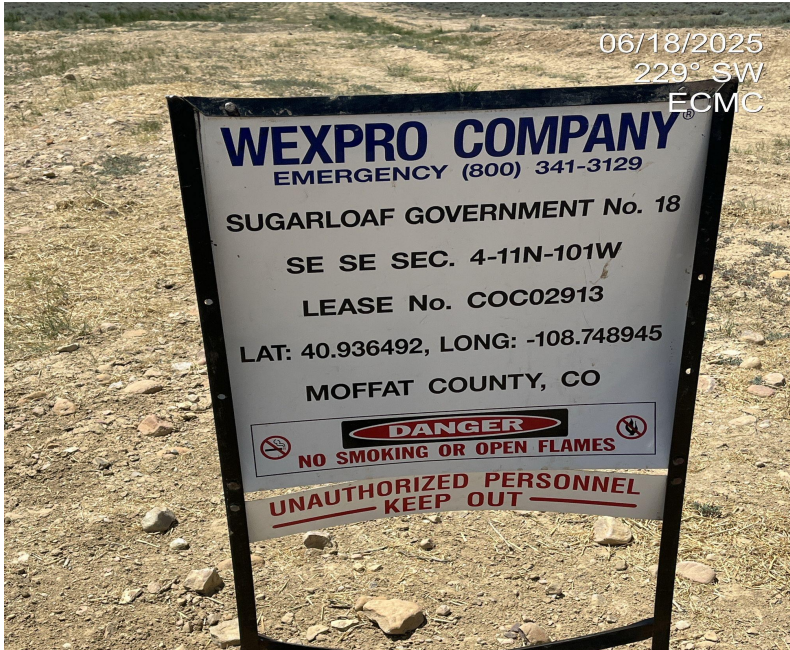
**Photo 1.** Photo illustrates signage at the access road entrance.

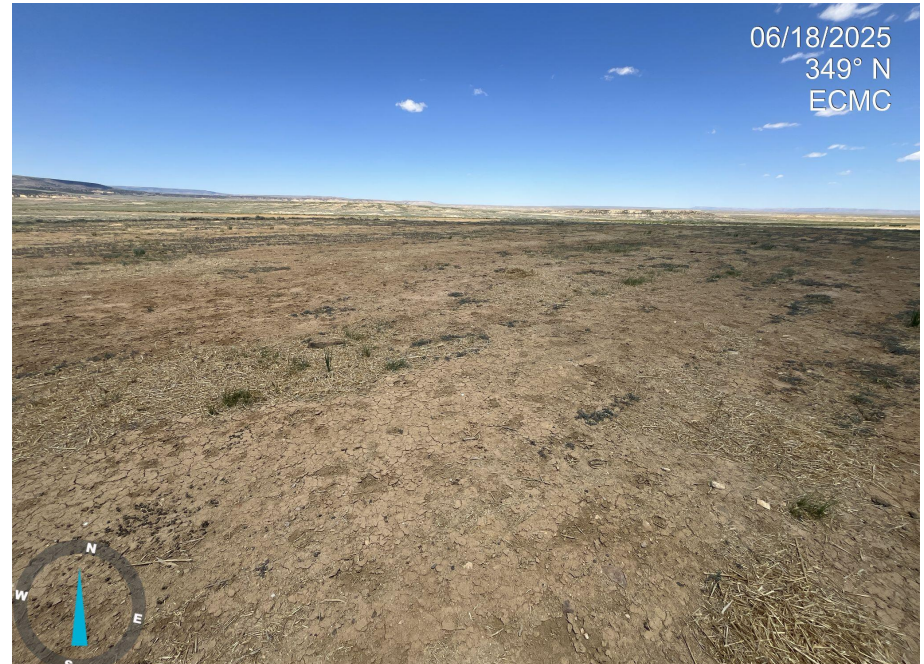
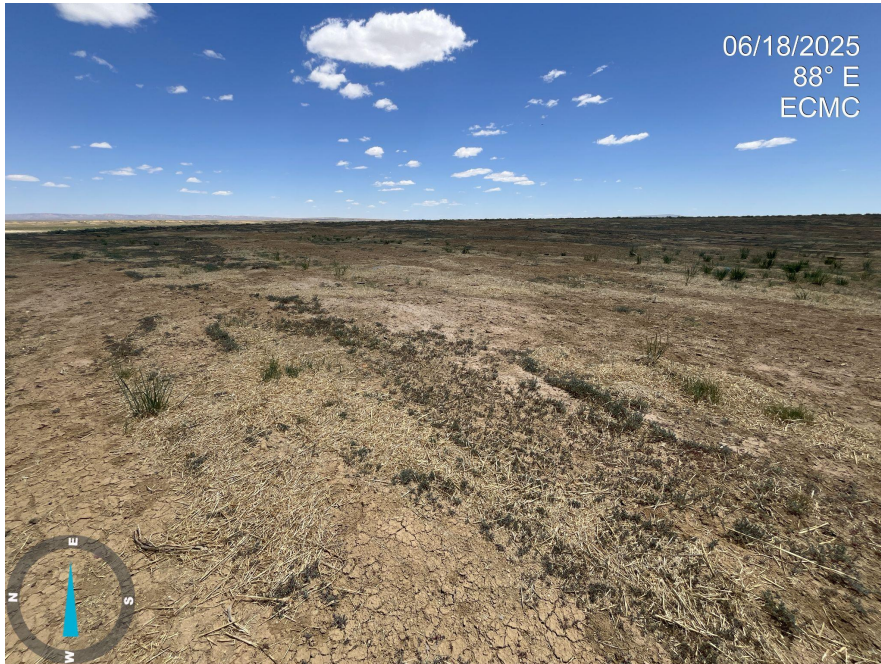
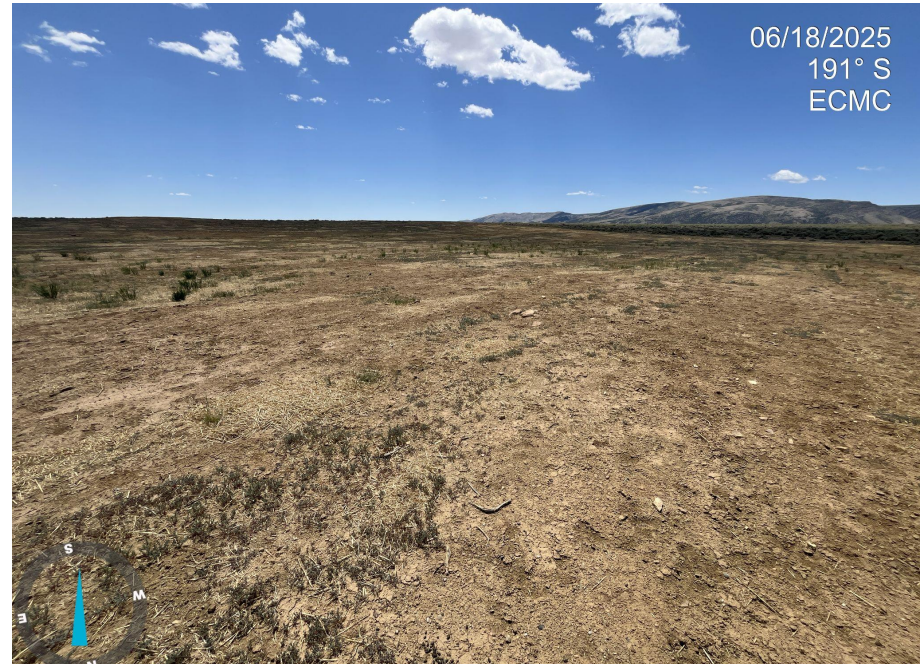
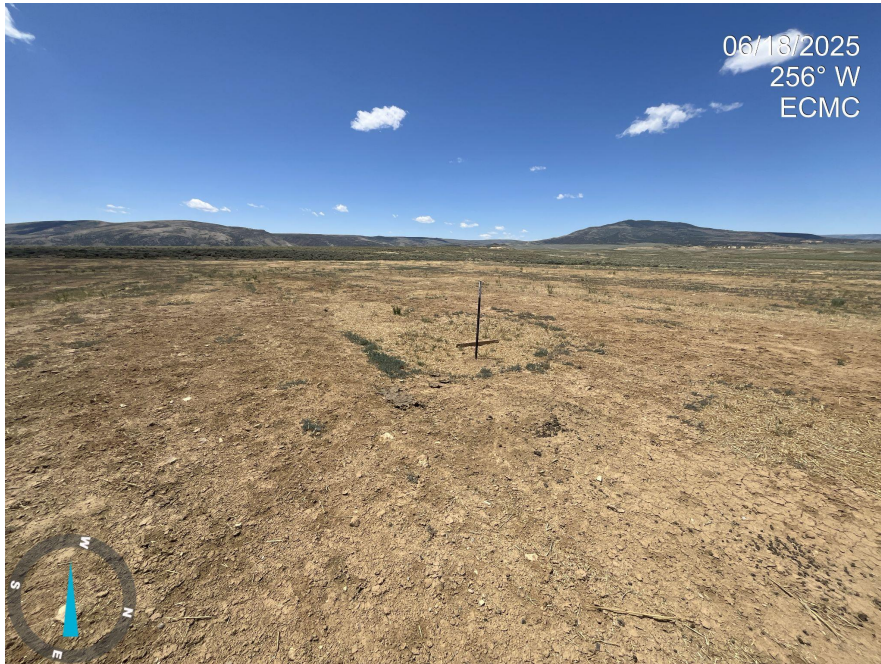
**Photo 3.** See comments under Photo 2.

**Photo 2.** Photos 2-5 show an overview of the Location, facing north, east, south, and west.

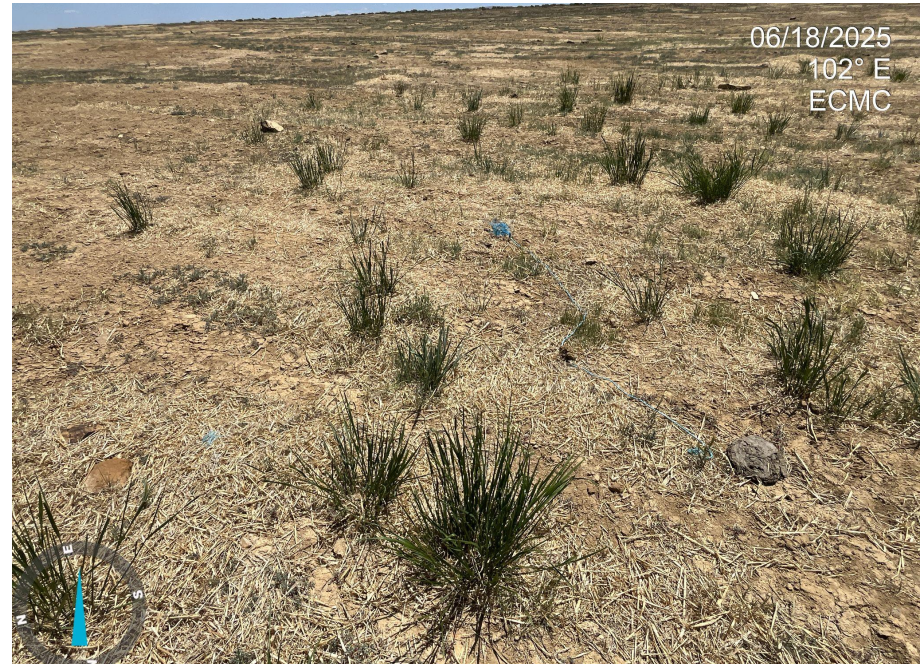
**Photo 6.** Areas remain bare with little to no vegetation growth. Straw mulch was observed, but appears to be more dense in some areas and bare in other areas. The vegetation is primarily Basin Wildrye, Halogeton, cheatgrass, and western wheatgrass.

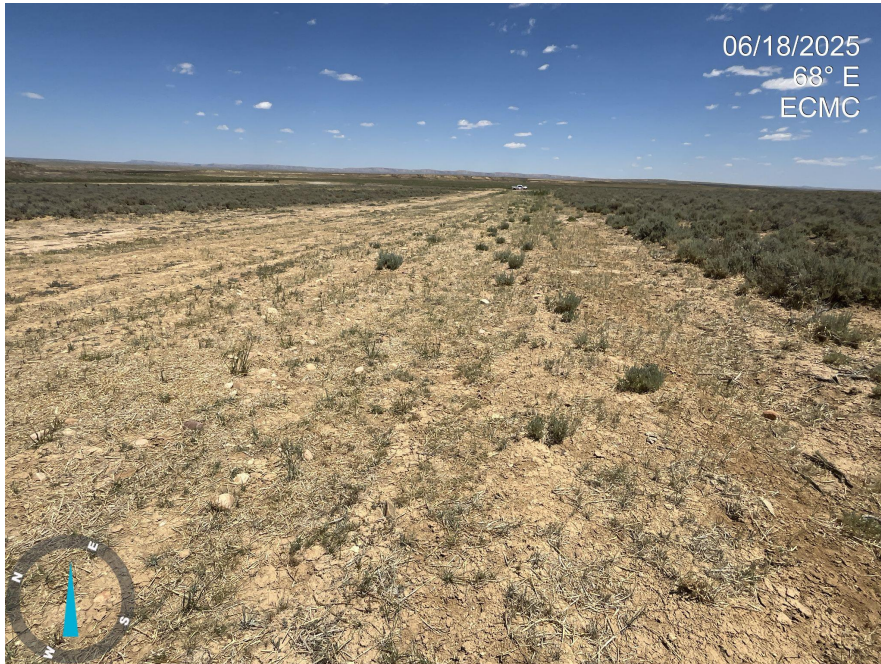
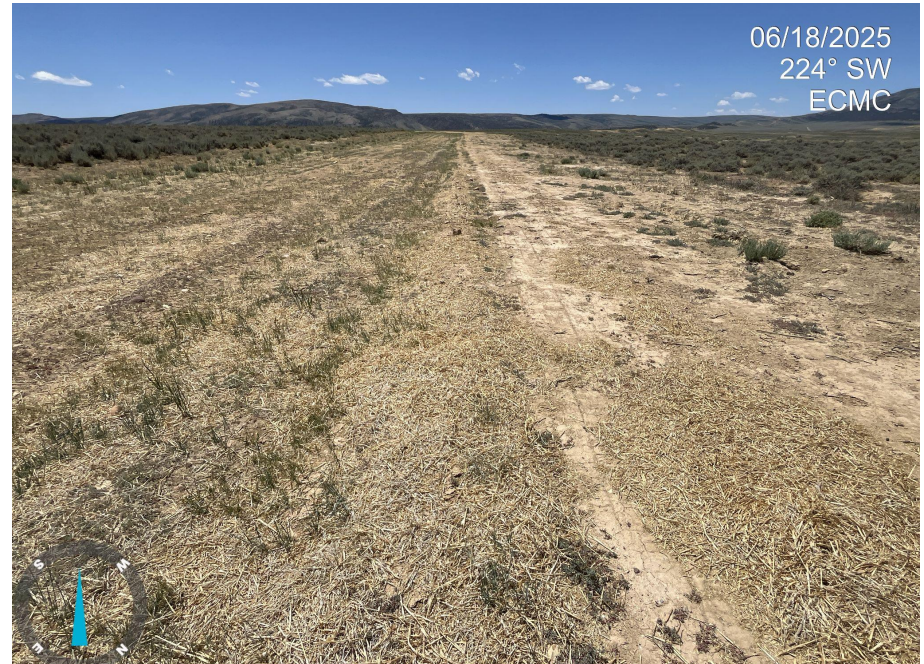
**Photo 8.** See comments under Photo 7.

**Photo 7.** Photos 7-8 taken of the access road. Most of the vegetation growing is Halogeton.

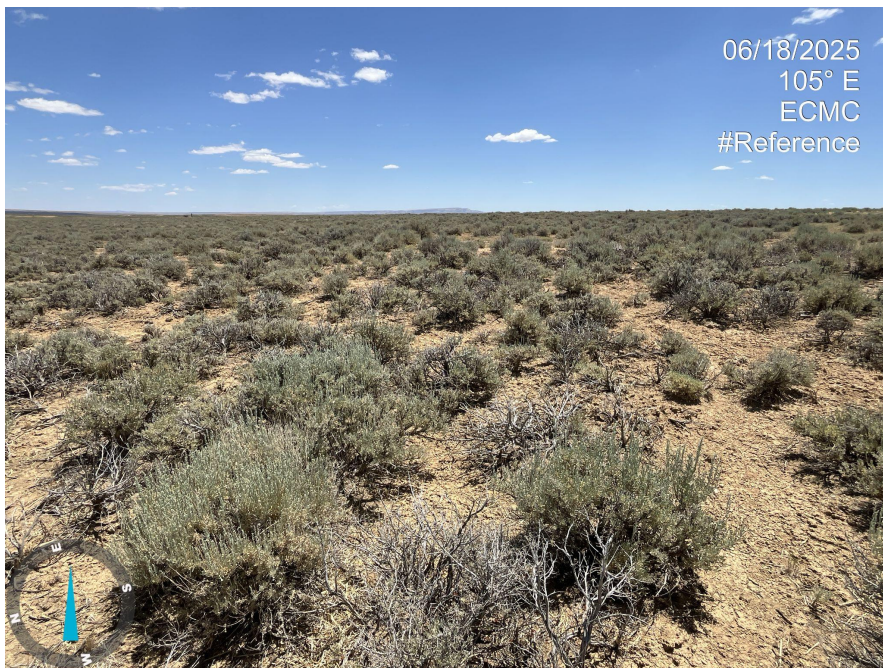
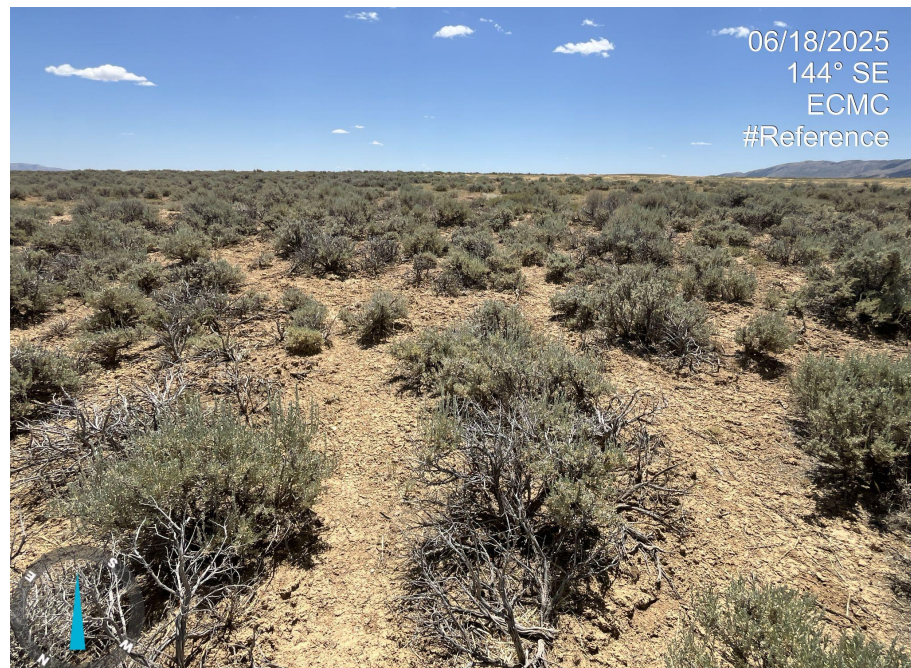
**Photo 10.** See comments under Photo 9.

**Photo 9.** Photos taken of the reference area vegetation, primarily sagebrush, winterfat, saltbrush, foxtail barley, and hooded phlox.
