Final Reclamation Inspection

Operator: STRACHAN EXPLORATION INC - 83130

Location ID: 331108

Inspection Photos
Location Name: HILL #6-1
Location ID: 331108

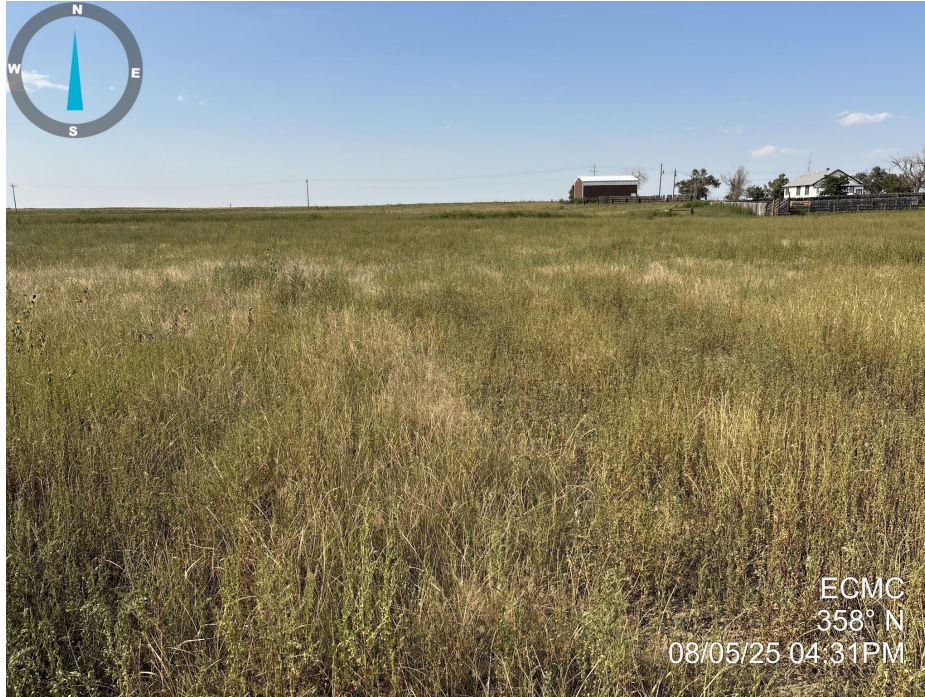
Photo 1. Photo taken of the well location, facing north. Photo illustrates that final reclamation activities have taken place, but vegetation establishment does not meet Rule 1004 standards. Weedy annual vegetation including kochia (*Bassia scoparia*) and cheatgrass (*Bromus tectorum*) was observed across the location.

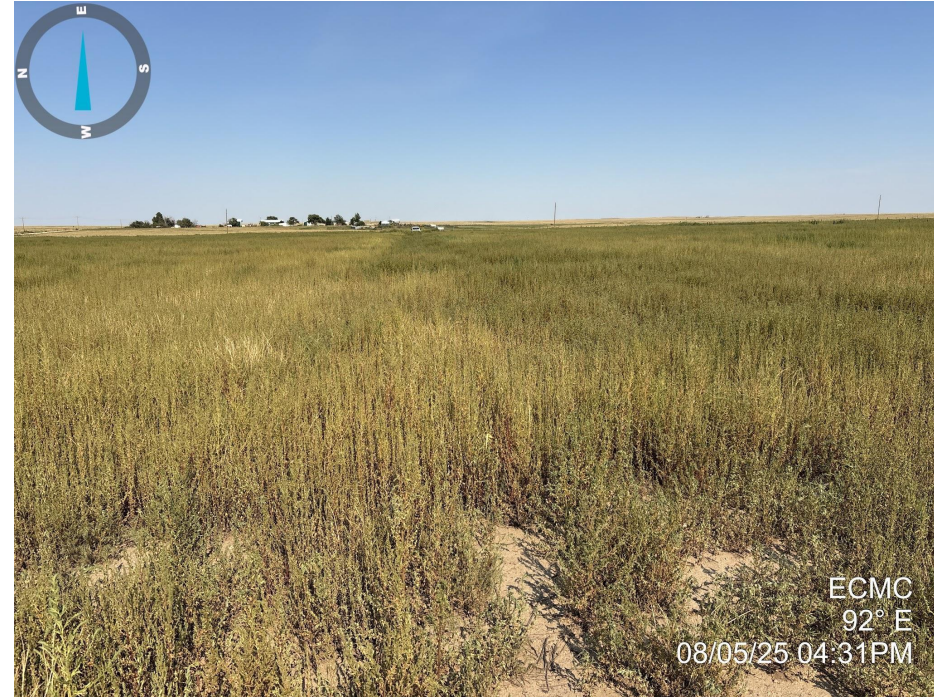
Photo 2. Photo taken of the well location, facing east. See comments under Photo 1.

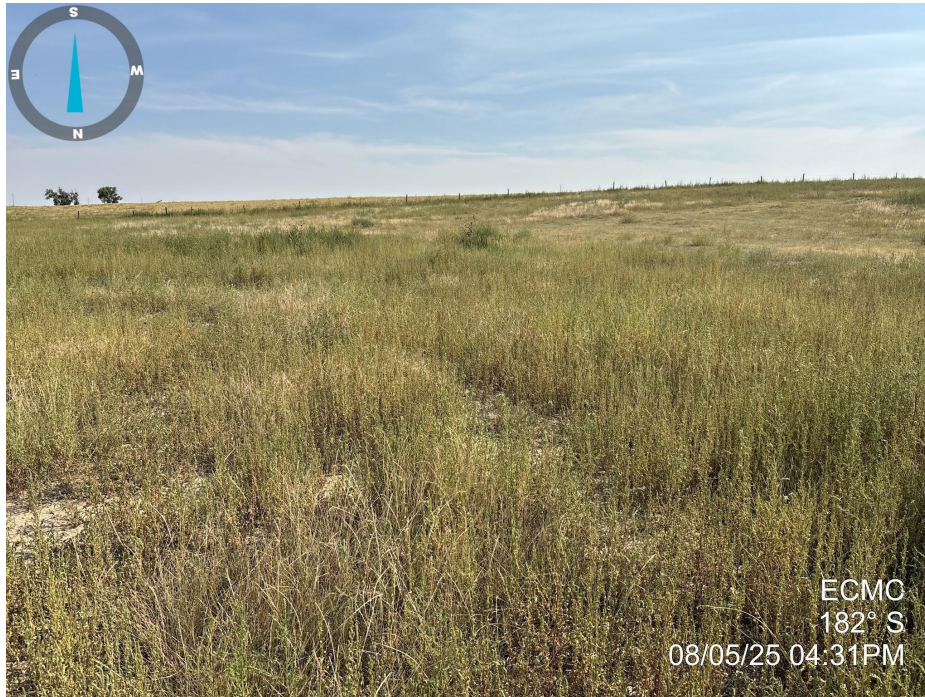
Photo 3. Photo taken of the well location, facing south. See comments under Photo 1.

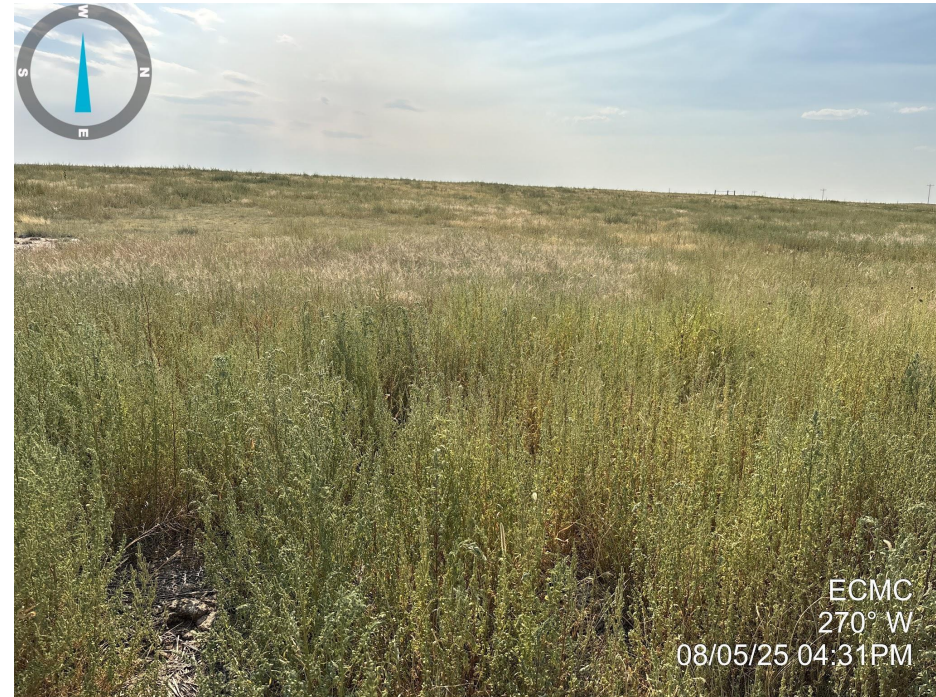
Photo 4. Photo taken of the well location, facing west. See comments under Photo 1.

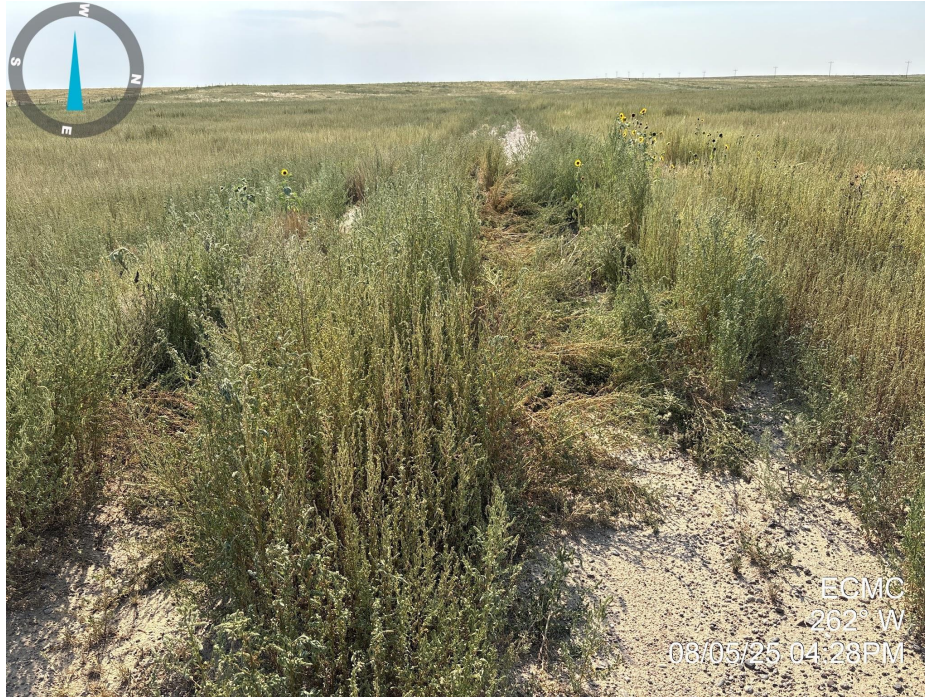
Photo 5. Photo taken of the access road to the well location, facing west, towards the location. Photo illustrates that the access road does not meet Rule 1004 standards as bare ground, gravel, and weedy annual vegetation were observed across the road.

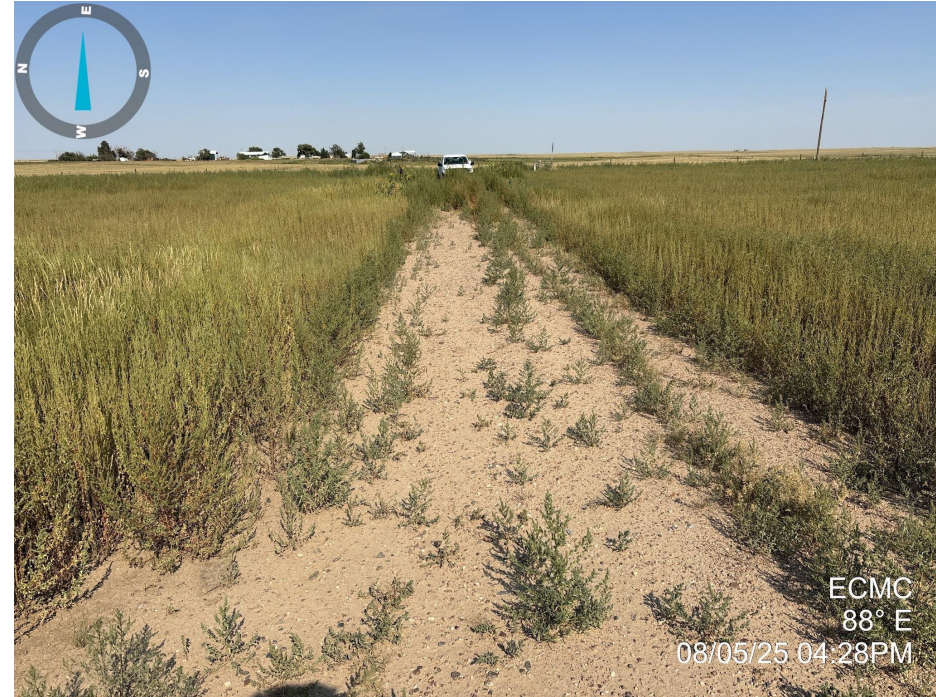
Photo 6. Photo taken of the access road to the well location, facing east, away from the location. See comments under Photo 5.

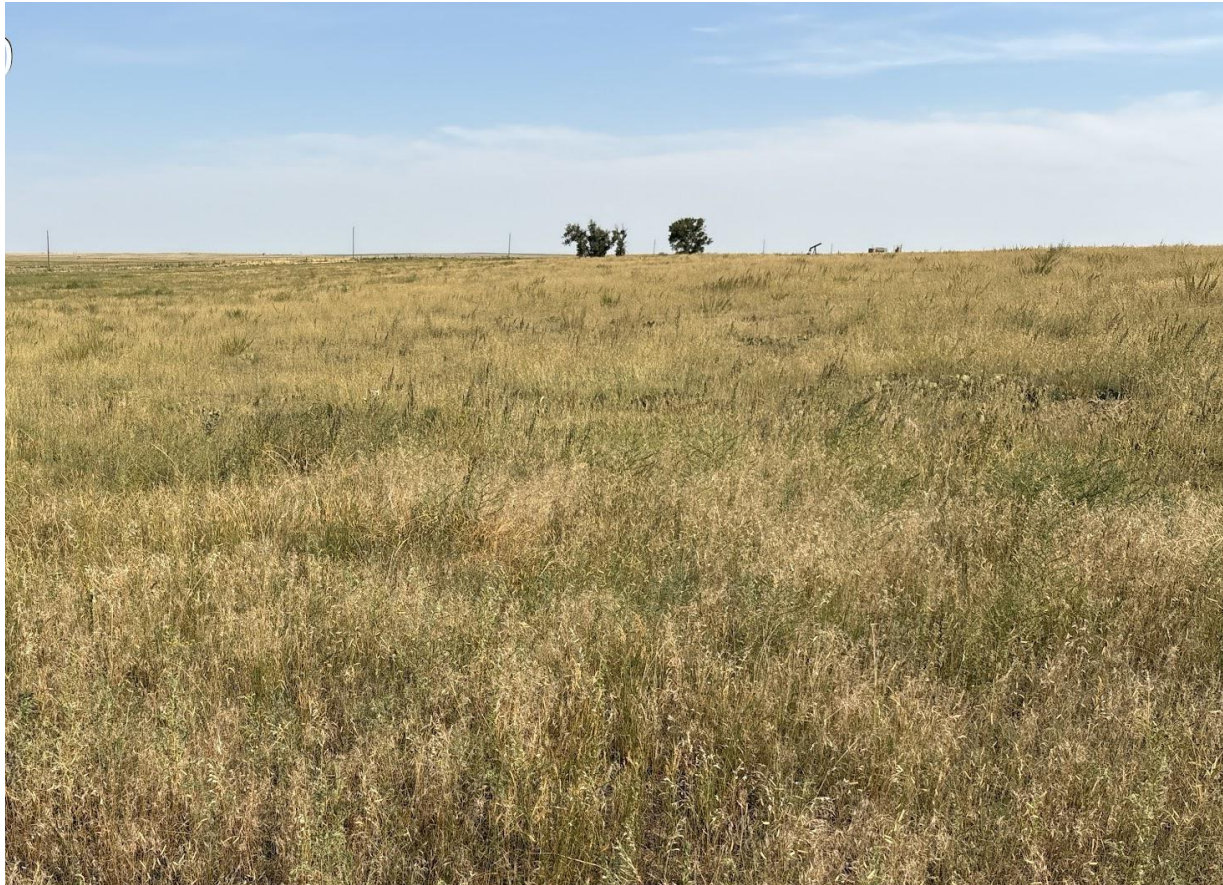
Photo 7. Photo taken of the reference area to the location, south of the location, facing southeast. Photo illustrates perennial grass and weedy annual vegetation.
