# Final Reclamation Inspection

Operator: STRACHAN EXPLORATION INC - 83130

Location ID: 330622

Inspection Photos  
Location Name: HILL #31-15-8  
Location ID: 330622

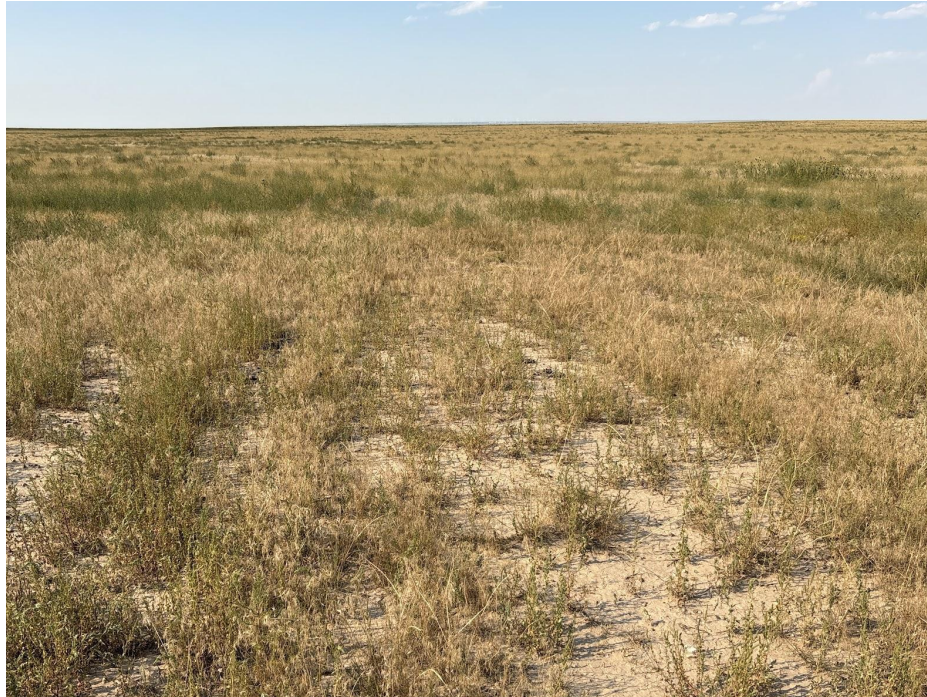
**Photo 1.** Photo taken of the well location, facing north. Photo illustrates that final reclamation activities have taken place, but vegetation establishment does not meet Rule 1004 standards. Bare ground and weedy annual vegetation, including kochia (*Bassia scoparia*) and cheatgrass (*Bromus tectorum*), were observed across the location.

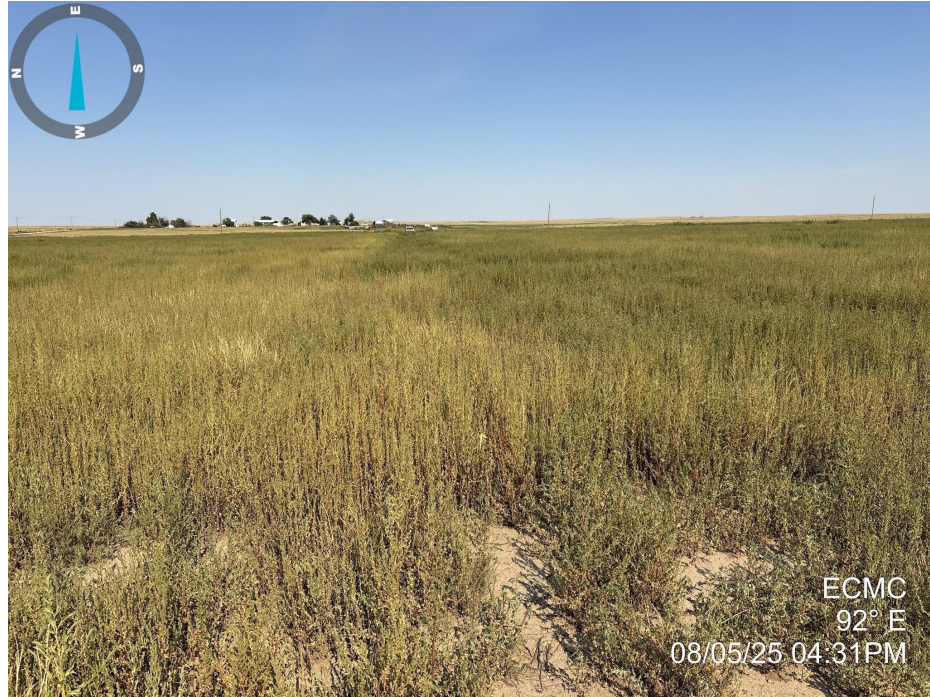
**Photo 2.** Photo taken of the well location, facing east. See comments under Photo 1.

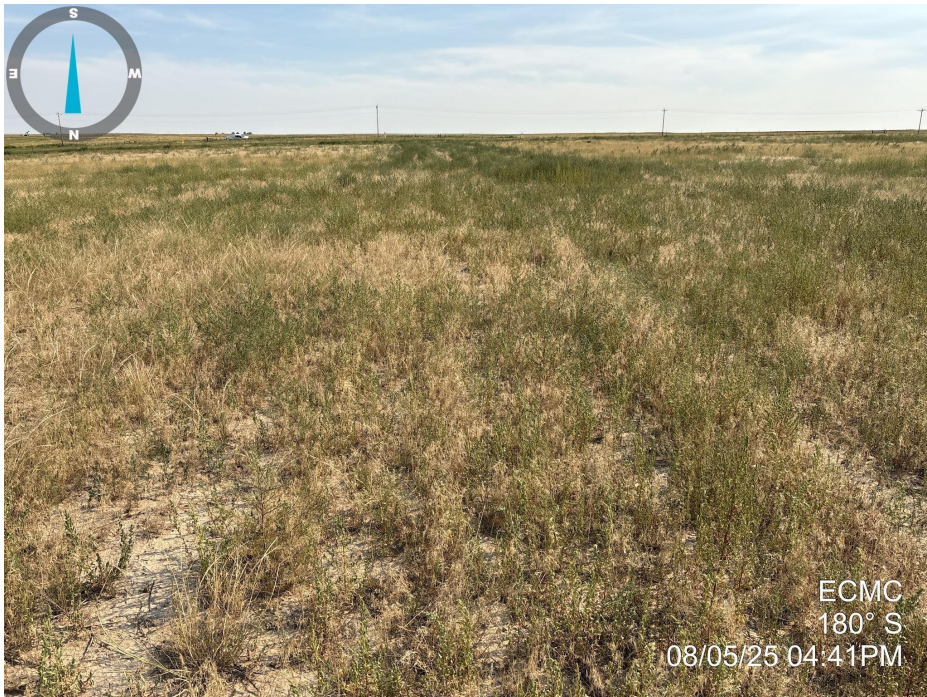
**Photo 3.** Photo taken of the well location, facing south. See comments under Photo 1.

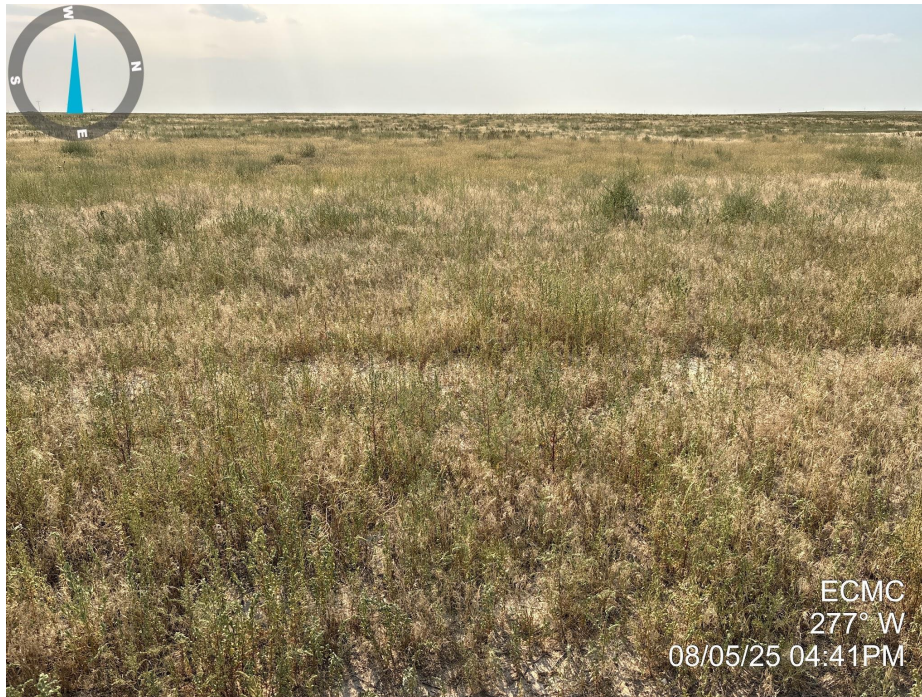
**Photo 4.** Photo taken of the well location, facing west. See comments under Photo 1.

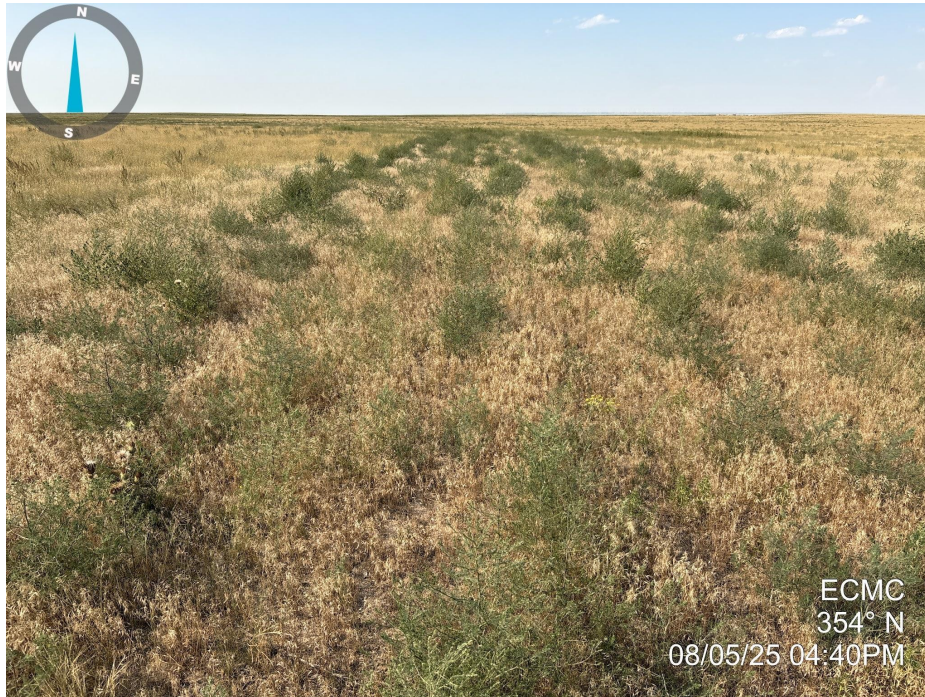
**Photo 5.** Photo taken of the access road to the well location, facing north, towards the location. Photo illustrates that the access road does not meet Rule 1004 standards as weedy annual vegetation were observed across the road.

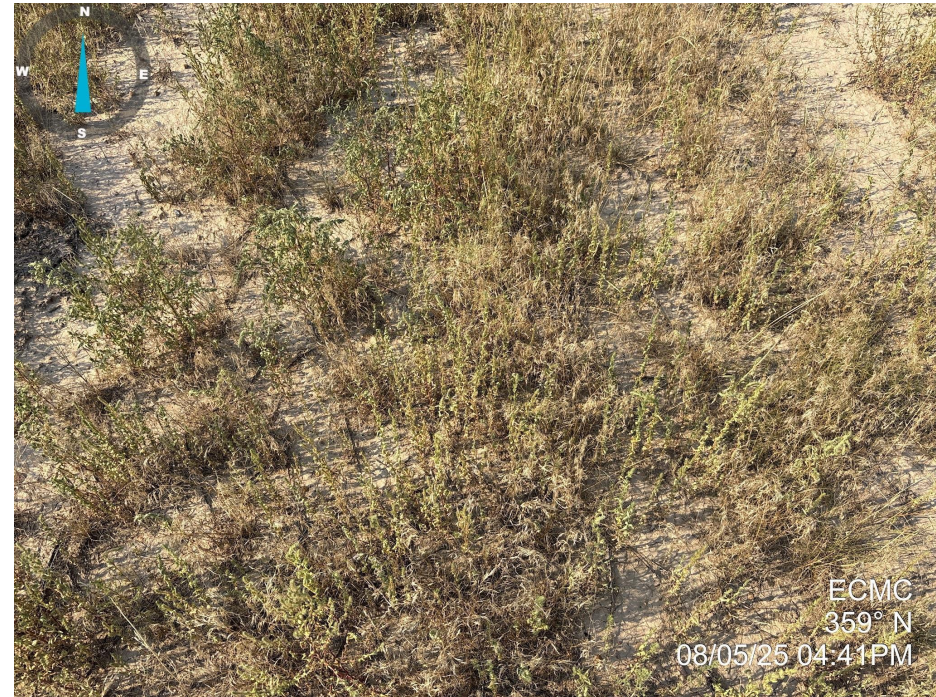
**Photo 6.** Photo taken of ground cover at the location. Photo illustrates weedy annual vegetation including kochia (*Bassia scoparia*) and cheatgrass (*Bromus tectorum*), a List C Noxious Weed species.

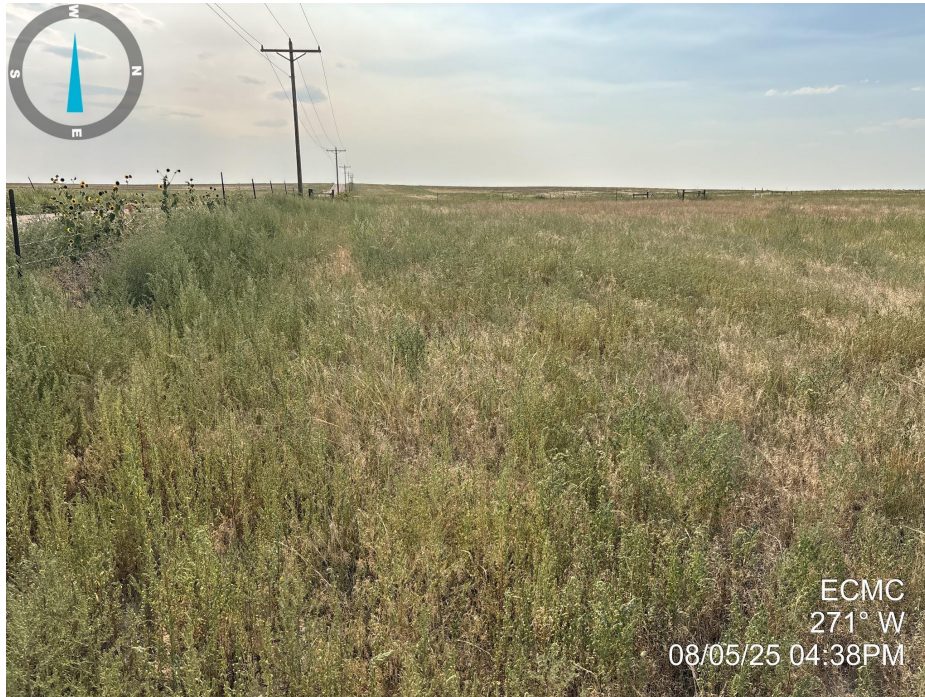
**Photo 7.** Photo taken of the tank battery location, facing west. Photo illustrates that final reclamation activities have taken place, but vegetation establishment does not meet Rule 1004 standards. Weedy annual vegetation, including kochia (*Bassia scoparia*) and cheatgrass (*Bromus tectorum*), a List C Noxious Weed species, were observed across the location.

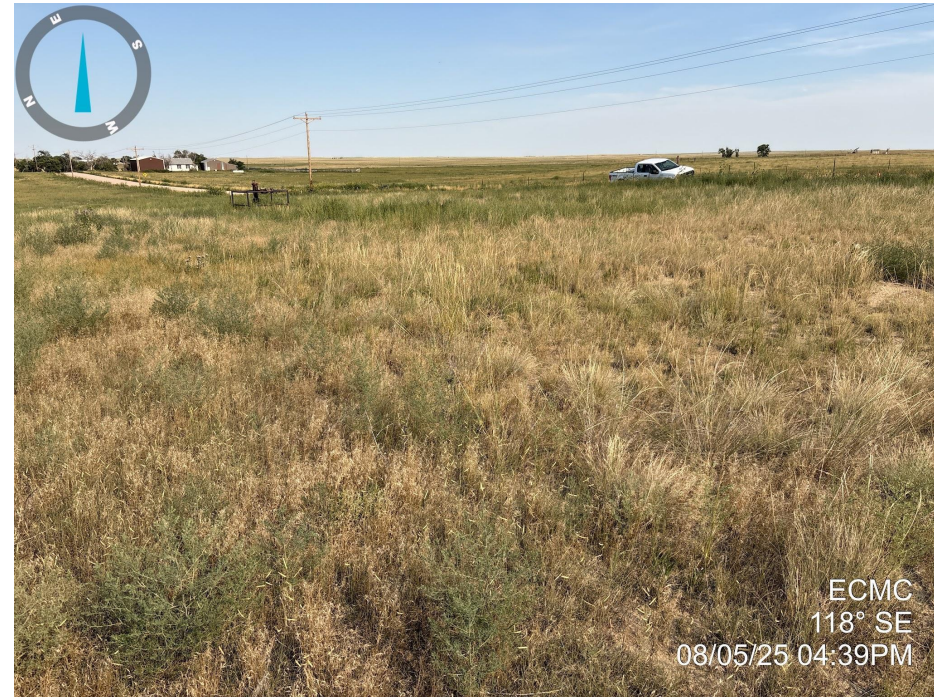
**Photo 8.** Photo taken of the tank battery location, facing southeast. See comments under Photo 7.

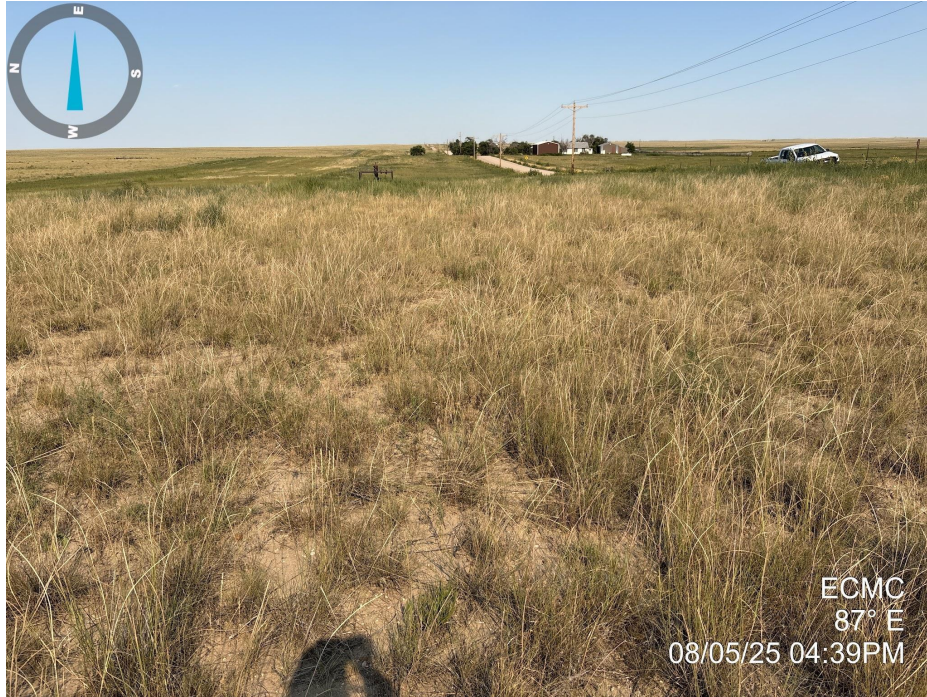
**Photo 9.** Photo taken of the tank battery location, facing east. See comments under Photo 7.

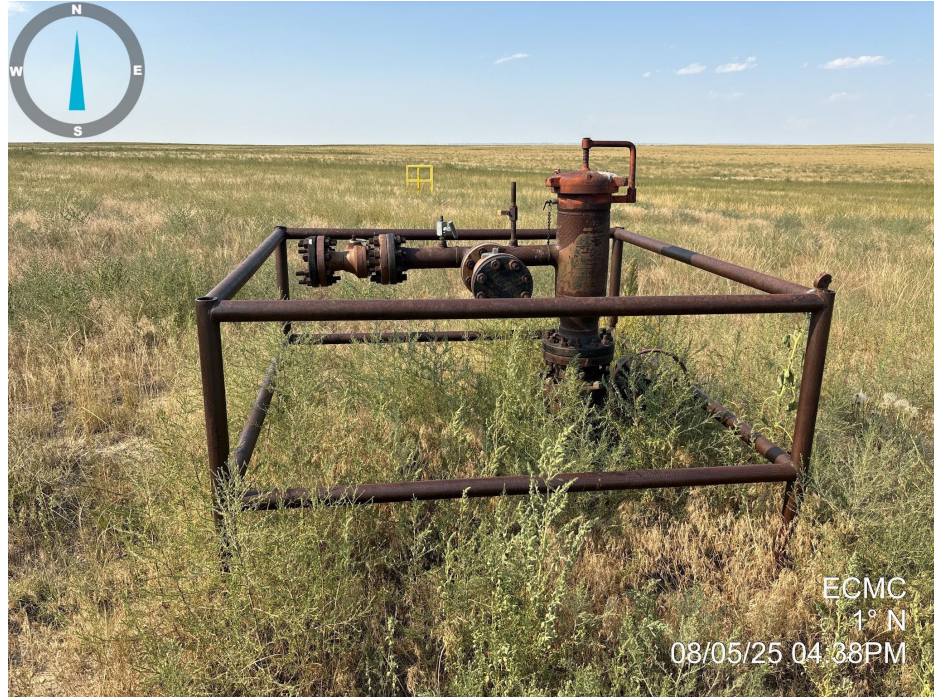
**Photo 10.** Photo taken of the tank battery location, facing north. Photo illustrates that midstream equipment remains at the location.

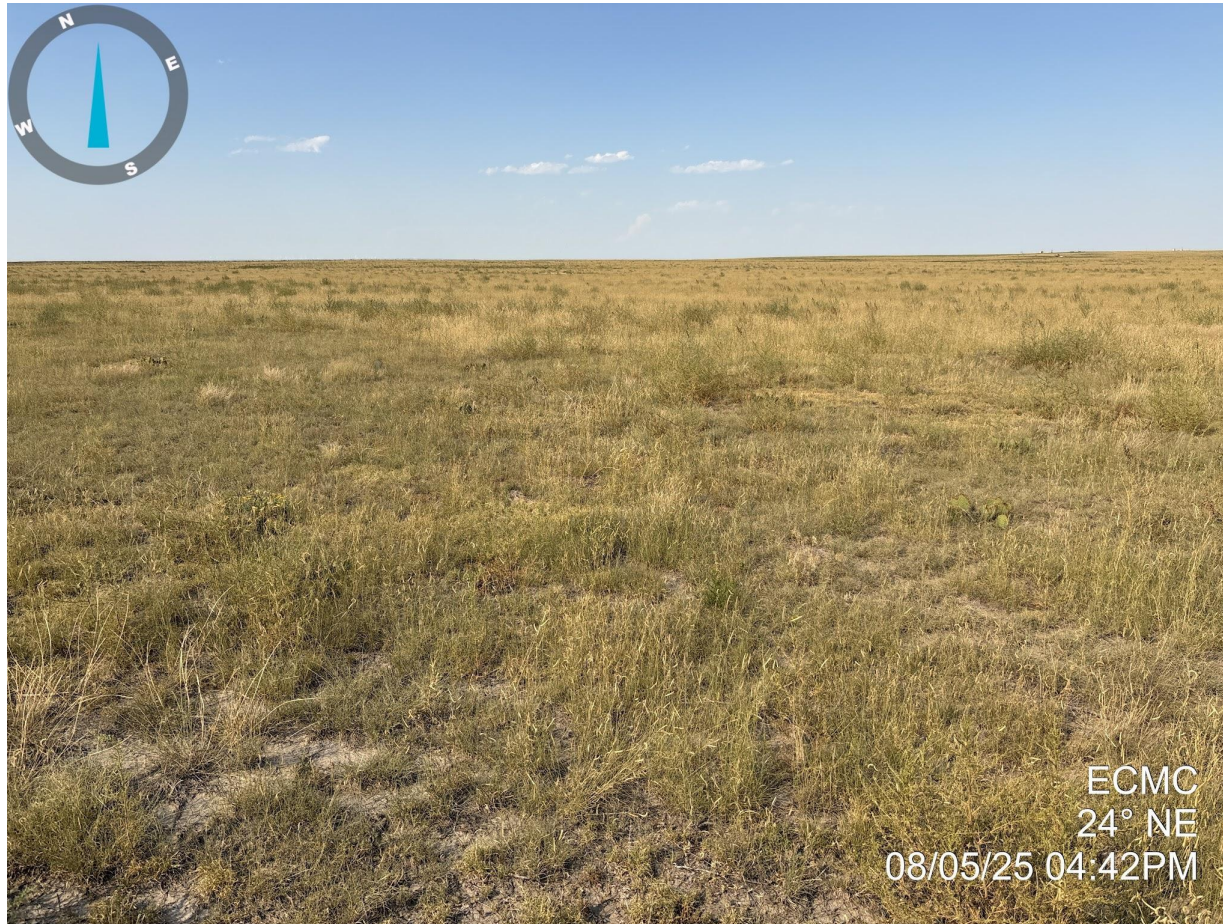
**Photo 11.** Photo taken of the reference area to the location, east of the location, facing northeast. Photo illustrates perennial grass vegetation.
