Final Reclamation Inspection

August 18, 2025

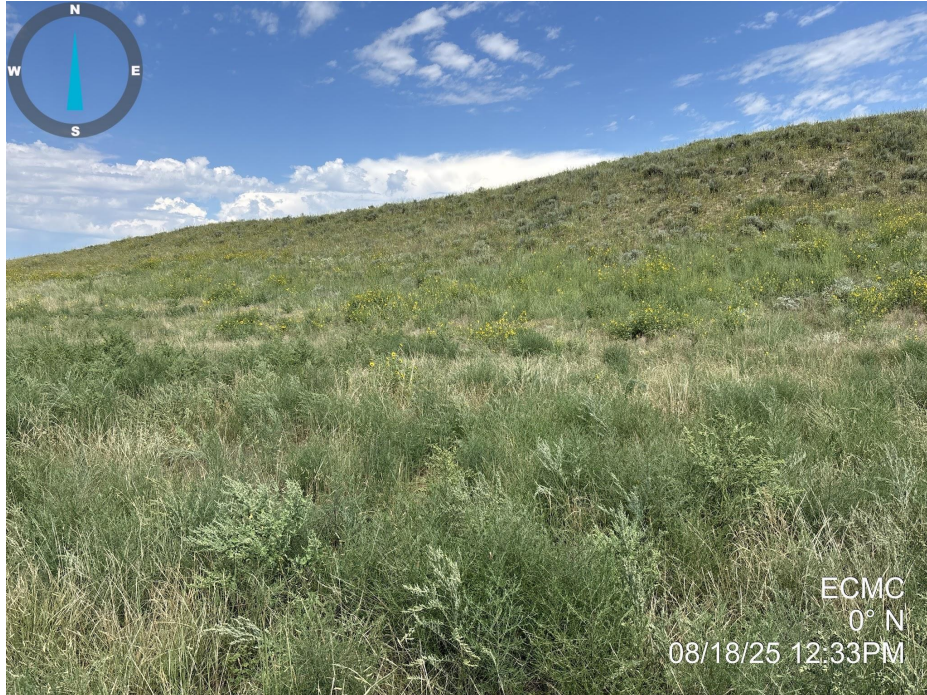
Photo 1. Photo taken from the pit location, facing north. Photo illustrates that final reclamation has taken place, but vegetation establishment does not meet Rule 1004 standards as weedy annual vegetation was observed across the location, including cheatgrass (*Bromus tectorum*) and russian thistle (*Salsola tragus*).

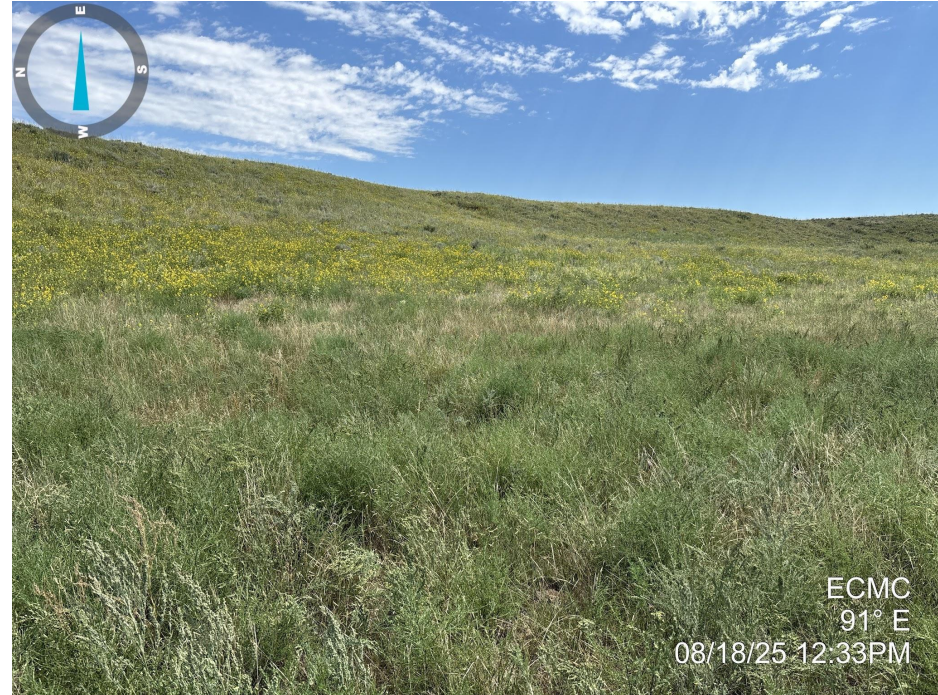
Photo 2. Photo taken of the pit location, facing east. See comments under Photo 1.

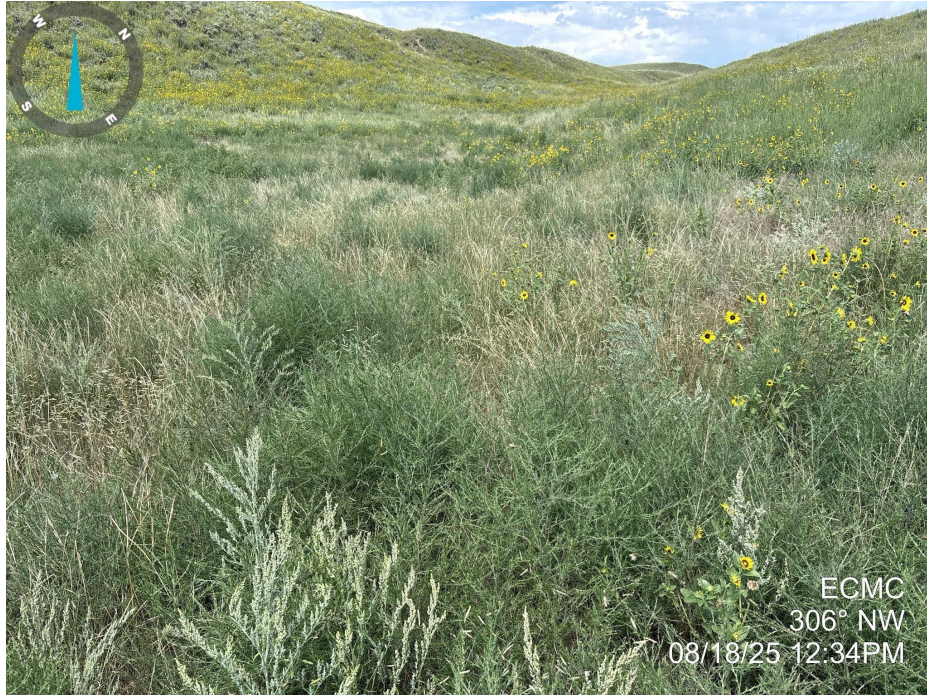
Photo 5. Photo taken of the access road to the location, facing northwest. Photo illustrates that final reclamation activities have taken place, but vegetation has not established to Rule 1004 standards. Weedy annual vegetation including cheatgrass (*Bromus tectorum*) and russian thistle (*Salsola tragus*) was observed across the location.

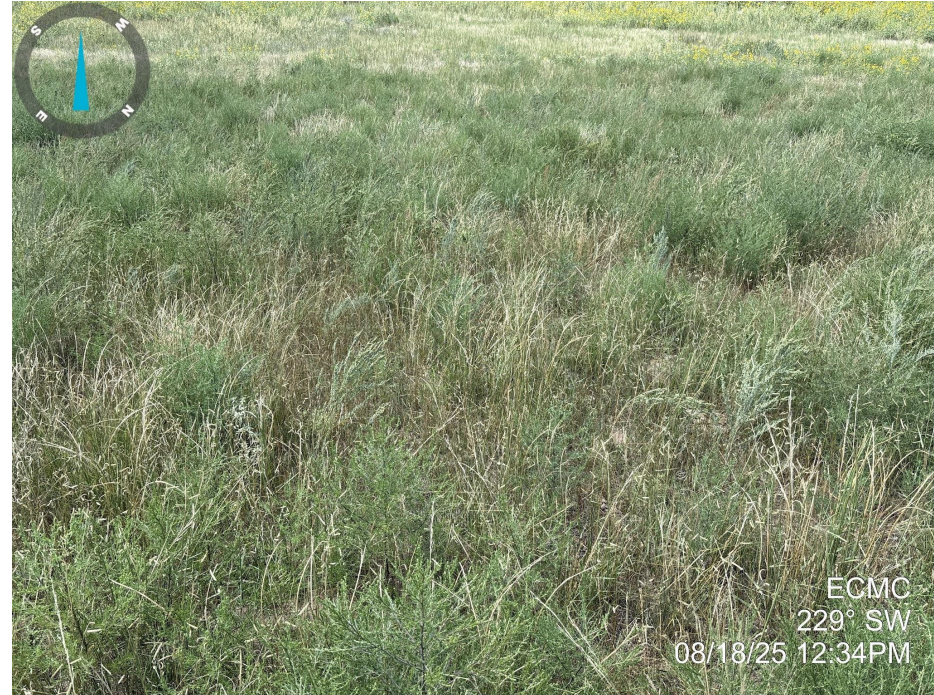
Photo 6. Photo taken of the access road to the location, facing southwest. See comments under Photo 5.
