Final Reclamation and Stormwater Inspection

Operator: SCHNEIDER ENERGY SERVICES INC - 76840

Well Name: WARD & SONS #1

Inspection Document #: 718600912

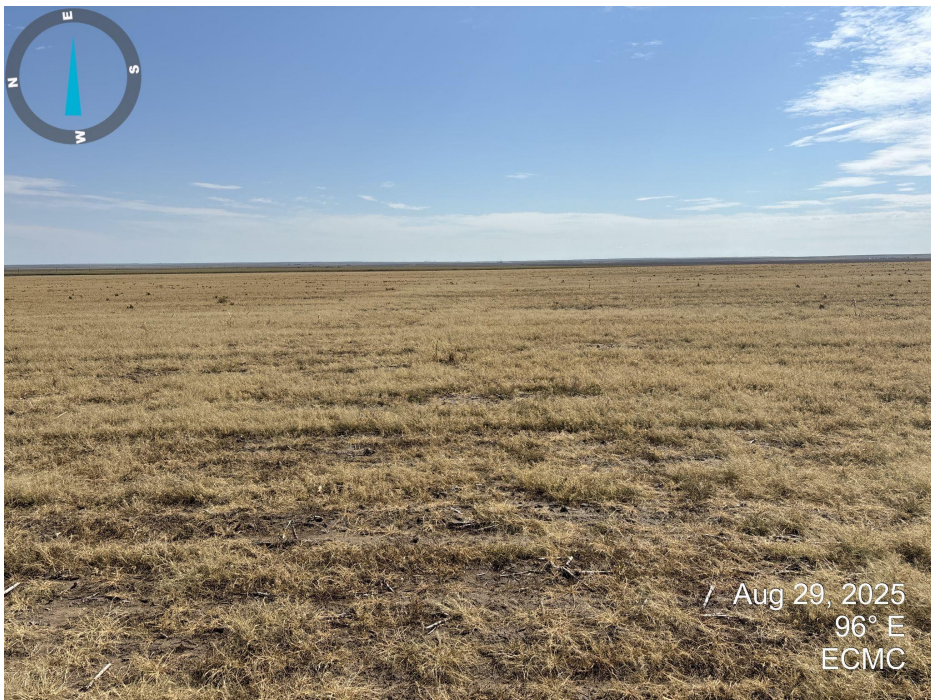
Photo 1. Looking east down the former access road towards the wellhead. It appears that reclamation was conducted. The access road and wellhead are in fallow cropland.

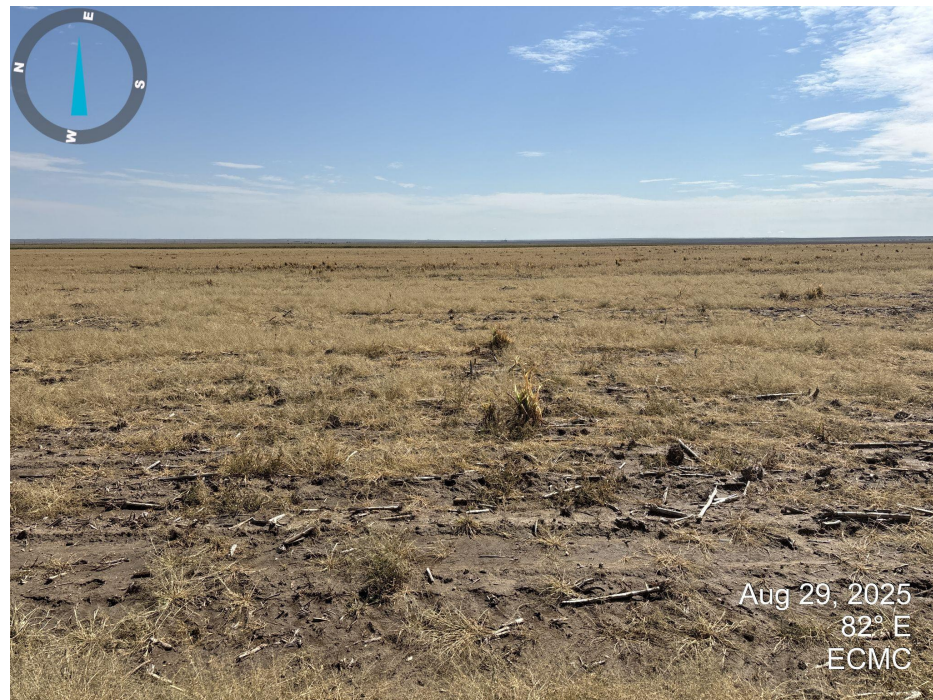
Photo 2. Looking east across the wellbore area. No oil and gas equipment remains. The wellhead is in fallow cropland.

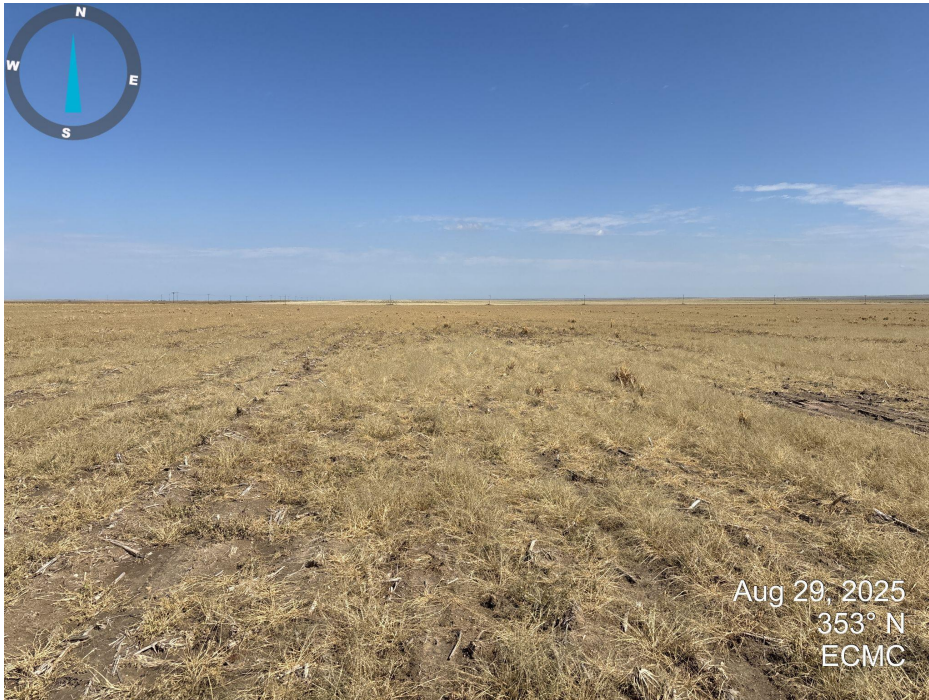
Photo 3. Looking north from the wellbore. See photo 2 comments.

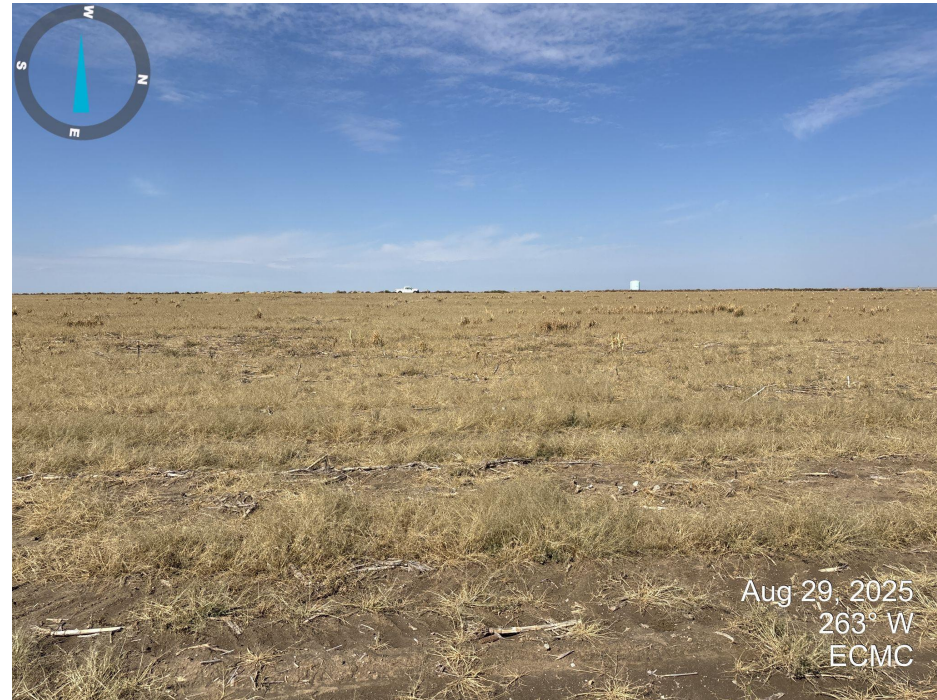
Photo 4. Looking west from the wellbore. See photo 2 comments.

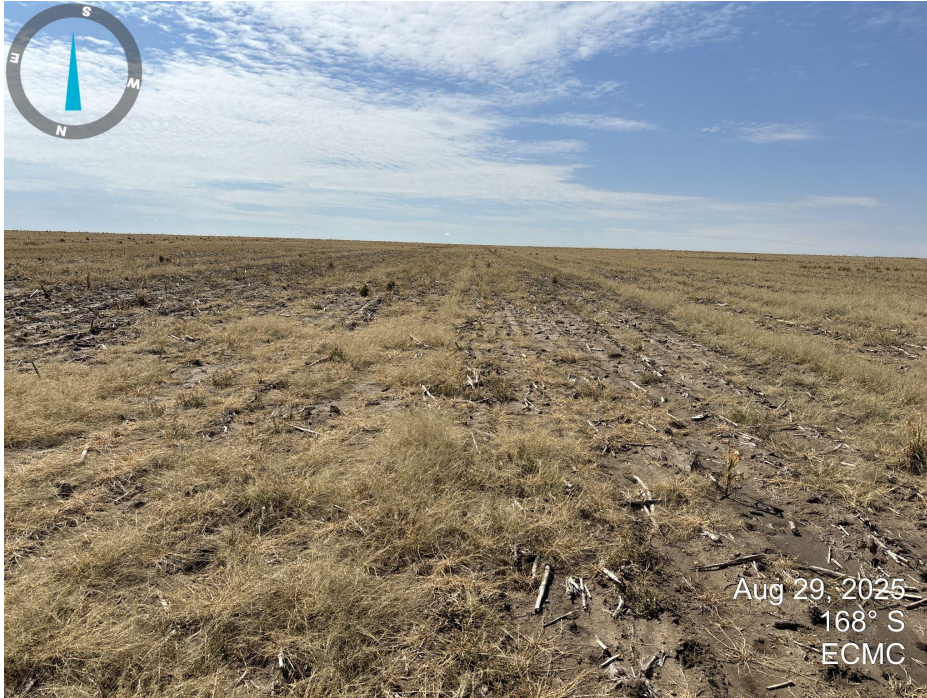
Photo 5. Looking south from the wellbore. See photo 2 comments.

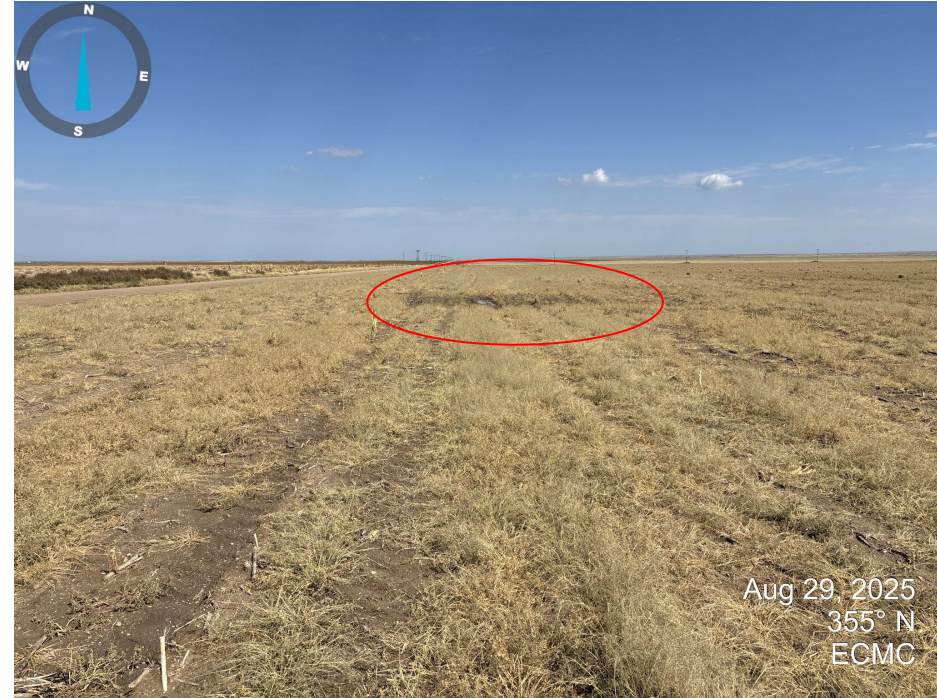
Photo 6. Picture taken at the south edge of the former tank battery area looking north. No equipment remains on location. The tank battery is located in fallow cropland. A low/ muddy spot is present in the area of the evap pond/ skim pit (red circle). See photos 7 & 8.

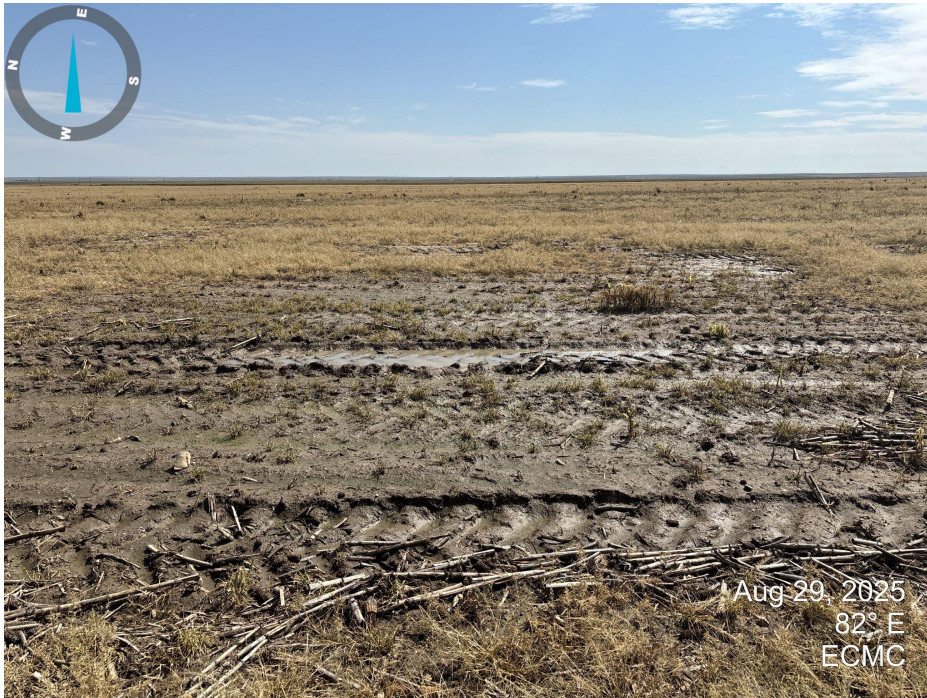
Photo 7. Picture taken approximately at the northwest side of the evap pond looking east across a low spot. This area appears to have some subsidence and water pooling.

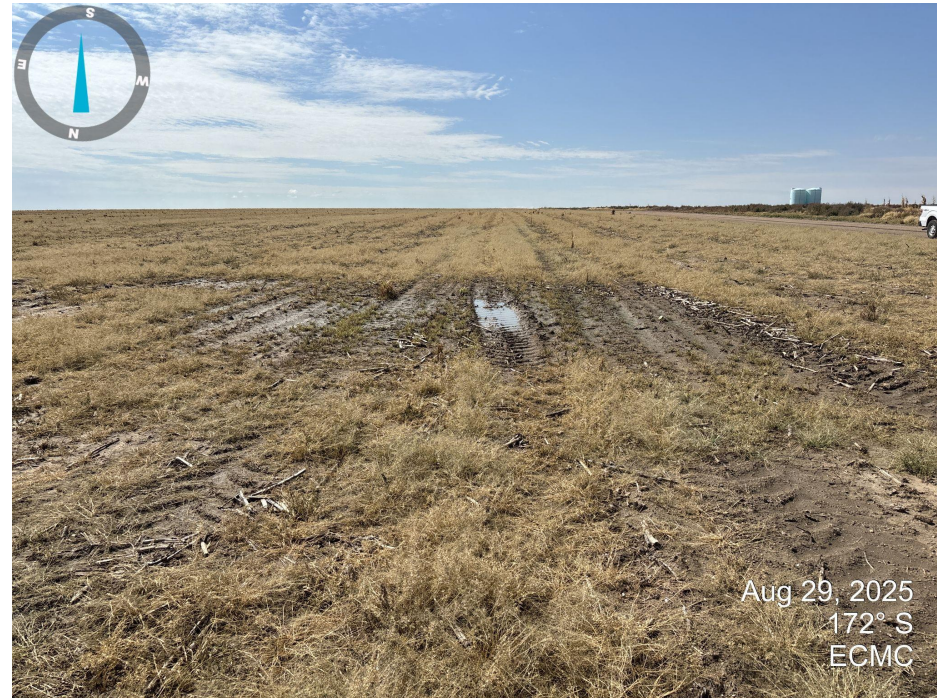
Photo 8. Looking south from the center of the location. See photo 7 comments.

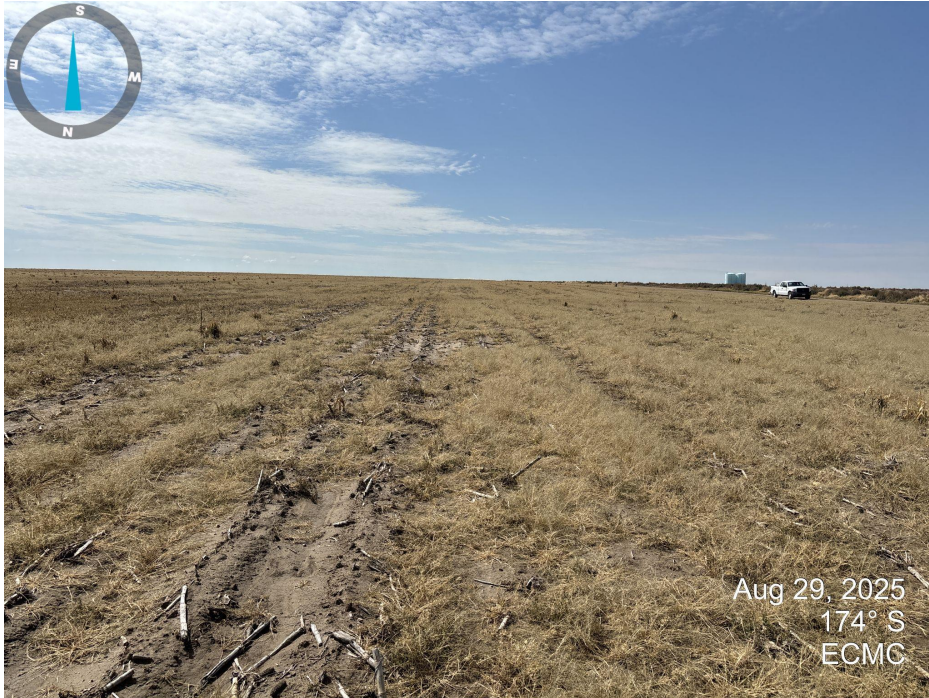
Photo 9. Picture taken at the north edge of the location looking south across the tank area. No oil and gas equipment remains on location.

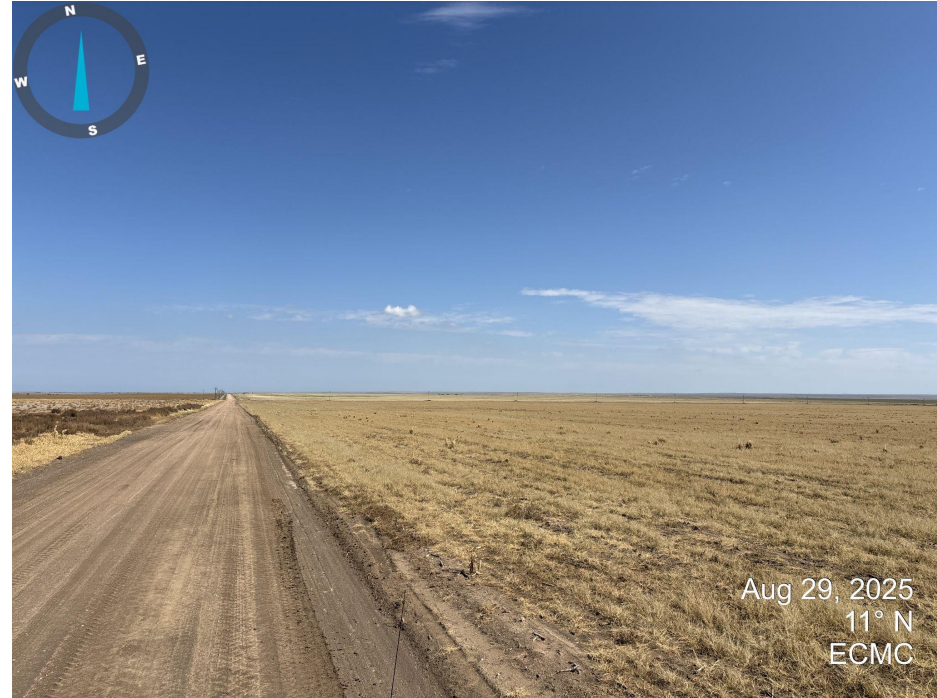
Photo 10. Overview of the tank battery and aces road entrance and reference land. The well, access road and tank battery are located in fallow cropland.
