Inspection Photos

Operator: QB Energy Operating LLC #10844

Location ID: 334785

Inspection Doc: 719200164

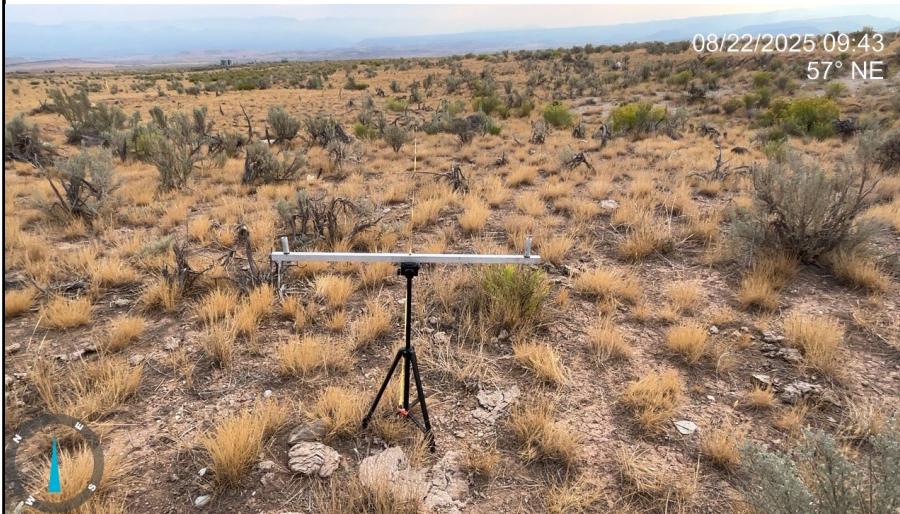
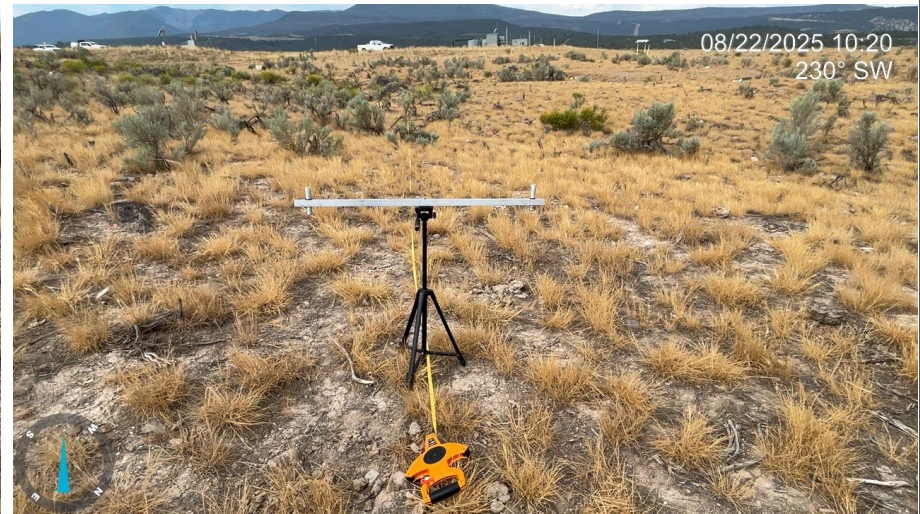
Photo 1: Photos show the beginning and end of the disturbed area vegetation transect, respectively.

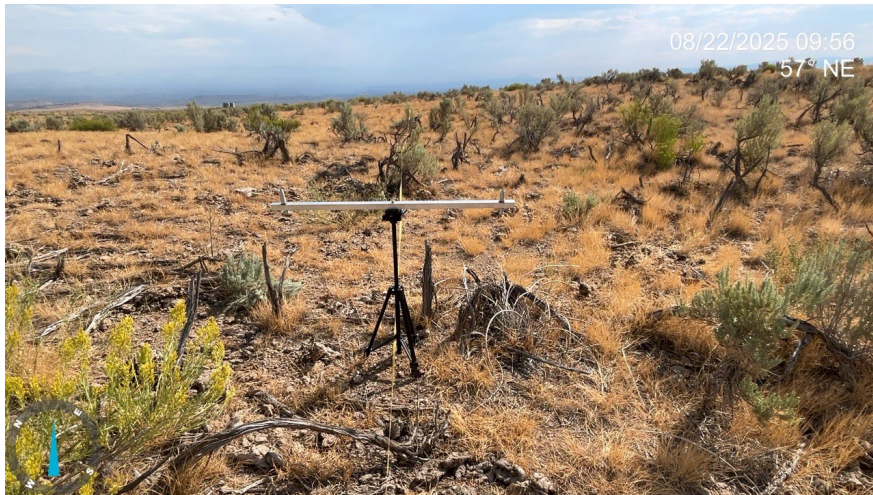
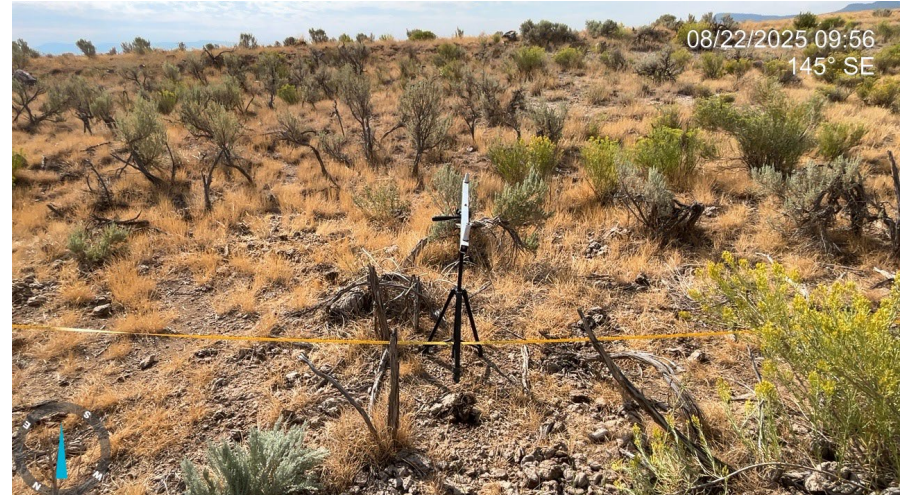
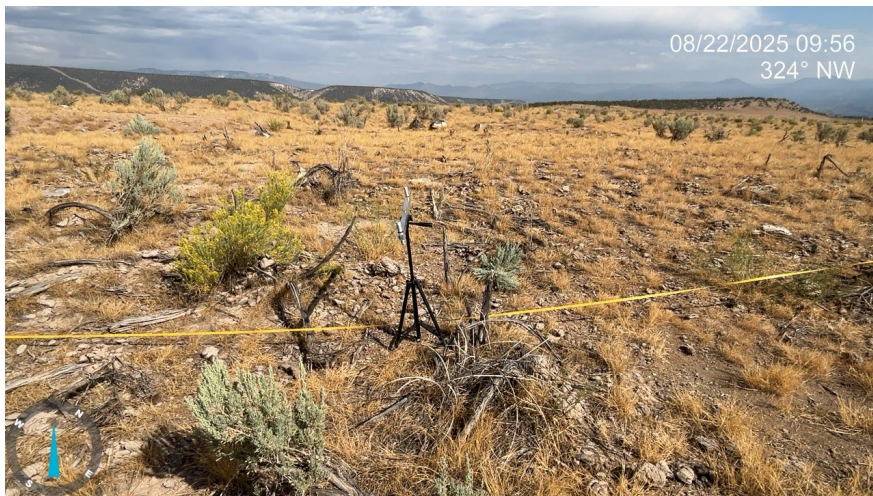
Photo 2: Photos show the middle of the disturbed area transect (top left), looking northwest (bottom left) and looking southeast (top right).

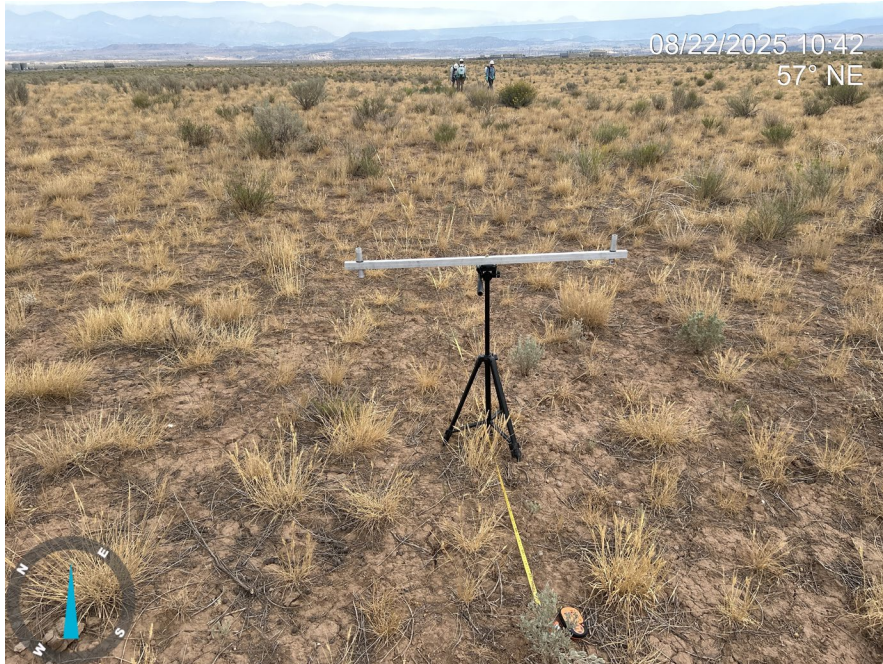
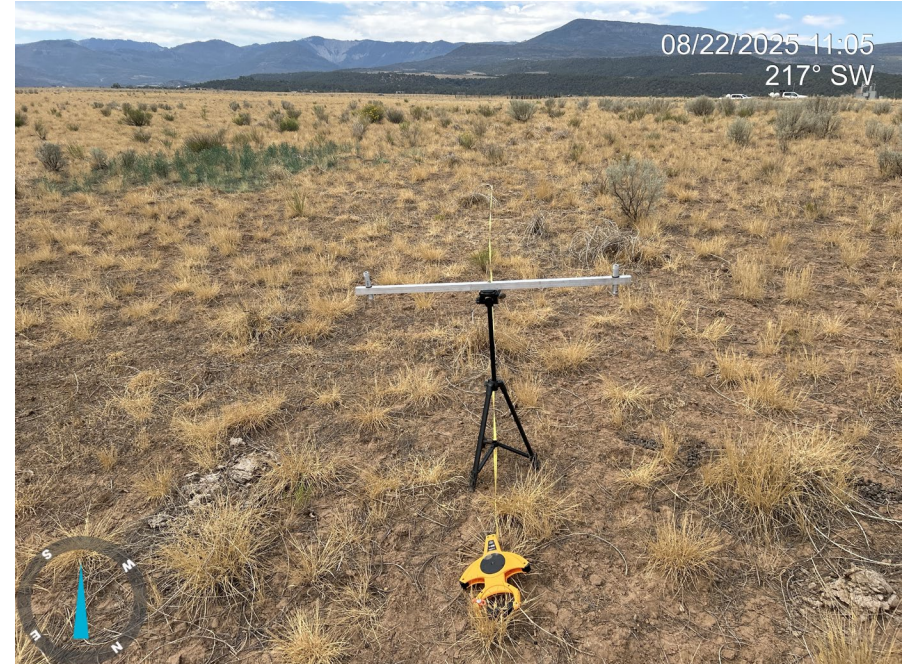
Photo 3: Photos show the beginning and end of the reference area vegetation transect, respectively.

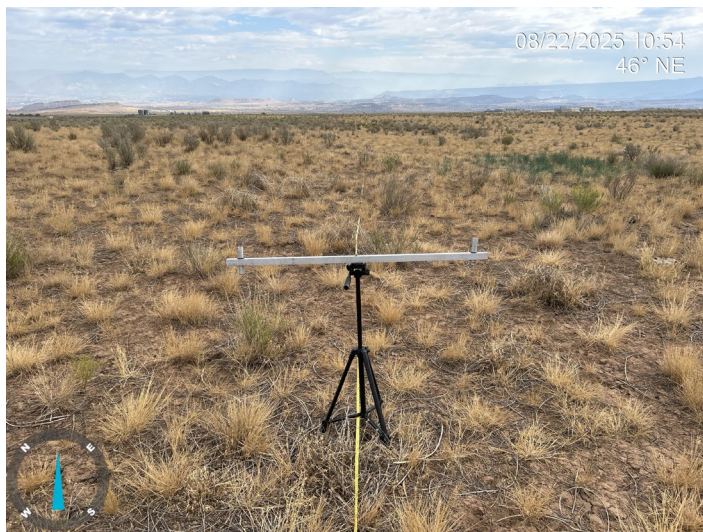
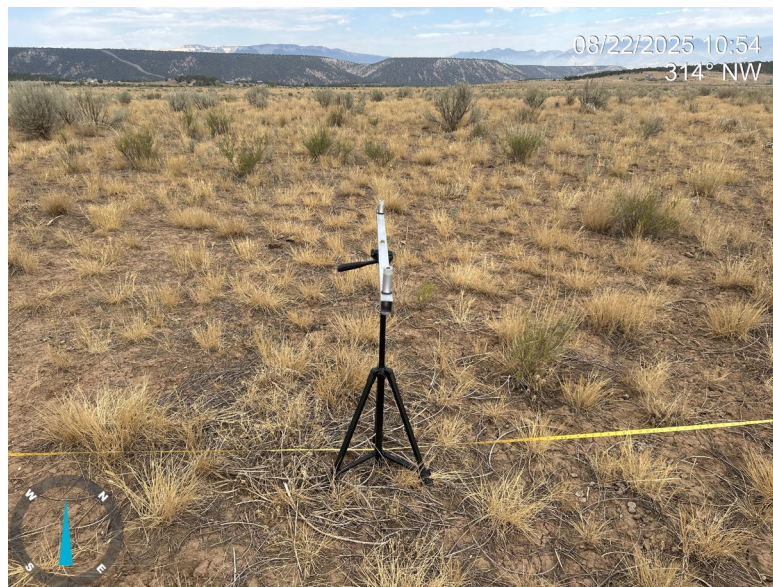
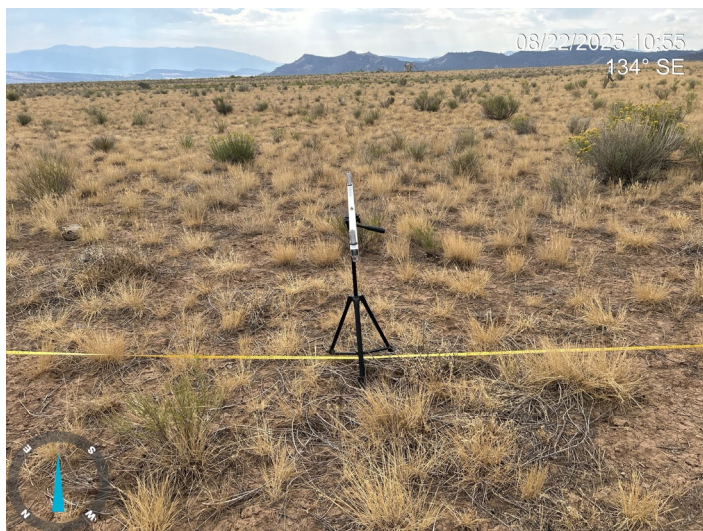
Photo 4: Photos show the middle of the reference area transect (top left), looking southeast (bottom left) and looking northwest (top right).

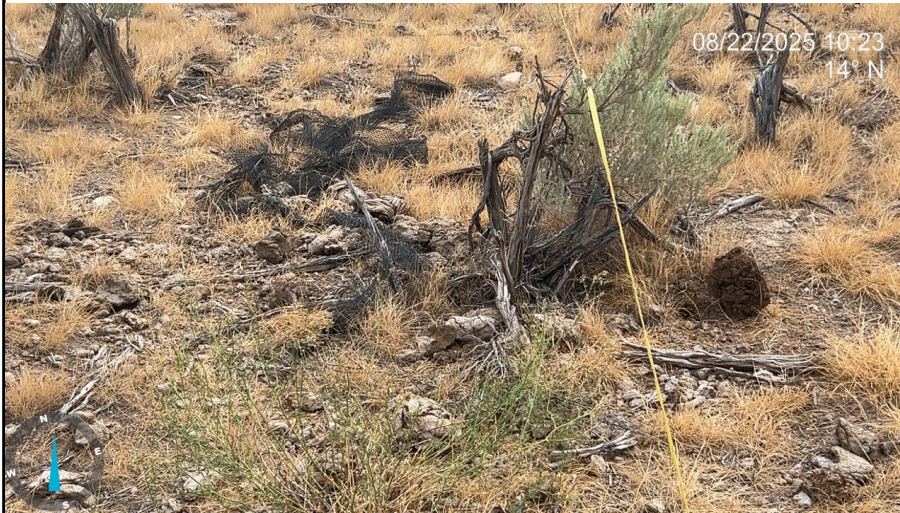
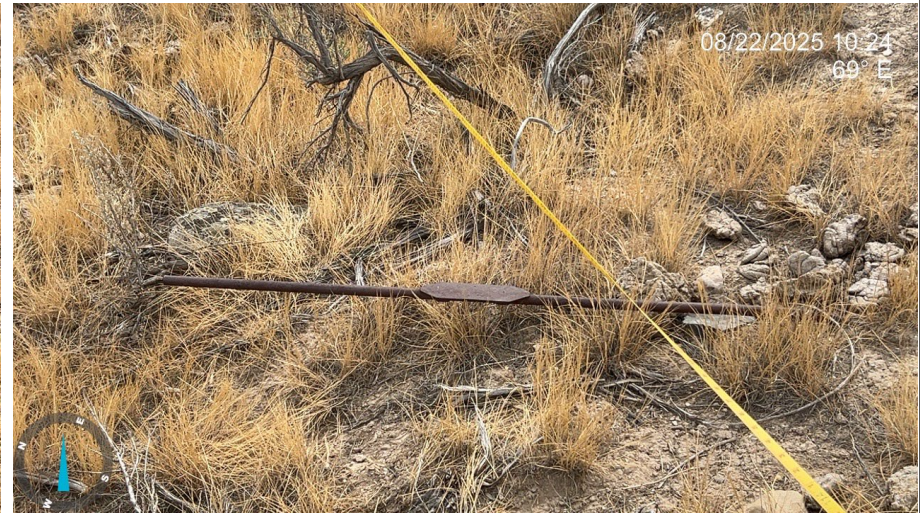
Photo 5: Photos show an example of trash and debris at the location. Damaged wattles, t-posts, steel cables and barbed wire appears to be present throughout the location. Comply with Rule 606.d.

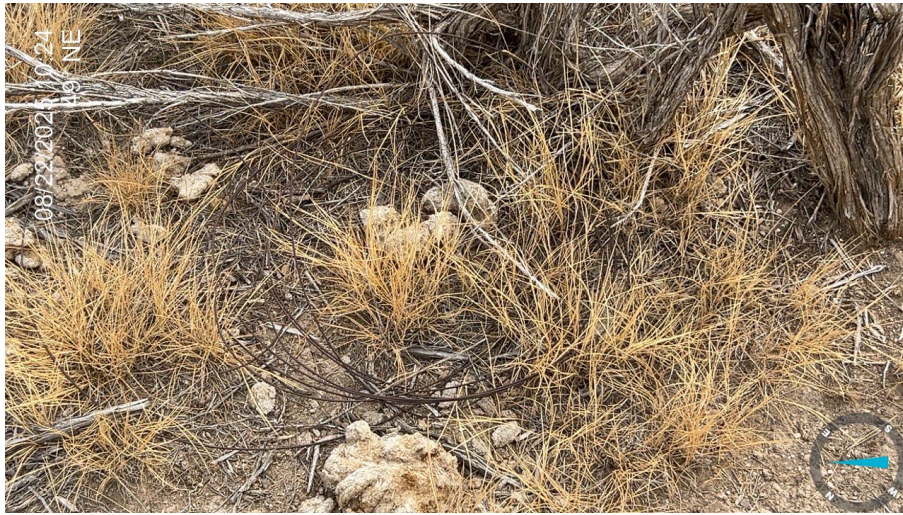
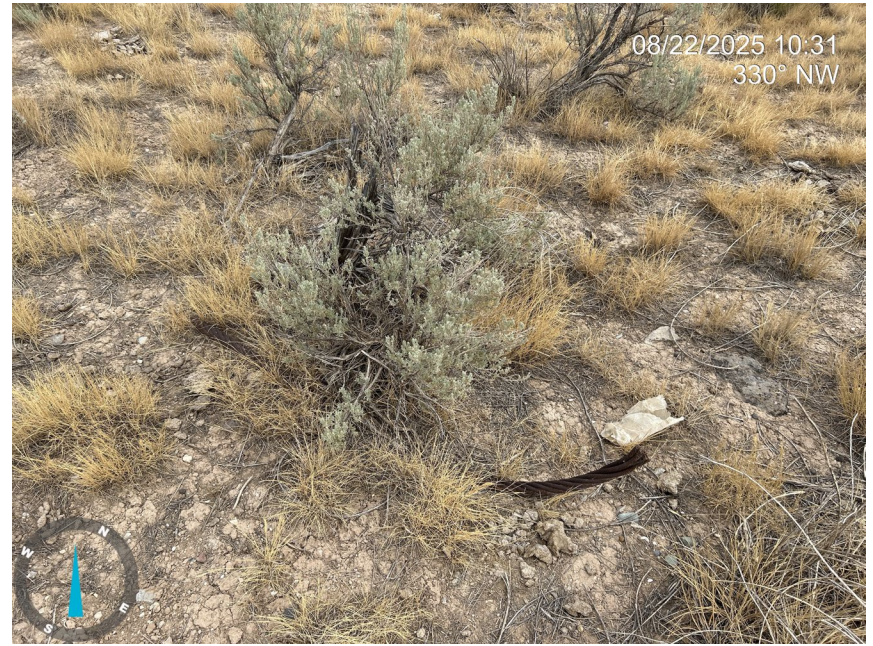
Photo 6: Photos show an example of trash and debris at the location. Damaged wattles, t-posts, steel cables and barbed wire appears to be present throughout the location. Comply with Rule 606.d.
