# Inspection Photos

Operator: TEP Rocky Mountain LLC #96850

Location ID: 323901

Inspection Doc: 719200147

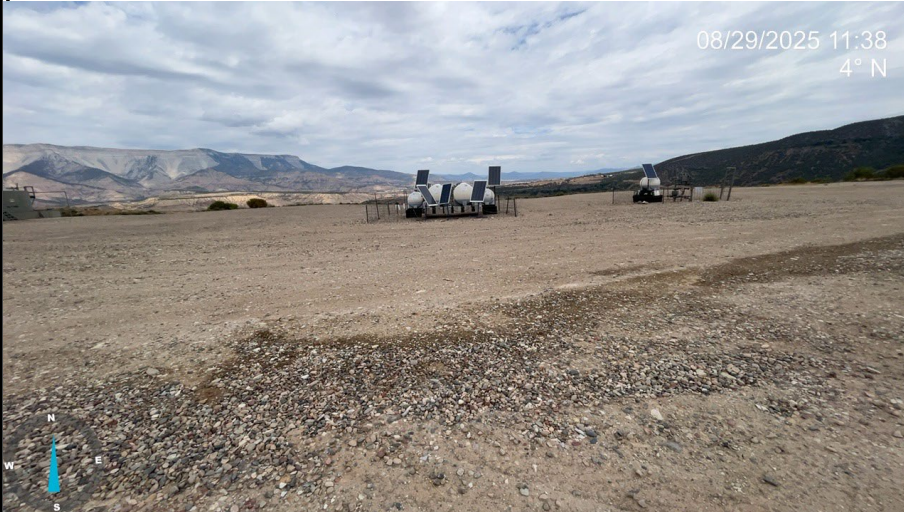
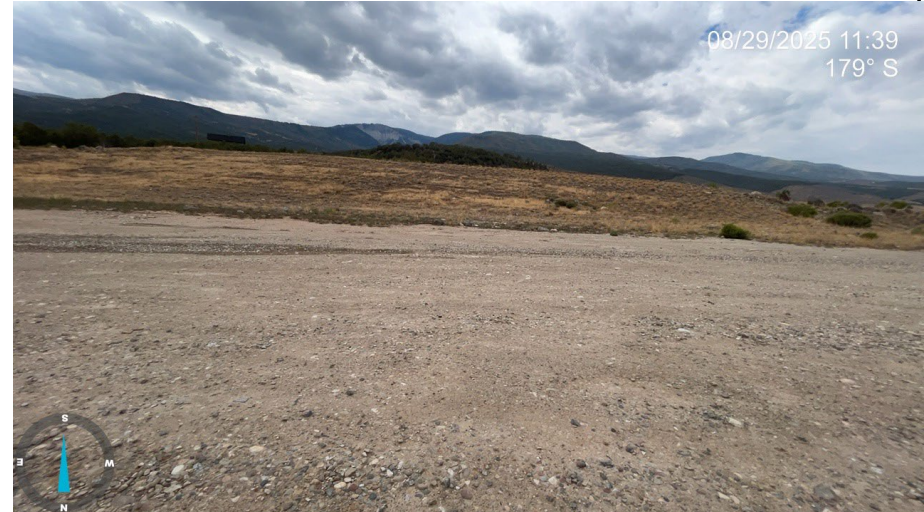
**Photo 1:** Photos show an overview of the location looking north and south, respectively.

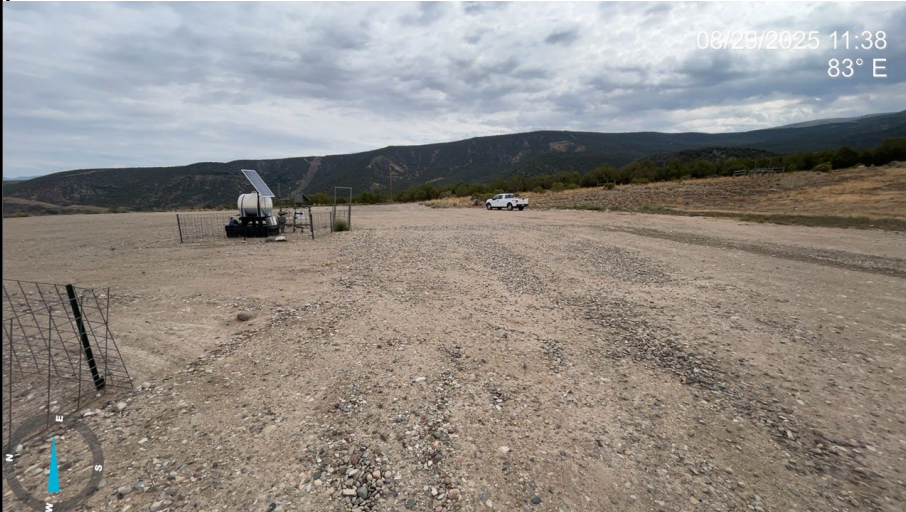
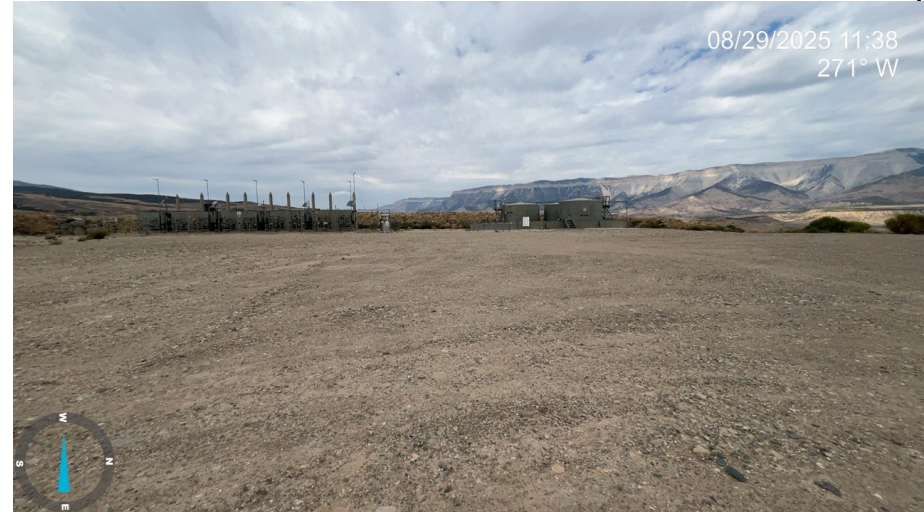
**Photo 2:** Photos show an overview of the location looking east and west, respectively.

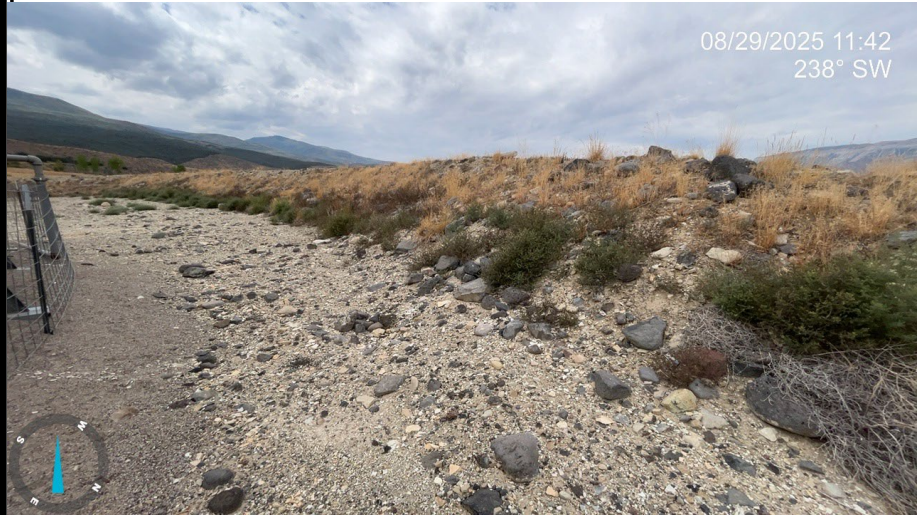
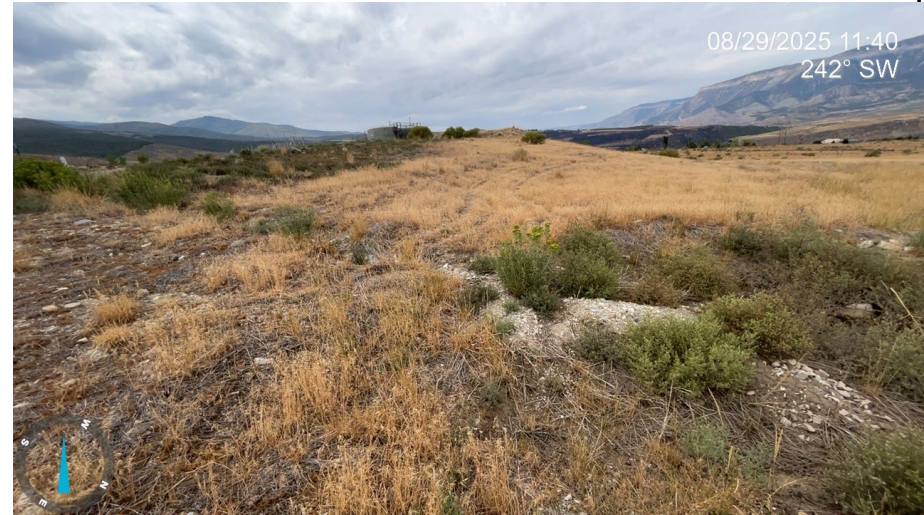
**Photo 3:** Photos show an example of undesirable plant species, cheatgrass and prickly Russian thistle, that are present on the perimeter of the working pad surface and throughout the interim areas at the location. Comply with Rule 606.c.

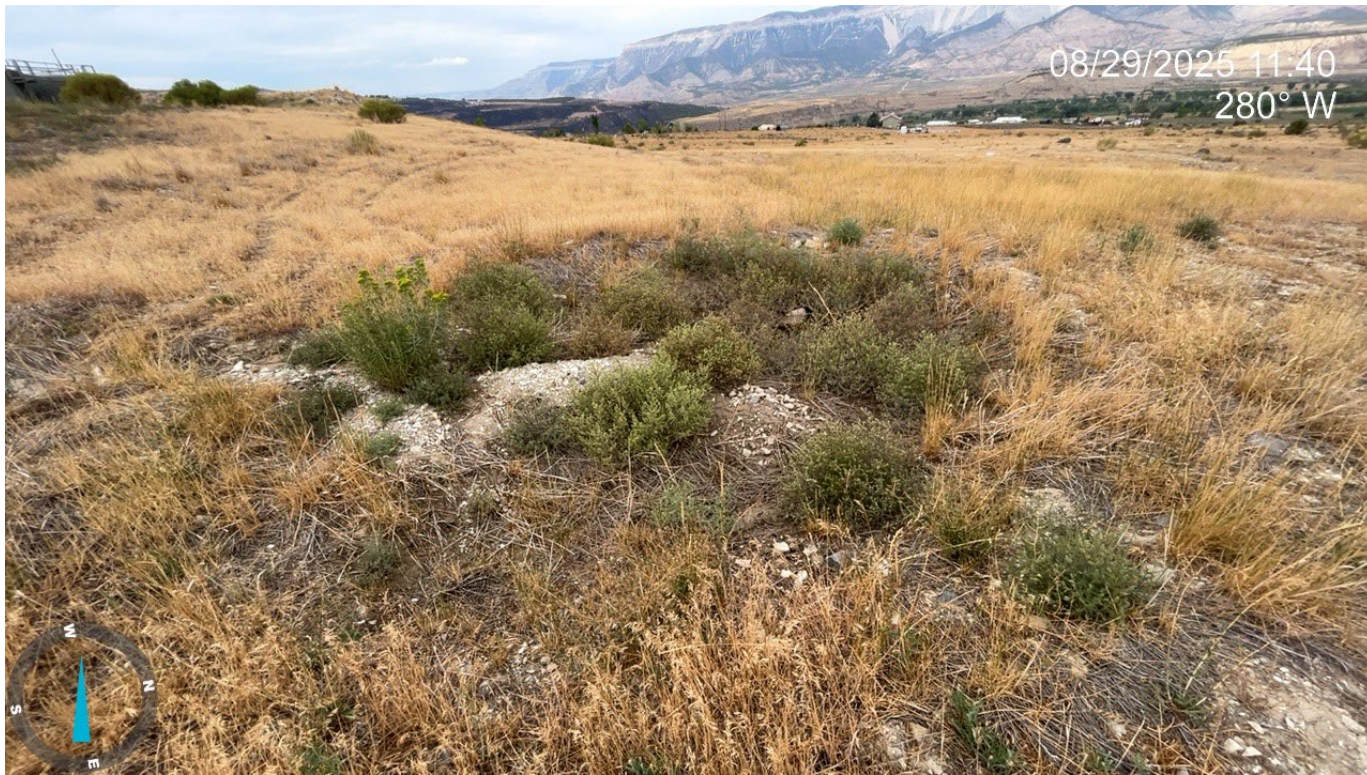
**Photo 4:** Photos show a sediment trap on the northern portion of the site is overtaken by undesirable plant species and requires maintenance.

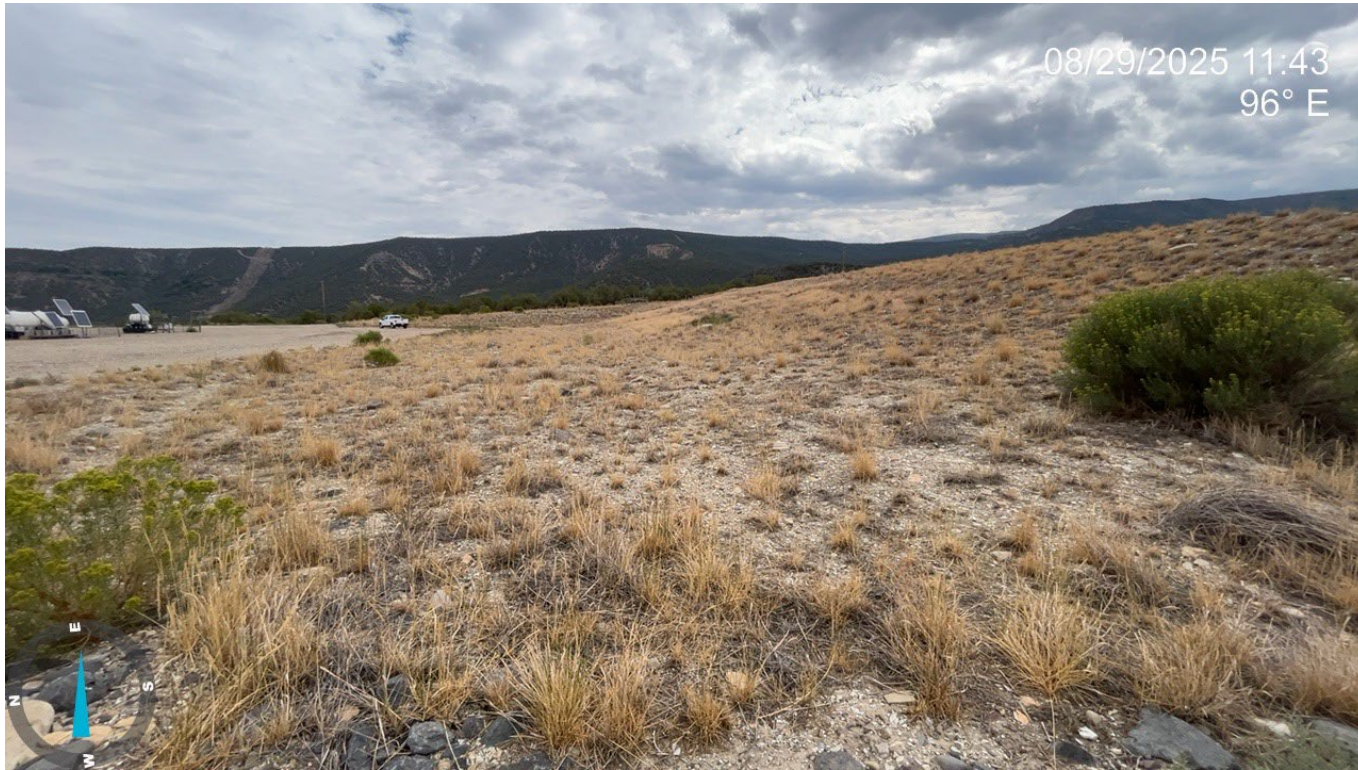
**Photo 5:** Photo shows that portions of the southern interim area are progressing towards 1003 reclamation requirements. This area is dominated by green needlegrass, crested wheatgrass and Russian wildrye.
