# Inspection Photos

**Operator:** BLUESTONE NATURAL RESOURCES, LLC-  
#10620

**Location ID:** 427088

**Inspection Document #:** 712300212

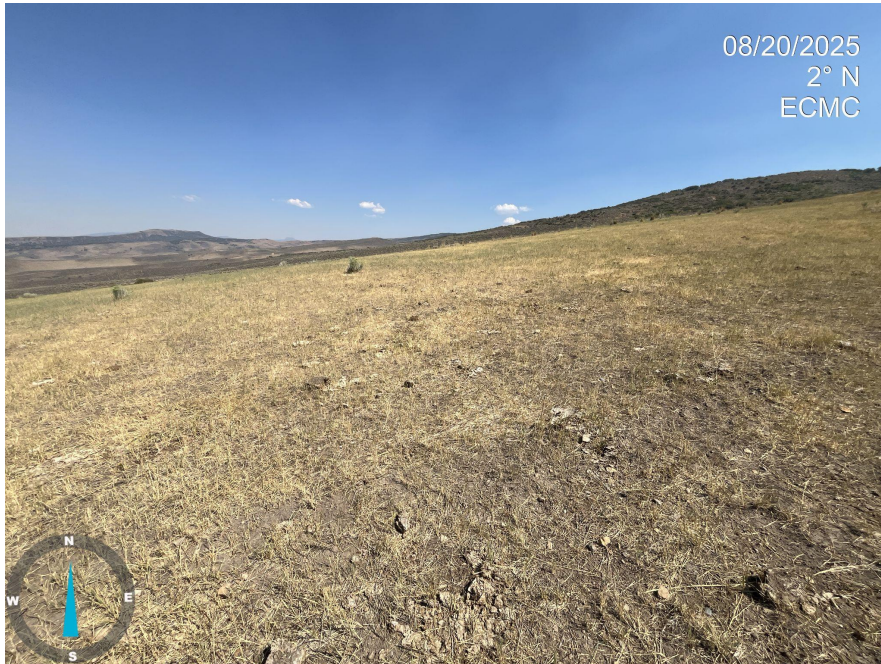
**Photo 1.** Photos 1-4 taken from the center of the pad, facing north, east, south, and west. Vegetation observed includes Sandberg bluegrass, intermediate/western wheatgrass, Basin wildrye, and rabbitbrush.

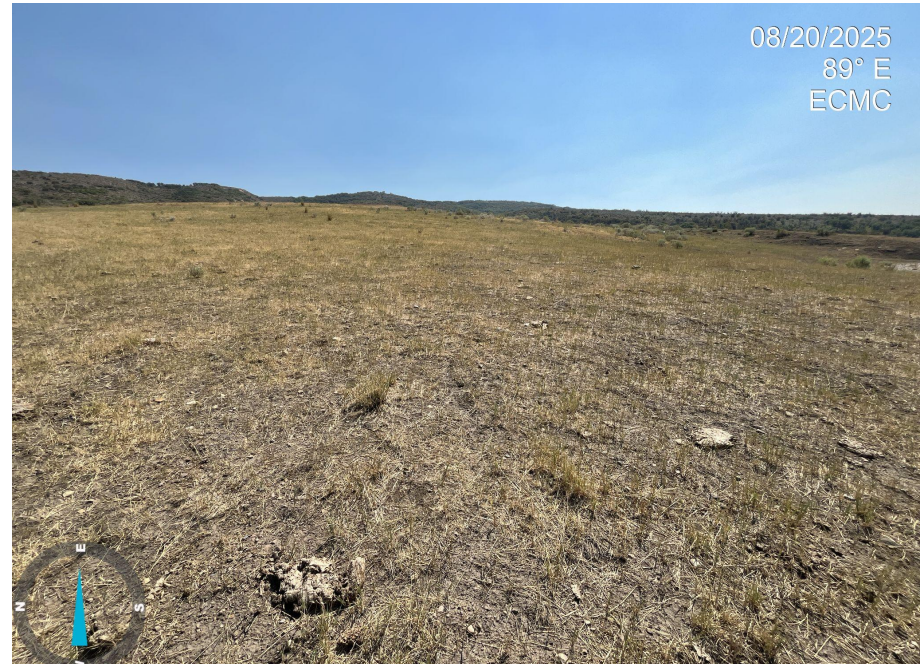
**Photo 2.** See comments under Photo 1.

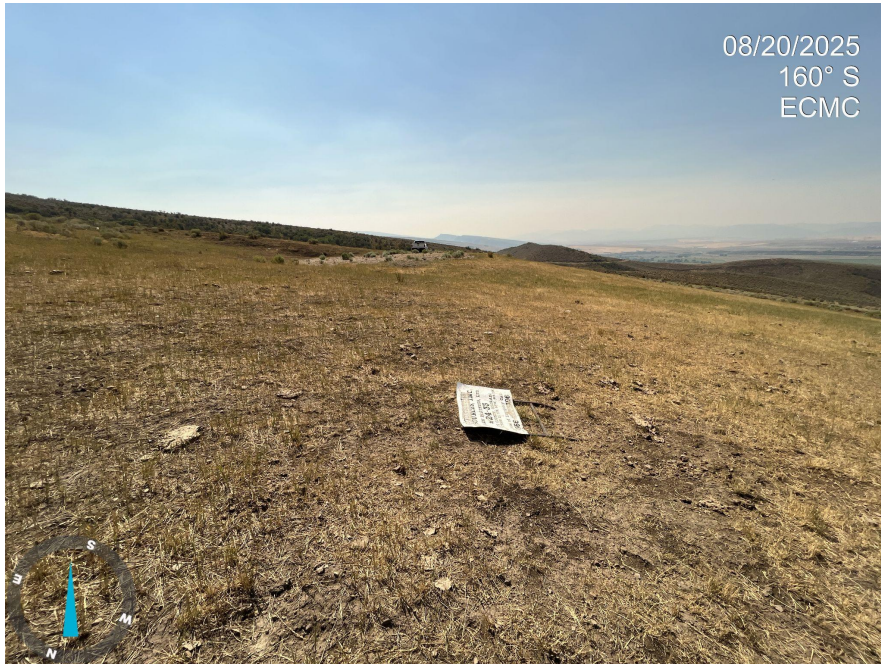
**Photo 3.** See comments under Photo 1. Sign remains on the Location.

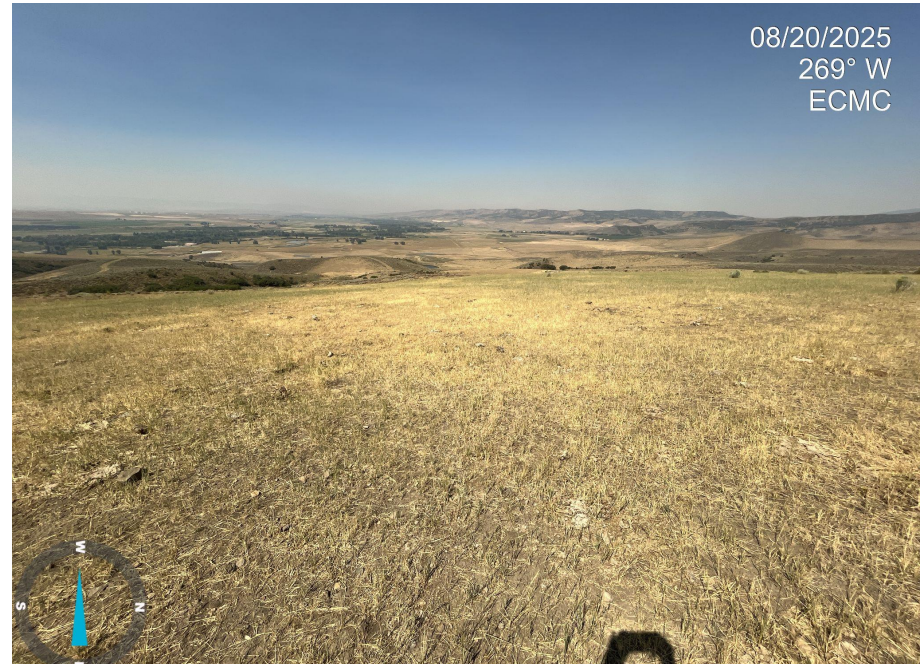
**Photo 4.** See comments under Photo 1.

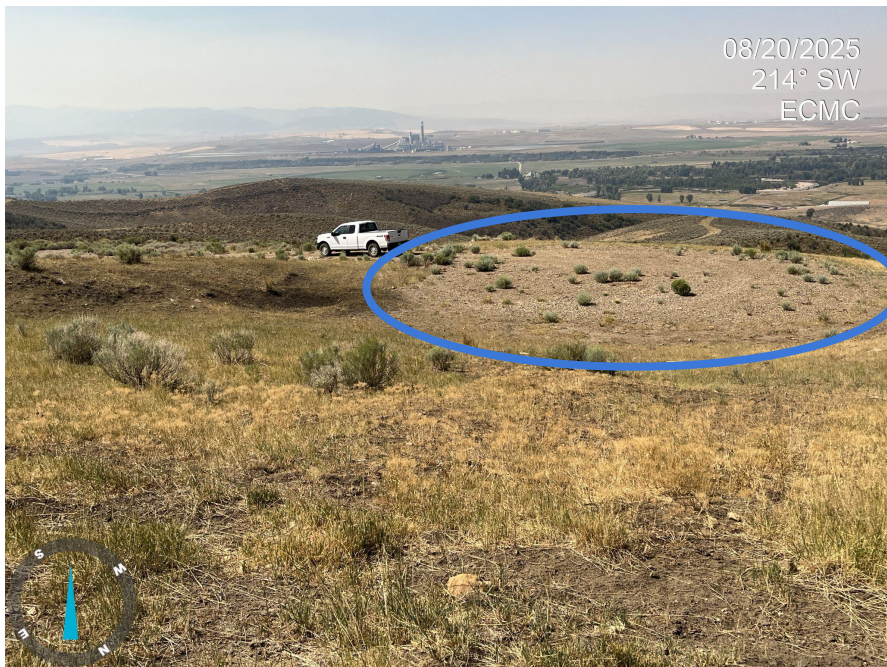
**Photo 5.** Photo taken from the northeastern portion of the pad, facing southwest towards the access road and remaining pad on the Location. Photo illustrates that a portion of the pad remains unreclaimed (Blue circle).

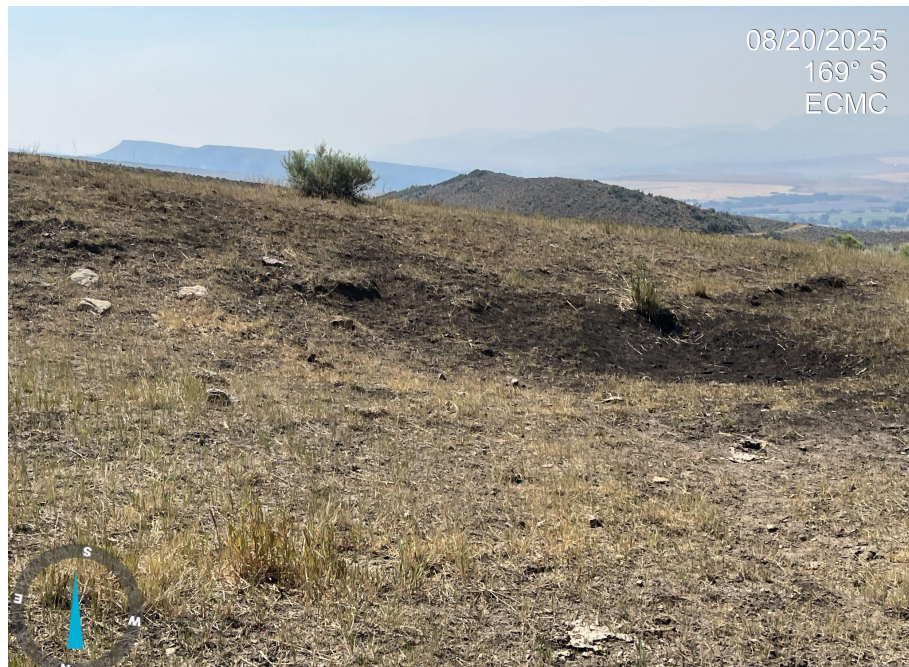
**Photo 6.** Photo taken near the entrance of the Location, facing south. Some areas remain without vegetation establishment, likely due to cattle.

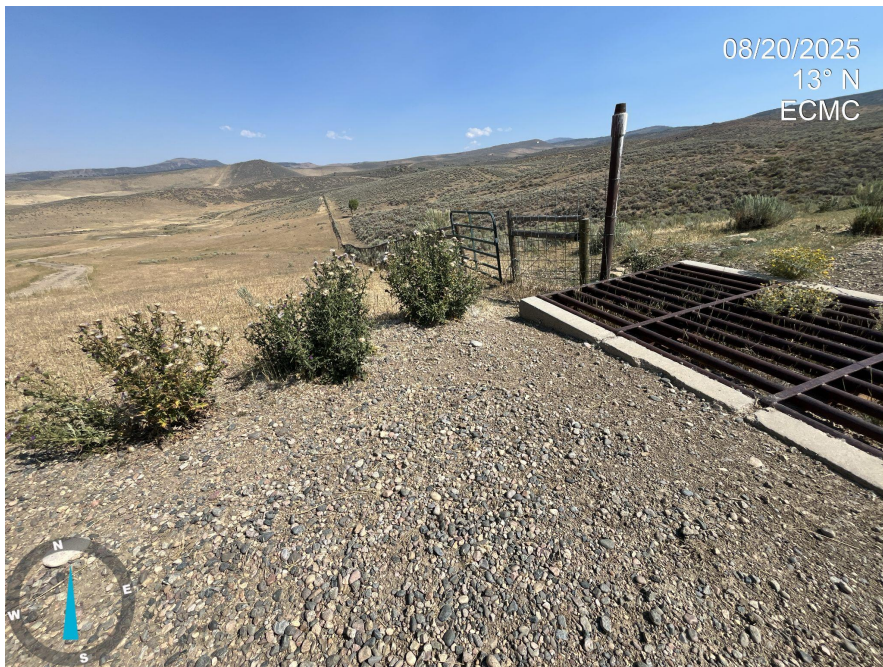
**Photo 7.** Photos 7-8 taken at the entrance of the access road. The cattle guard and gate remain present. Weeds, such as Bull thistle observed along the access road.

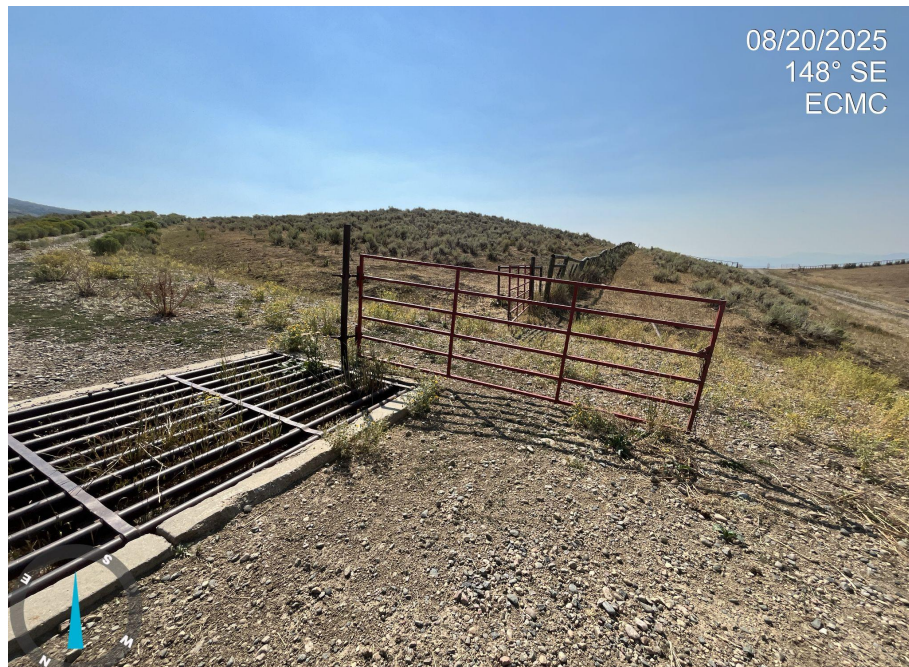
**Photo 8.** See comments under Photo 1.

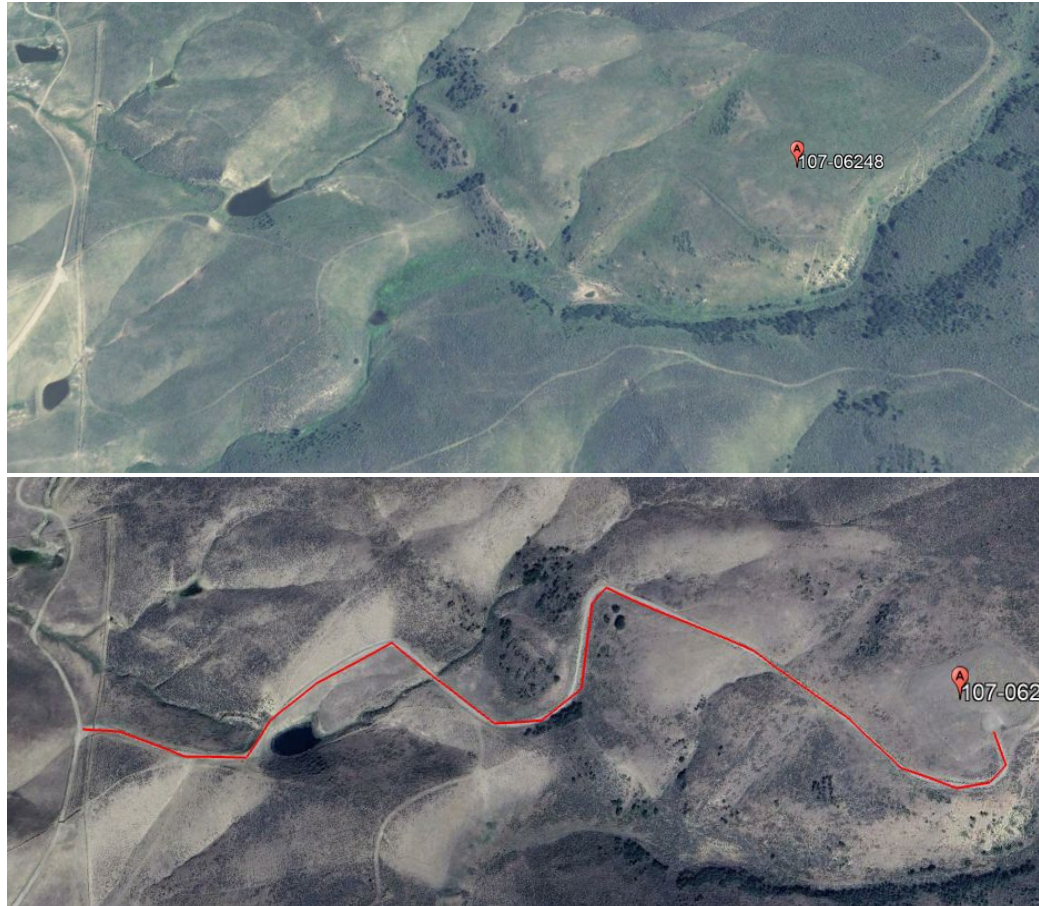
**Photo 9.** The access road was not apparent prior to oil and gas Operations, is approximately 1 mile in length, and will require final reclamation. (Google Earth Imagery: Top photo 8/10/2011, Bottom Photo 10/08/2024)

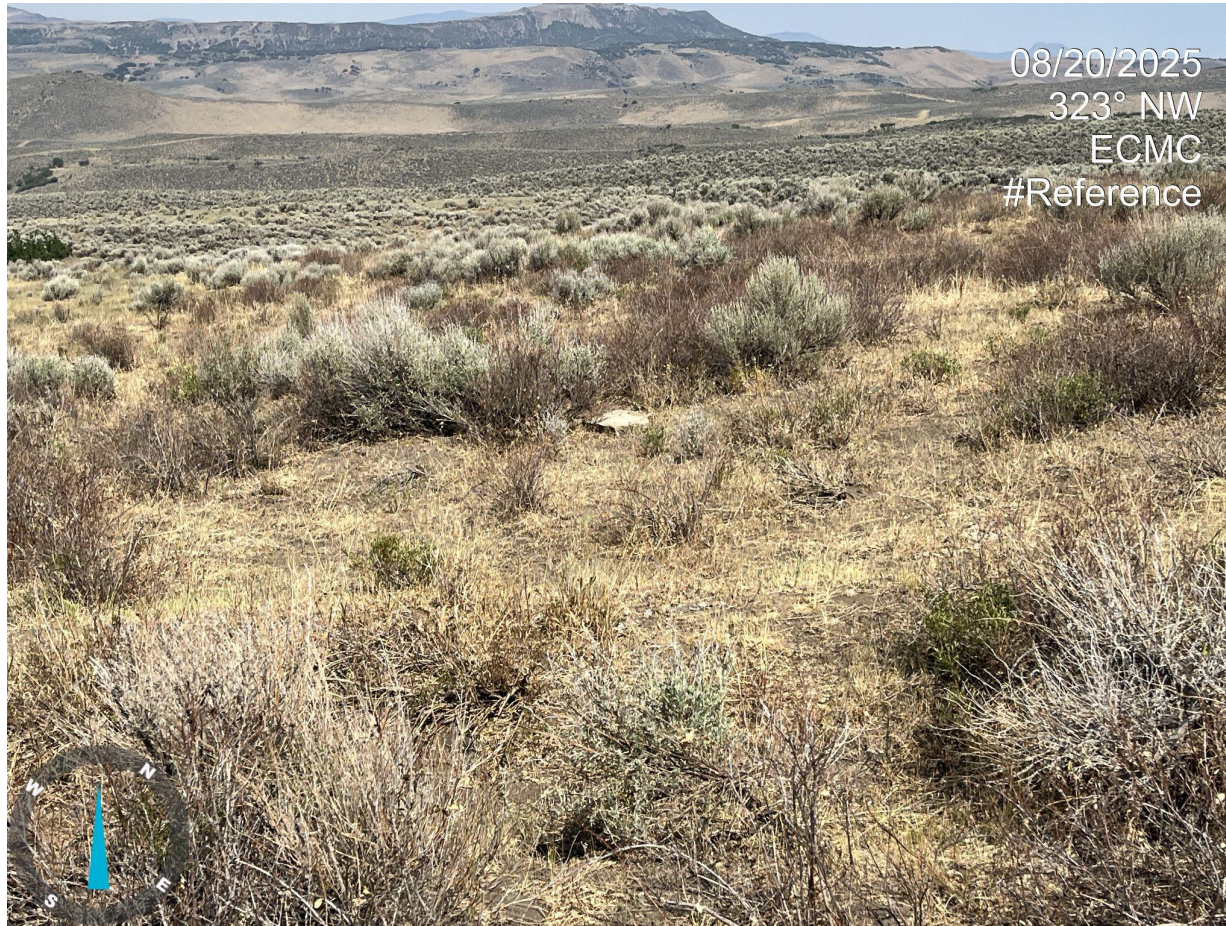
**Photo 10.** Photo taken of the reference area vegetation north of the Location, facing northwest. Species observed include sagebrush and western wheatgrass.
