Inspection Photos

Operator: SCOUT ENERGY MANAGEMENT LLC
- 10779

Location ID: 396980

Inspection Doc: 718100781

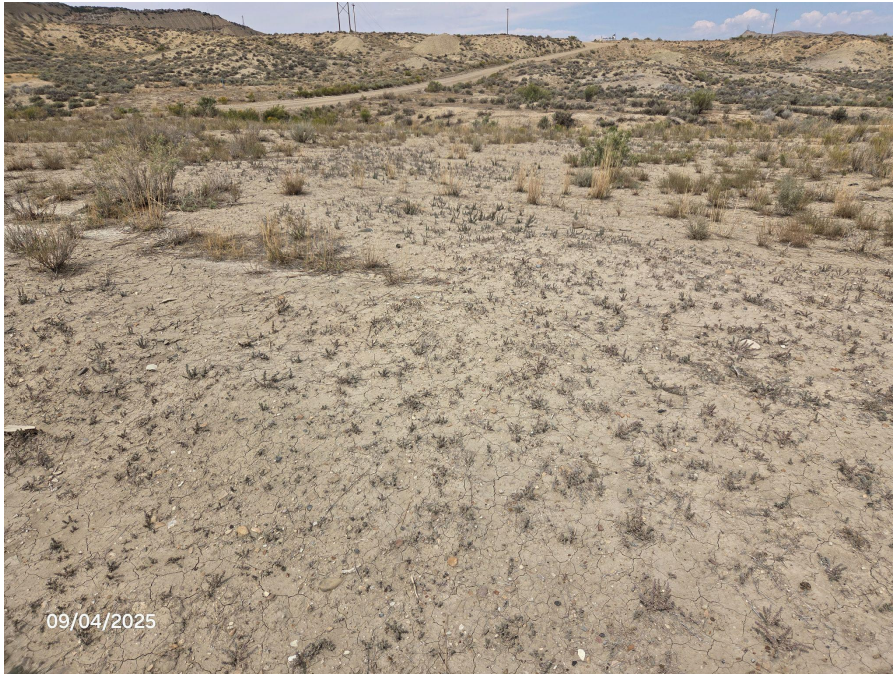
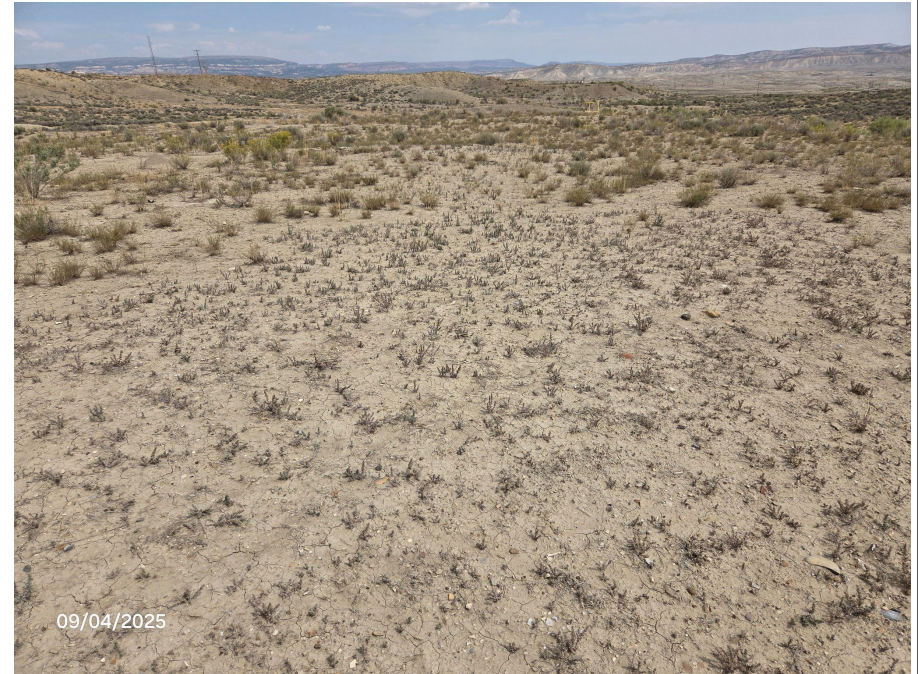
Photo 1: Photos taken from the south end of the Location, facing northwest and northeast. Photos examples showing areas of the Location where desirable perennial vegetation has not achieved uniform distribution or establishment. Areas remain bare or vegetated by undesirable plant species, such as halogeton.

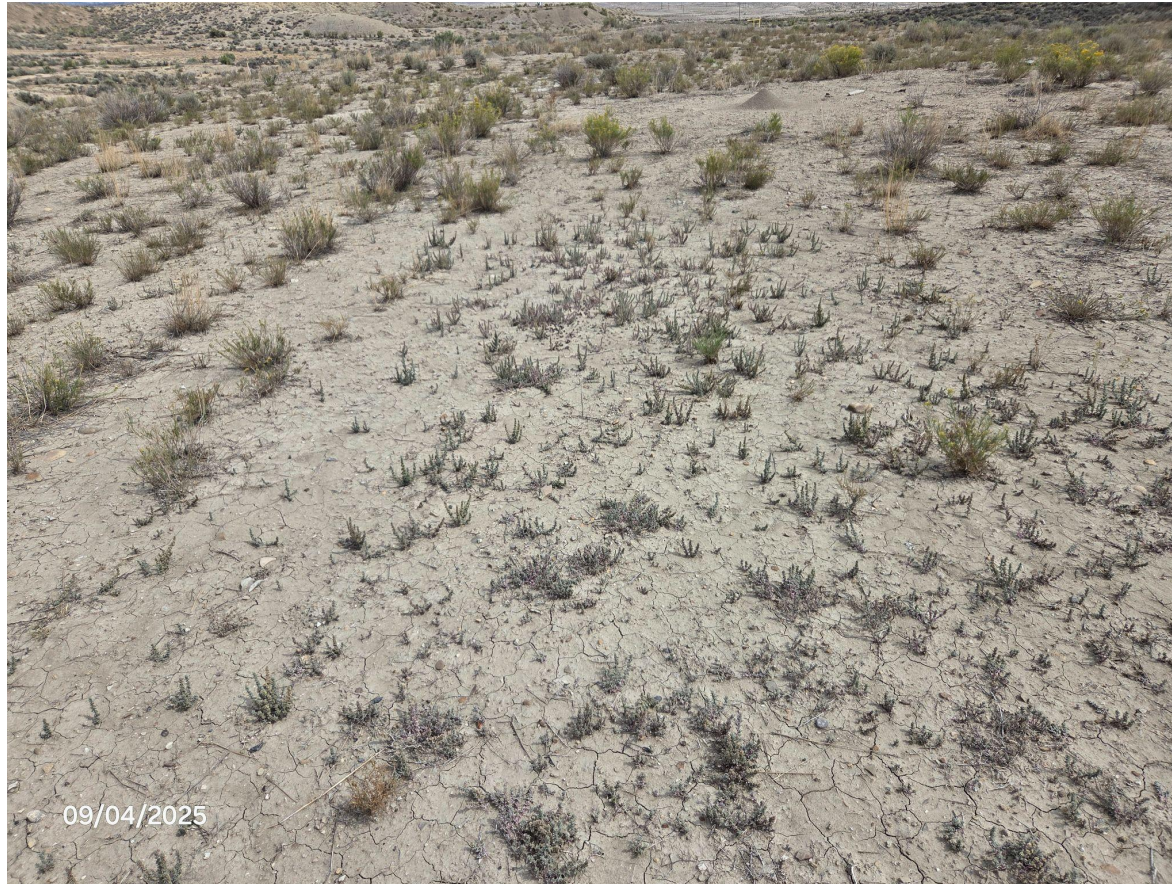
Photo 2: Photos taken from the central areas of the Location, facing north. Photos example showing areas of the Location where desirable perennial vegetation has not achieved uniform distribution or establishment. Areas remain bare or vegetated by undesirable plant species, such as halogeton.

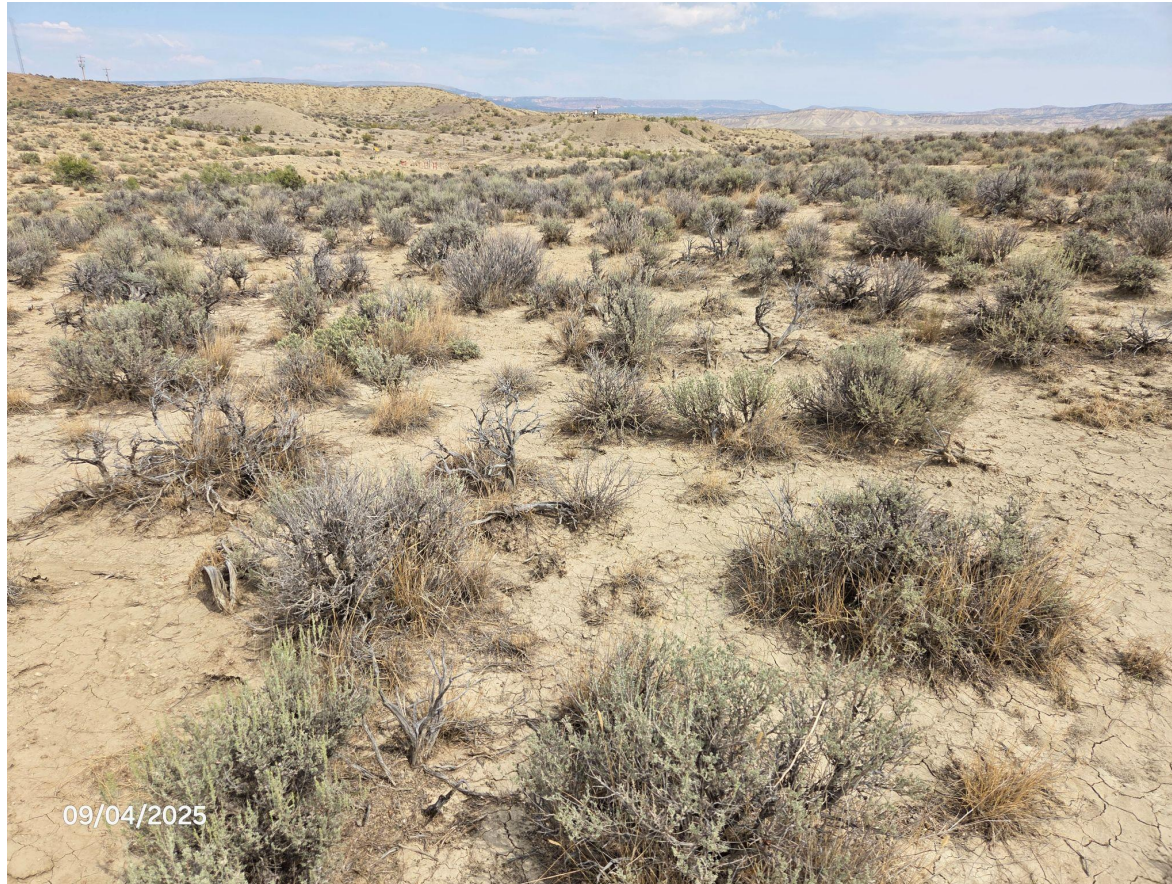
Photo 3: Photos taken from the the adjacent reference for comparison.
