Inspection Photos

API: 017-06410

Operator: **WILLIFORD ENERGY COMPANY**

Inspection Date: 9/5/2025

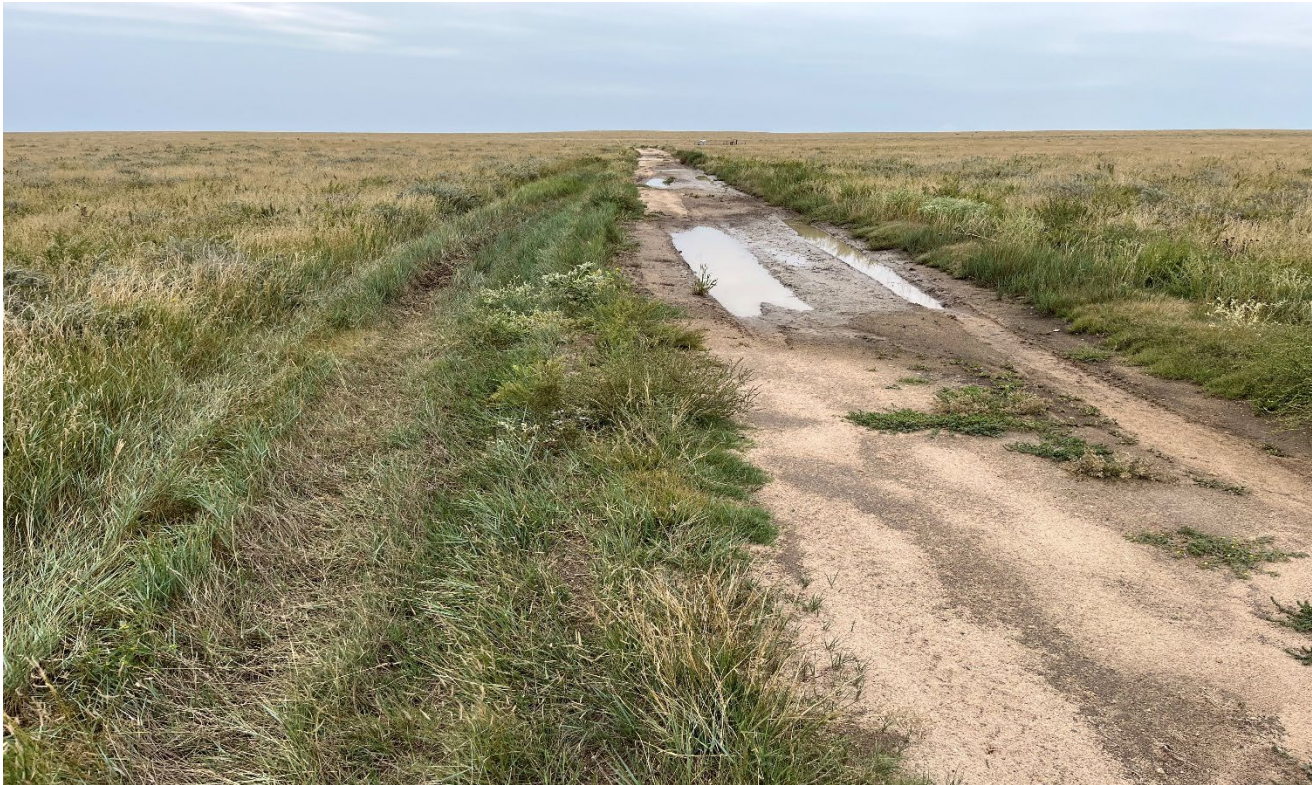
Photo 1. Facing south along the access road. Vehicles are causing unnecessary disturbance driving outside of the access road due to stormwater pooling on the road. The access road must be maintained and vehicles shall not drive outside of the access road boundary. Previous corrective action was not completed.

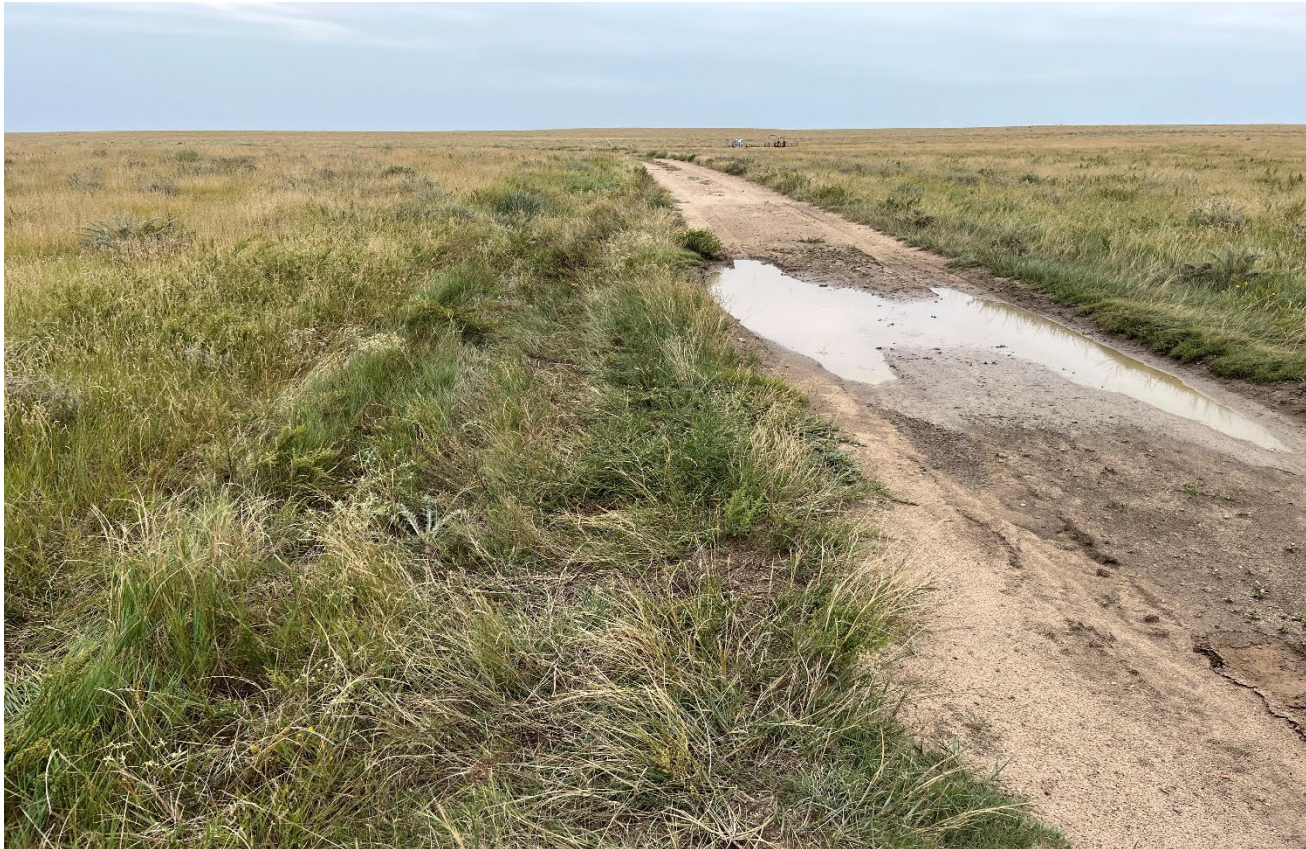
Photo 2. Facing south along the access road. Vehicles are causing unnecessary disturbance driving outside of the access road due to stormwater pooling on the road.

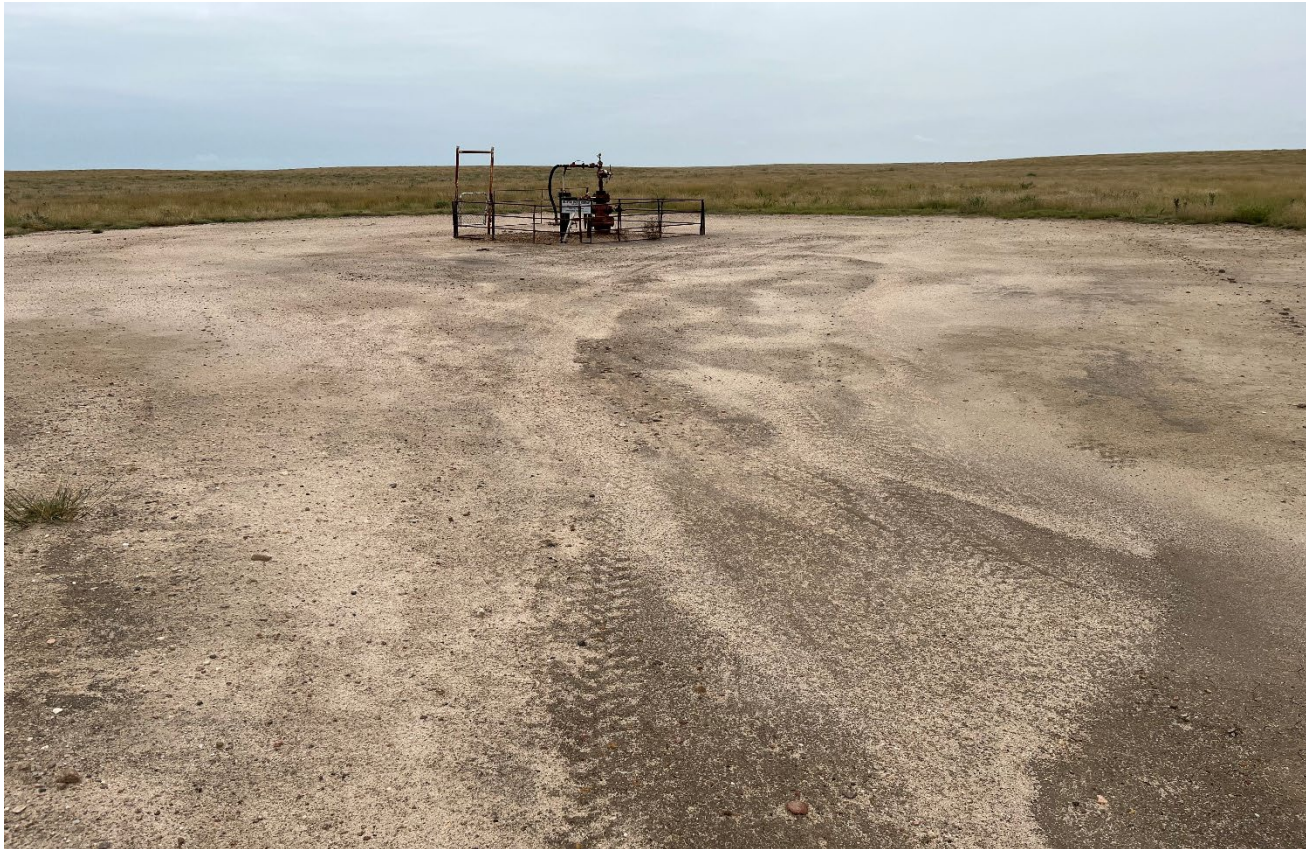
Photo 3. Facing southwest toward the wellsite.

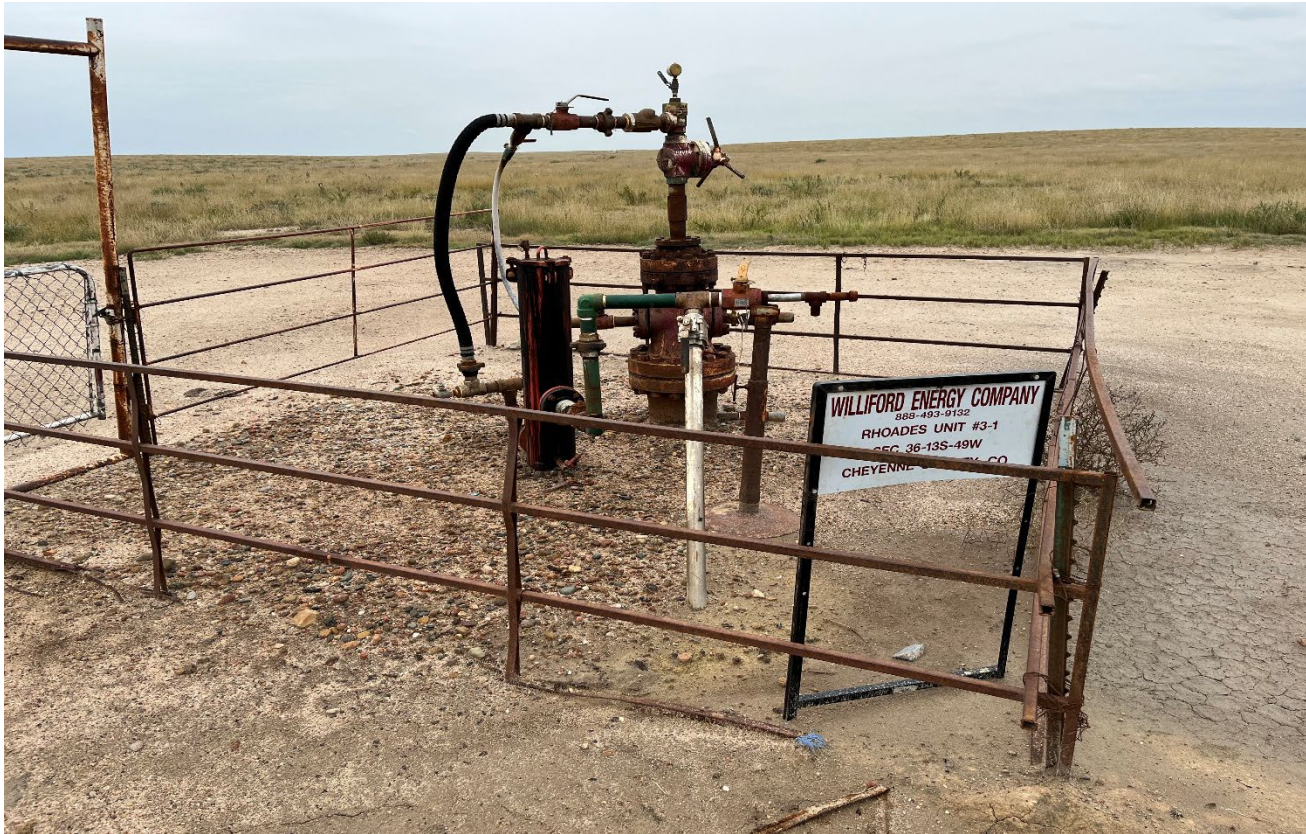
Photo 4. Sign is posted at the wellhead.
