Inspection Photos

Operator: QB ENERGY OPERATING LLC

Location ID: 334405

Inspection Doc: 718100799

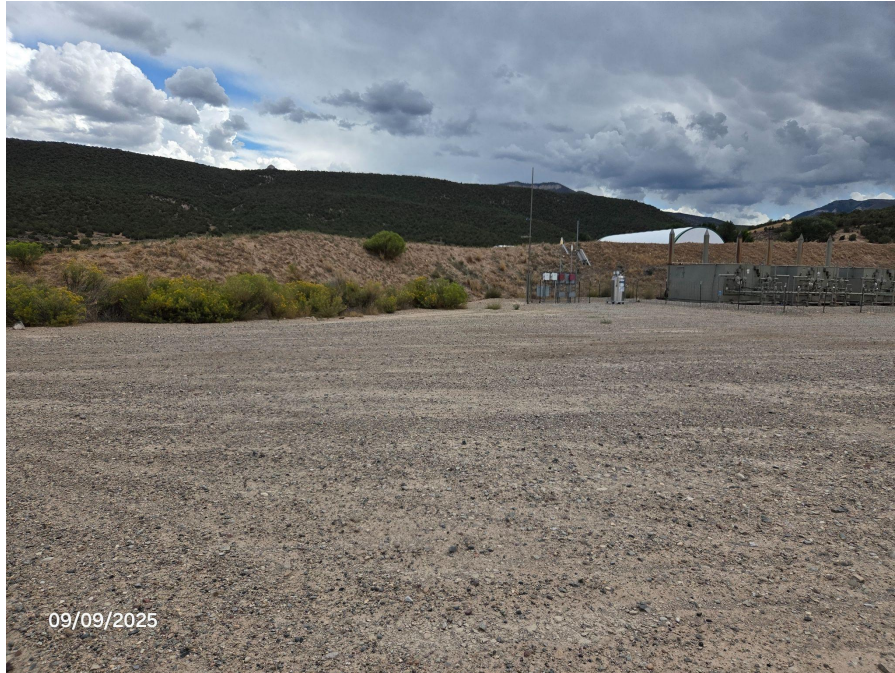
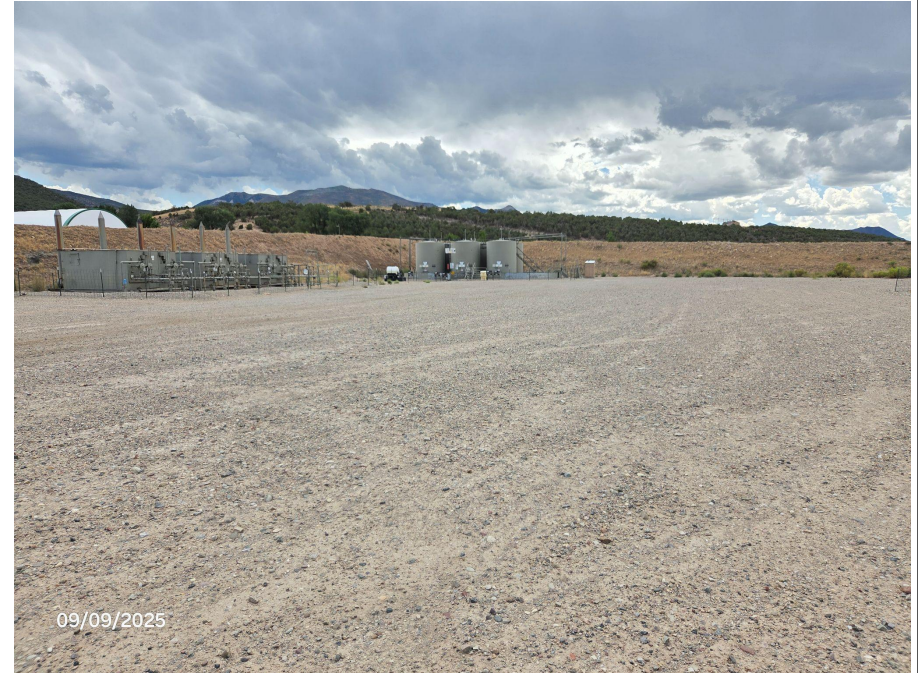
Photo 1: Photos 1-2 taken from the north end of the Location. Photos provide an overview of the Location from east, southeast, southwest to west.

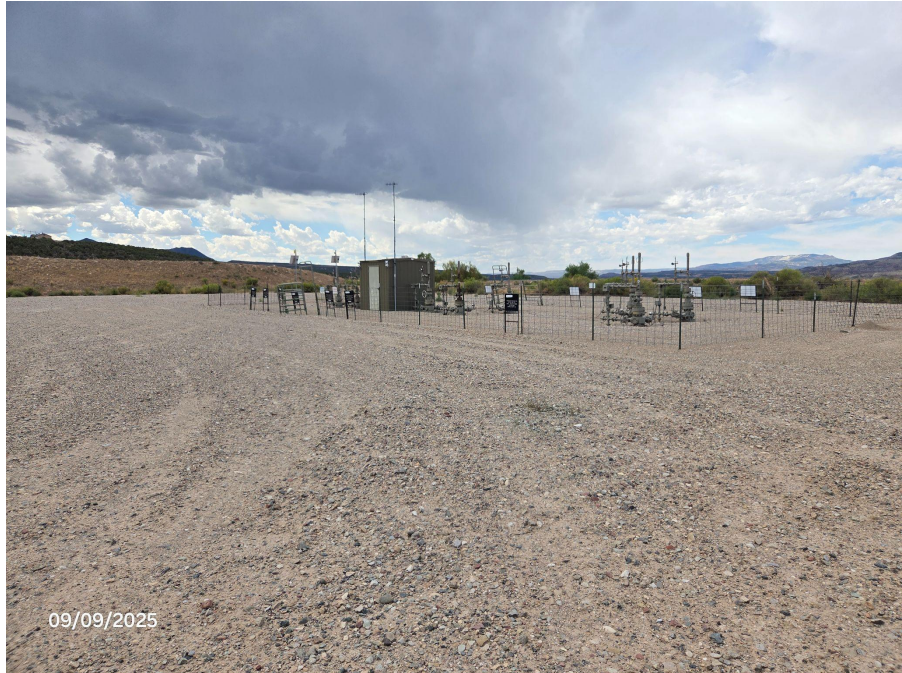
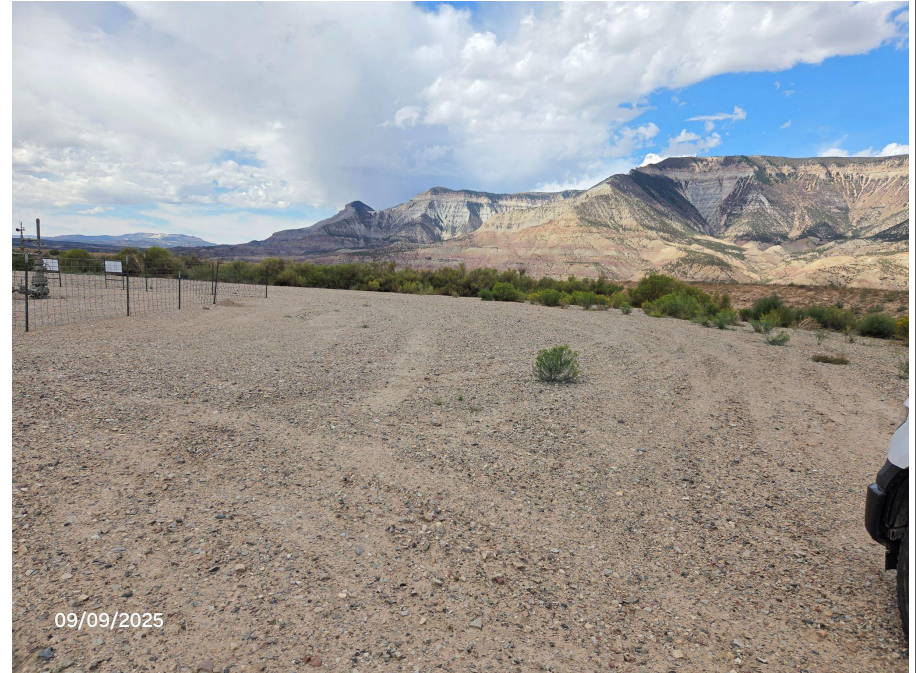
Photo 2: See comments under photo 1.

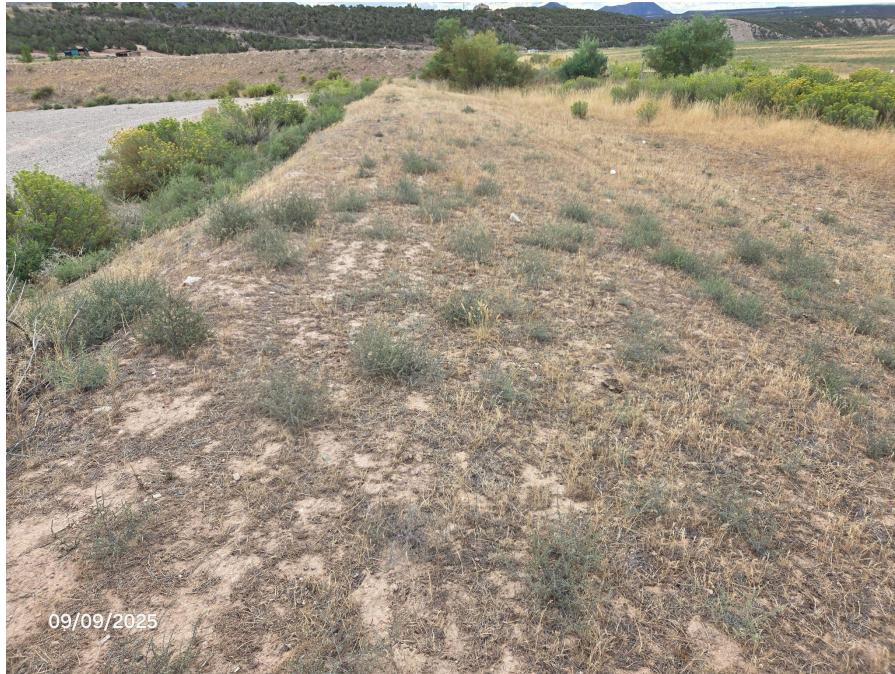
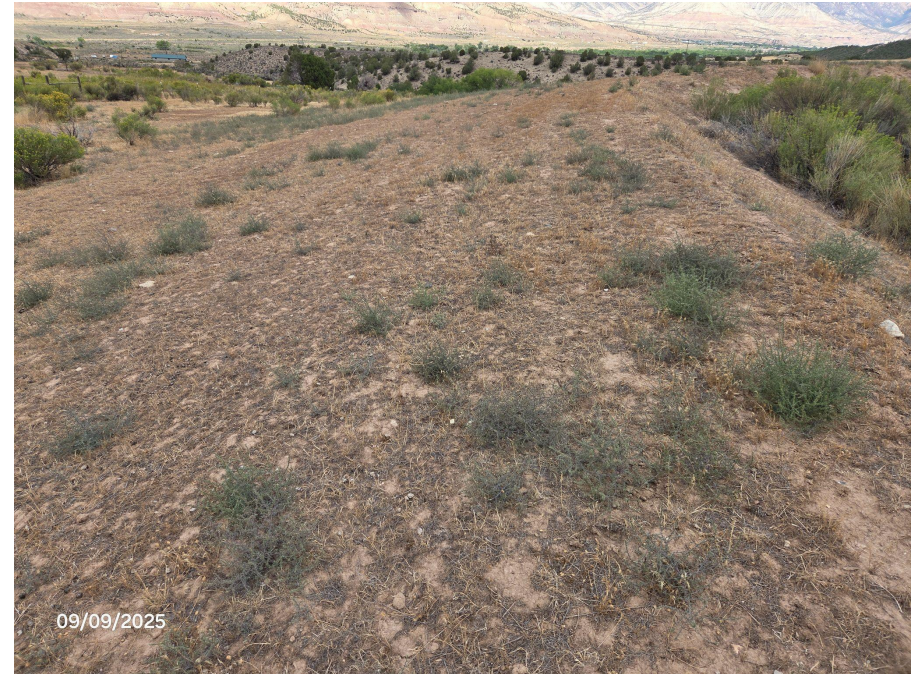
Photo 3: Photos taken from the interim areas on the west end of the Location, facing south and north respectively. Photos examples showing interim areas of the Location are not progressing towards 1003.e standards; vegetation is predominantly Undesirable Plant Species such as Cheatgrass, Annual Wheatgrass and Russian thistle. Desirable perennial vegetative establishment (predominantly Crested Wheatgrass) is sparse.

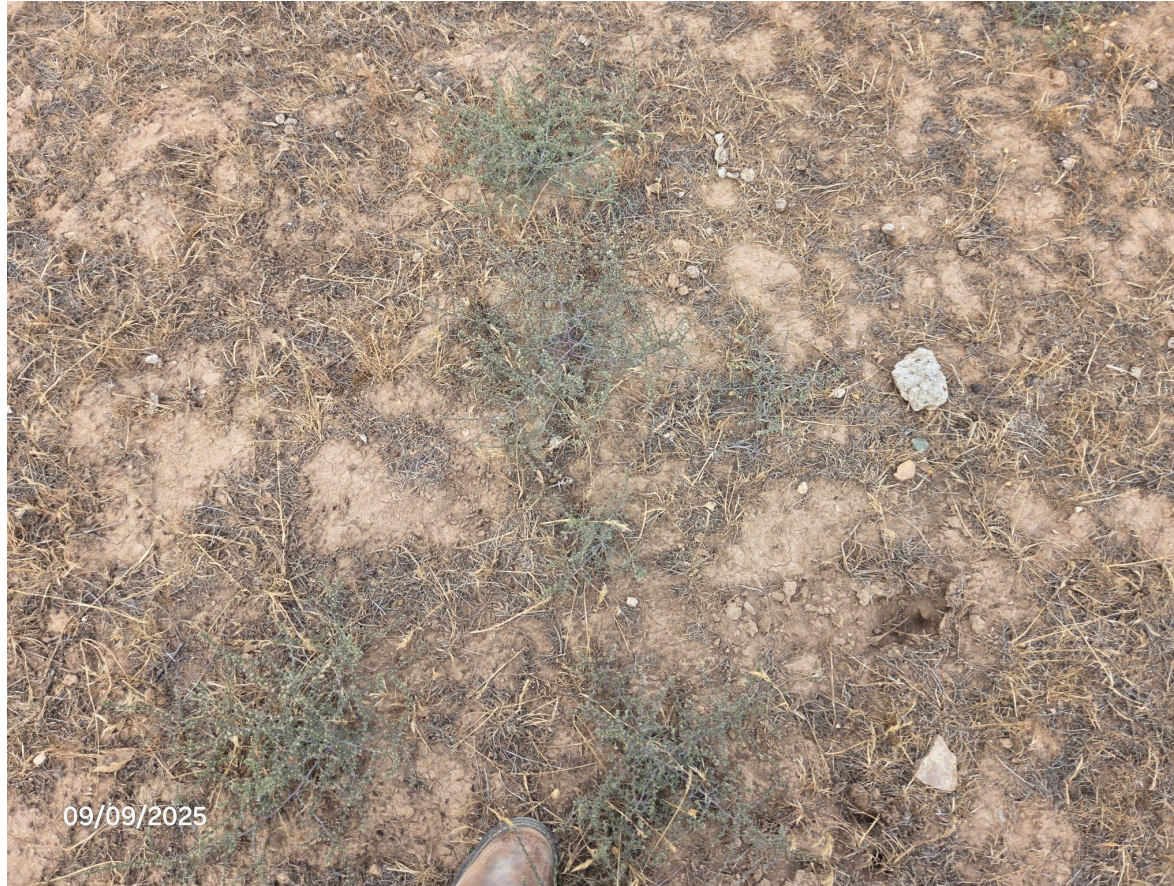
Photo 4: Continued from photo 3. Photo example showing vegetation within the interim areas are predominantly Undesirable Plant Species such as Cheatgrass, Annual Wheatgrass and Russian thistle. Desirable perennial vegetative establishment (predominantly Crested Wheatgrass) is sparse.

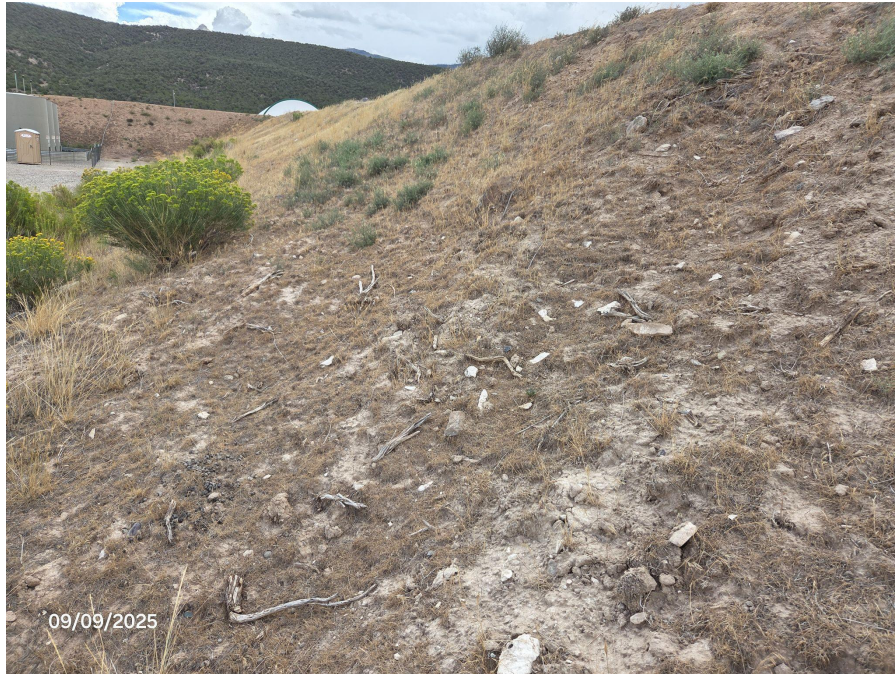
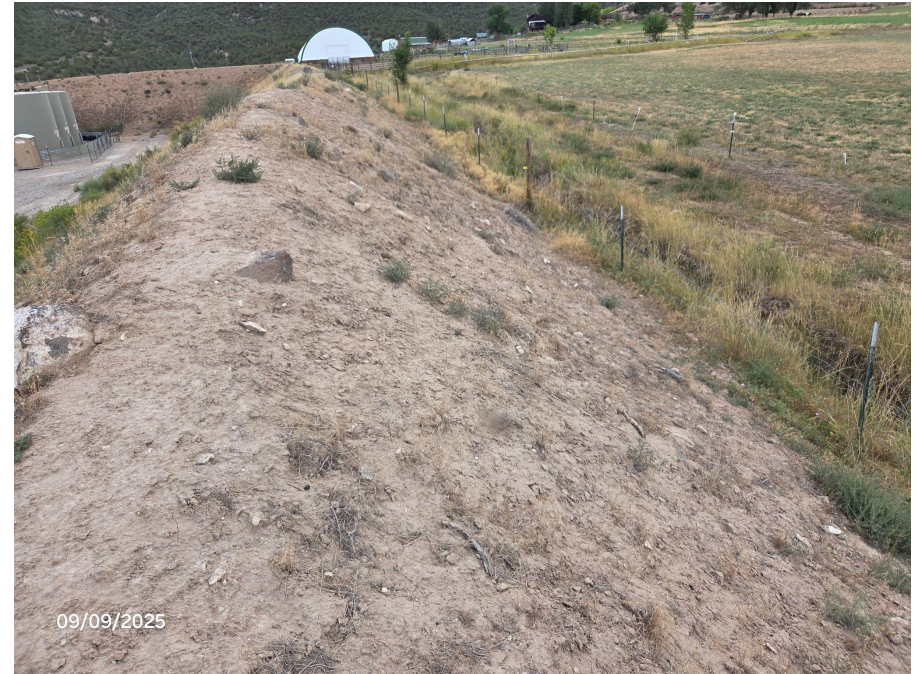
Photo 5: Photos taken from interim areas/slopes on the south end of the Location, facing east. Slopes on the Location are largely bare, and vegetation is predominantly Undesirable Plant Species such as Cheatgrass, Annual Wheatgrass and Russian thistle.

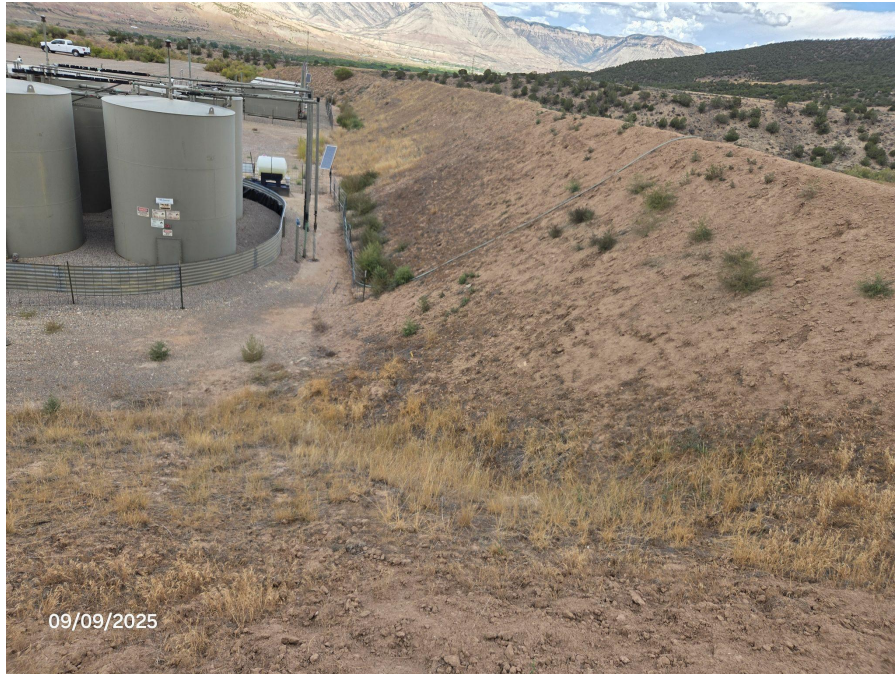
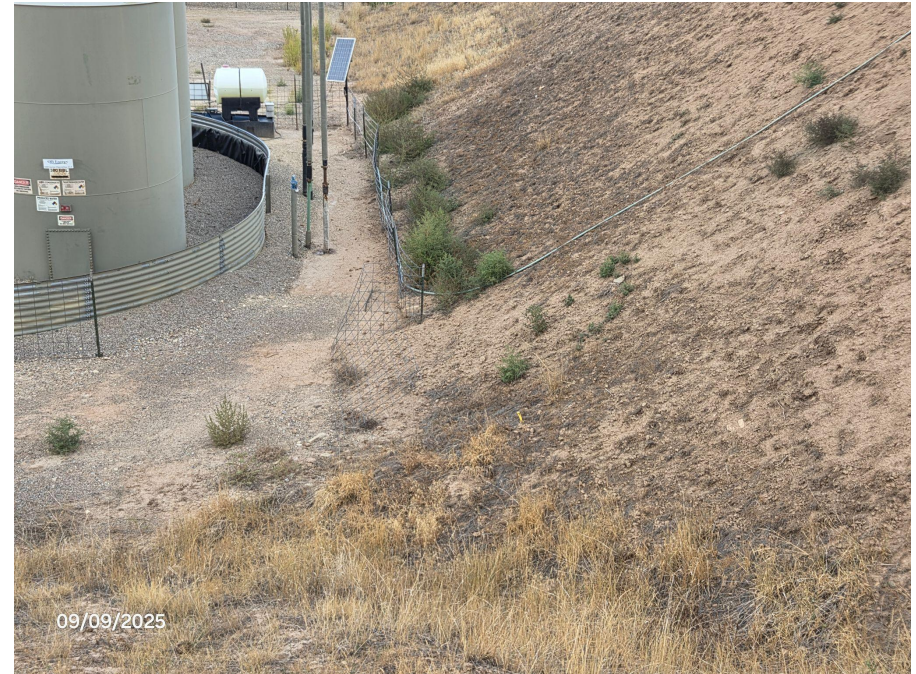
Photo 6: Photos taken from interim areas/slopes on the southeast end of the Location, facing north. Slopes on the Location are largely bare, and vegetation is predominantly Undesirable Plant Species such as Cheatgrass, Annual Wheatgrass and Russian thistle. Photo right also show sediment deposition due to sediment transport.

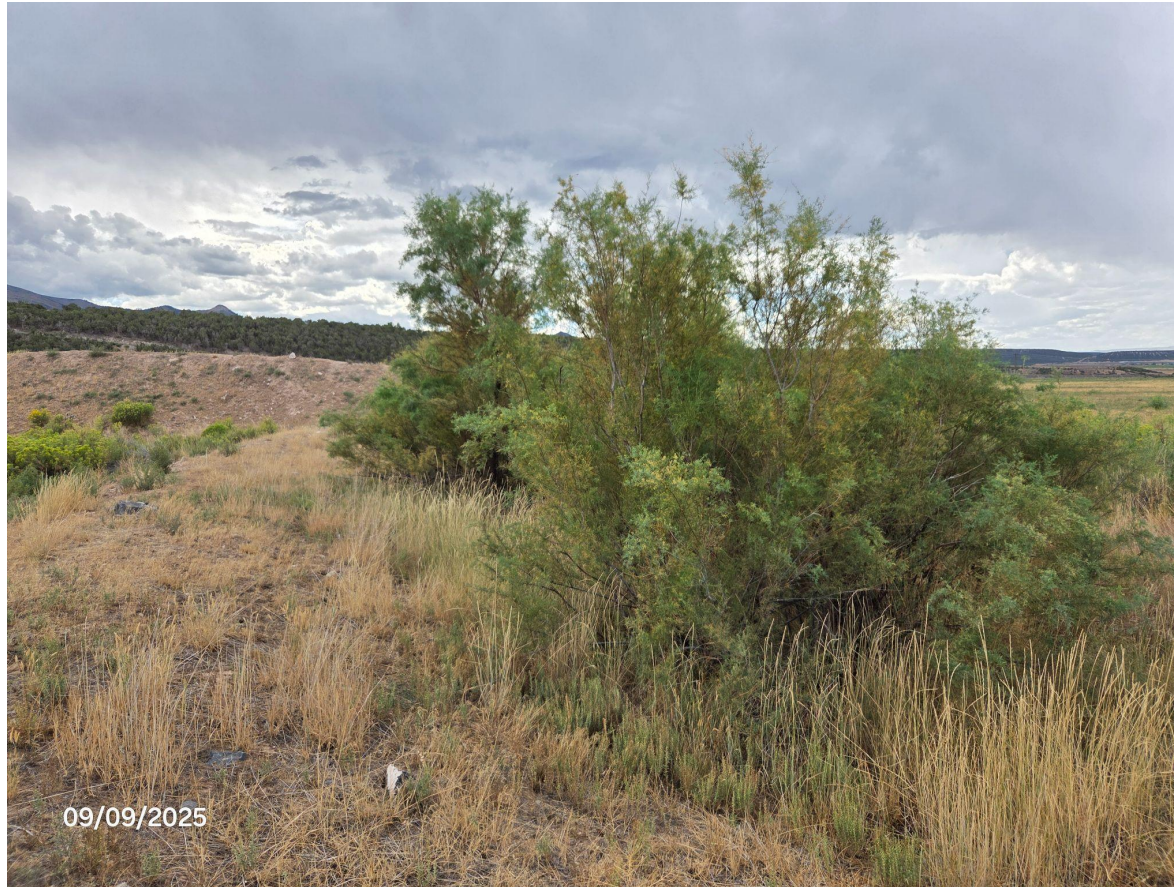
Photo 7: Photo taken from the interim areas on the southwest end of the Location. Photo shows Salt Cedar (*Tamarix. sp.*) establishment within interim areas of the Location.

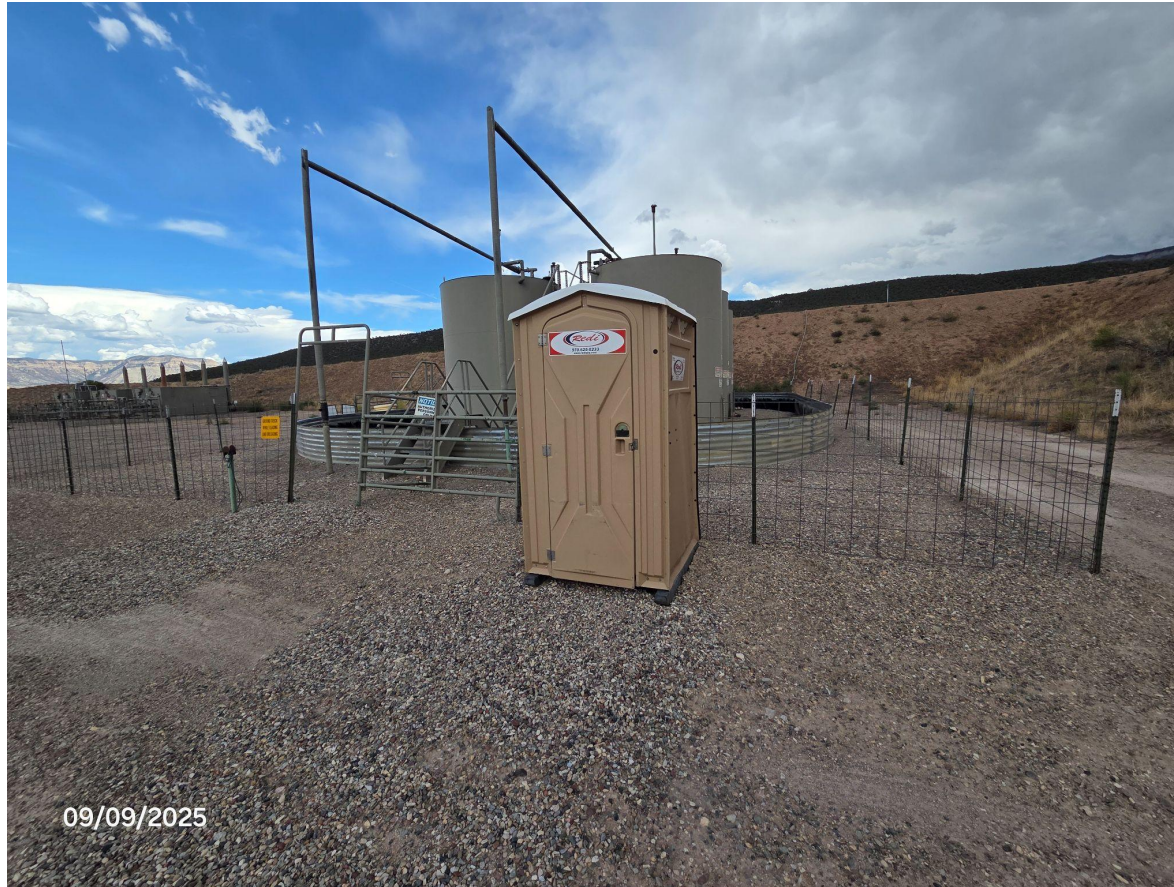
Photo 8: Photo taken from the southwest end of the working pad surface, facing east. Photo shows port-john on Location; sanitary facility has not been physically secured pursuant to Rule 602.m requirements.

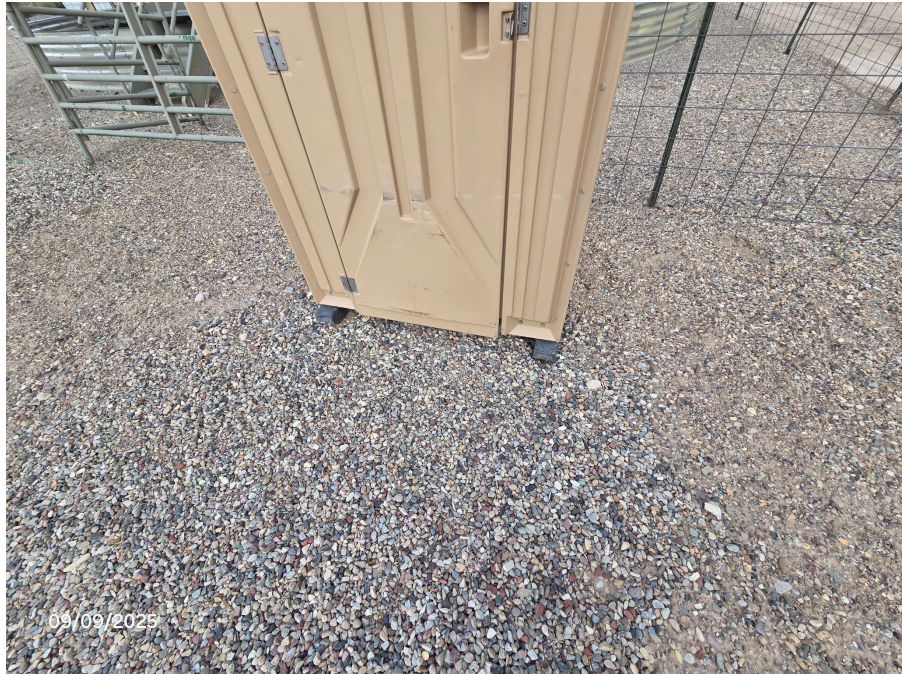
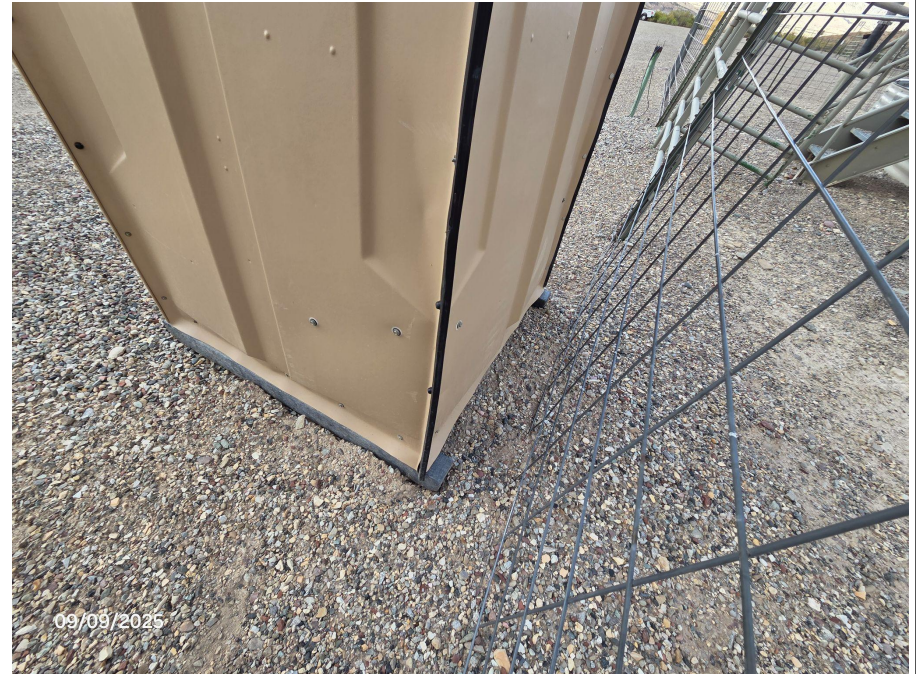
Photo 9: See comments under photo 8.

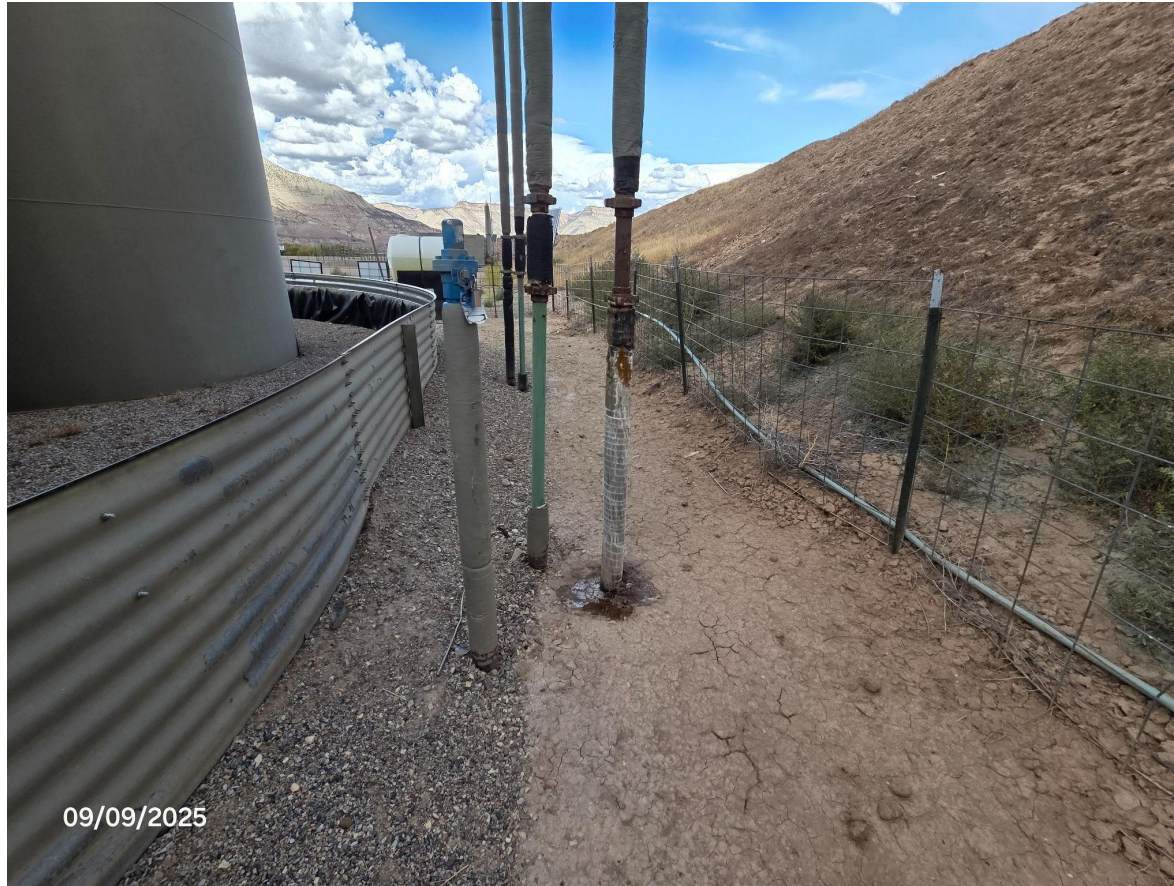
Photo 10: Photo taken from the east end of the battery facility, facing north. Photo shows line at the facility appears to be leaking. Maintenance required; spill requires cleaning.

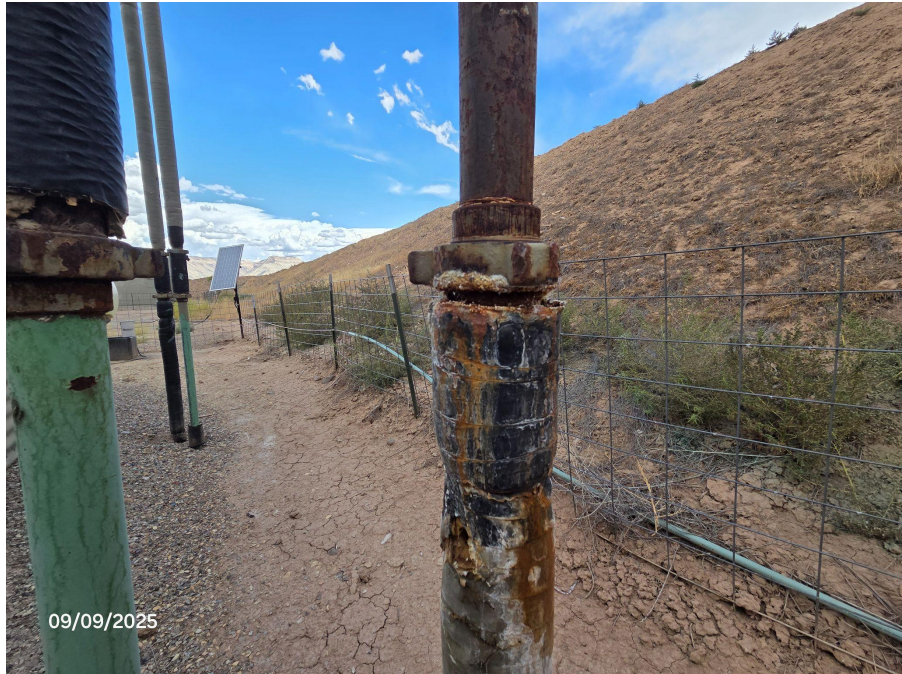
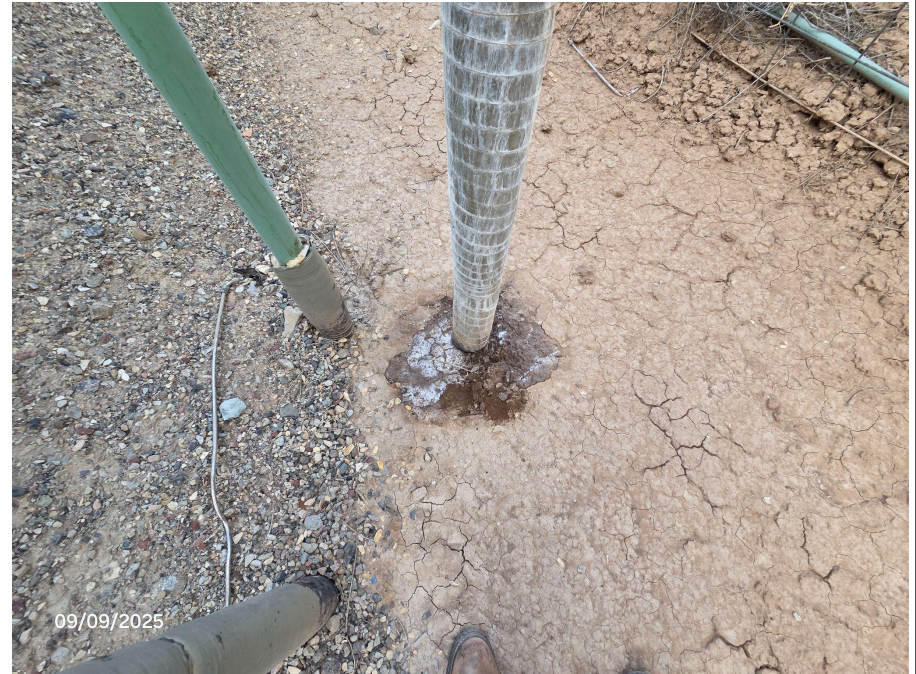
Photo 11: Continued from photo 10. Photos show line at the facility appears to be leaking. Maintenance required; spill requires cleaning.
