Third Party Flowline Abandon in place Witness Letter

Rasmussen 12-28

Client: Crestone Peak Resources Operating LLC

Facility Name: Rasmussen 12-28

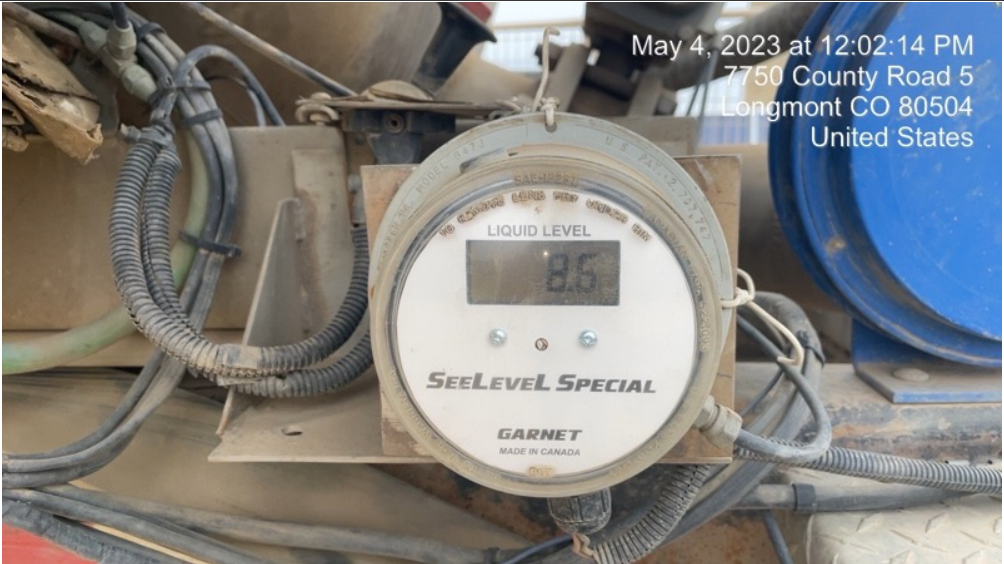
Information		Photo
Photo #: Location: Description:	3 End B at separator Meter on vacuum truck prior to flushing activity

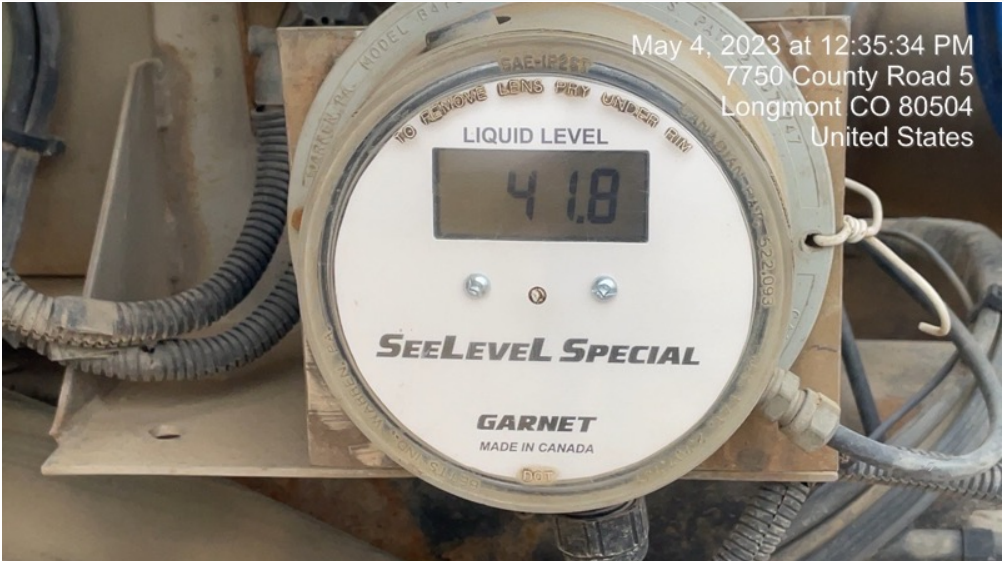
<p>May 4, 2023 at 12:02:14 PM 7750 County Road 5 Longmont CO 80504 United States</p>
Photo #: Location: Description:	4 End B at separator Meter on vacuum truck
