Final Reclamation Inspection

Location ID: 327743

Inspection Document #: 718800782

Weld County, CO

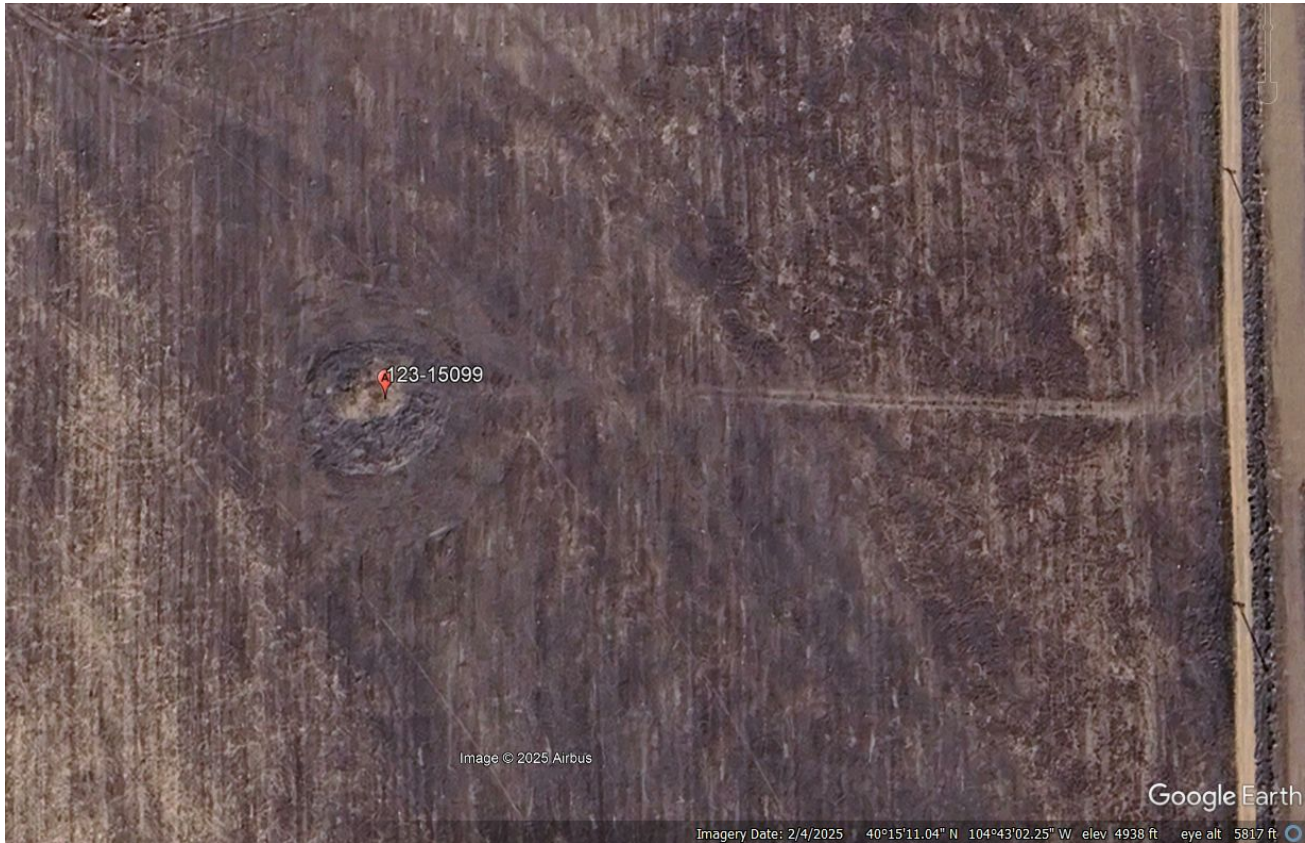
Photo 2. Google Earth Aerial Imagery from February 4, 2025 depicting the well location and access road after plugging operations.

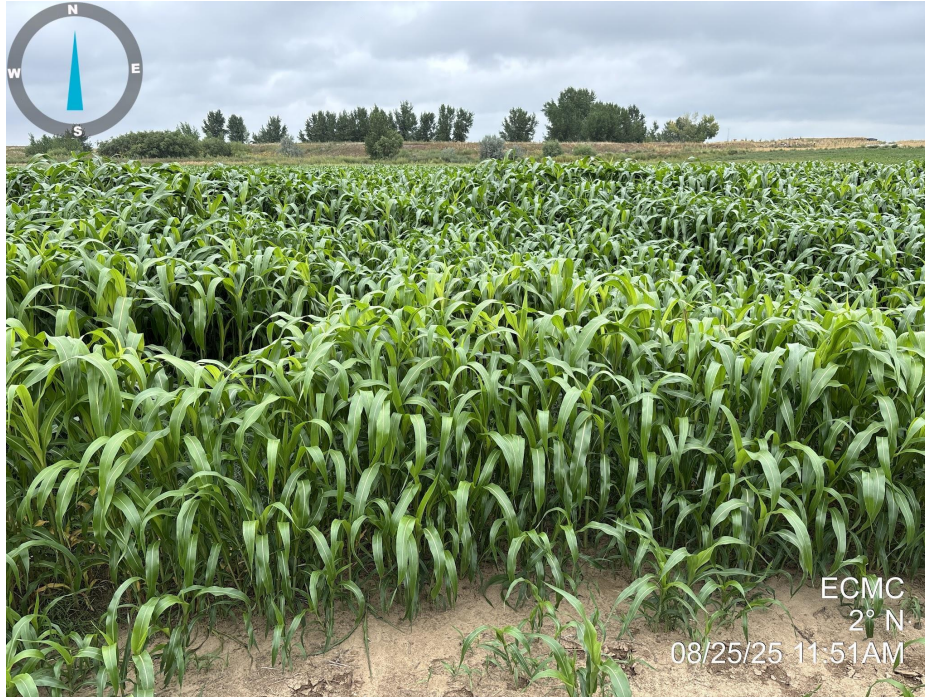
Photo 3. Photo taken of the well location, facing north. Photo illustrates that vegetation establishment does not meet Rule 1004 standards and bare ground remains at the location.

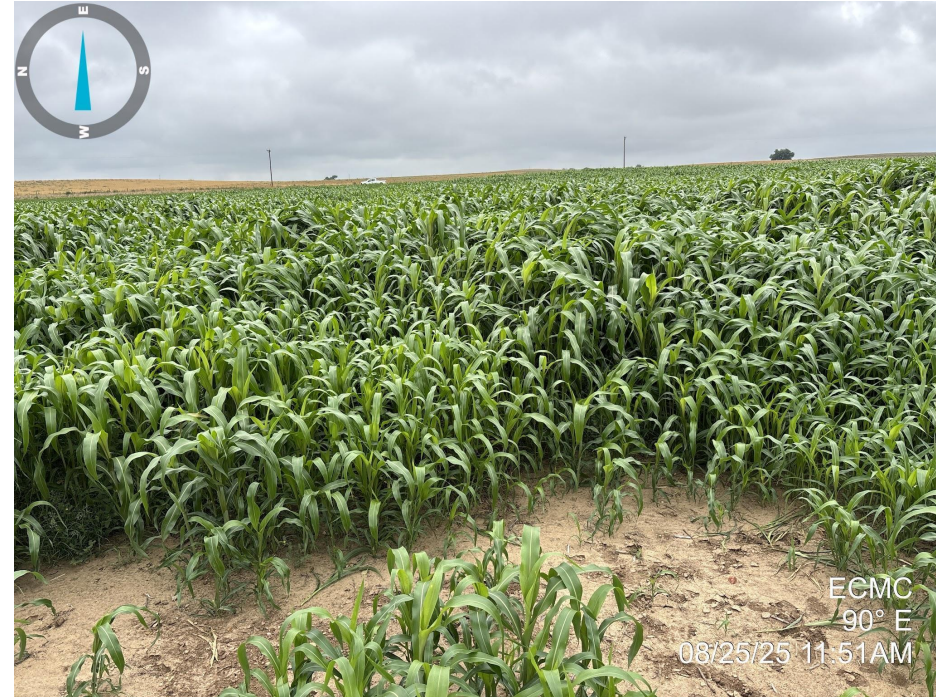
Photo 4. Photo taken of the well location, facing east. See comments under Photo 3.

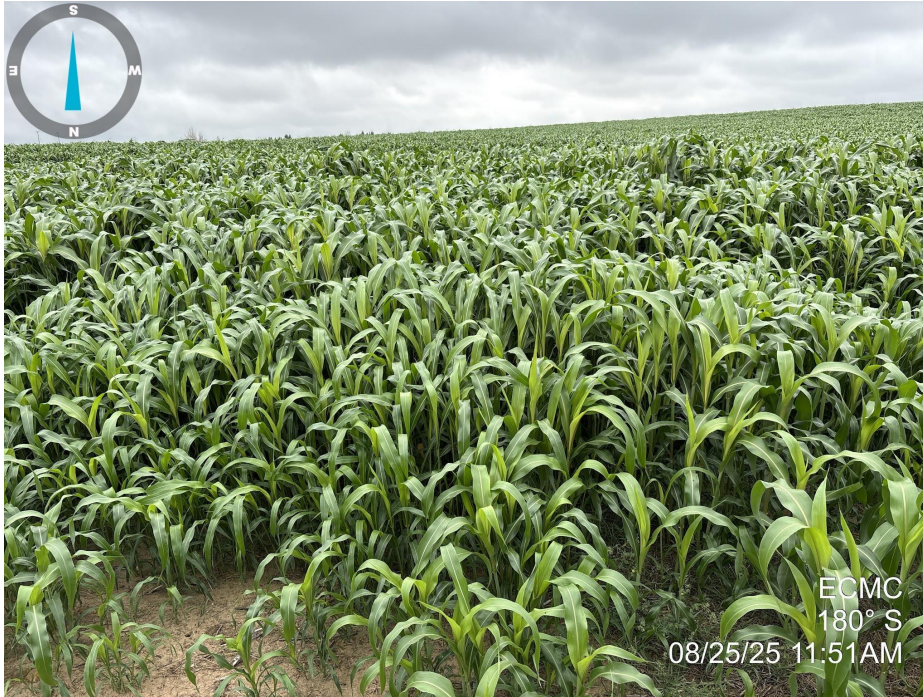
Photo 5. Photo taken from the well location, facing south. See comments under Photo 3.

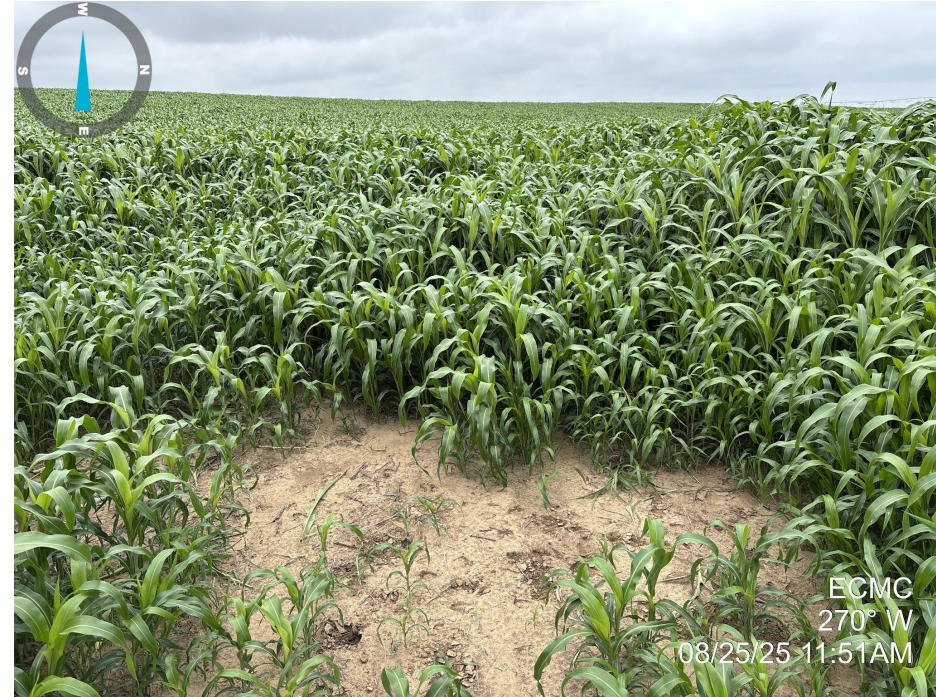
Photo 6. Photo taken from the well location, facing west. See comments under Photo 3.

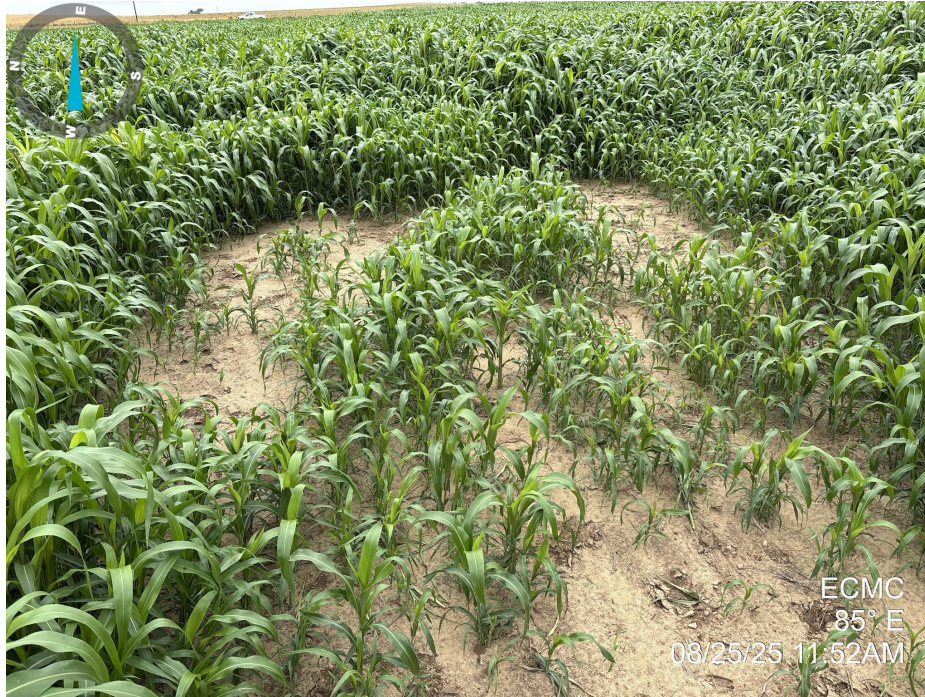
Photo 7. Photo taken from the well location, facing east. See comments under Photo 3.

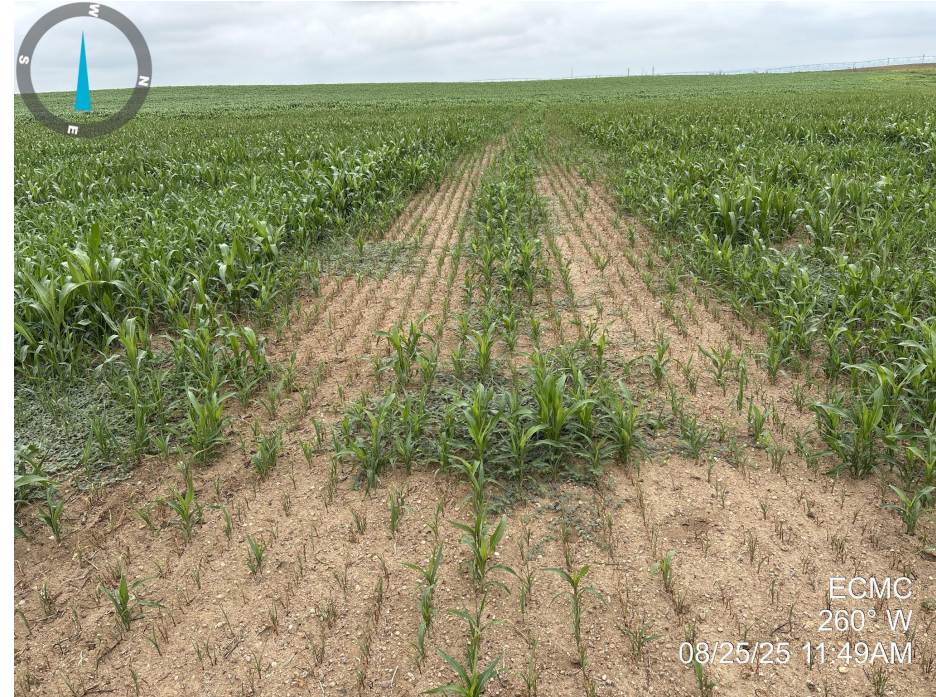
Photo 8. Photo taken of the access road to the well location, facing west, towards the location. Photo illustrates that vegetation has not established to Rule 1004 standards, gravel remains, and weedy annual vegetation including puncture vine (*Tribulus terrestris*) was observed across the road.

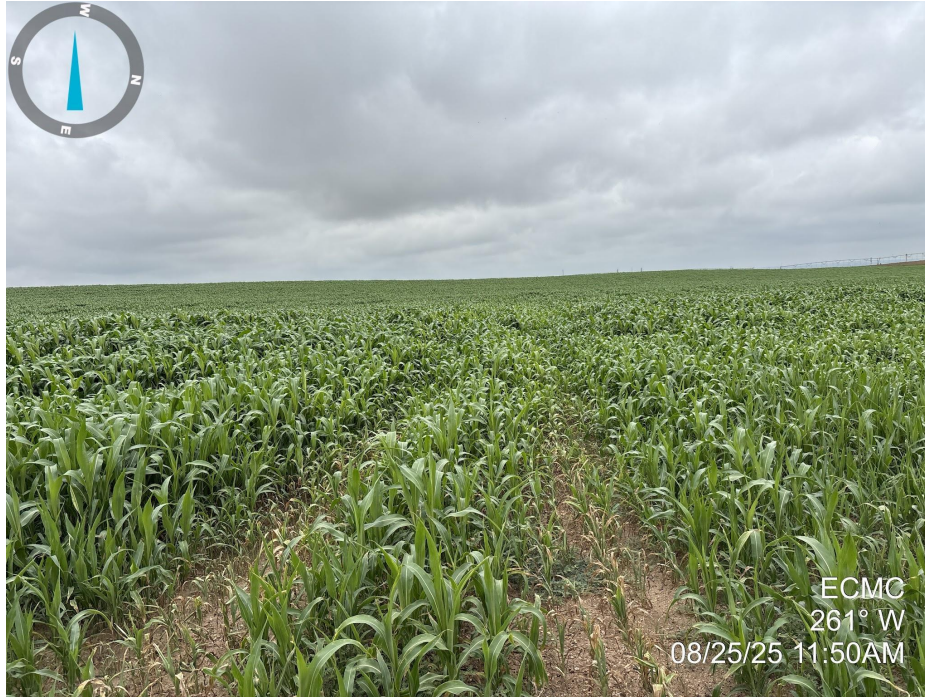
Photo 9. Photo taken of the access road to the well location, facing west, towards the location. See comments under Photo 8.

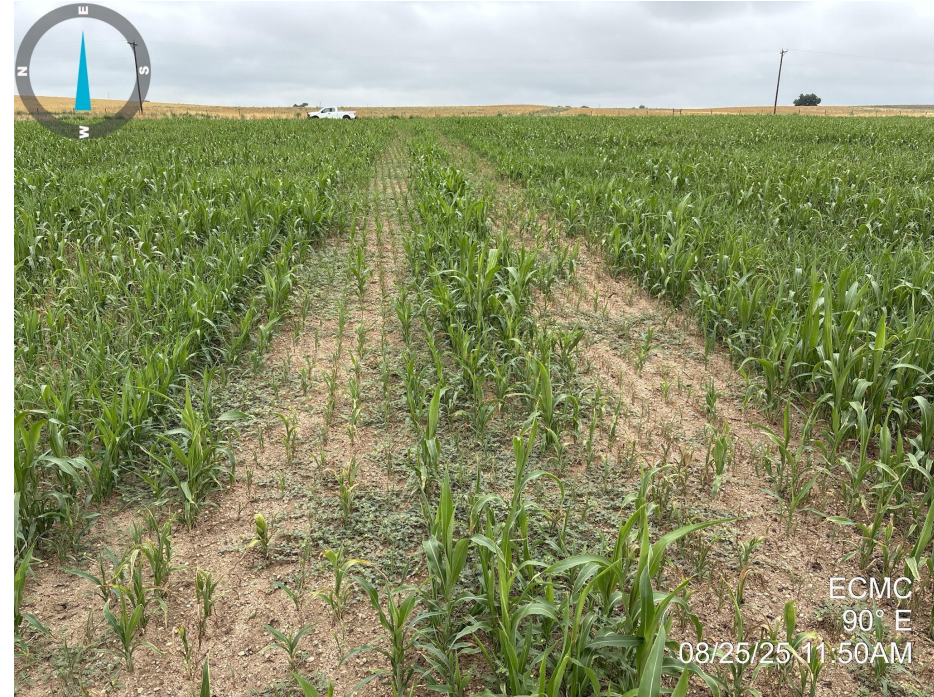
Photo 10. Photo taken of the access road to the well location, facing east, away from the location. See comments under Photo 8.

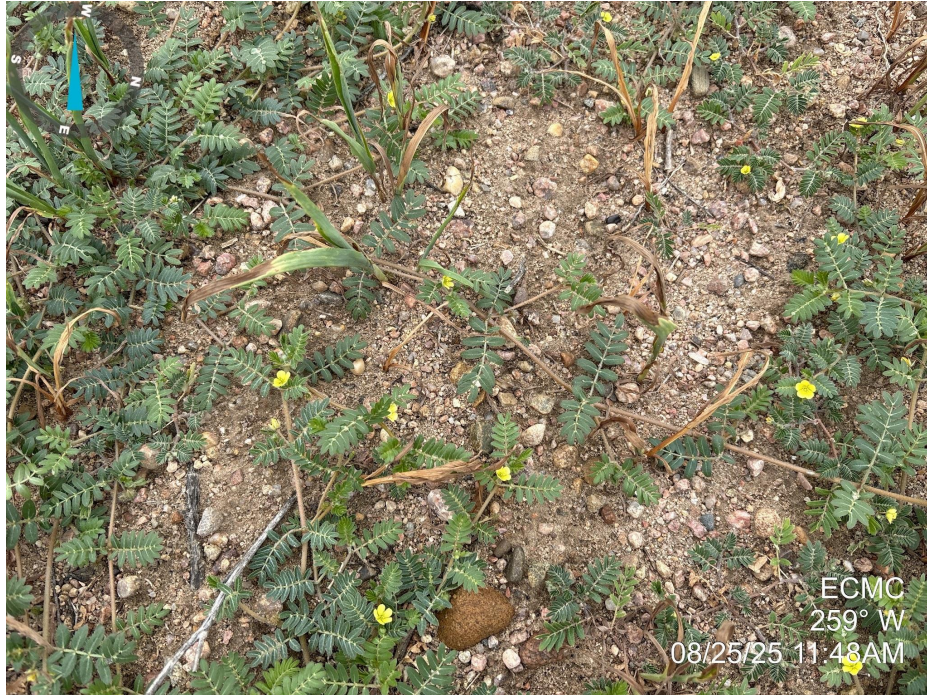
Photo 11. Photo taken of ground cover along the access road. Photo illustrates gravel and puncture vine (*Tribulus terrestris*), a List C Noxious Weed species.

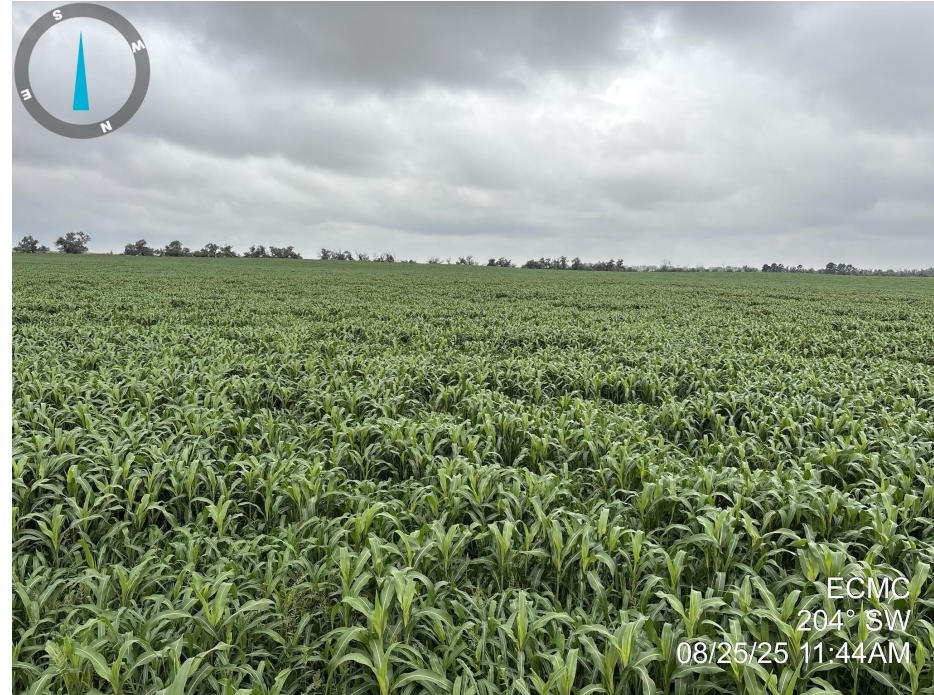
Photo 12. Photo taken of the reference area, southwest of the location, facing southwest. Photo illustrates corn cropland.
