Final Reclamation and Stormwater Inspection

Location ID: 317595

Well Name: ECHEVERRIA #1

Inspection Document #: 718600964

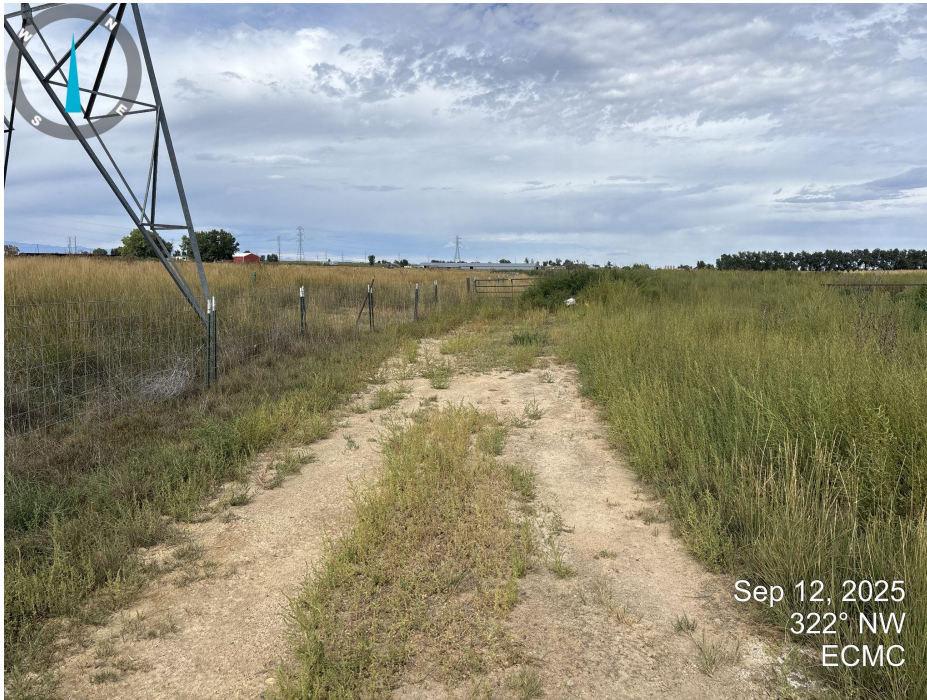
Photo 1. Looking north down the access road. Undesirable weeds such as kochia and russian thistle are present at the entrance of the access road.

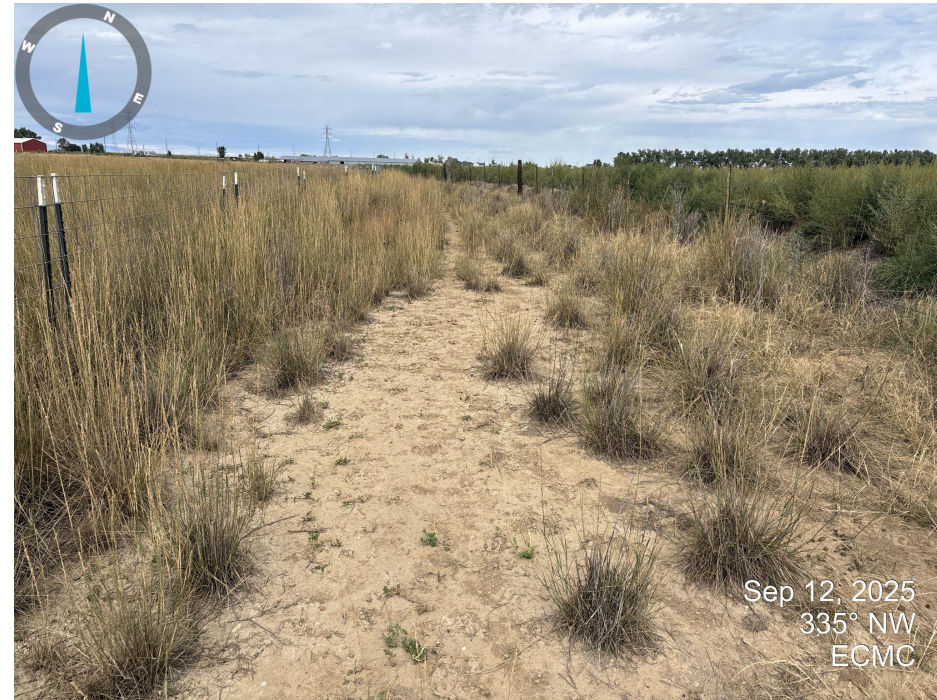
Photo 2. Photo taken around the midpoint of the access road. Some areas of the access road have less desirable vegetation coverage than surrounding reference area. List B noxious weed scotch thistle was present but dead at the time of inspection and may have been treated.

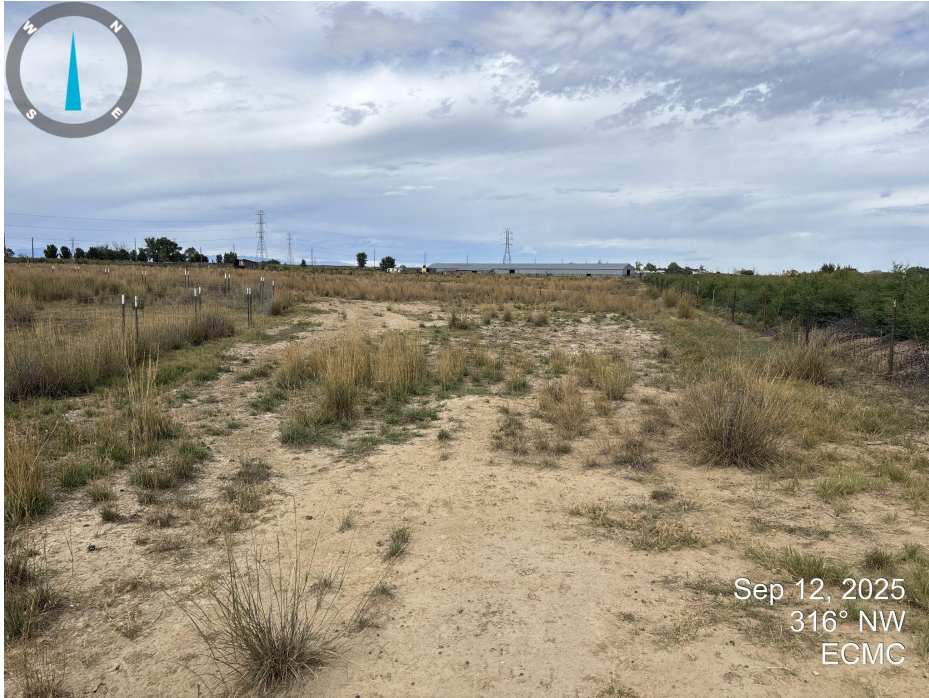
Photo 3. Photo taken near the entrance of the location. Areas of bare soil and lower vegetative coverage are present.

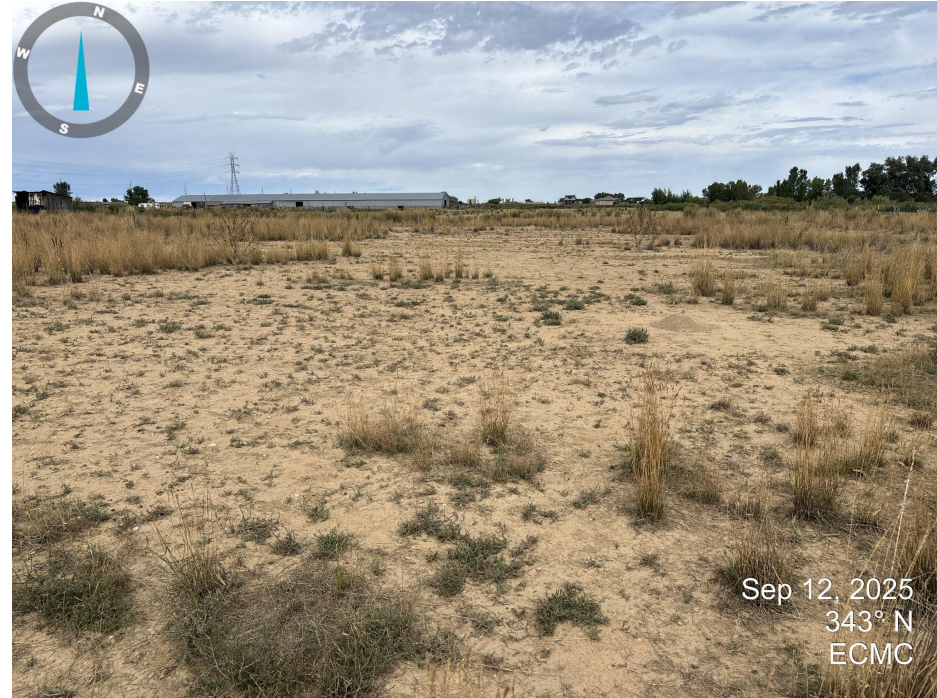
Photo 4. Looking north across the center of the location approximately where the separator was located. A patch of bare soil and undesirable weeds approximately 250 ft long is present. List B noxious weed scotch thistle is present on location, dead at the time of inspection.

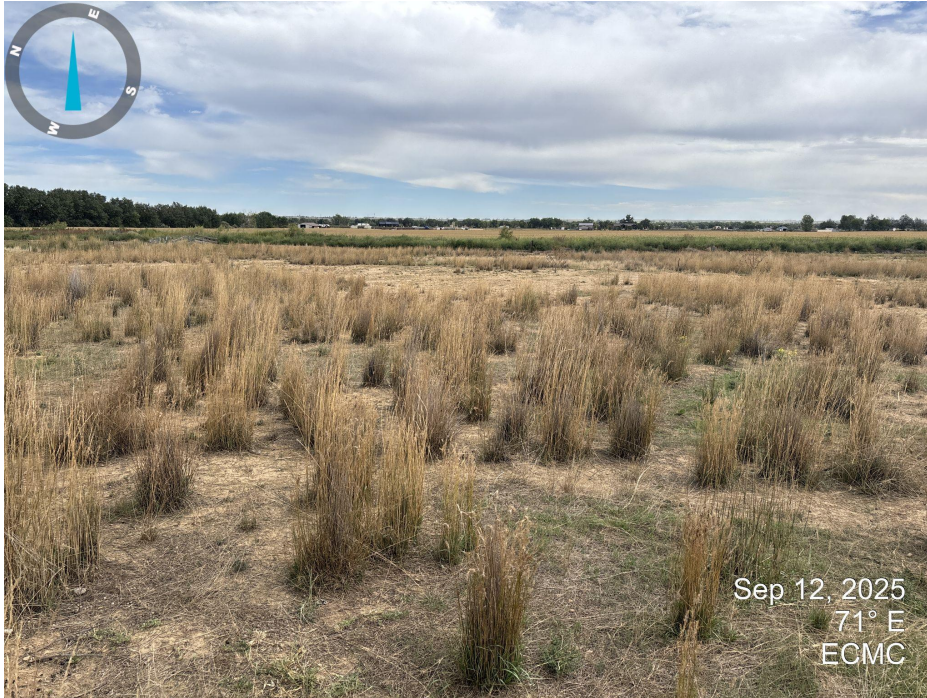
Photo 5. Looking east across the location from the tank battery area. Desirable plant species such as crested wheatgrass and intermediate wheatgrass are present on location but the density appears lower than the surrounding reference area.

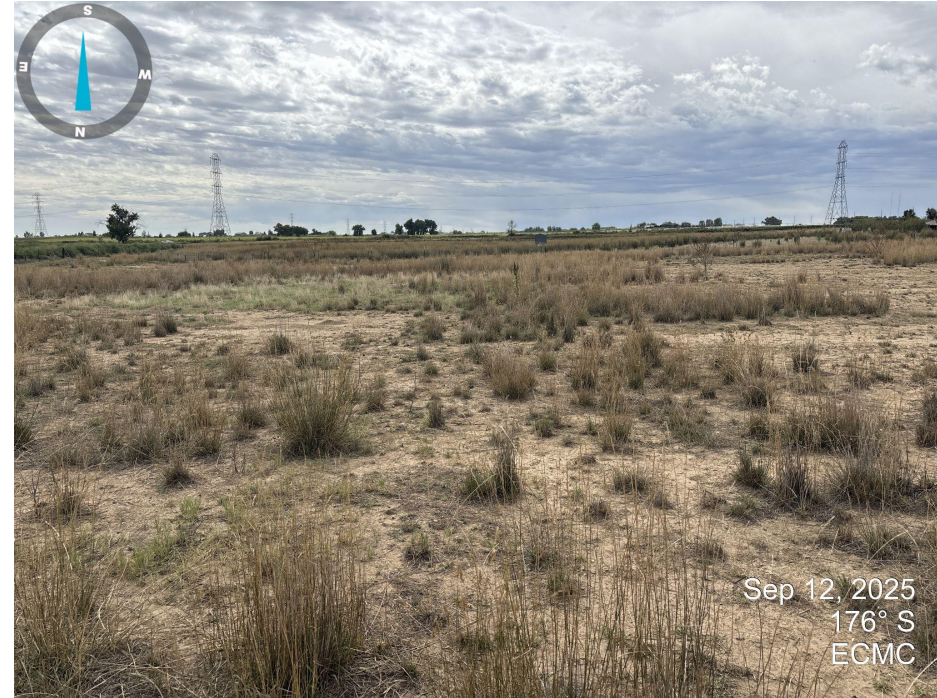
Photo 6. Looking south from the wellbore location. Vegetation on location does not appear uniform with bare soil patches present throughout the location. Undesirable weeds such as kochia, russian thistle and list C noxious weeds mullein, and field bindweed are present on location. Desirable vegetation is also present on location.

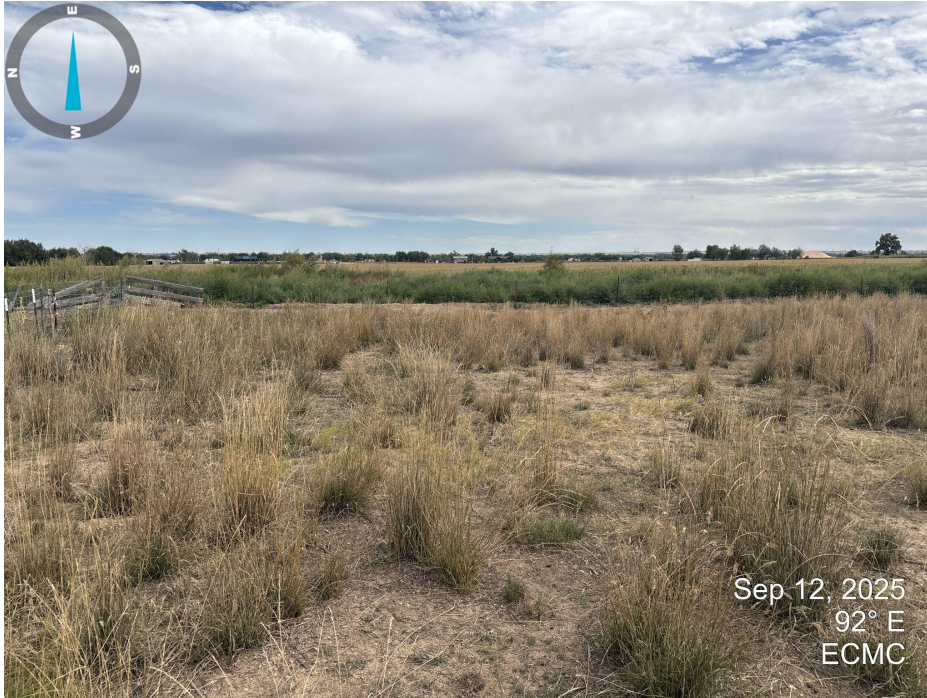
Photo 7. Looking east from the wellbore location. See photo 6 comments.

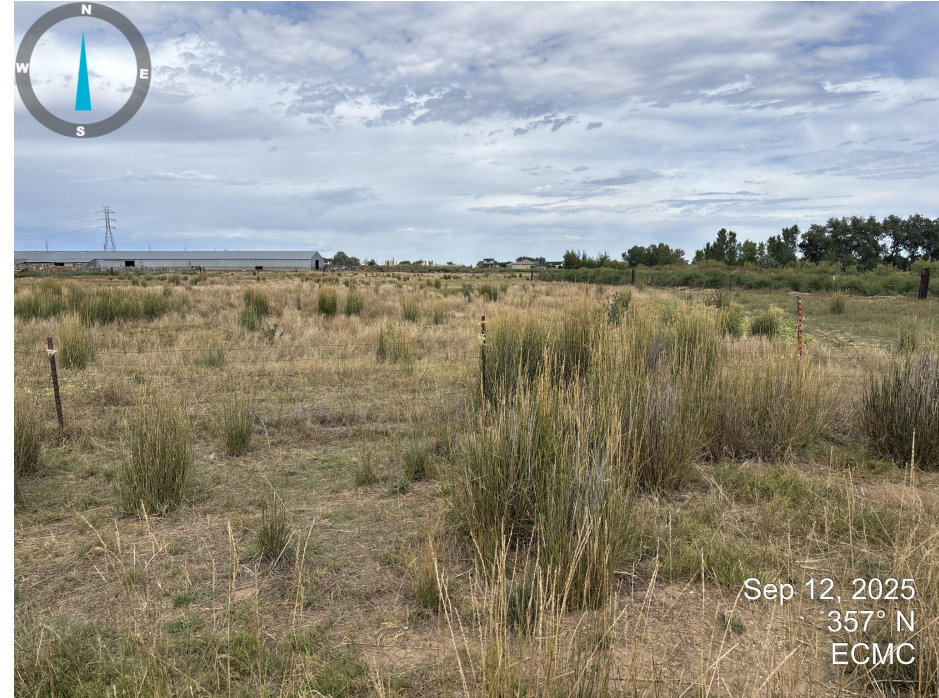
Photo 8. Looking north from the wellbore location. See photo 6 comments.

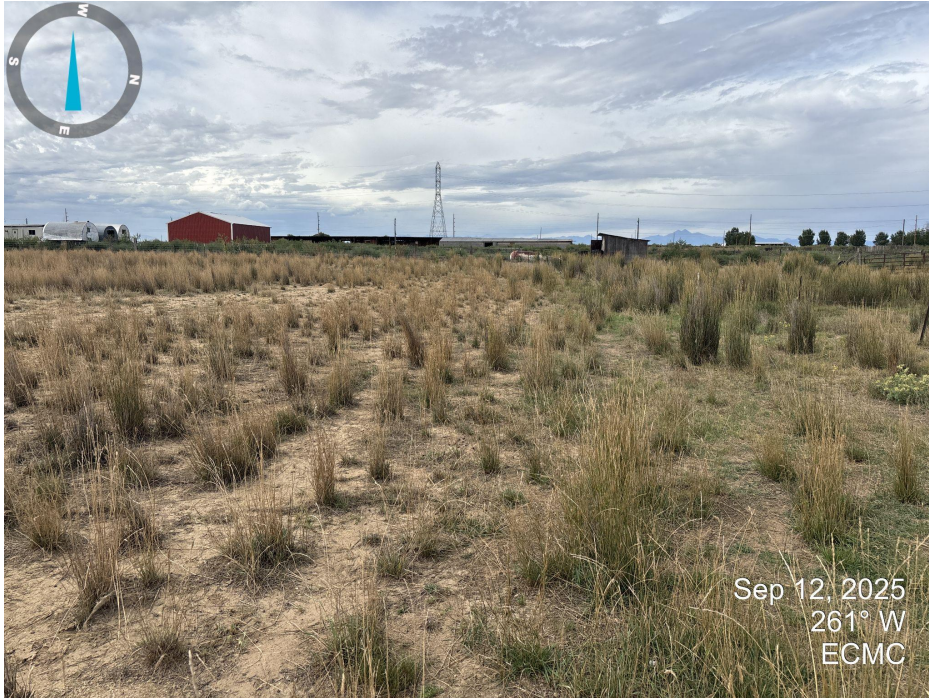
Photo 9. Looking west from the wellbore location. See photo 6 comments.

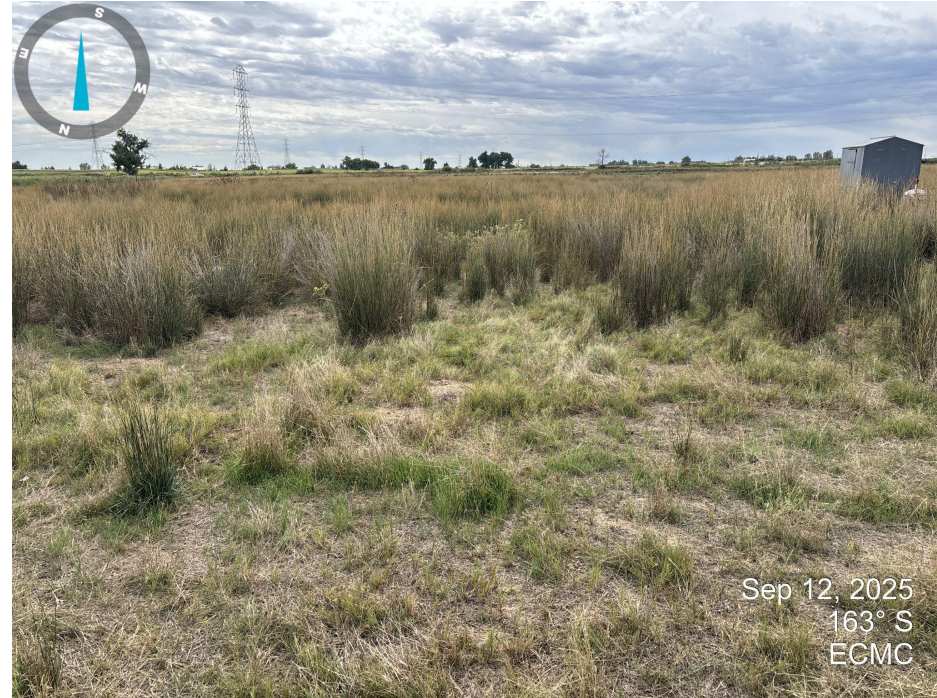
Photo 10. Reference area to the south of the location.
