Inspection Photos

API: 017-06480

Operator: **CITATION OIL & GAS CORP**

Inspection Date: 9/5/2025

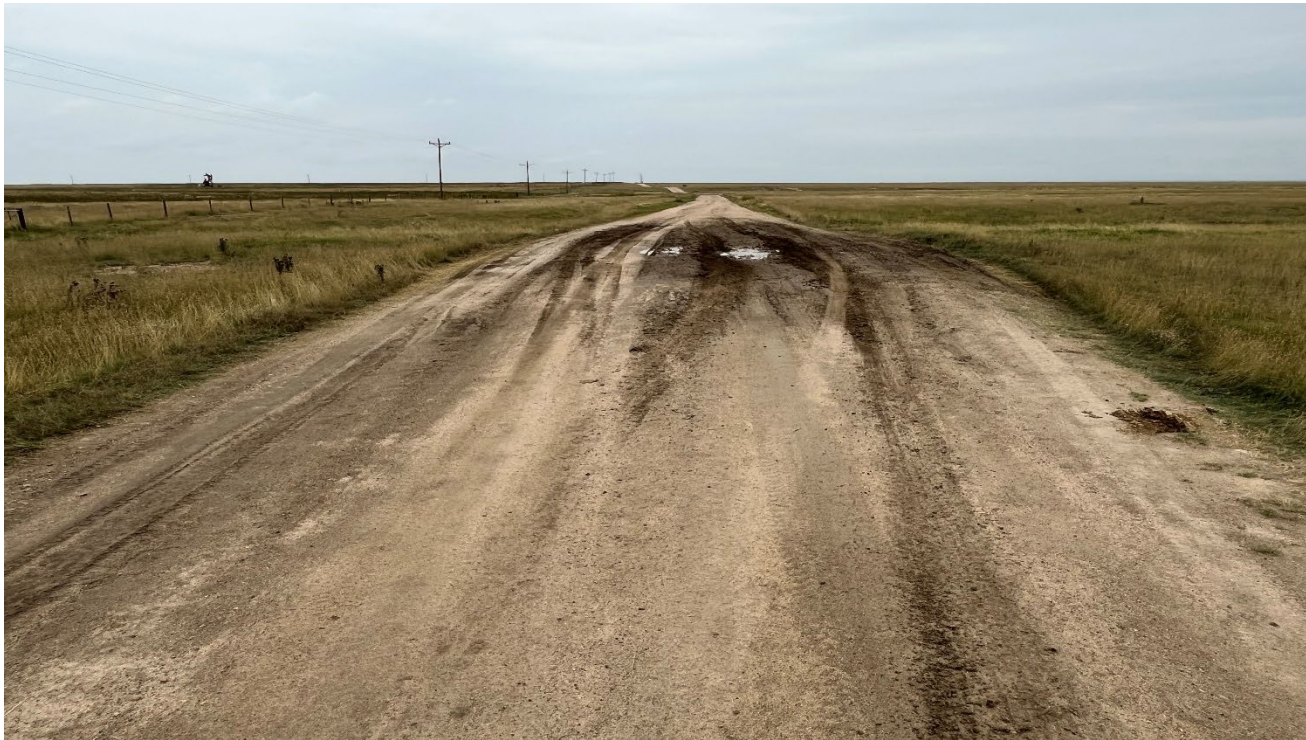
Photo 1. Facing east along the access road. Vehicles are causing unnecessary disturbance driving outside of the access road due to stormwater pooling on the road. The access road needs to be repaired and stabilized with BMP's.

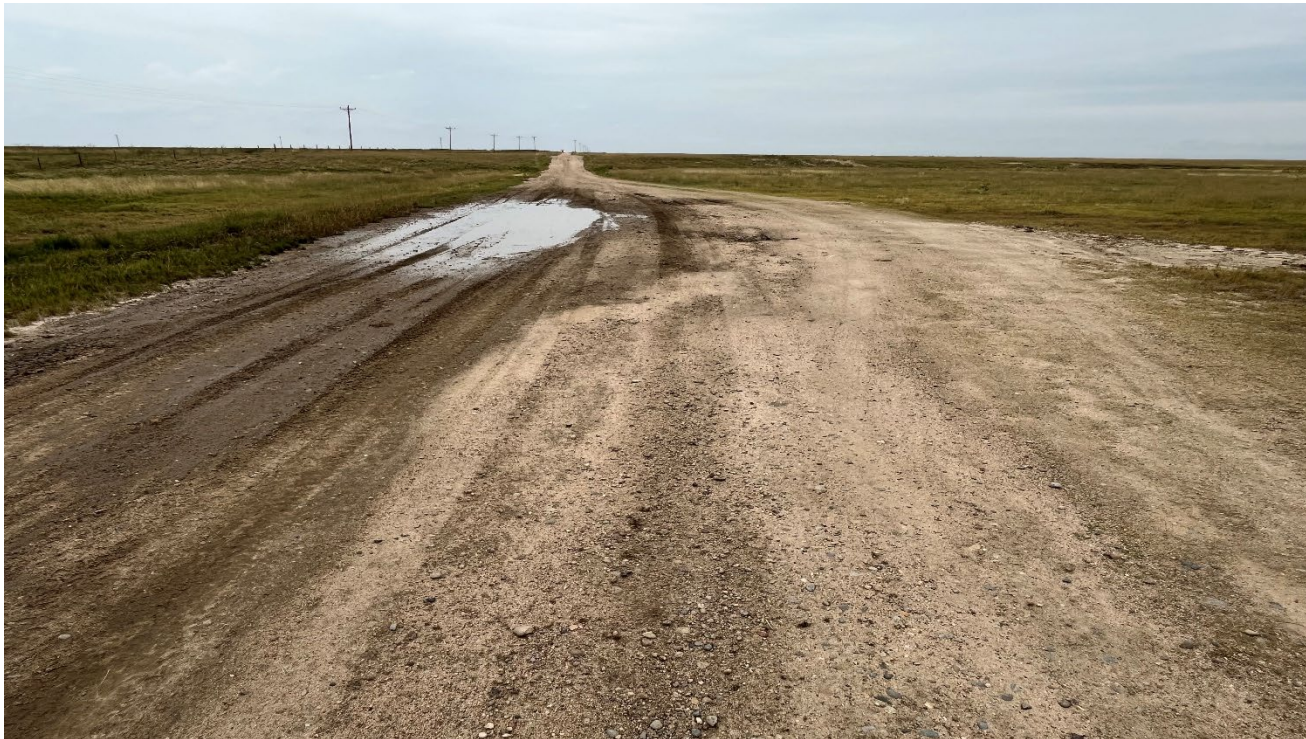
Photo 2. Facing east along the access road. Vehicles are causing unnecessary disturbance driving outside of the access road due to stormwater pooling on the road. The access road needs to be repaired and stabilized with BMP's. Areas of disturbance need to be reclaimed.

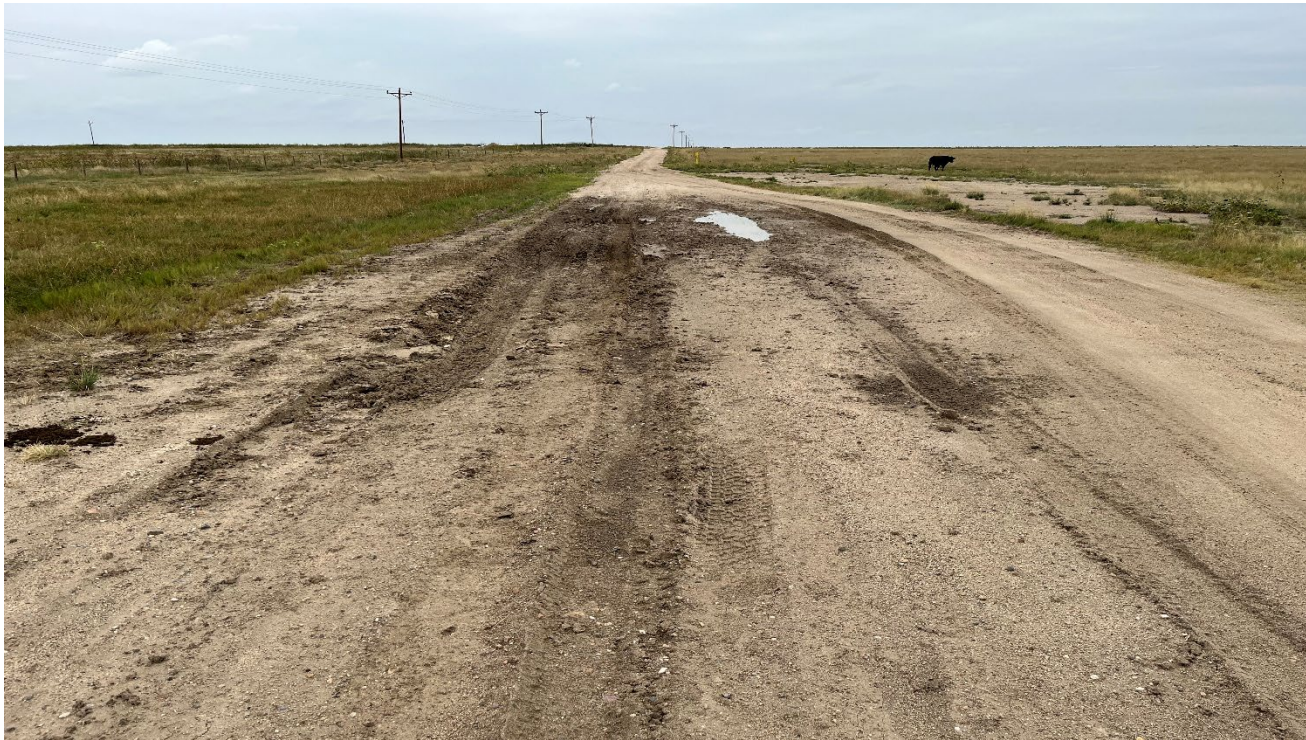
Photo 3. Facing east along the access road. Vehicles are causing unnecessary disturbance driving outside of the access road due to stormwater pooling on the road. The access road needs to be repaired and stabilized with BMP's.

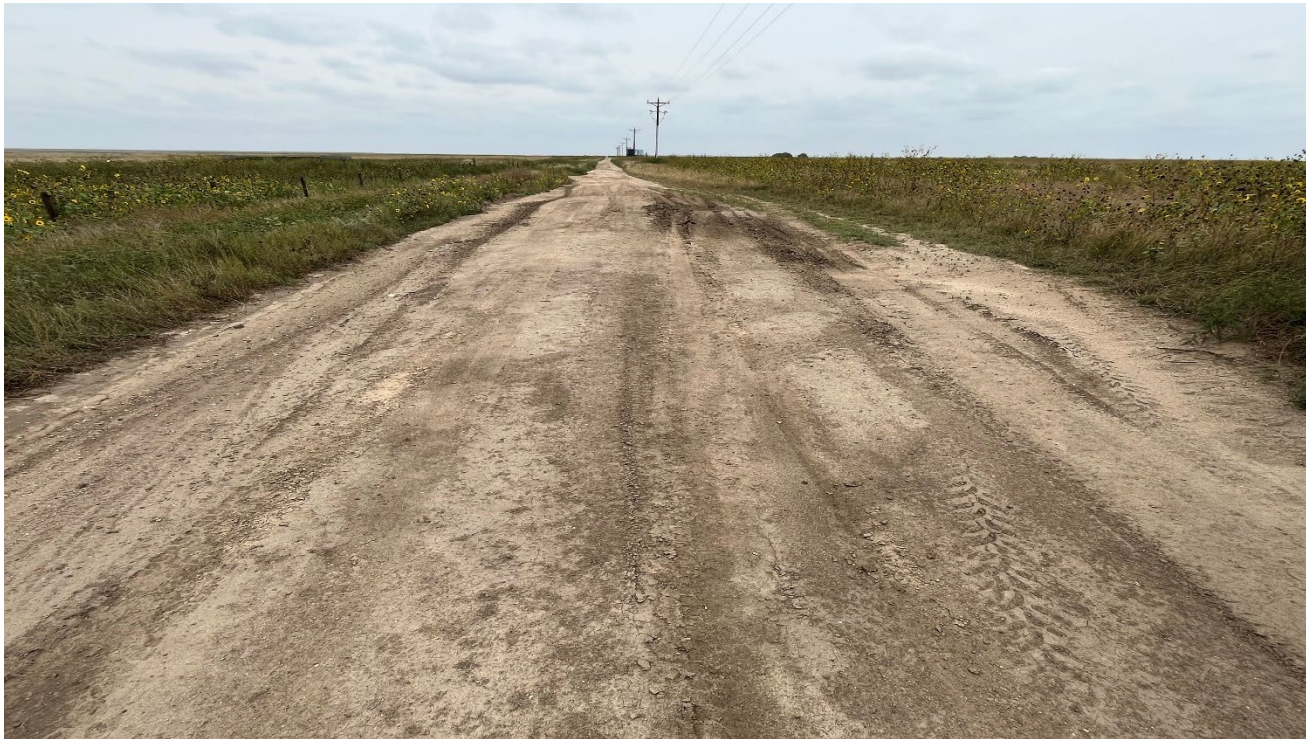
Photo 4. Facing north along the access road. Vehicles are causing unnecessary disturbance driving outside of the access road due to stormwater pooling on the road. The access road needs to be repaired and stabilized with BMP's.
