# Inspection Photos

**Operator:** PETROLEUM RESOURCE MANAGEMENT  
CORP - #10421

**Location ID:** 436485

Inspection Photos  
Location Name: WPU 36-1  
Location ID: 436485

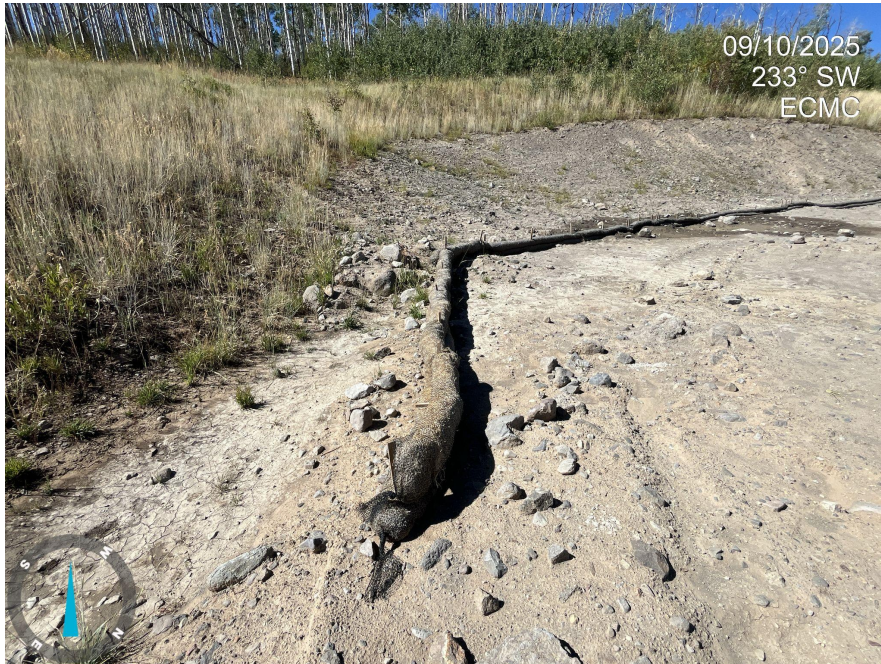
**Photo 1.** Photos 1-5 taken at the southeastern portion of the Location, near the cut slope where the cuttings waste was stored. Photos illustrate that stormwater BMPs are no longer functioning per good engineering practices. Stormwater has commingled with cuttings material and has moved onto the pad.

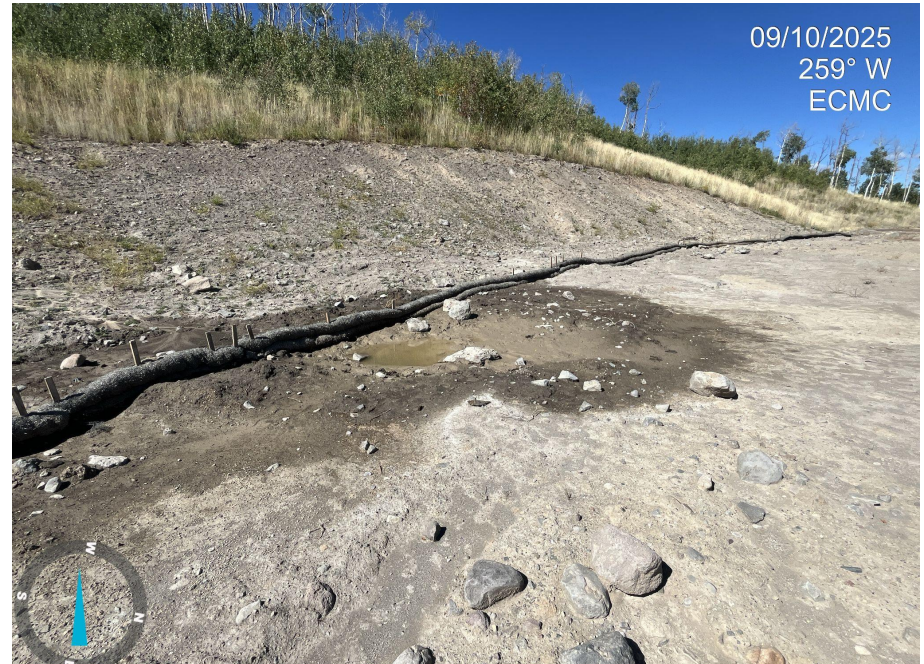
**Photo 2.** See comment under Photo 1.

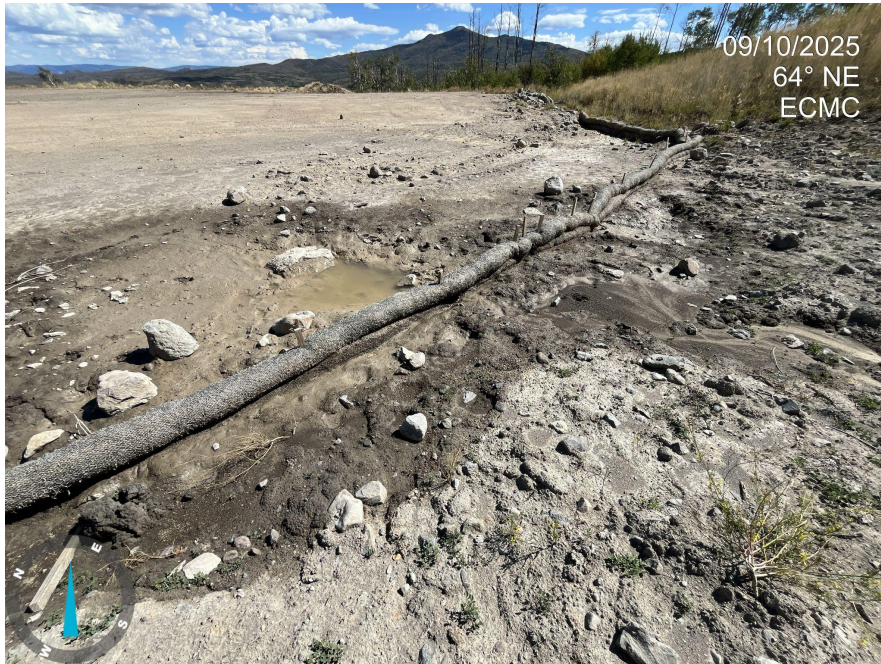
**Photo 3.** See comment under Photo 1.

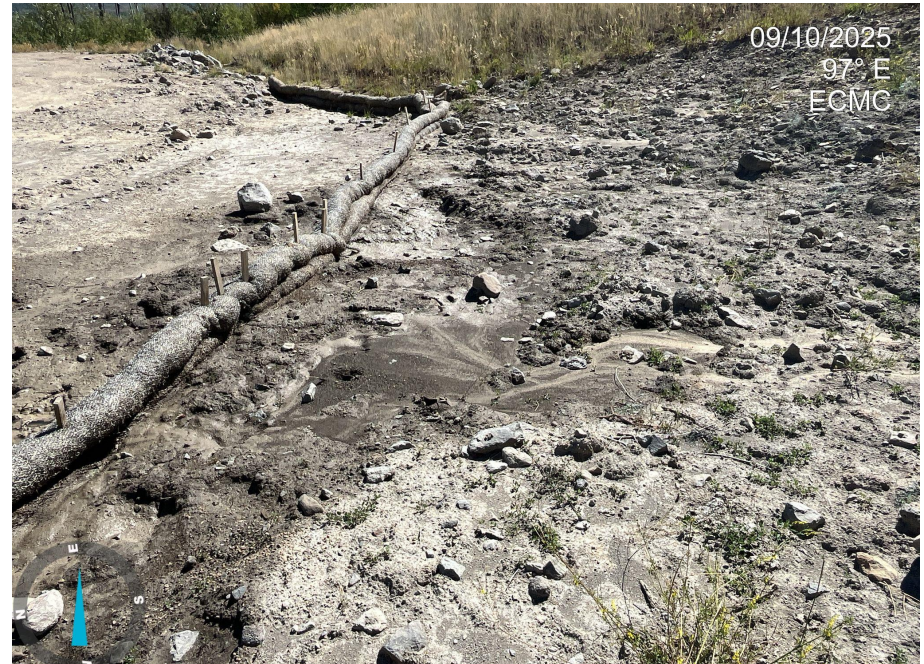
**Photo 4.** See comment under Photo 1.

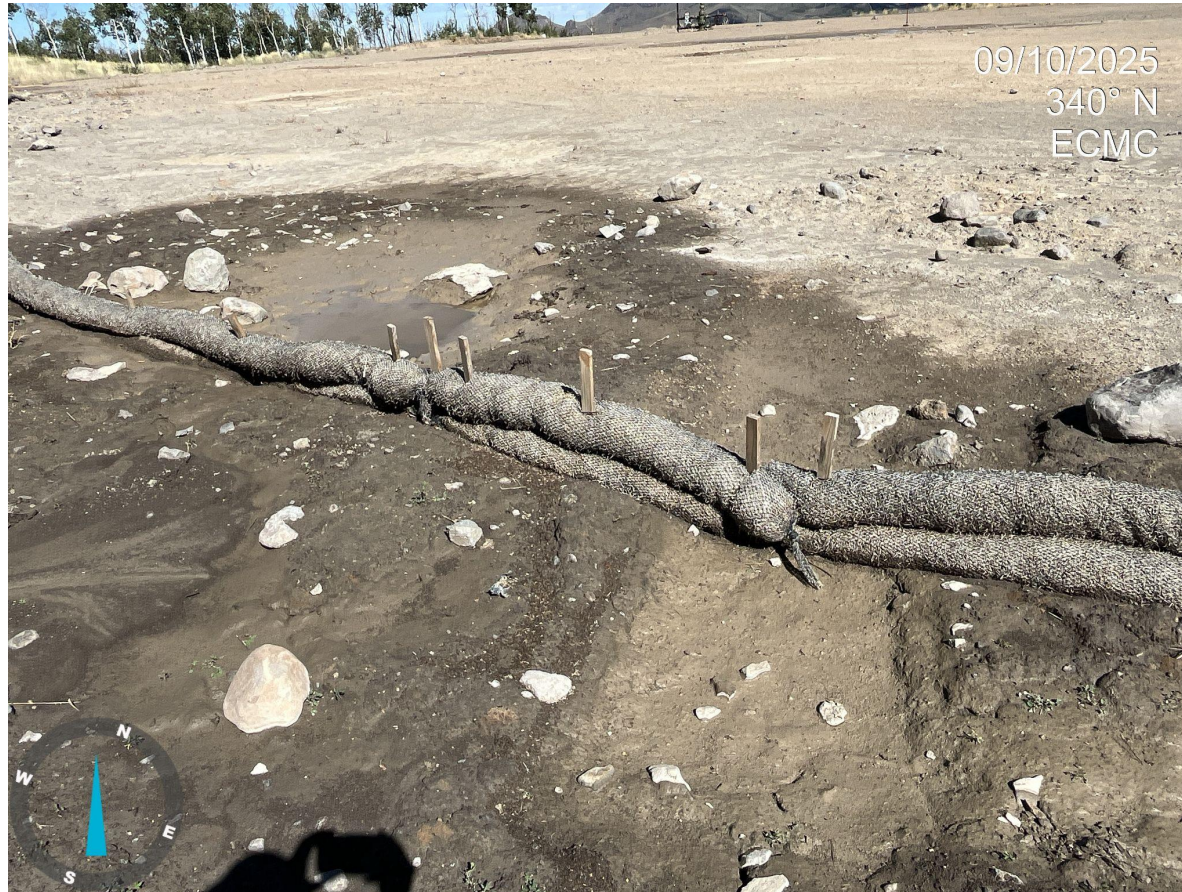
**Photo 5.** See comment under Photo 1.

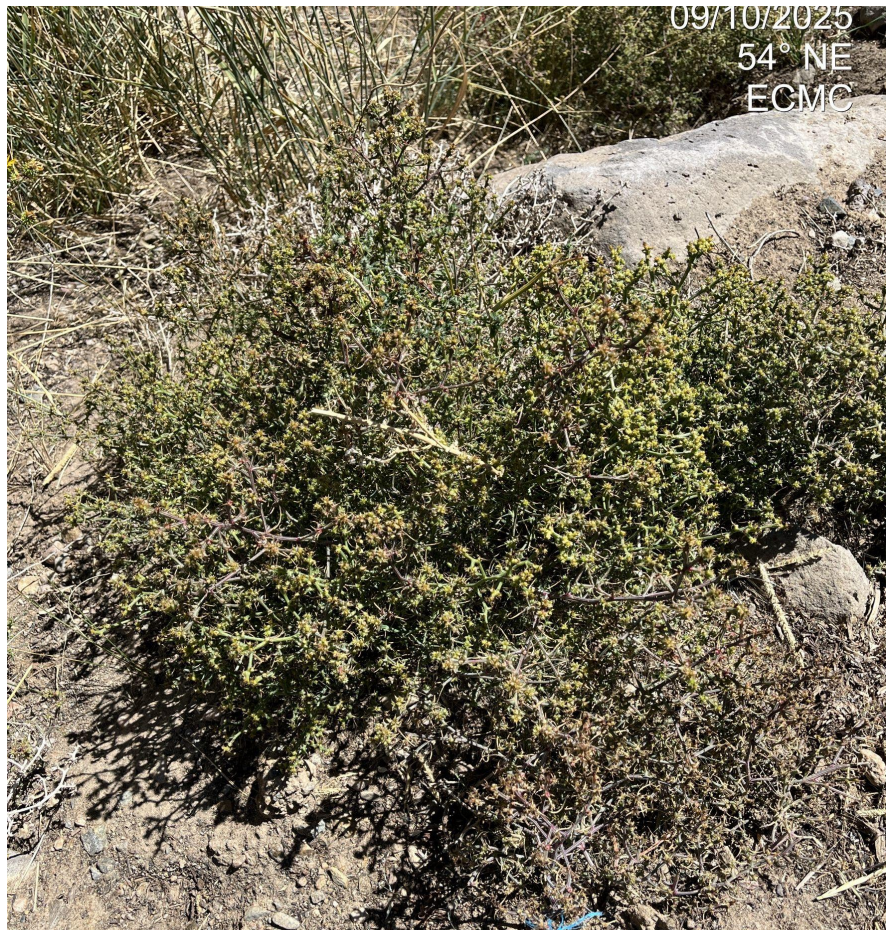
**Photo 6.** Photos 6-7 illustrate examples of weeds found along the perimeter berms and fill slopes of the Location. Photo illustrates Puncturevine.

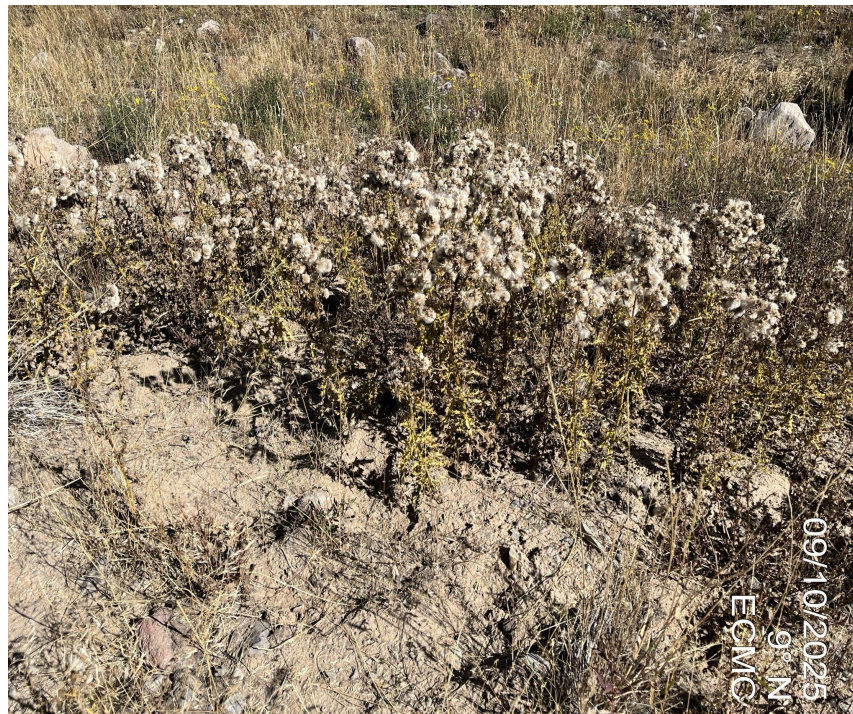
**Photo 7.** See comment under Photo 7. Photo illustrates Canada thistle, which was apparent to be dying back, either through herbicides or dormancy.

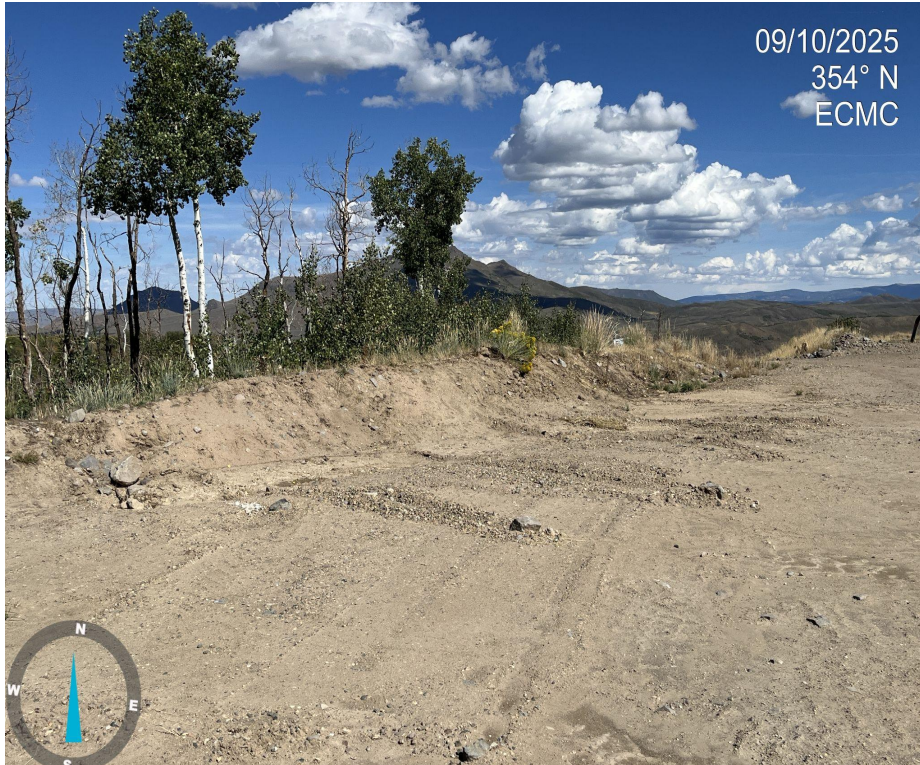
**Photo 8.** Photo taken on the western portion of the pad, facing north. Photo illustrates that the rock/debris pile has been removed.

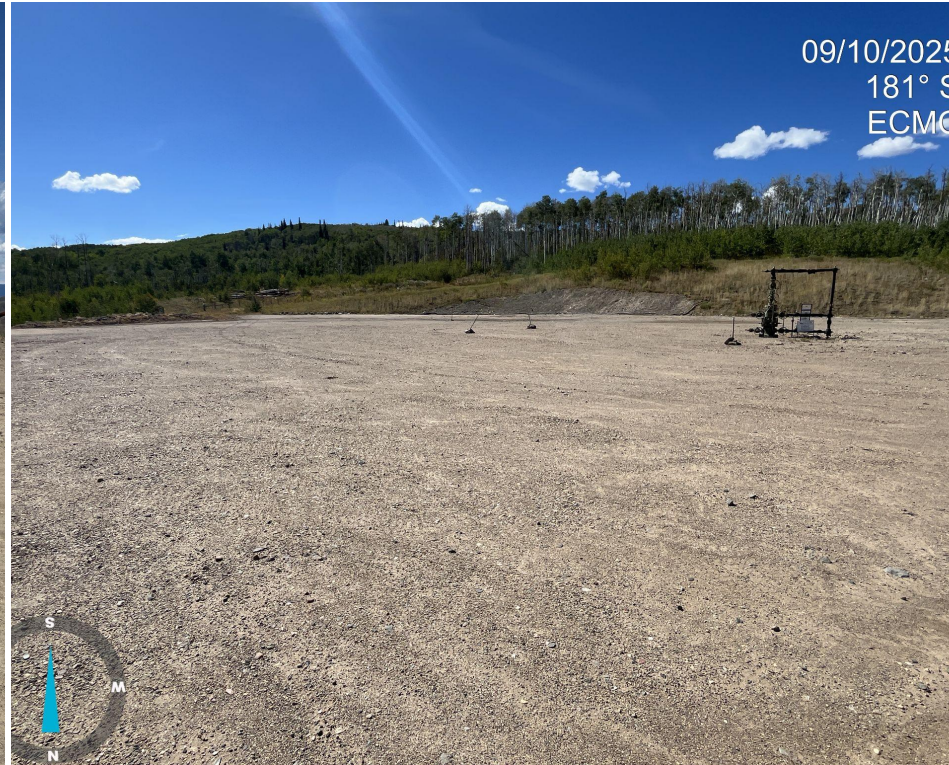
**Photo 9.** Photo taken near the entrance of the Location, facing south. Photo illustrates overview of Location. Additional trash/equipment has been removed.
