Inspection Photos

Operator: TEP Rocky Mountain LLC #96850

Location ID: 335546

Inspection Doc: 719200186

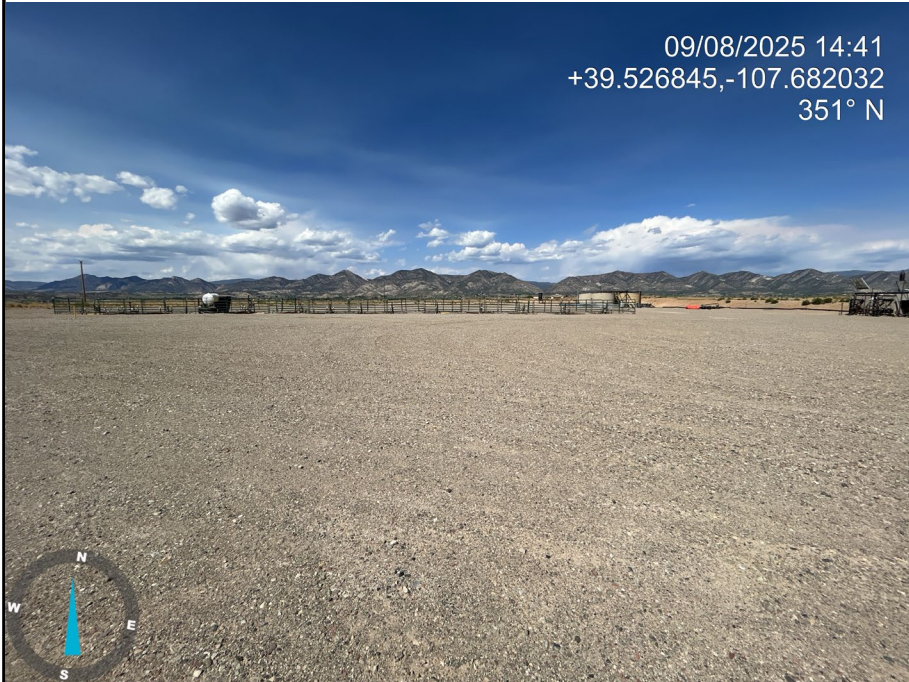
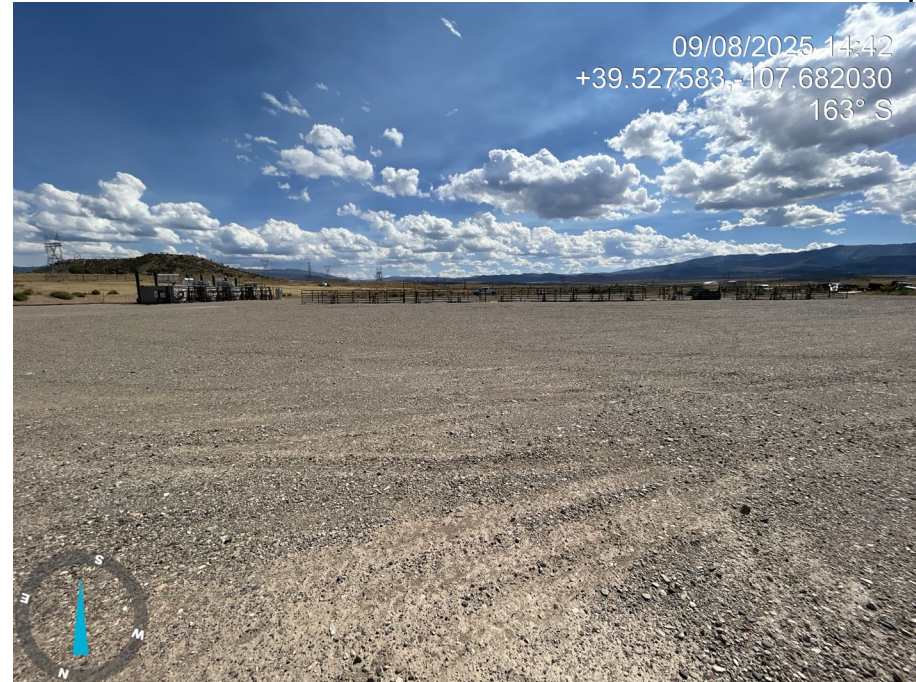
Photo 1: Photos showing an overview of the location looking north and south, respectively.

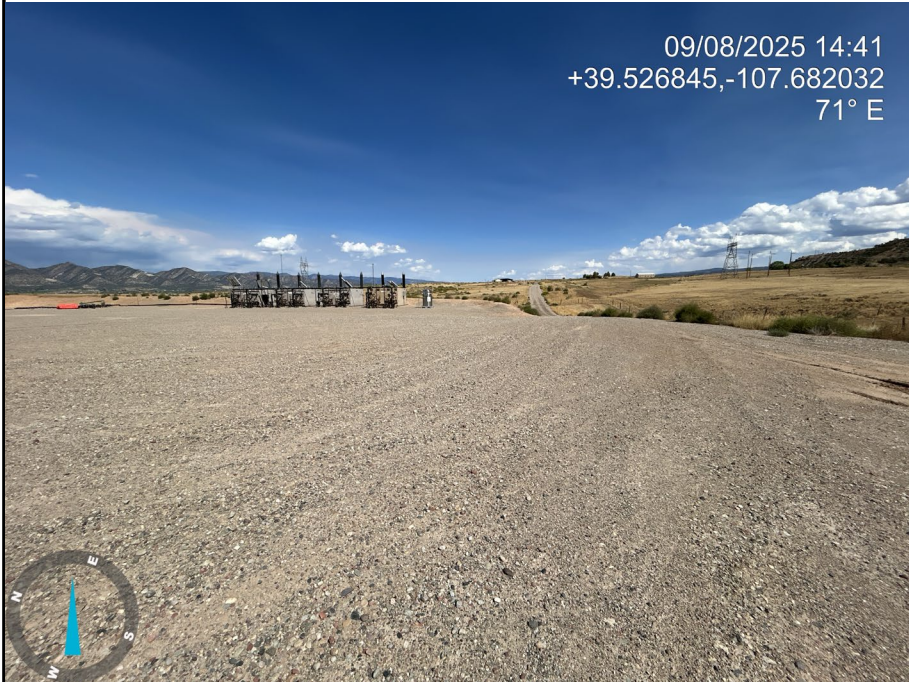
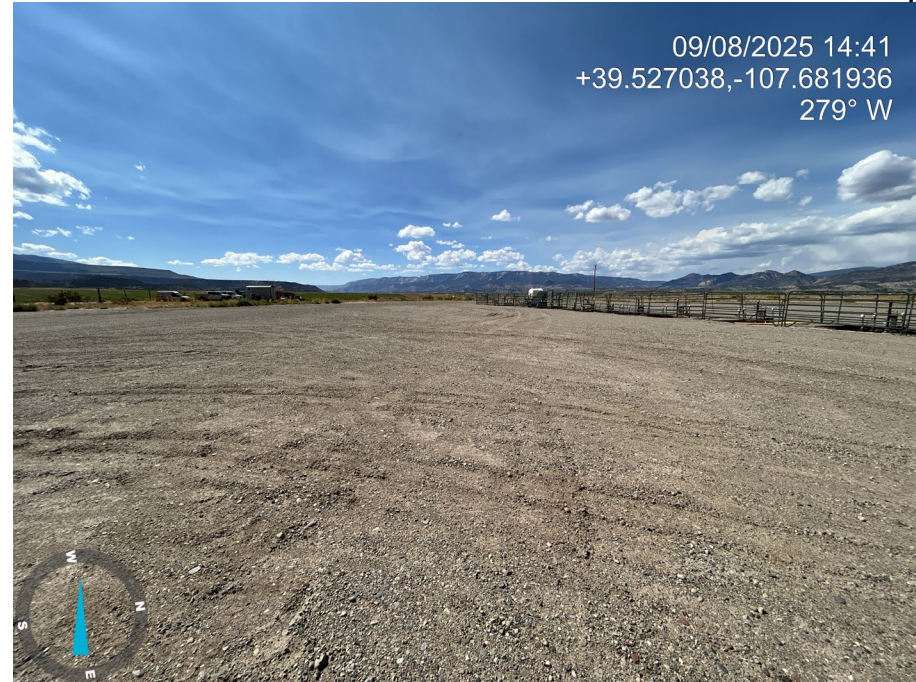
Photo 2: Photos showing an overview of the location looking east and west, respectively.

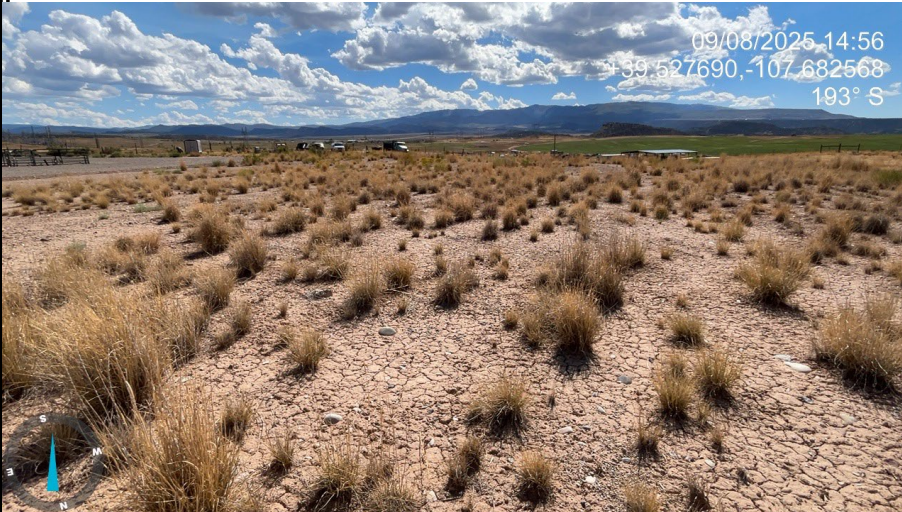
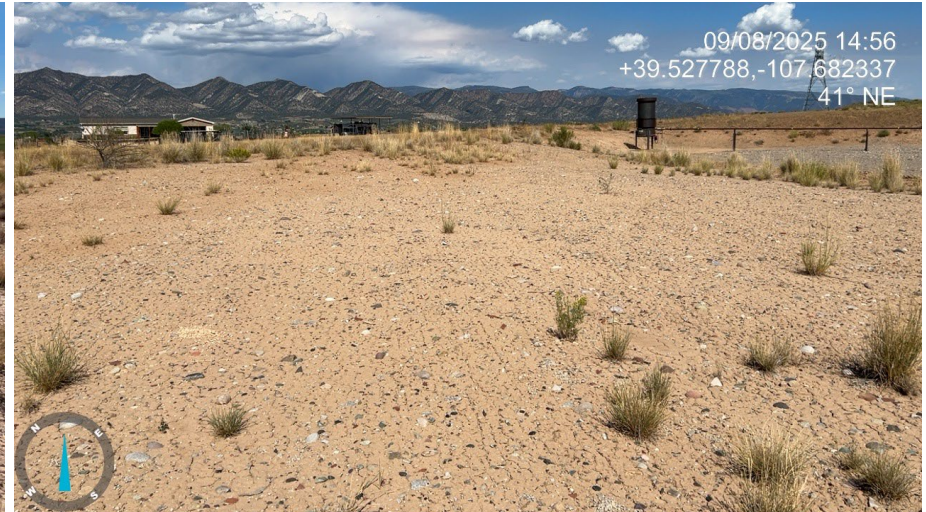
Photo 3: Photos showing portions of the northwestern and northern interim areas, respectively. Some portions of the interim areas are progressing towards 1003 reclamation requirements; other portions remain bare and appear to have compaction issues. Additional reclamation efforts may be necessary in these portions of the interim areas.

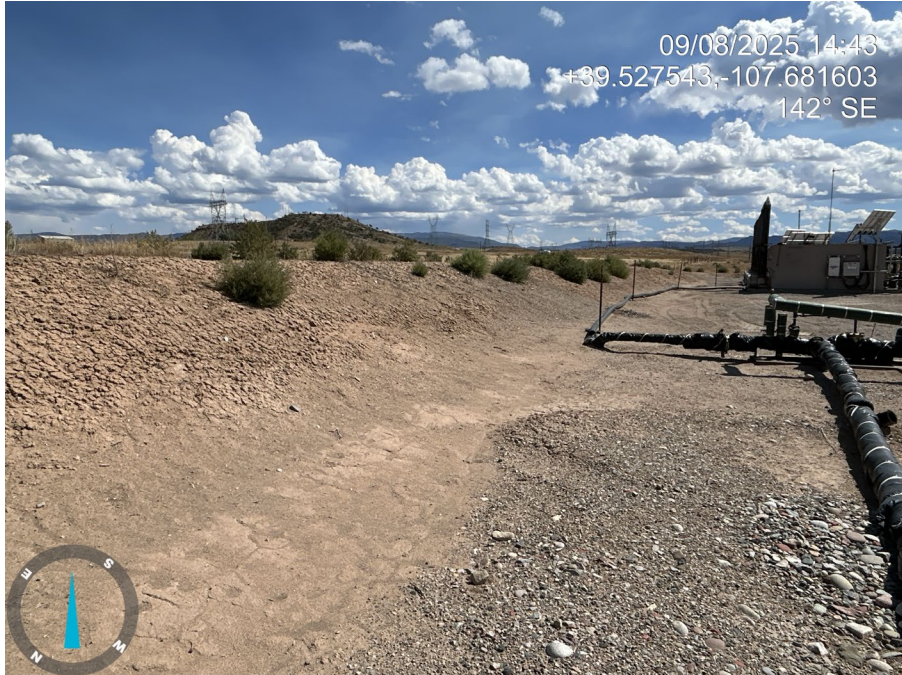
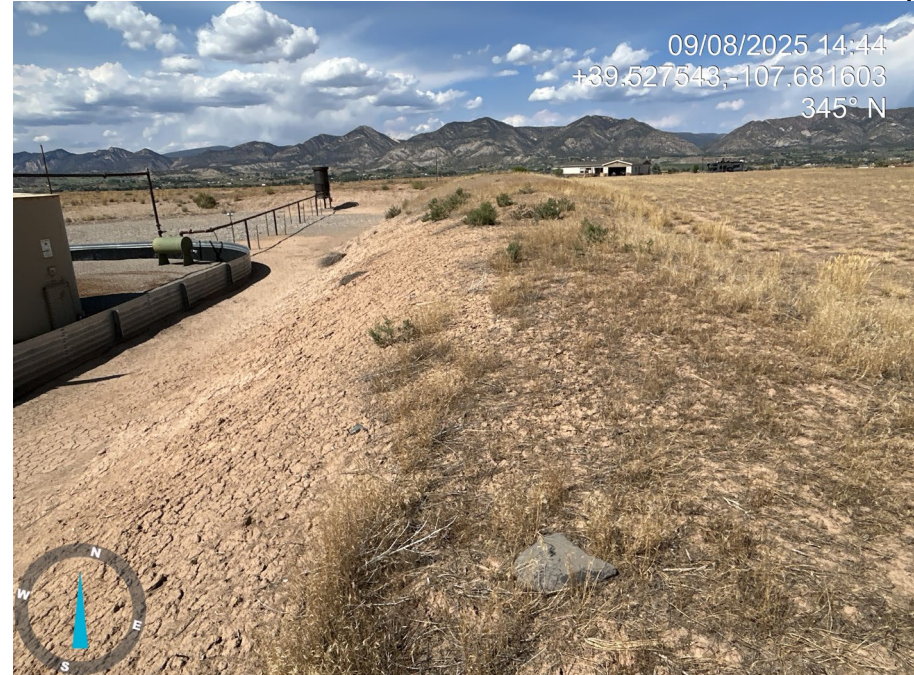
Photo 4: Photos showing bare cut slopes on the eastern portion of the location behind production equipment. The Corrective Action to implement or maintain stormwater BMP's remains outstanding.

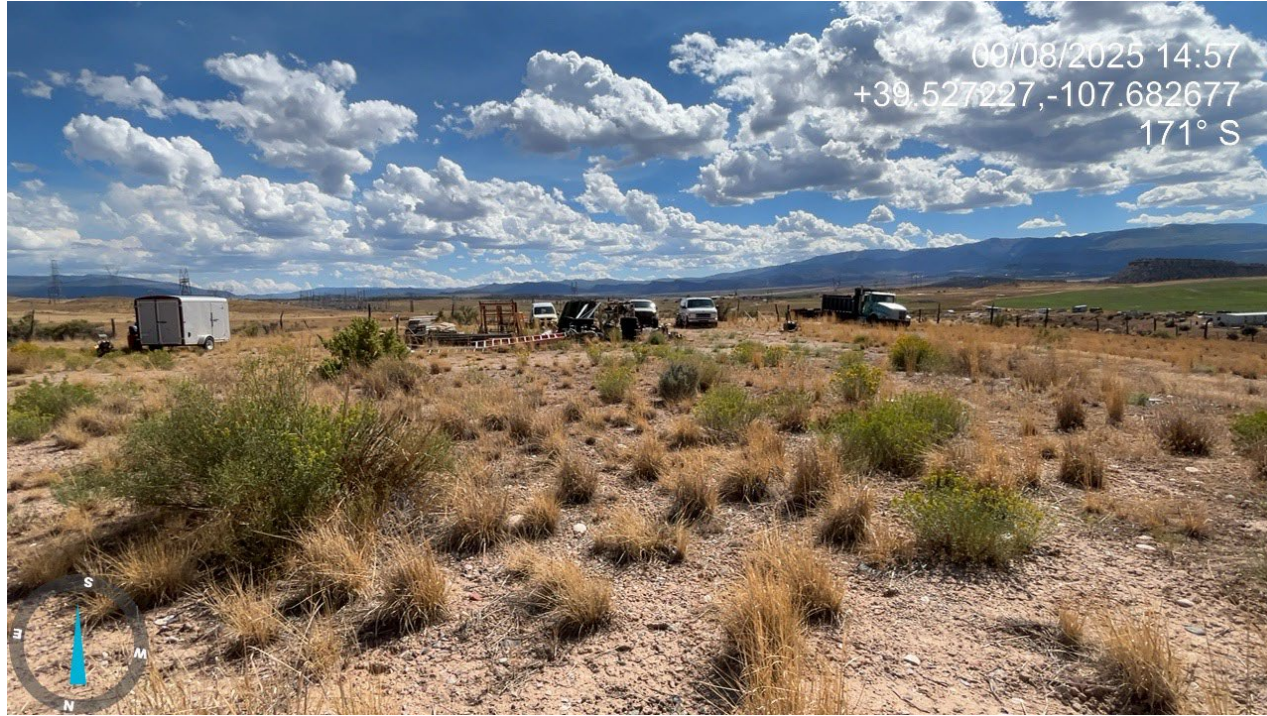
Photo 5: Trailers, vehicles and other materials are being stored in the interim area. Removal is required. Comply with Rule 606.a.

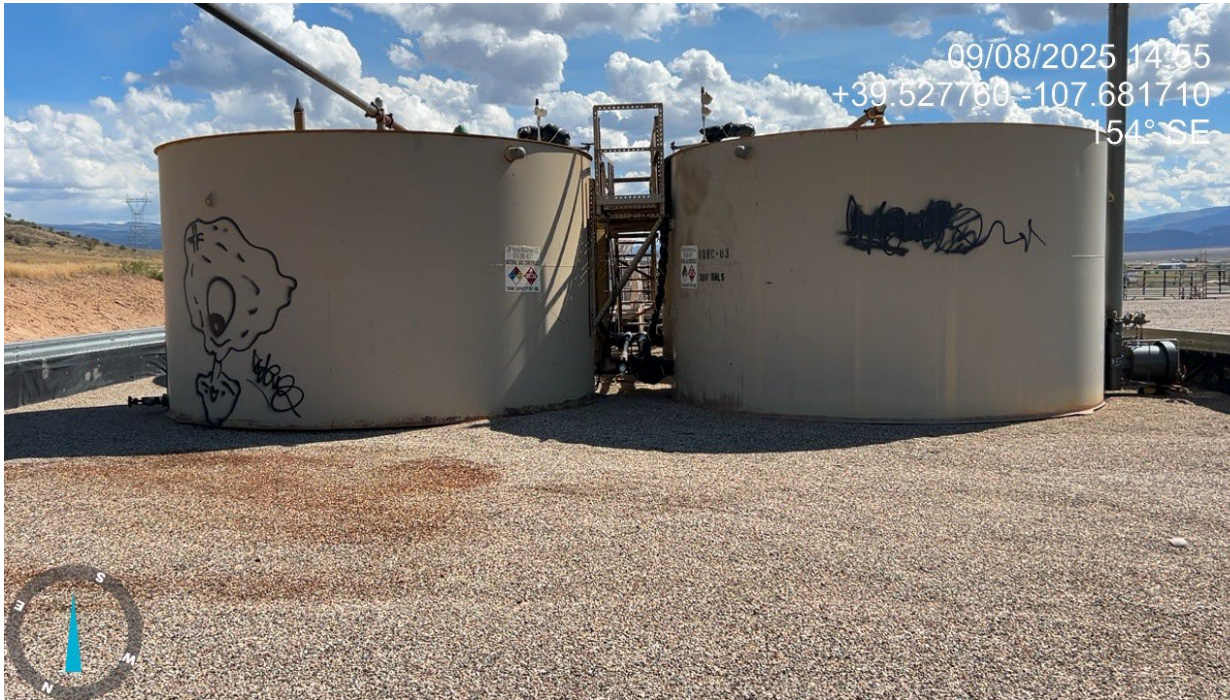
Photo 6: Graffiti appears to be present on tanks at the location.
