Inspection Photos

Operator: TEP Rocky Mountain LLC #96850

Location ID: 335548

Inspection Doc: 719200183

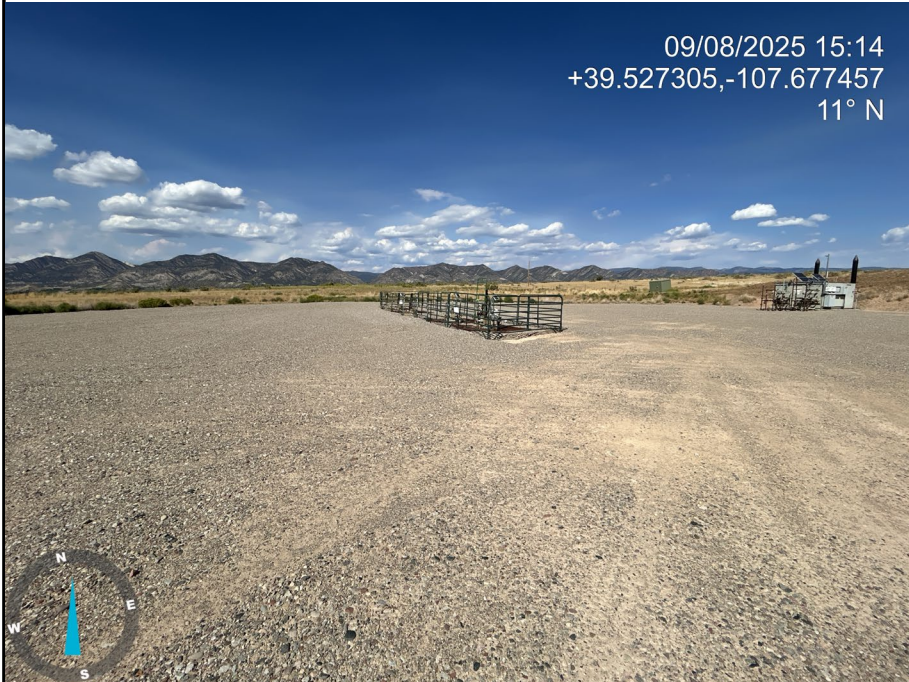
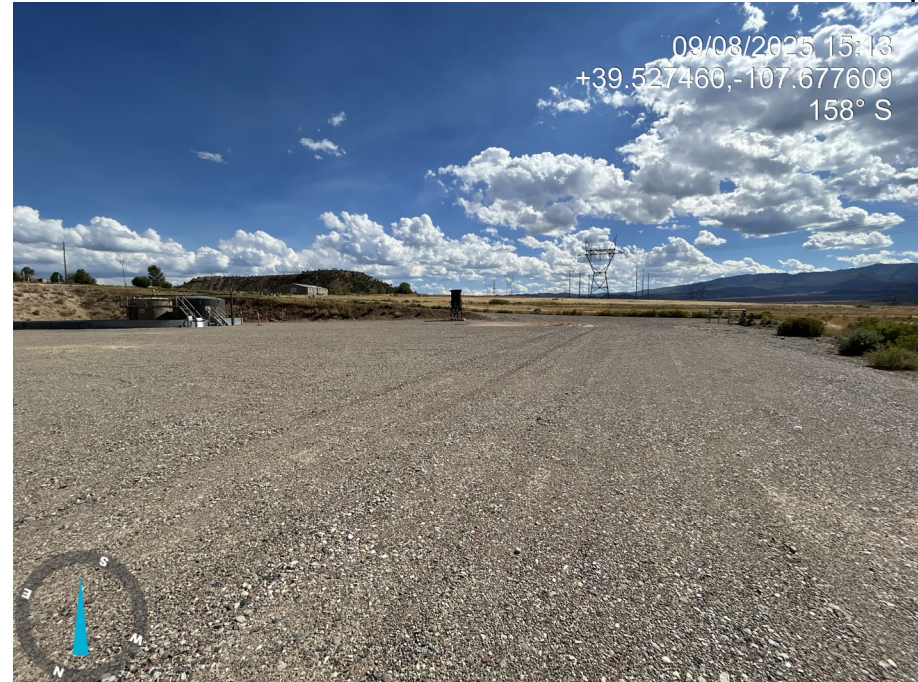
Photo 1: Photos showing an overview of the location looking north and south, respectively.

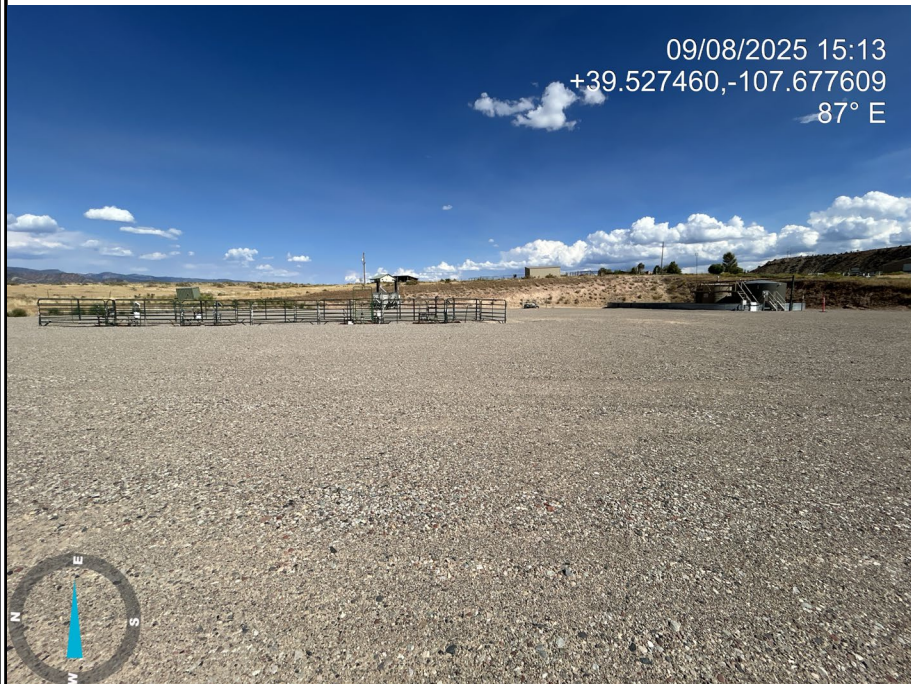
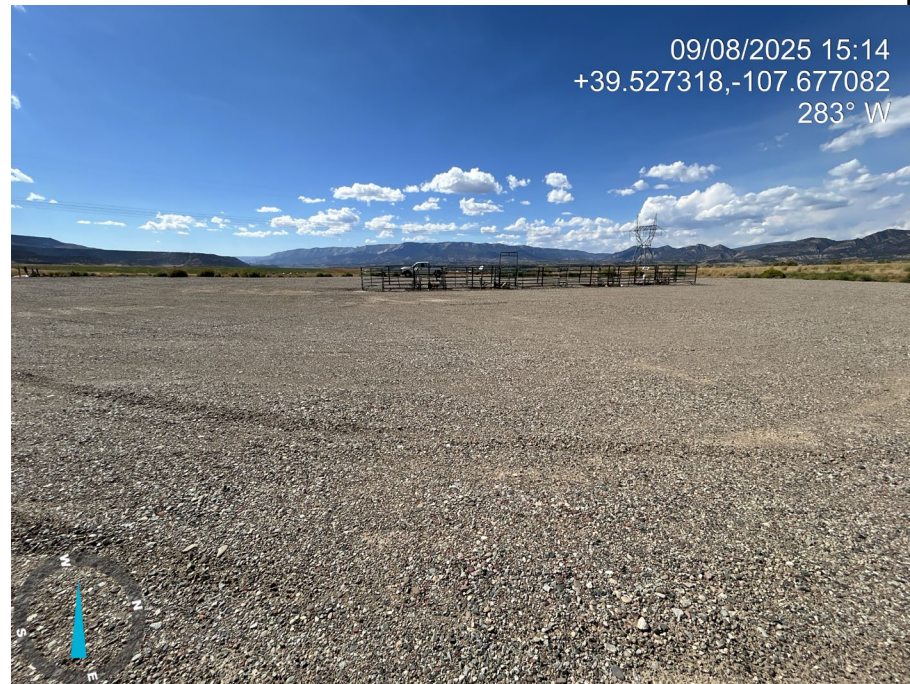
Photo 2: Photos showing an overview of the location looking east and west, respectively.

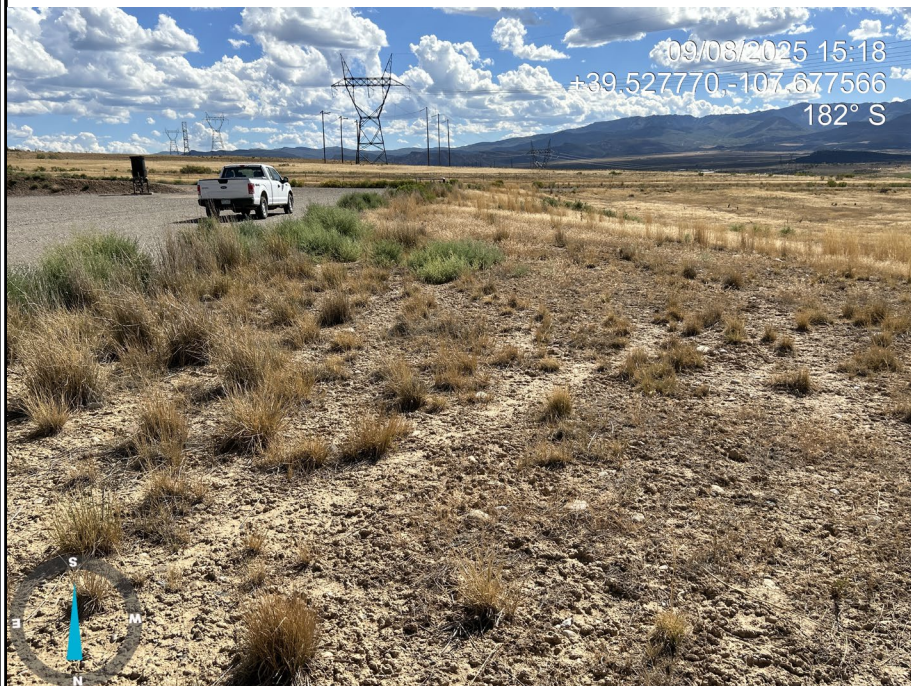
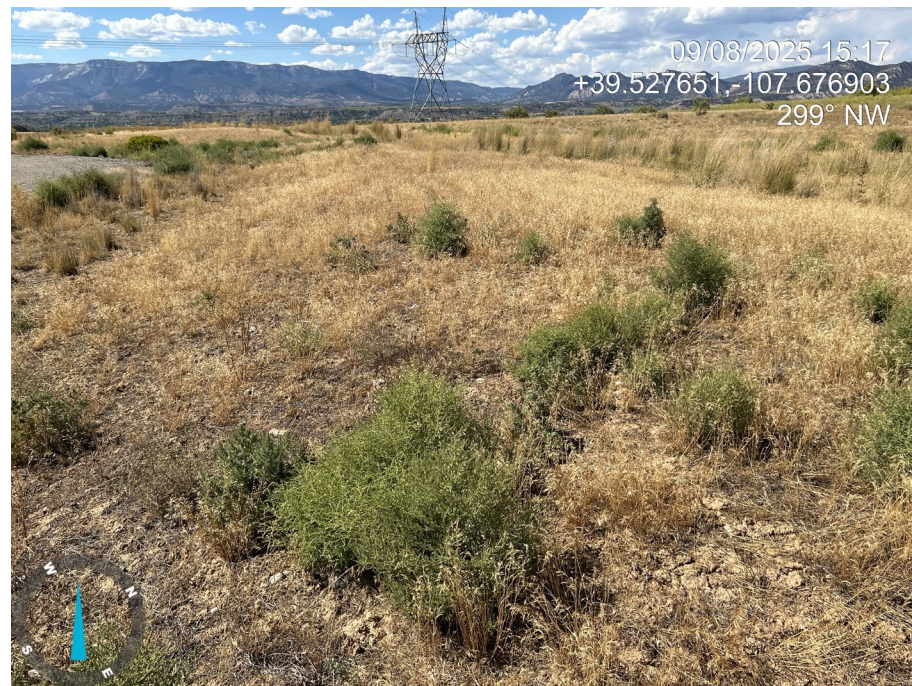
Photo 3: Photos showing the western and northern interim areas, respectively. Russian wildrye and rubber rabbitbrush are present on the margins of the interim area, however, cheatgrass and prickly Russian thistle are dominant throughout the interim areas. Interim areas are In Process. Weed management is required.

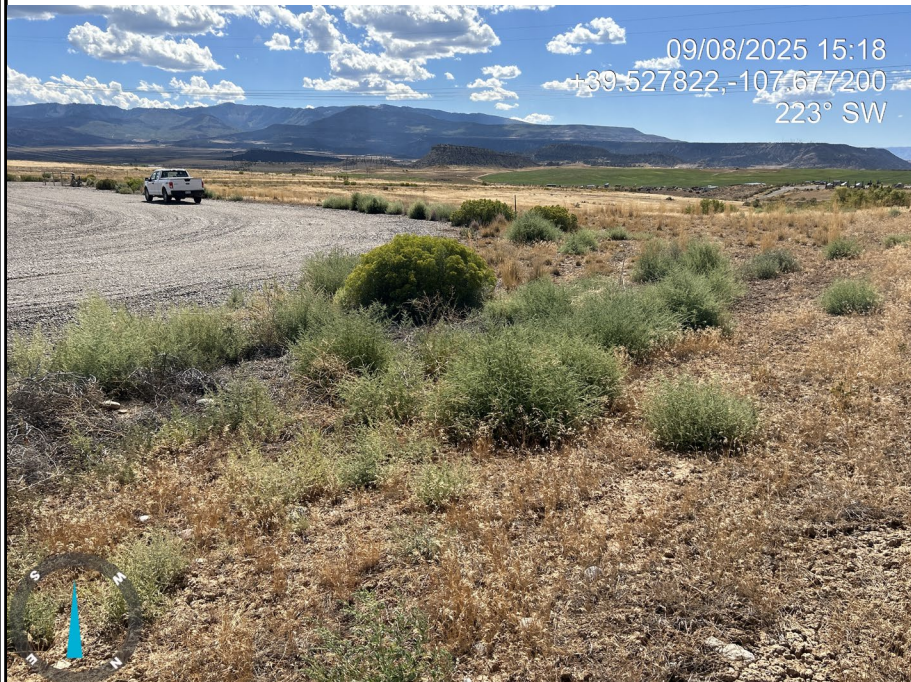
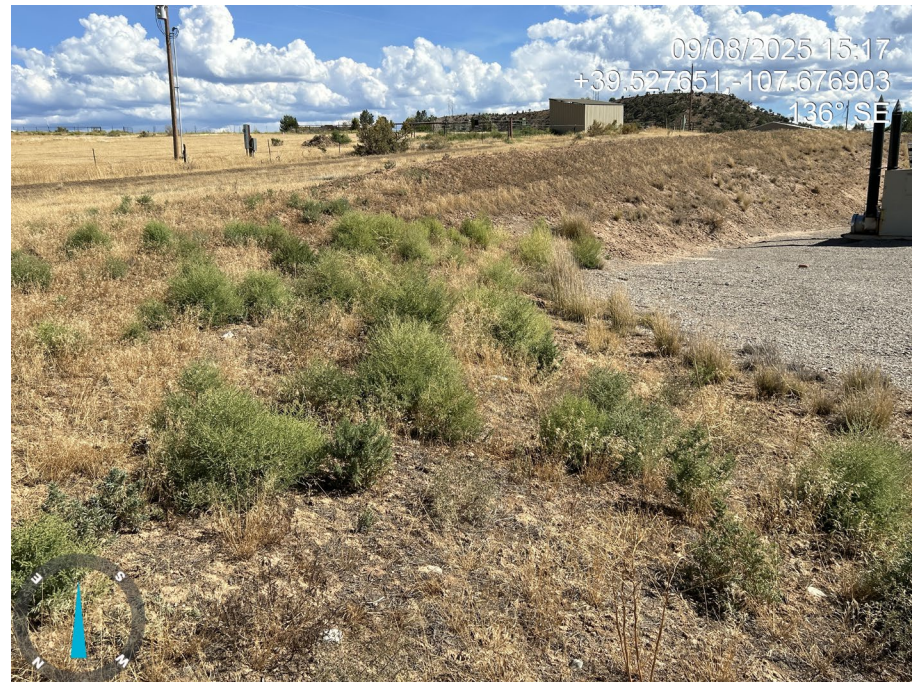
Photo 4: Photos showing the northern and northeastern interim areas, respectively. Undesireable plant species, such as kochia and cheatgrass, are present throughout the interim areas. Weed management is required.

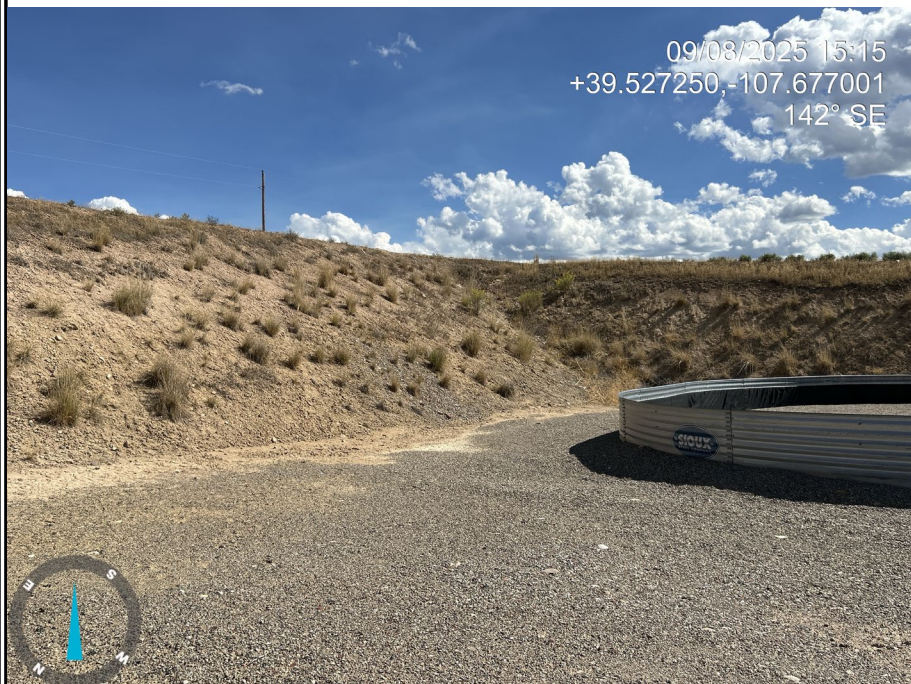
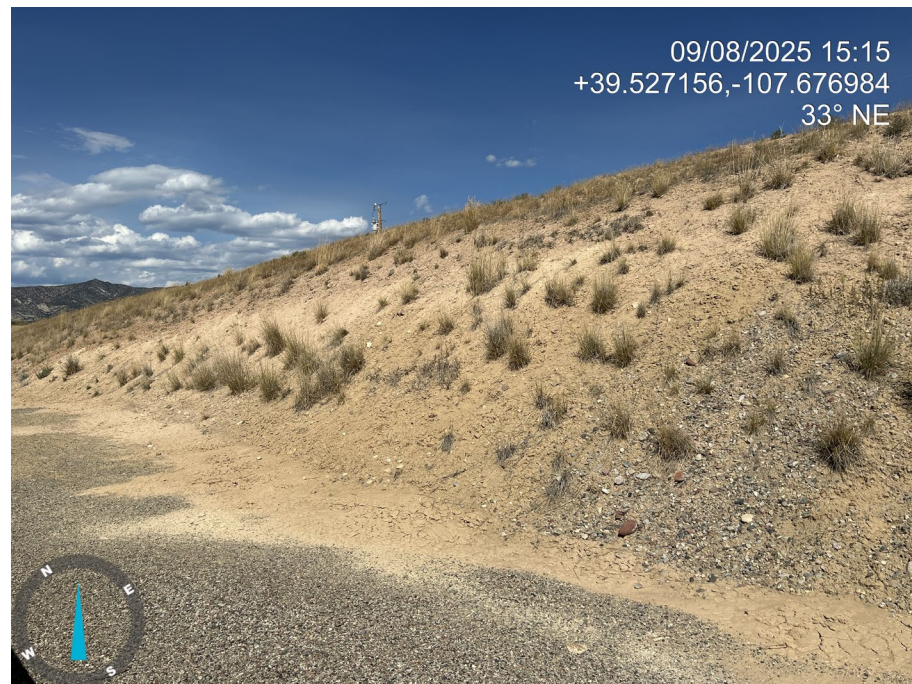
Photo 5: Desirable vegetation has established on the cut slope, however, some sediment deposition appears to be present on the working pad surface.

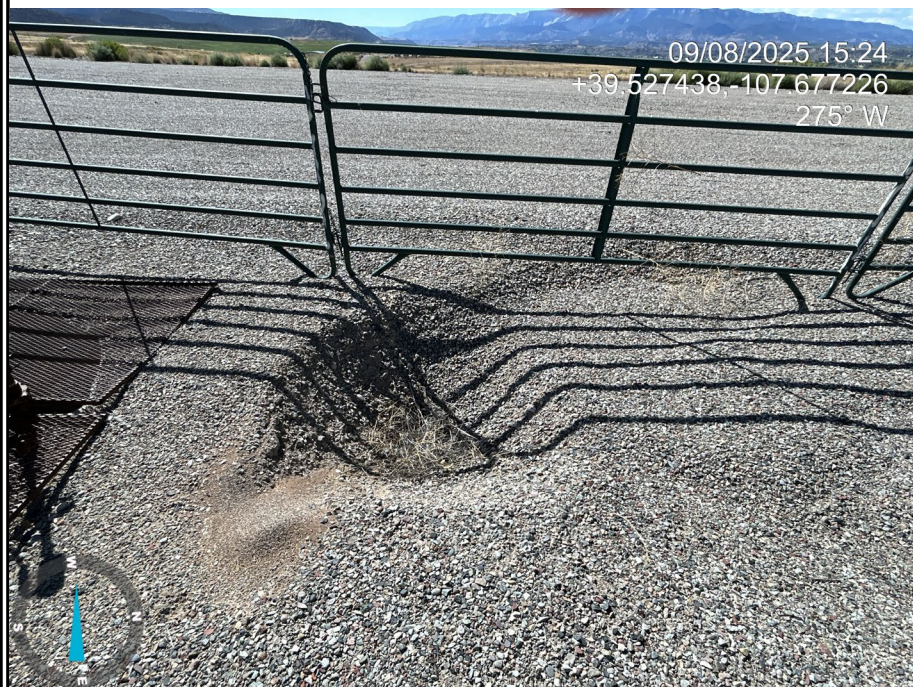
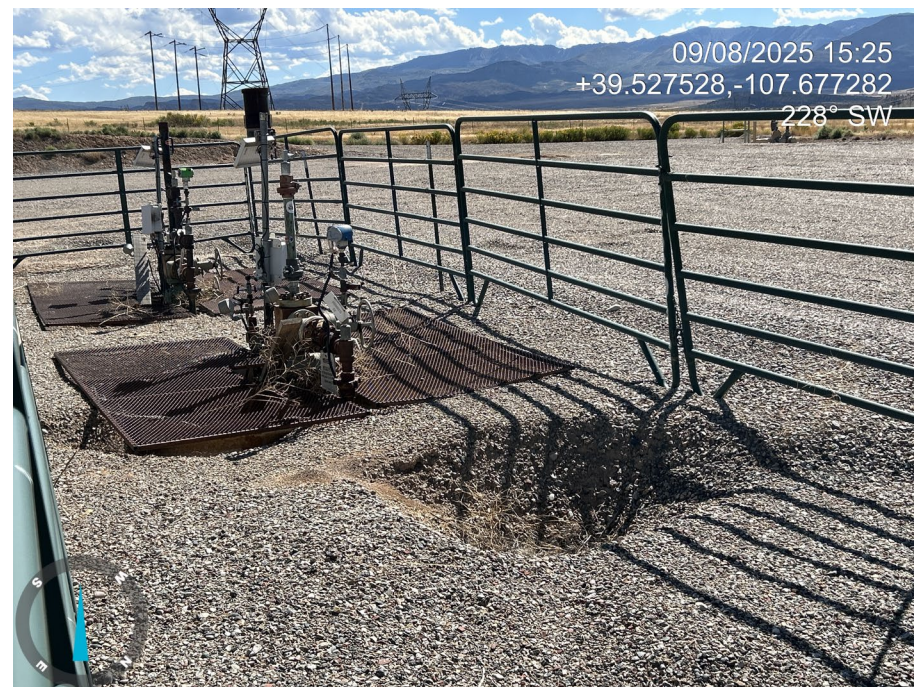
Photo 6: A subsidence appears to be developing at the wellheads. Additional stabilization and recontouring efforts may be required to ensure the working pad surface remains stabilized.
