# Final Reclamation and Stormwater Inspection

Location ID: 316926

Well Name: STATE #2

Washington County, CO

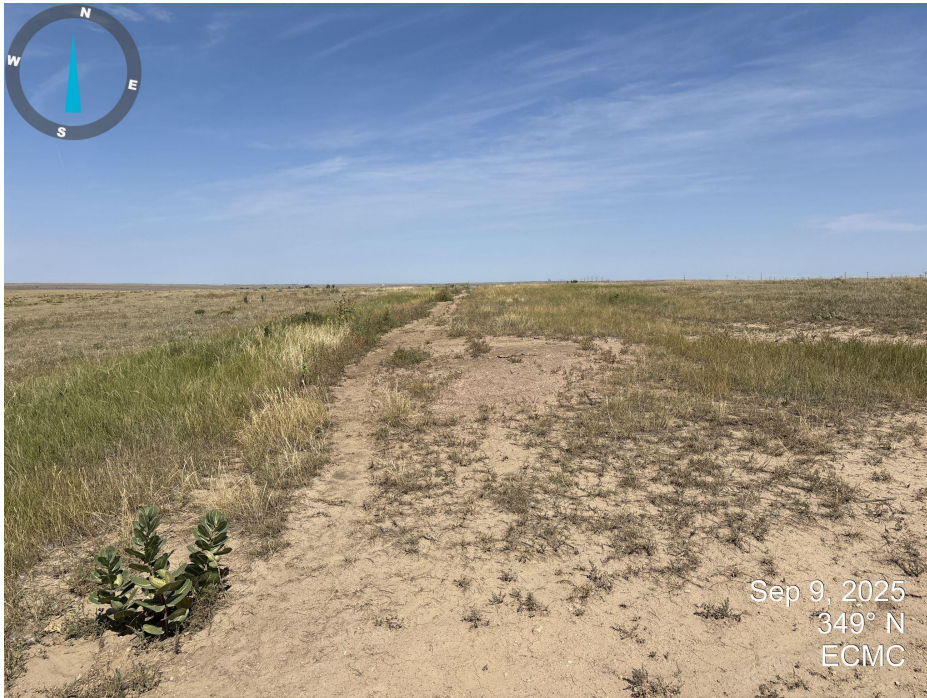
**Photo 1.** Looking north down the former access road. Some desirable vegetation is present. Undesirable weeds such as kochia are present in a higher concentration than the surrounding area particularly at the junction of the remaining access road.

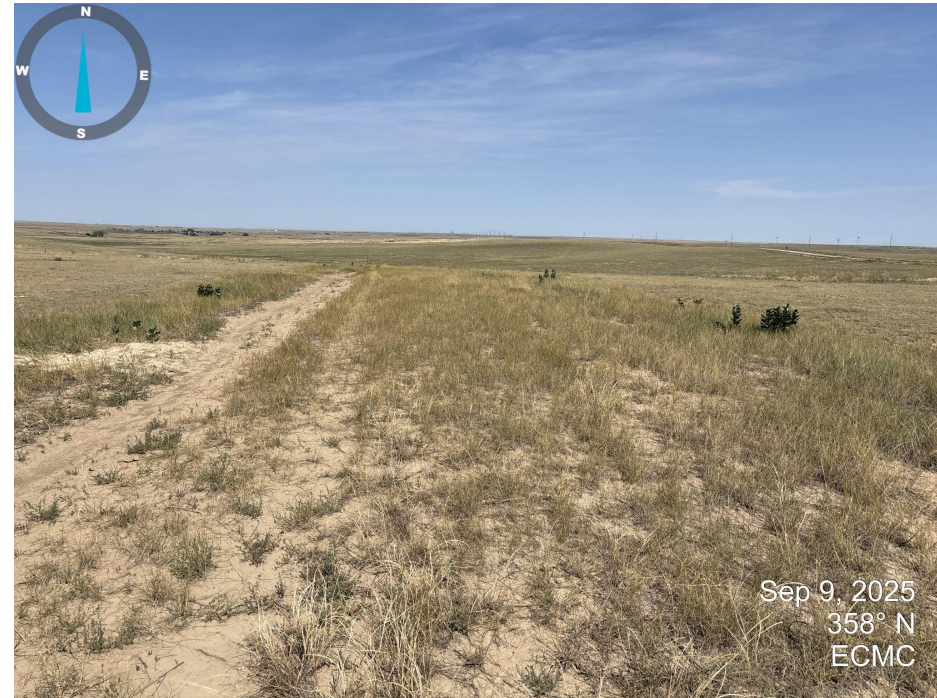
**Photo 2.** Photo taken at the midpoint of the access road leading to the location. The access road does not appear to have been recontoured. A cattle path is present down the length of the road. vegetation density appears to be less than 80% of the surrounding area.

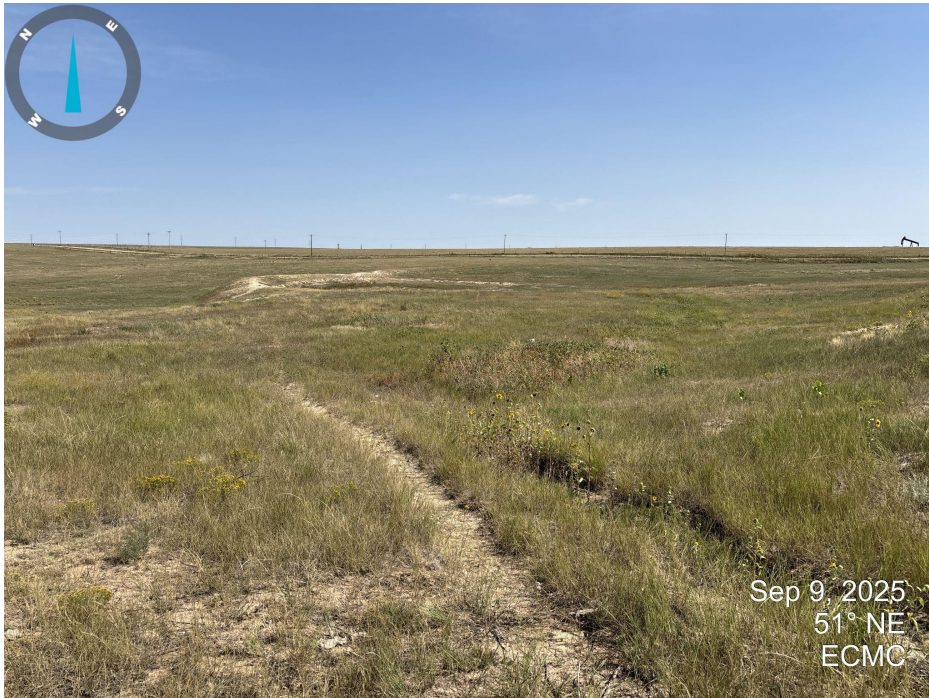
Sep 9, 2025  
51° NE  
ECMC

**Photo 3.** Looking across the well location. No oil and gas equipment remains on location. It does not appear that the location was recontoured.

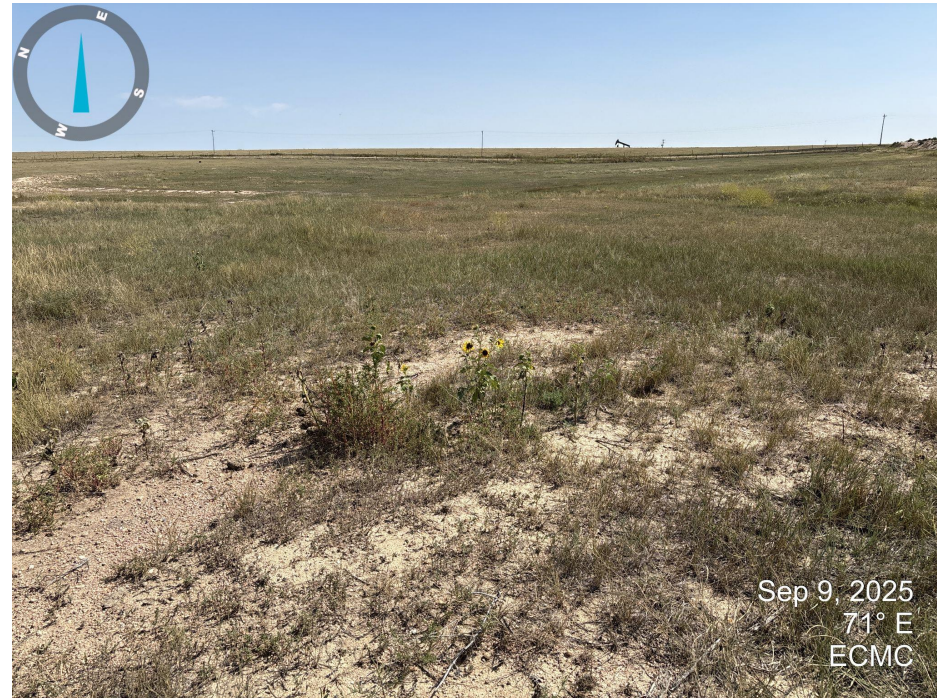
Sep 9, 2025  
71° E  
ECMC

**Photo 4.** Looking east across the wellbore area. This area has patchy vegetation coverage that contains undesirable weeds such as kochia. The location has several other areas with lower desirable vegetation coverage than the reference area.

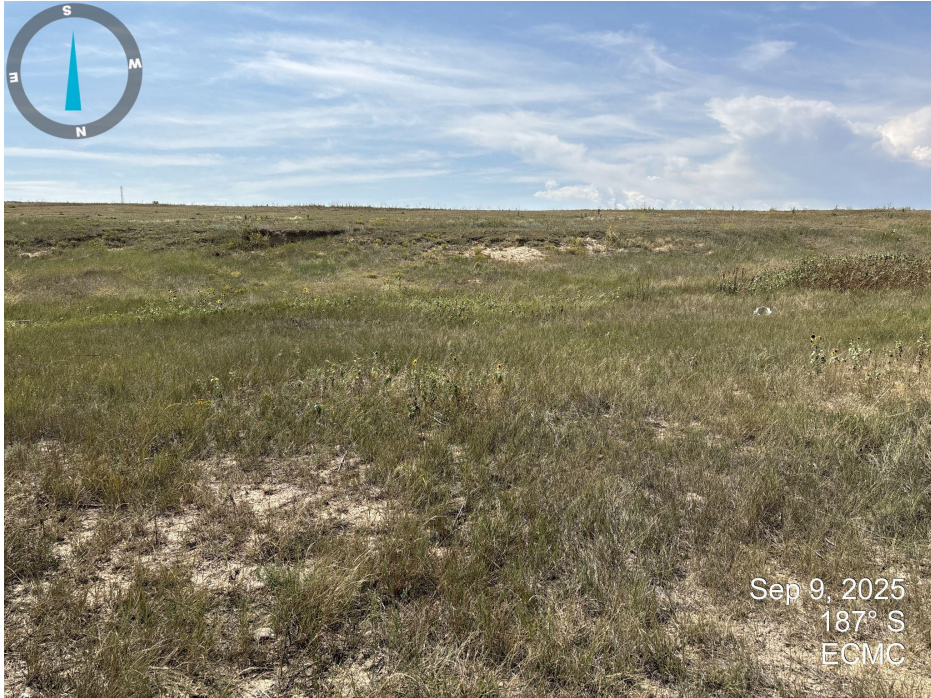
**Photo 5.** Looking south from the wellbore area. See photo 4 comments.

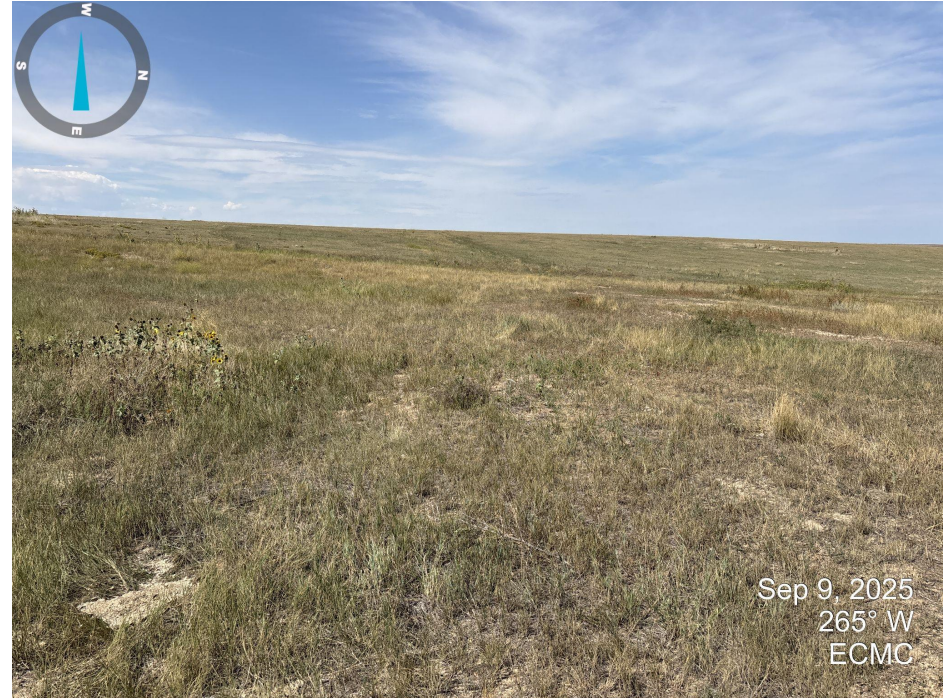
**Photo 6.** Looking south from the wellbore area. See photo 4 comments.

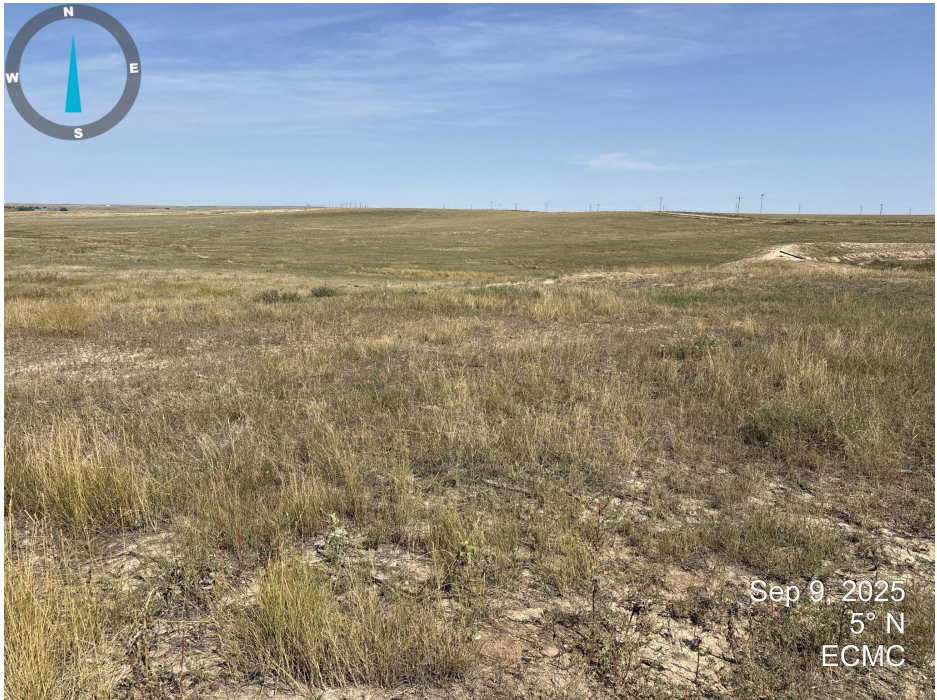
**Photo 7.** Looking north from the wellbore area. This area displays vegetation coverage that is lower than the surrounding reference area and contains undesirable weedy species such as kochia.

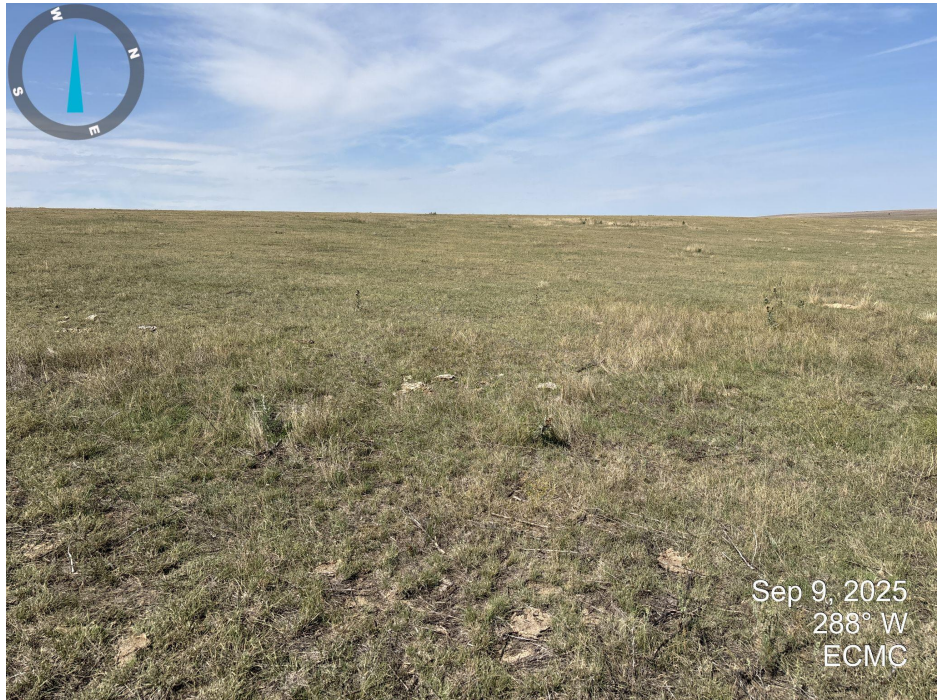
**Photo 8.** Reference area to the west of the well location.
