Final Reclamation and Stormwater Inspection

Location ID: 316931

Well Name: STATE #4

Washington County, CO

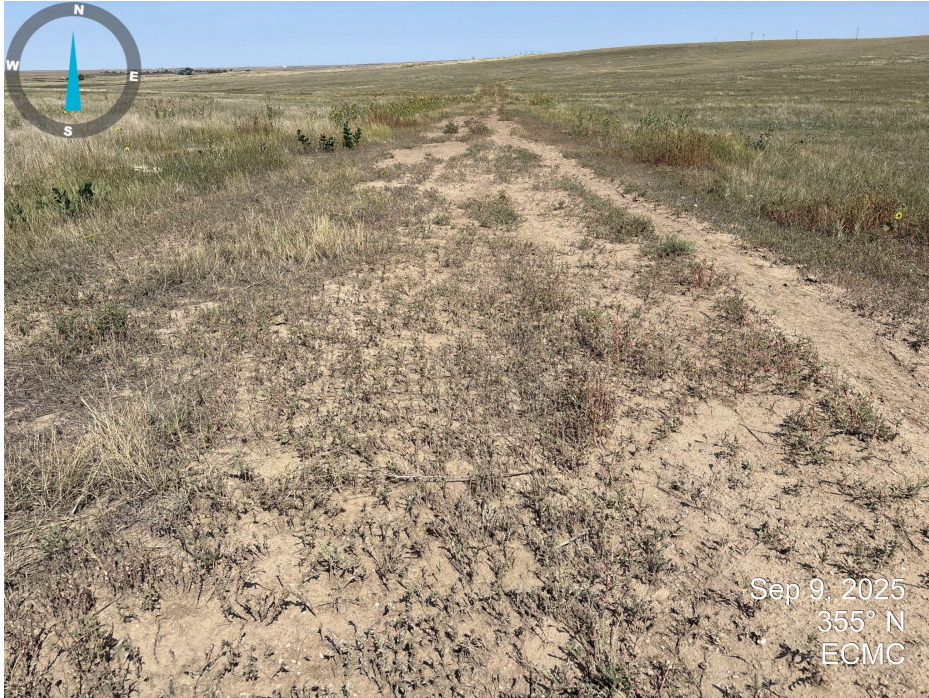
Photo 1. Picture taken near the midpoint of the access road looking north. Vegetation is predominantly undesirable weeds such as kochia and not reflective of the surrounding area.

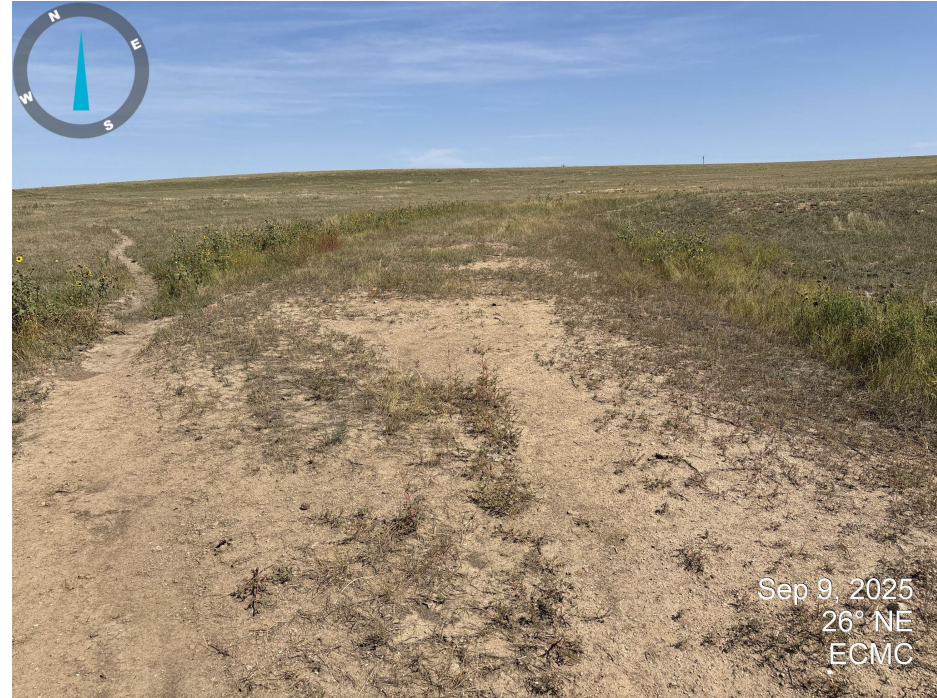
Photo 2. Photo taken on the access road near the well location looking north. A patch of bare soil is present.

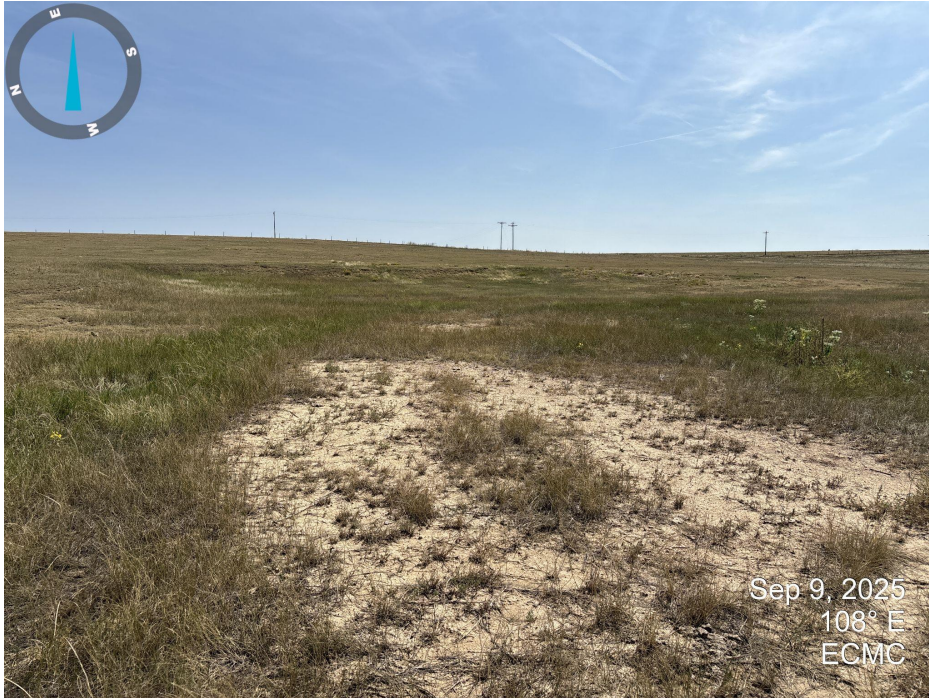
Sep 9, 2025
108° E
ECMC

Photo 3. Looking east across the well location. No oil and gas equipment remains on location. It does not appear that the location was recontoured. Vegetation is not uniform on location with bare spots present, particularly near the entrance of the access road.

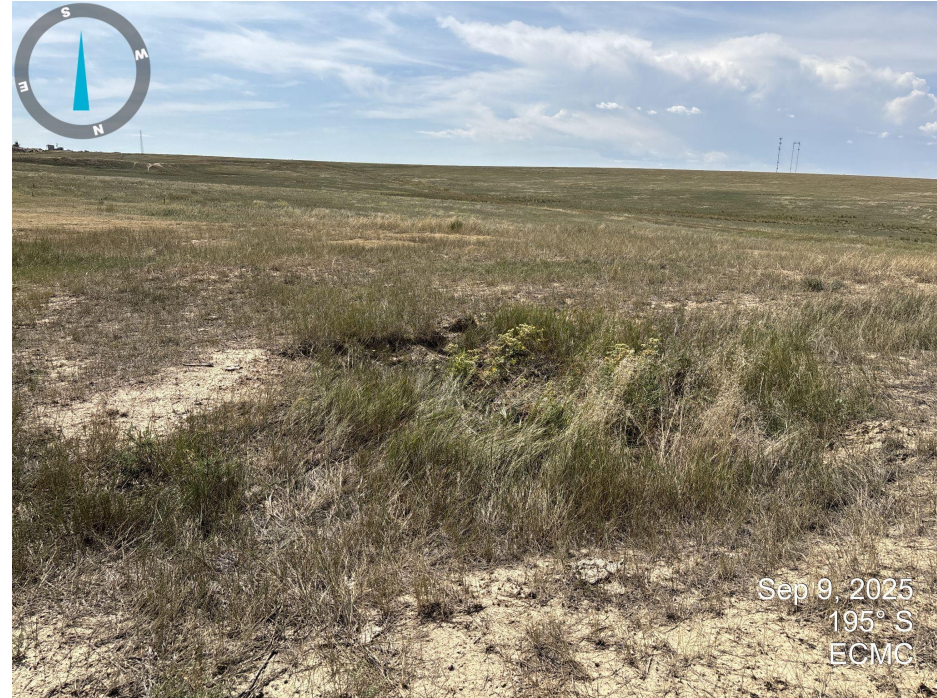
Sep 9, 2025
195° S
ECMC

Photo 4. Picture taken near the wellbore looking south. An area of subsidence approximately 10x10x2ft deep is present near the wellbore.

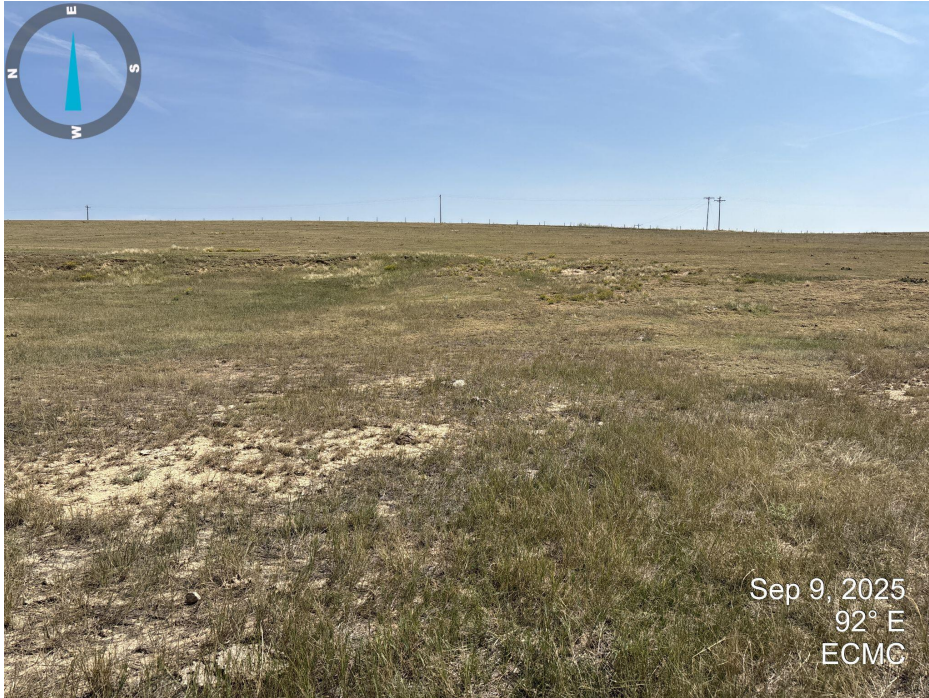
Photo 5. Looking east from the wellbore area. Desirable vegetation is present on portions of the location. Bare soil spots are present particularly near the entrance of the location.

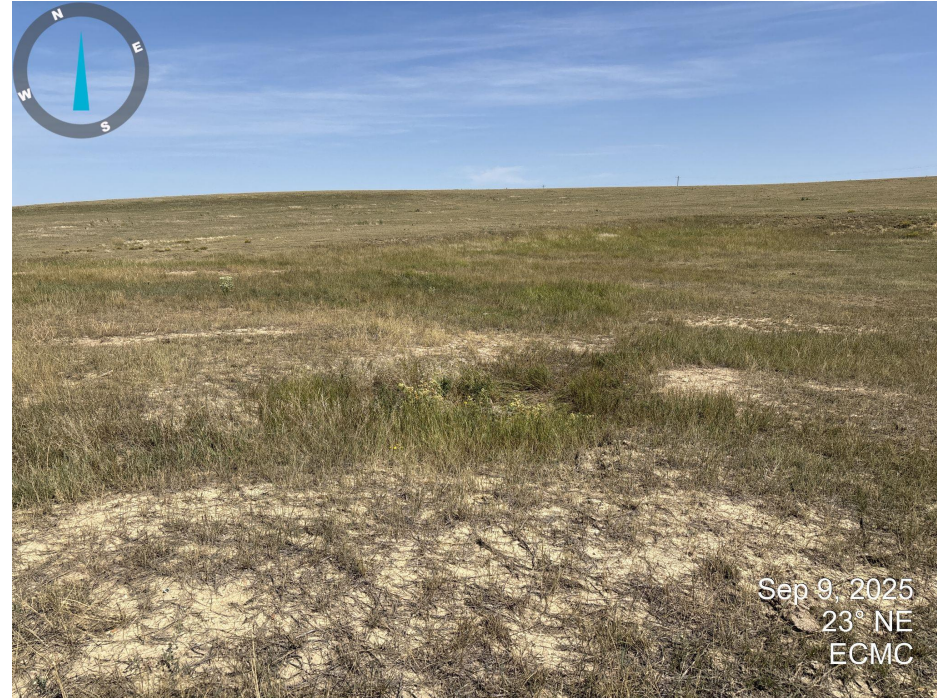
Photo 6. Looking north from the wellbore area. See photo 5 comments.

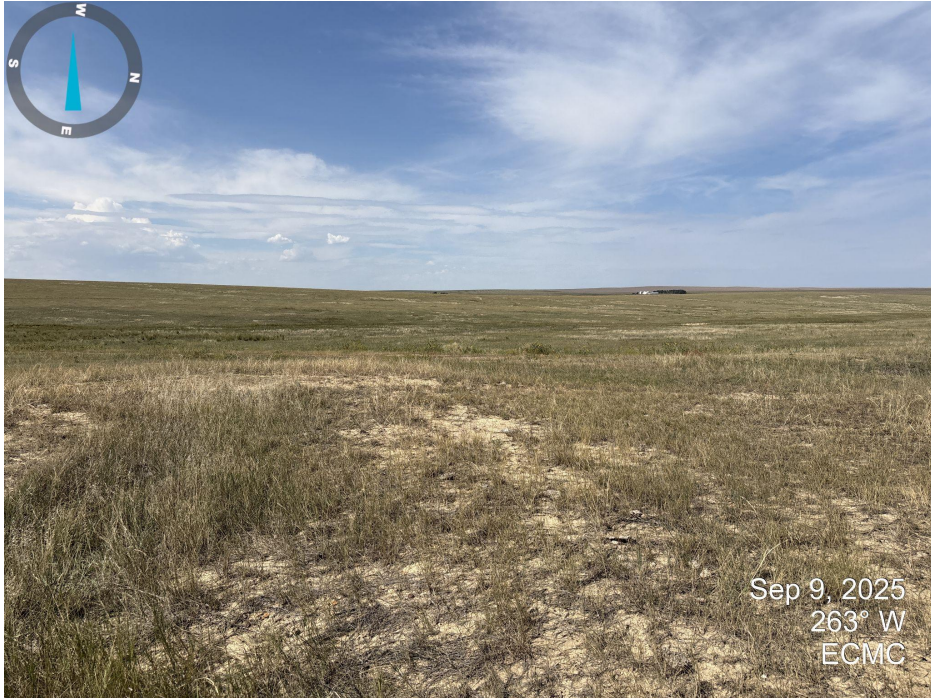
Photo 7. Looking west from the wellbore area. See photo 5 comments.

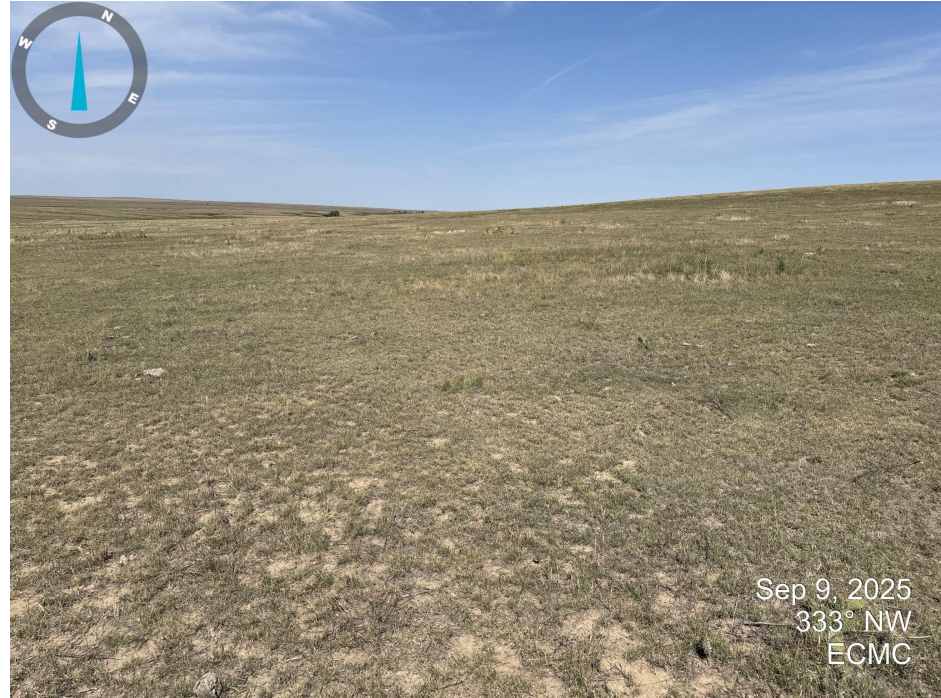
Photo 8. Reference area to the north of the well location.
