Final Reclamation Inspection

Operator: FOUNDATION ENERGY MANAGEMENT LLC -
10112

Location ID: 304152

Inspection Photos
Location Name: SIMMONS #5-19
Location ID: 304152

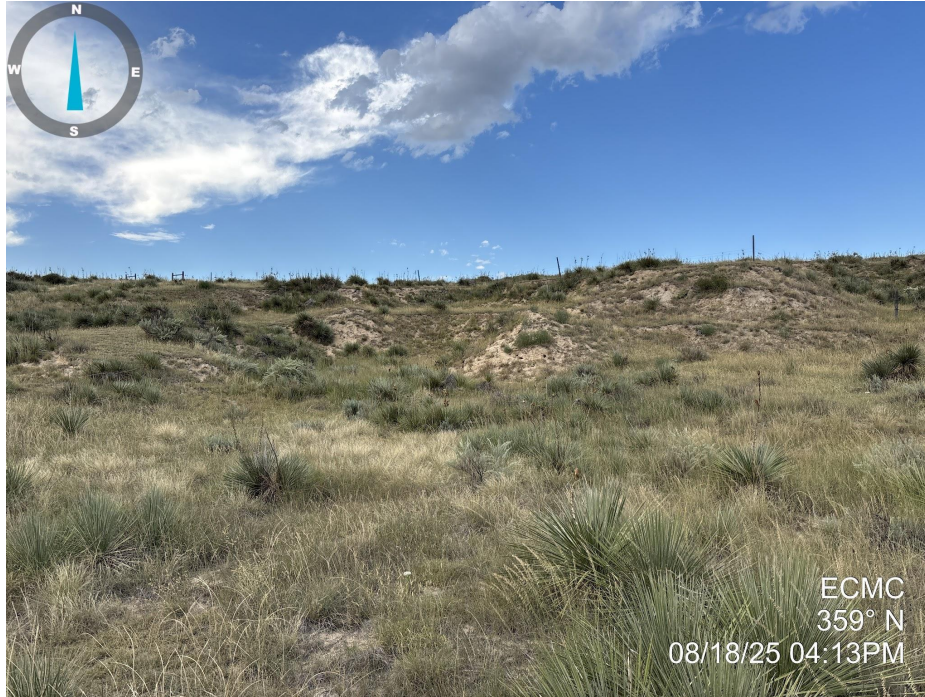
Photo 1. Photo taken from the well location, facing north. Photo illustrates that final reclamation meets Rule 1004 standards at the well location. However, the location does not meet reclamation regulations as stormwater erosion was observed along the access road.

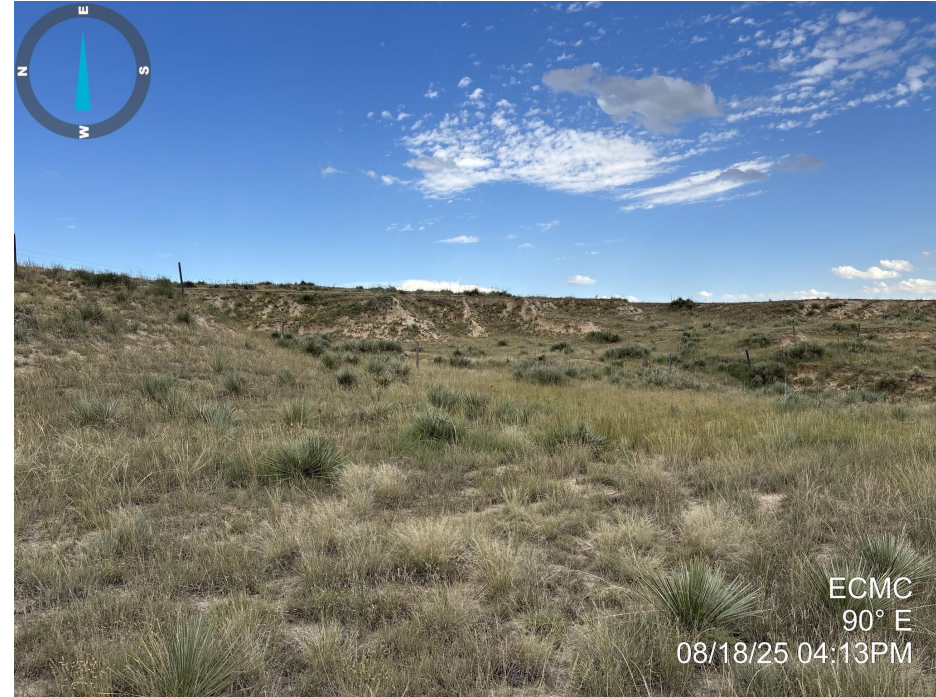
Photo 2. Photo taken from the well location, facing east. See comments under Photo 1.

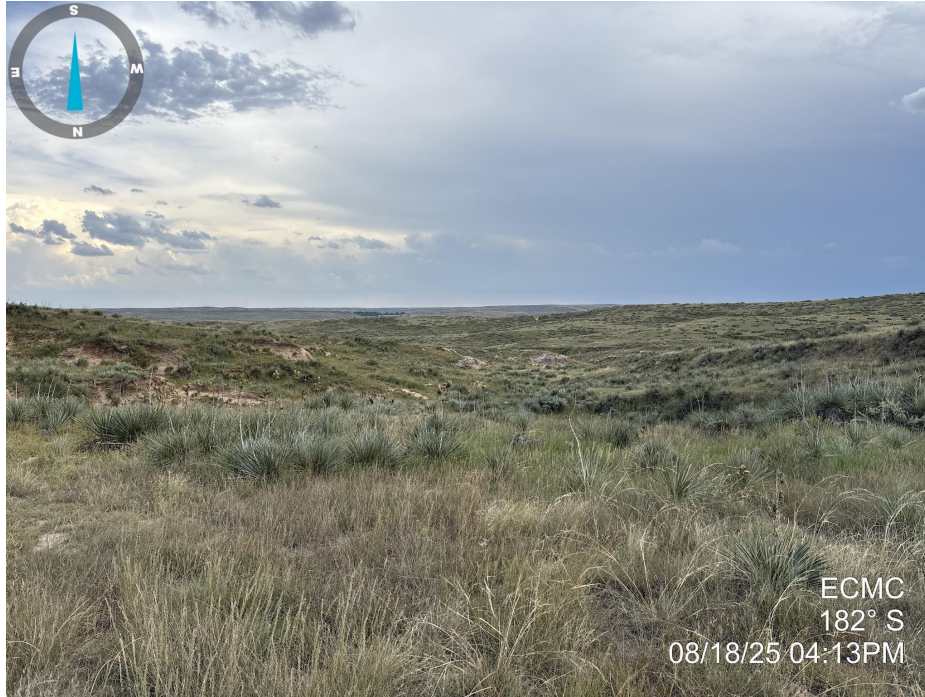
Photo 3. Photo taken from the well location, facing south. See comments under Photo 1.

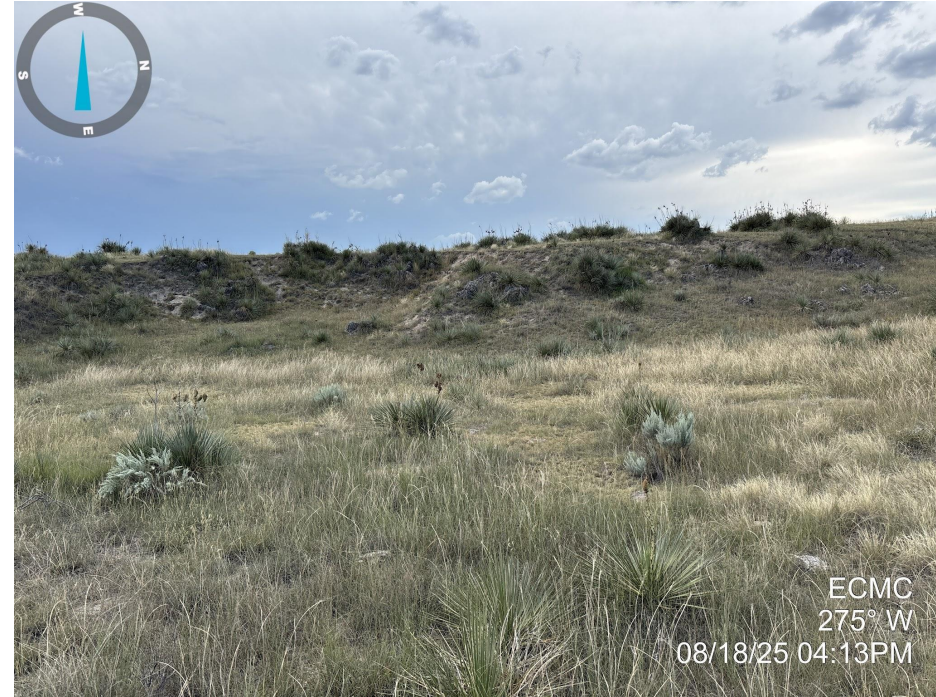
Photo 4. Photo taken from the well location, facing west. See comments under Photo 1.

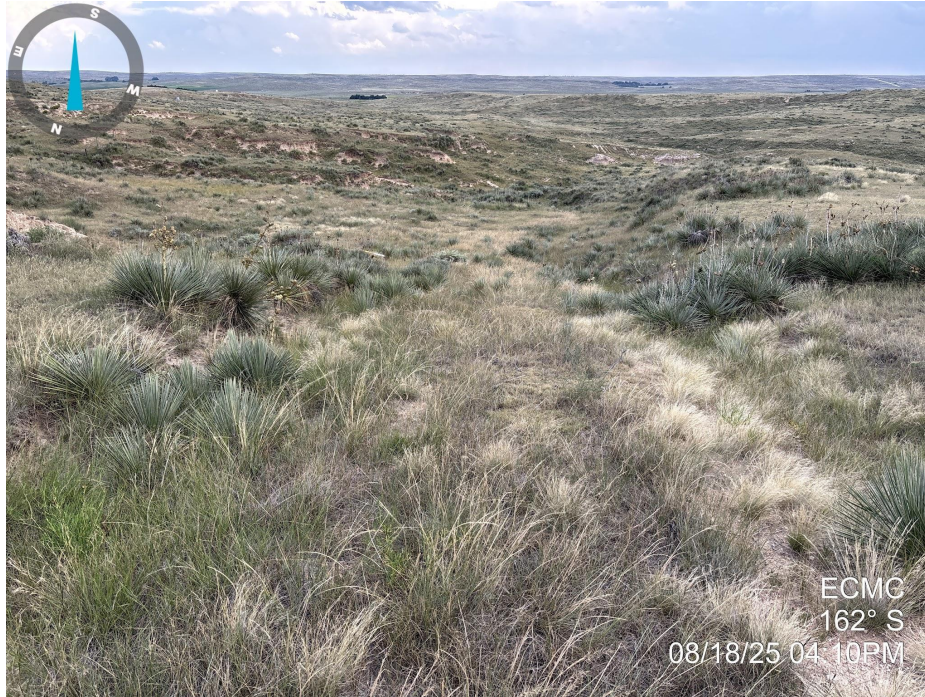
Photo 5. Photo taken of the access road to the well location, facing south, towards the location. Photo illustrates that final reclamation activities have taken place, but the road appears to have not been contoured and gravel remains. Stormwater erosion was observed along the access road.

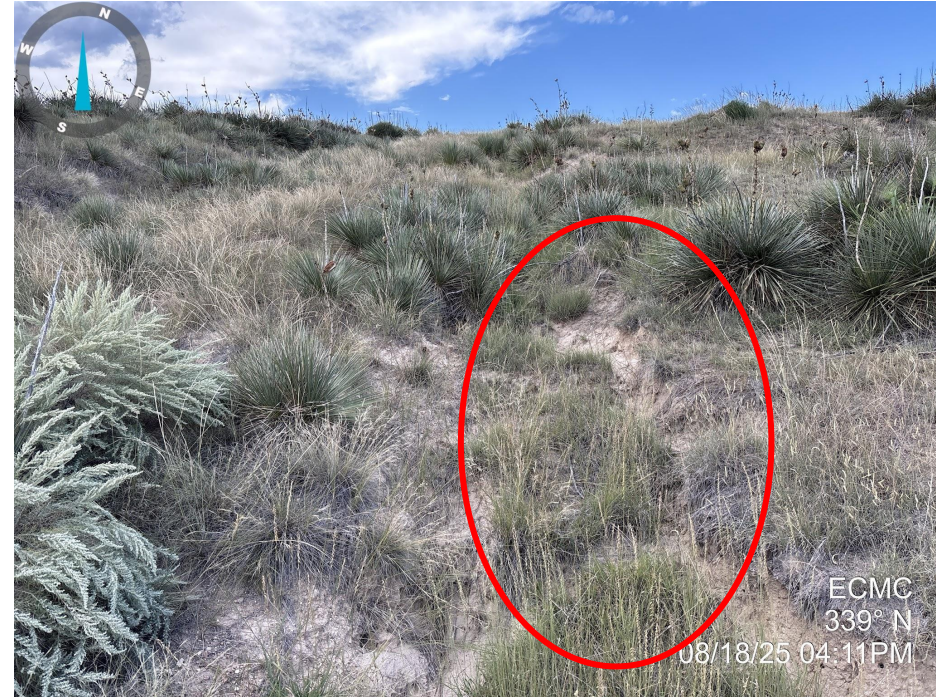
Photo 6. Photo taken of the access road to the well location, facing north, away from the location. Photo illustrates stormwater erosion, highlighted in red.

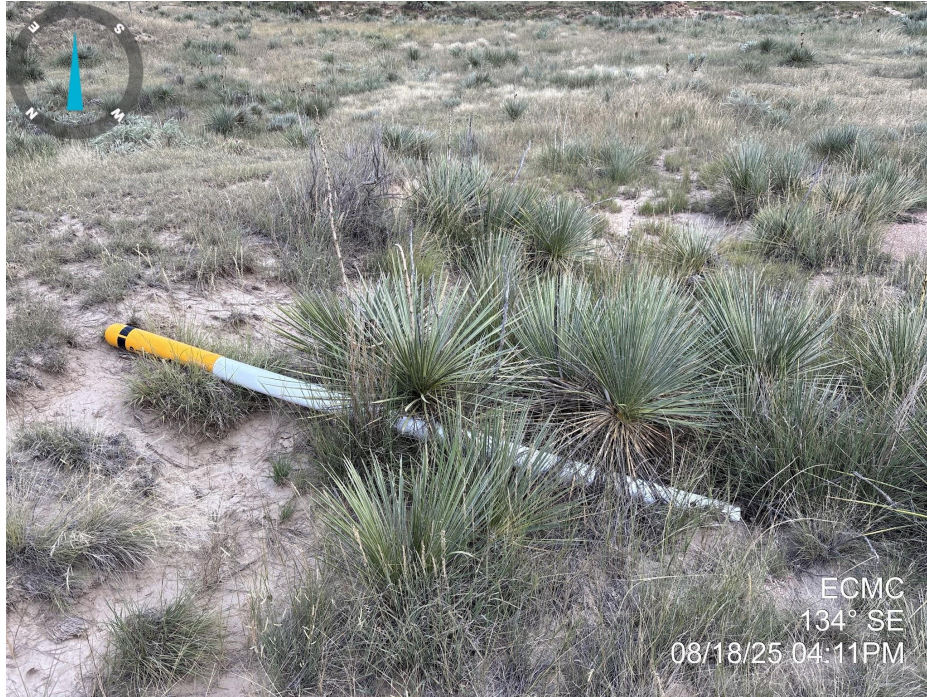
Photo 7. Photo taken from the access road, facing southeast. Photo illustrates midstream equipment that has fallen over.

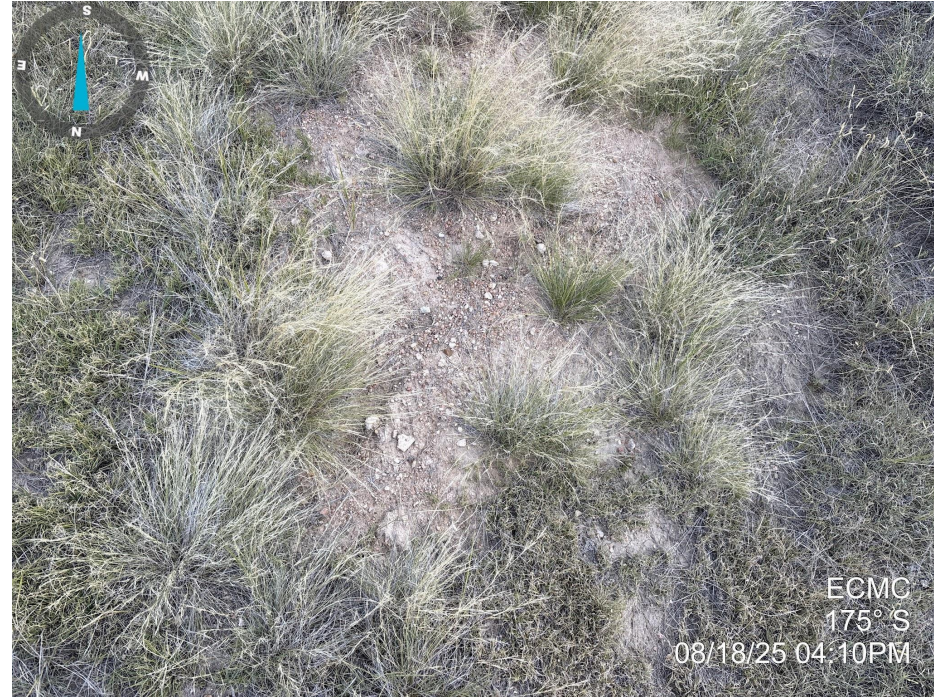
Photo 8. Photo taken of ground cover along the access road. Photo illustrates that gravel remains, but vegetation has established to Rule 1004 standards.

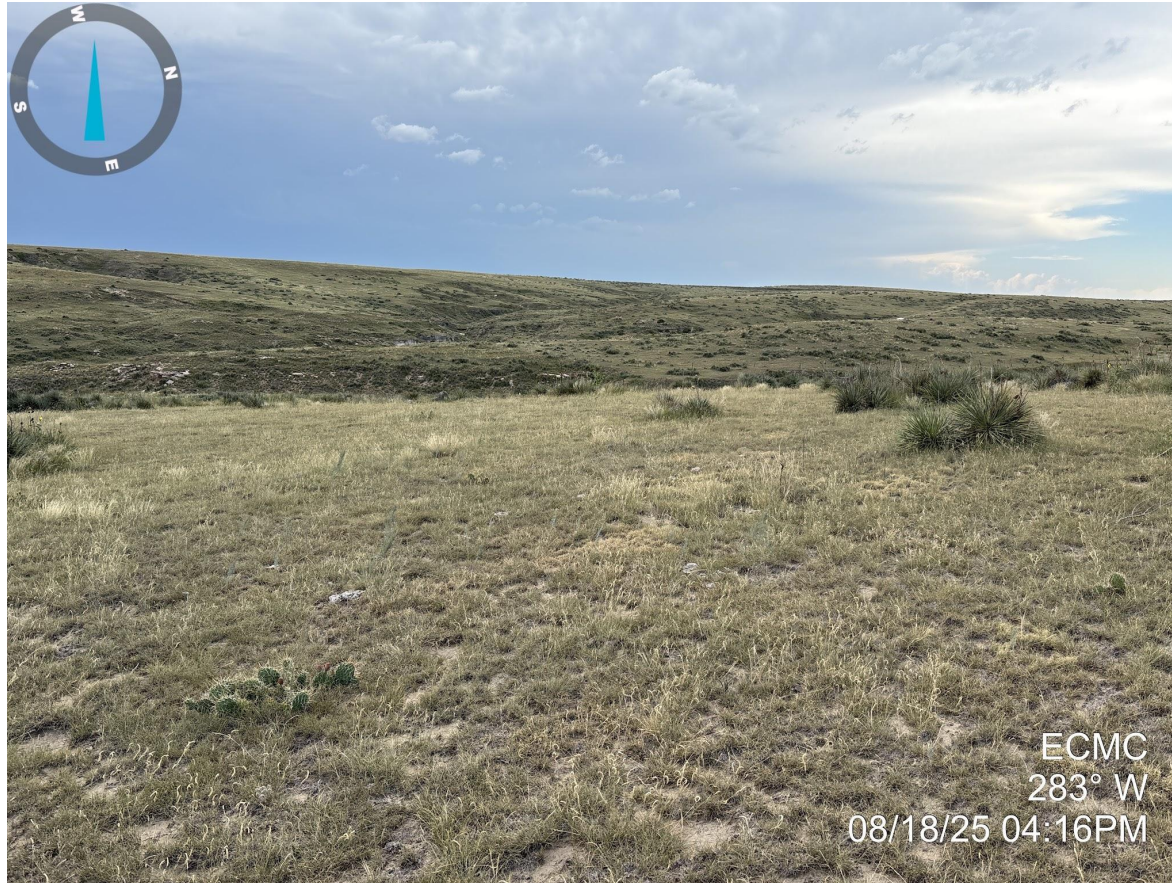
Photo 9. Photo taken of the reference area to the location, northwest of the location, facing west. Photo illustrates perennial grass vegetation.
