WELL NAME: COSWORTH FEDERAL 31-23, API #: 071-09201, INSP. # 716301548

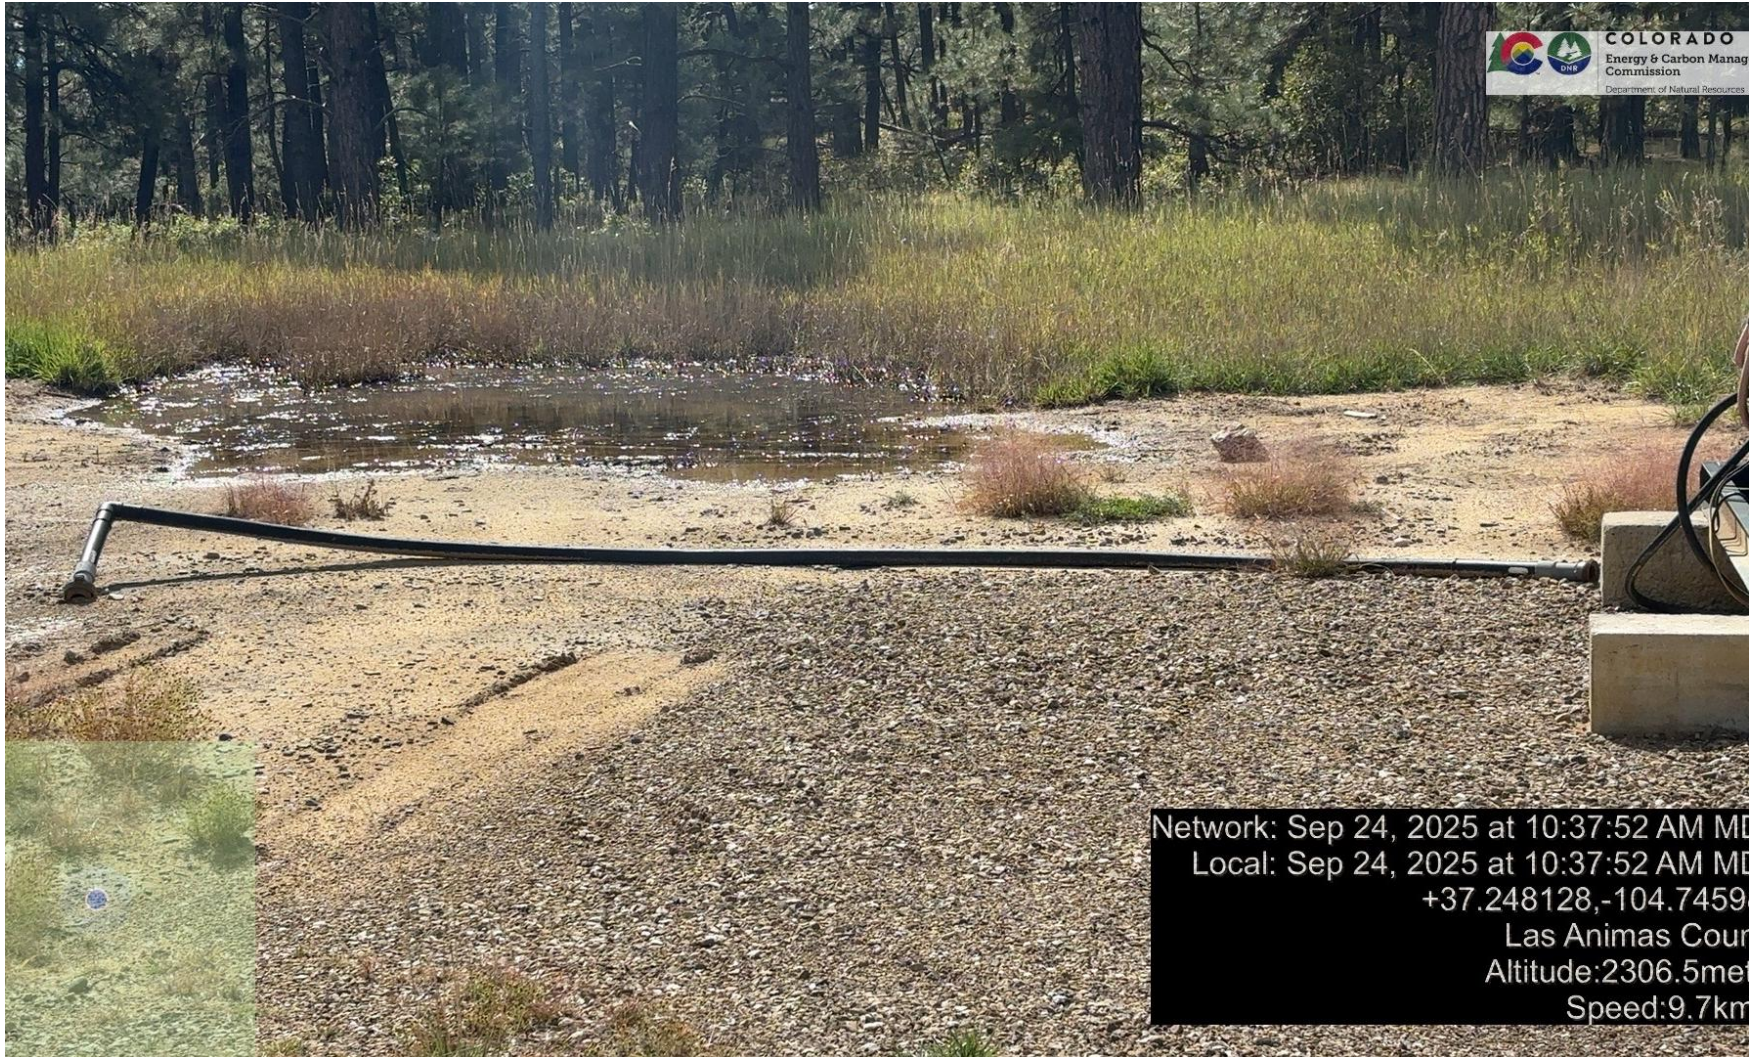
PHOTO 3: UNUSED 2" POLY PIPE STORED ON LOCATION. REMOVE UNUSED EQUIPMENT PER RULE 606. CA DATE 10-24-2025.

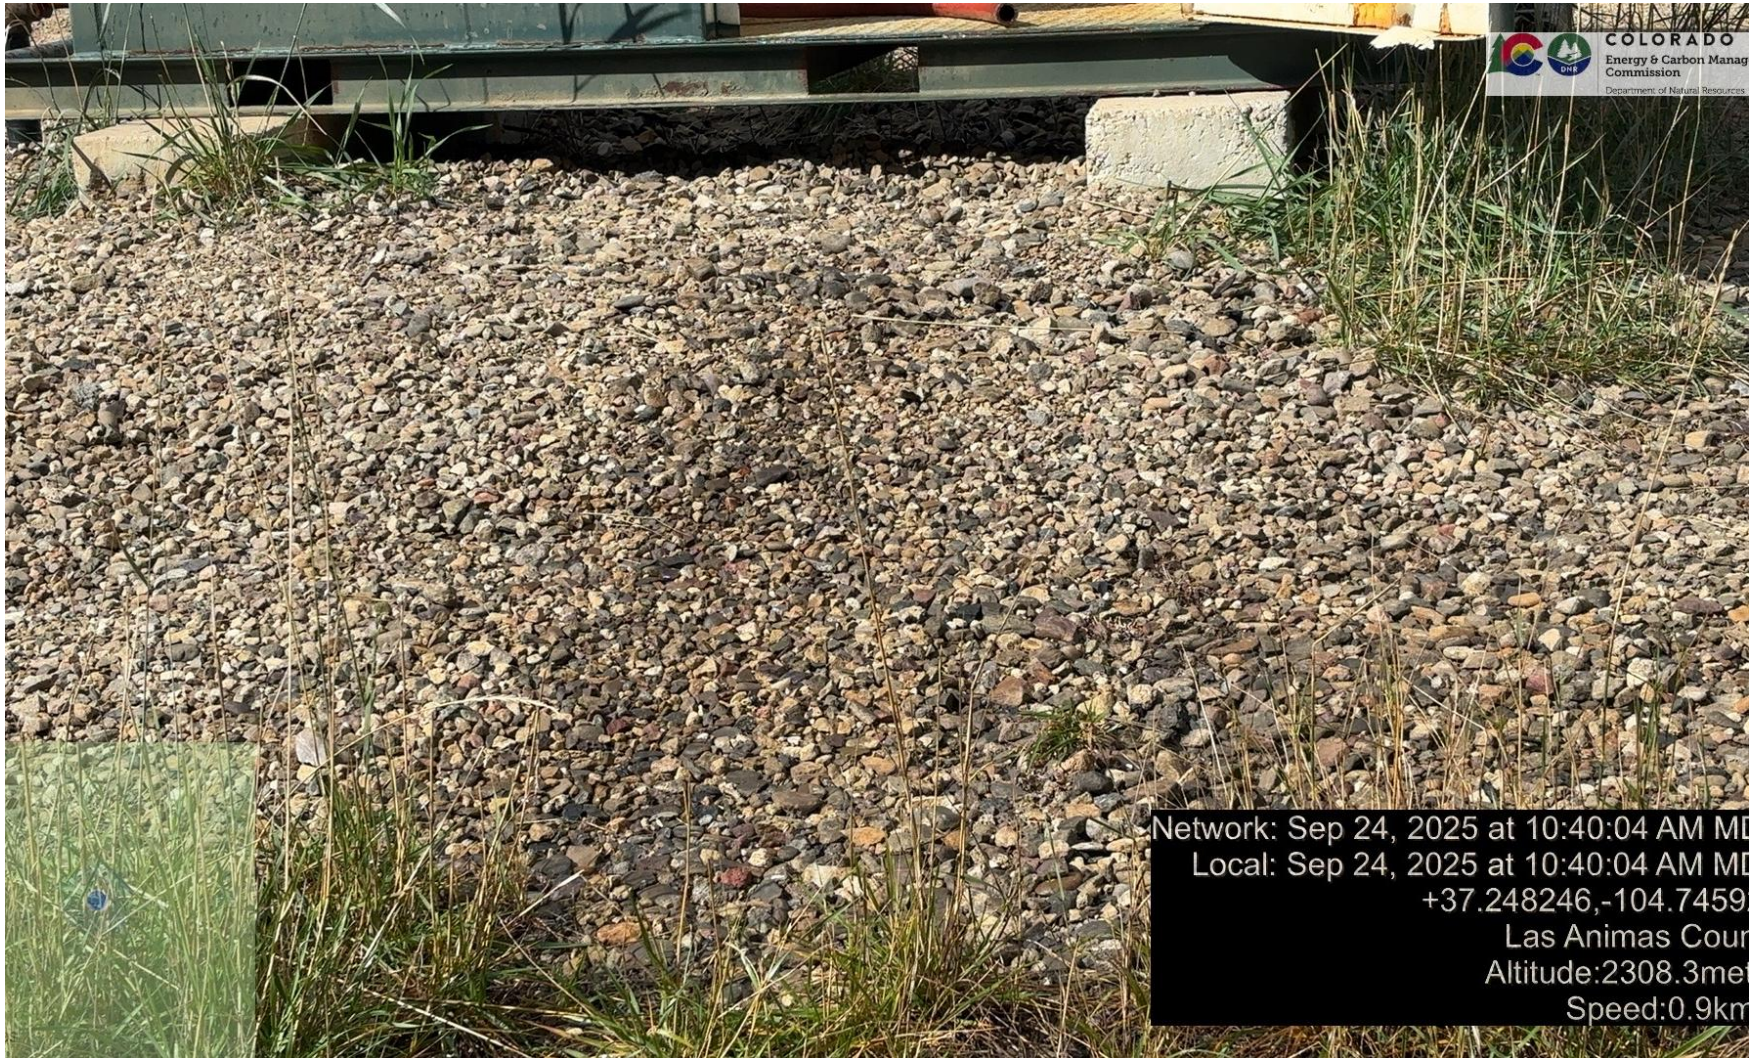
PHOTO 4: AREA OF IMPACTED SOIL OUTSIDE OF SEPARATOR HOUSE APPEARS TO BE FROM DRAINING SEPARATOR ON THE GROUND. IMMEDIATELY DISCONTINUE DRAINING OILY WATER FROM SEPARATOR INTO LOCATION AND Conduct maintenance on equipment, cleanup stained material and review self inspection processes. COMPLY WITH RULE 1002,.(2).D. CA DATE 10-24-2025.

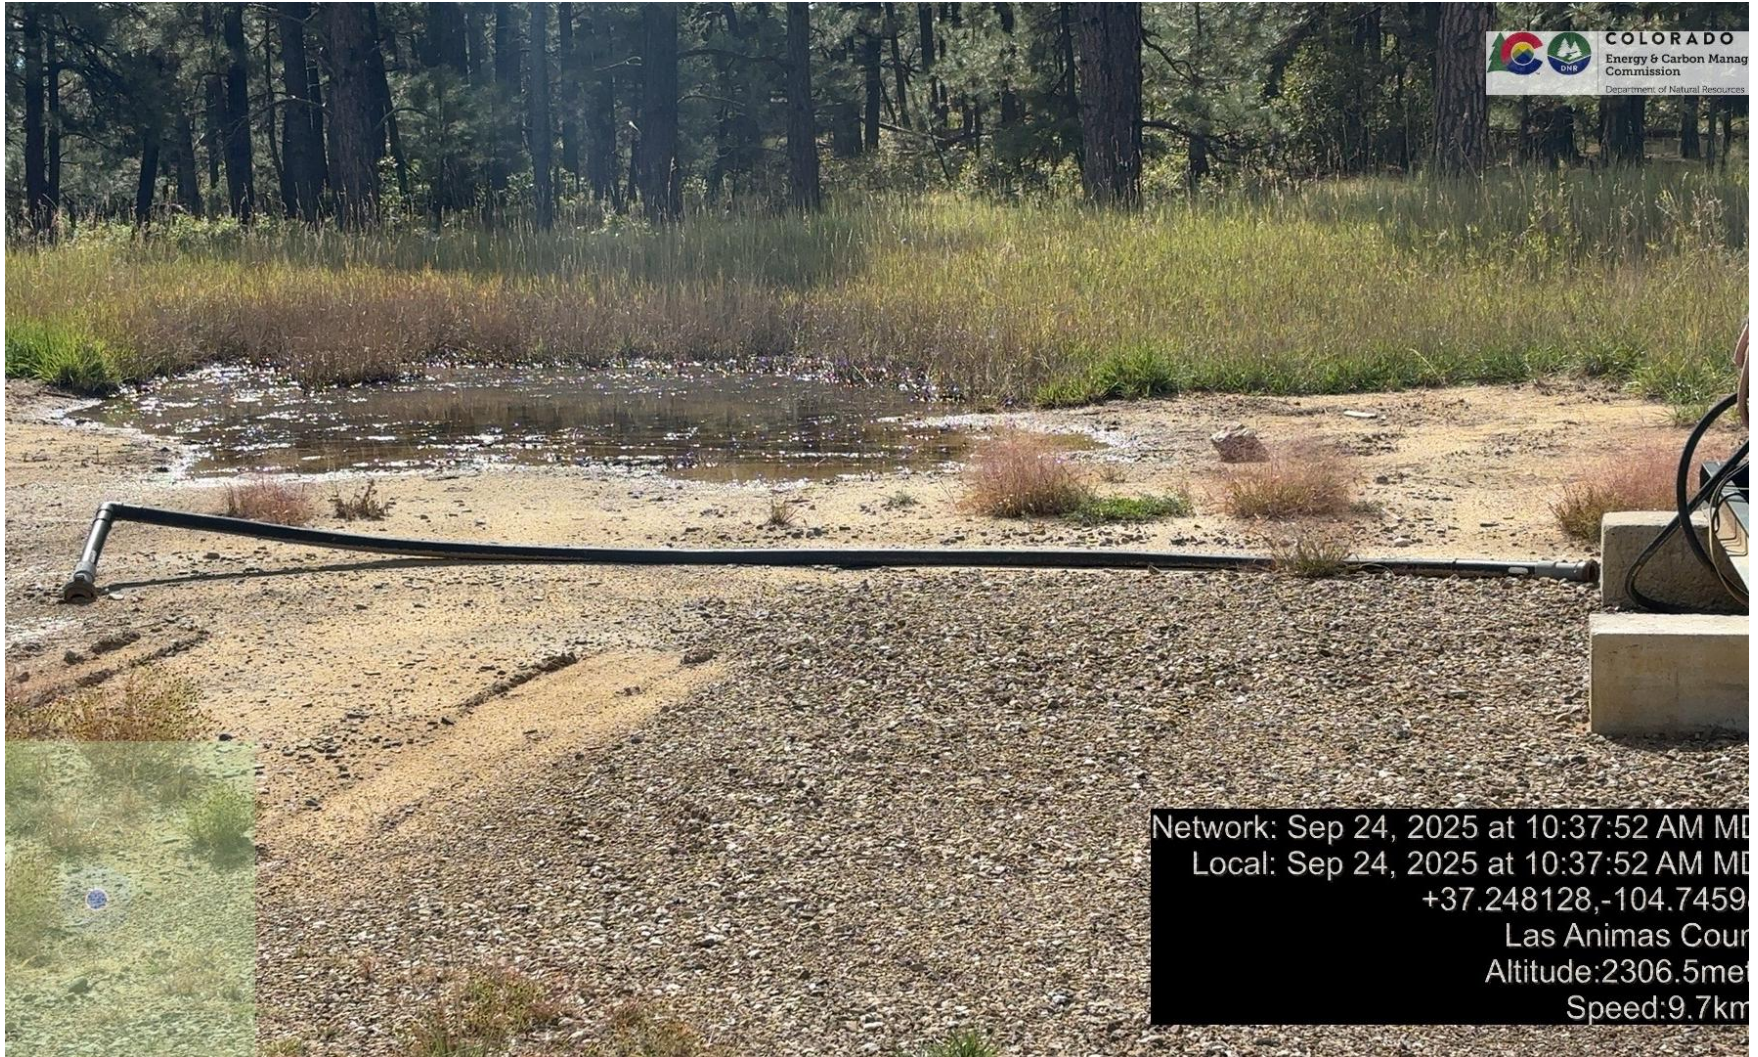
PHOTO 5: THE STORMWATER POOLING ON LOCATION SHOULD BE DRAINED. INSTALL AND MAINTAIN BMP'S TO PREVENT STORMWATER POOLING ON LOCATIONS PER 1002 SERIES RULES. CA DATE 10-24-2025.
