Storm Water Management and Erosion control
Location Name: TEP ROCKY MOUNTAIN LLC AP 22-24-696 Pad
Location ID: 335485

**Location Overview: Location is within Black Bear Habitat area
& in close proximity to High Priority/Density Habitat areas.
Location is approximately 377 yards from Rule 411a Surface
Water External Buffer**

Section/Township/Range: 24 6S96W

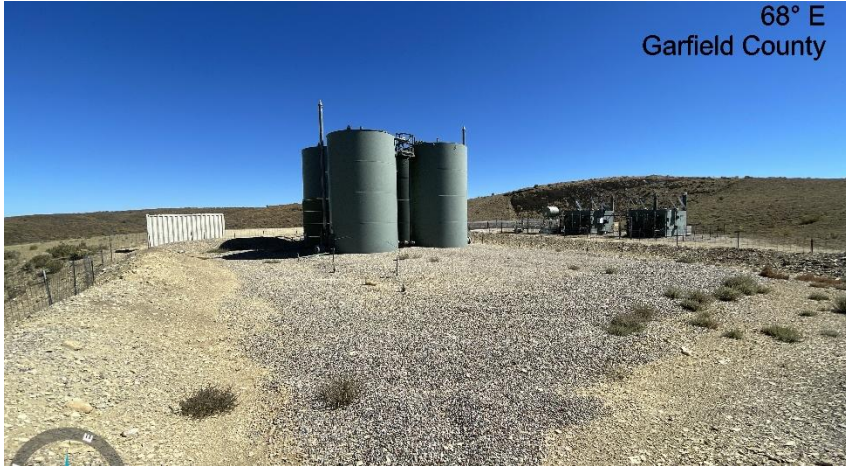
North West corner of location.

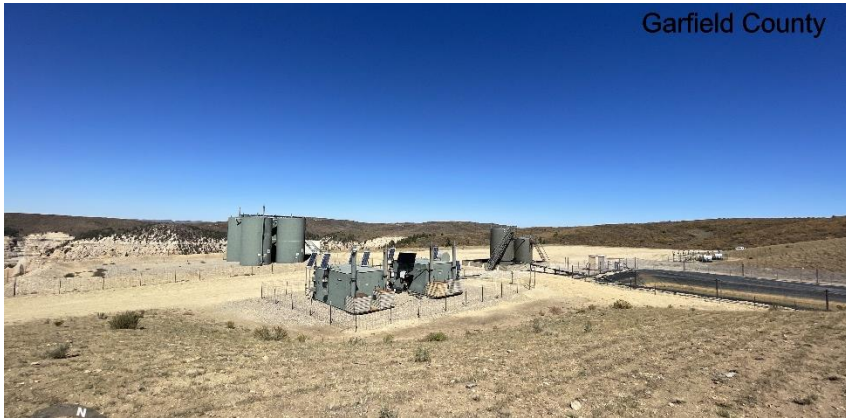
South West corner of location.

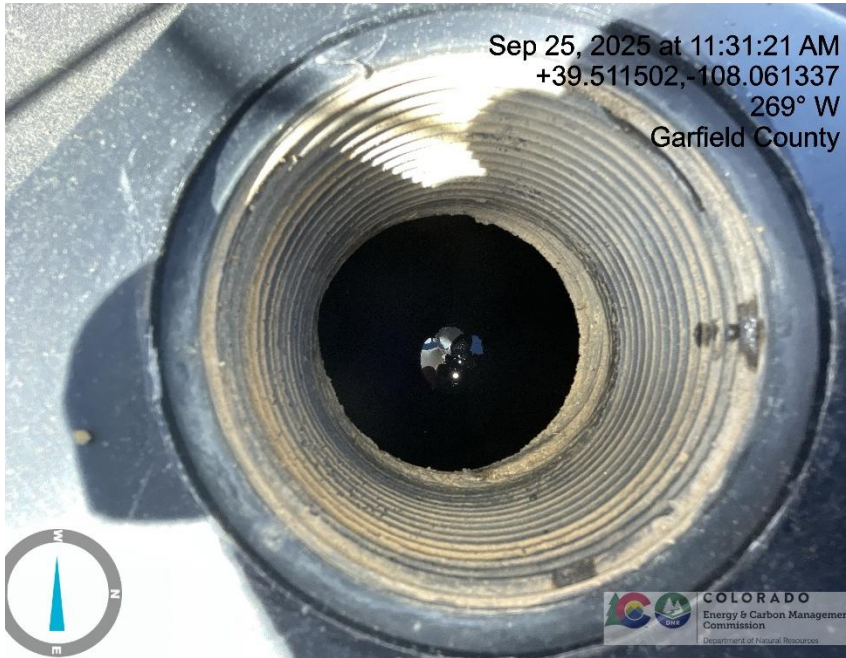
Photo # 2548 Failure to maintain chemical BMP – Chemical tank containment approximately 3/4 full of fluid/BMP insufficient to contain possible spill

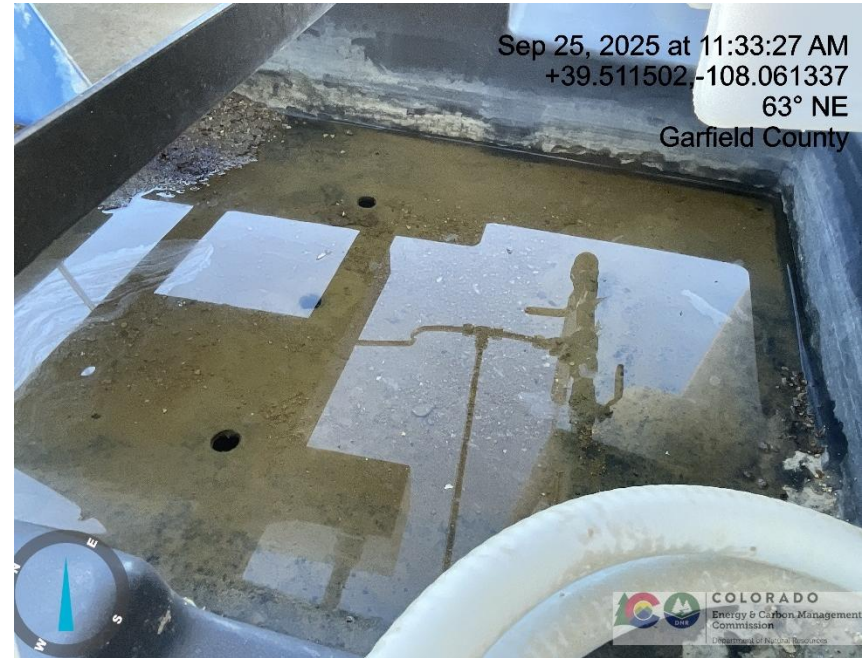
Photo # 2549 Failure to maintain chemical BMP – Chemical tank containment approximately 3/4 full of fluid/BMP insufficient to contain possible spill (Additionally standing fluid on containment constitutes a wildlife hazard)

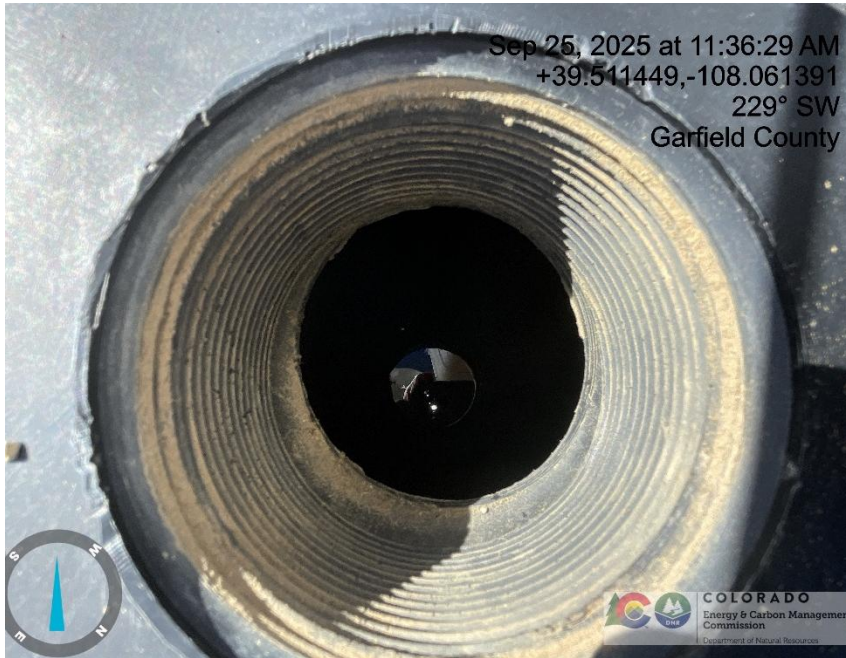
Photo # 2550 Failure to maintain chemical BMP – Chemical tank containment approximately 3/4 full of fluid/BMP insufficient to contain possible spill

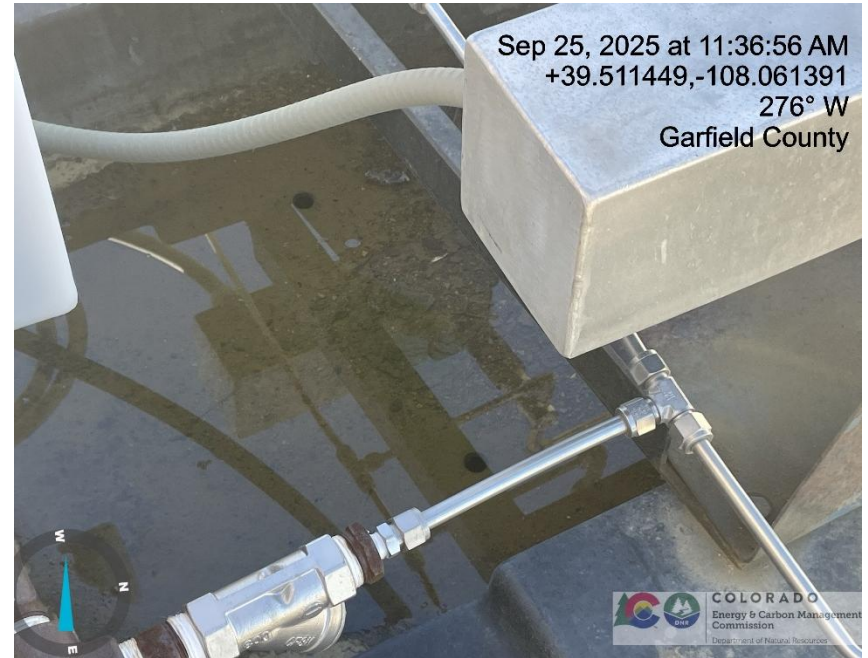
Photo # 2551 Failure to maintain chemical BMP – Chemical tank containment approximately 3/4 full of fluid/BMP insufficient to contain possible spill (Additionally standing fluid on containment constitutes a wildlife hazard)
