Inspection Photos

Loc: 485921

Operator: WAVETECH HELIUM INC

Inspection Date: 9/24/2025

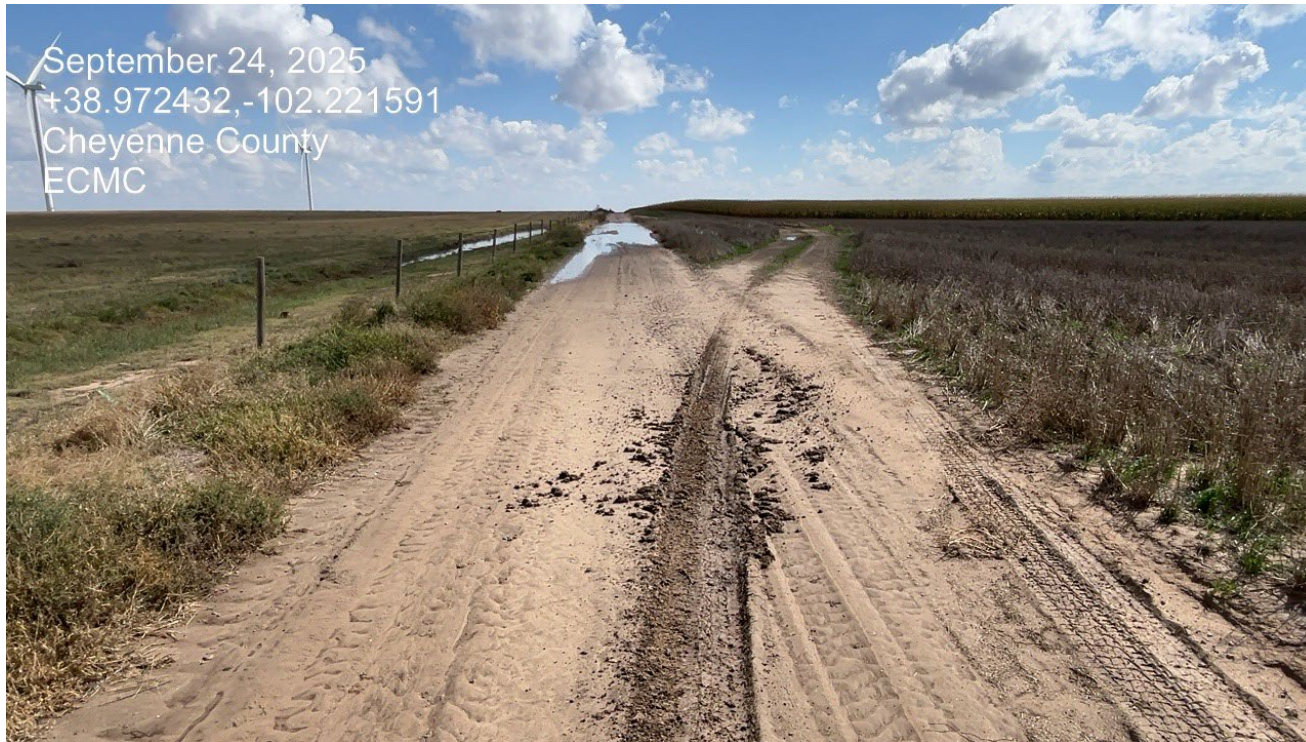
Photo 1. Facing east along the access road. There is water pooling on the road and vehicles are driving outside of the road causing unnecessary disturbance. The road must be constructed with BMP's.

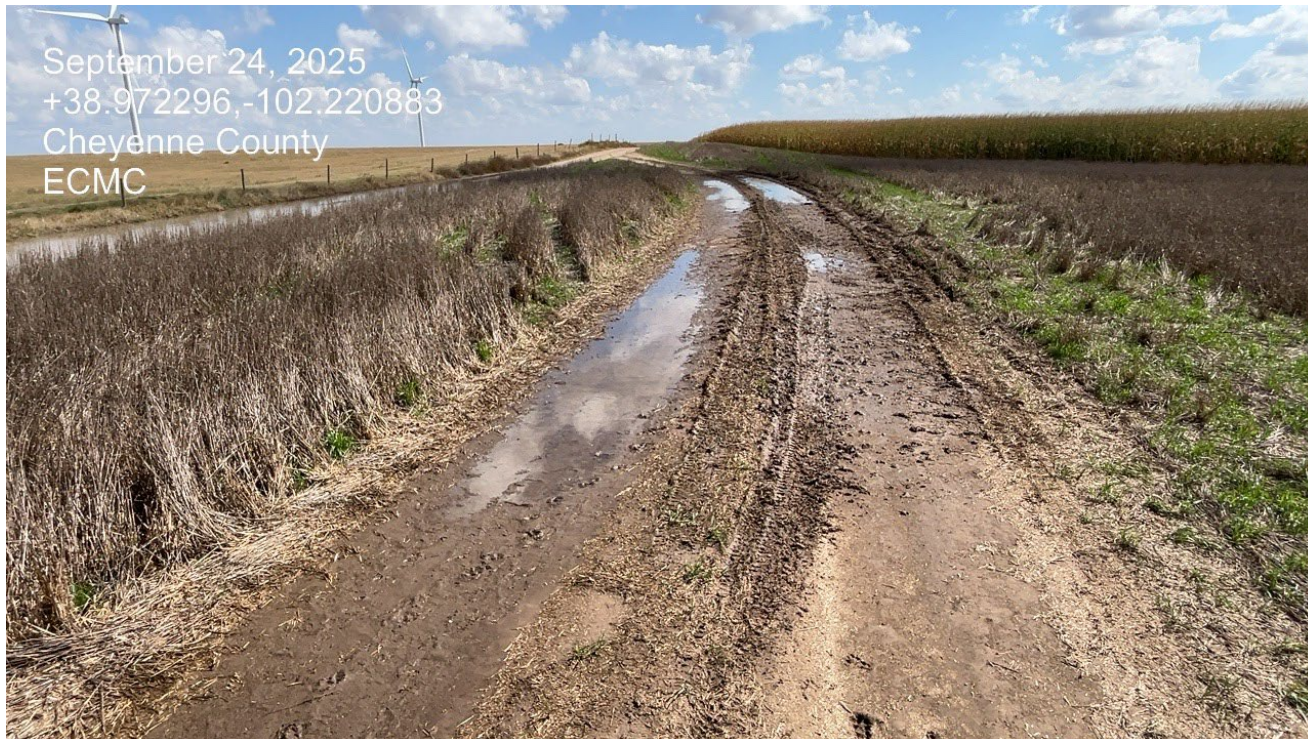
Photo 2. Facing east along the area where vehicles are driving off the designated road causing crop damage.

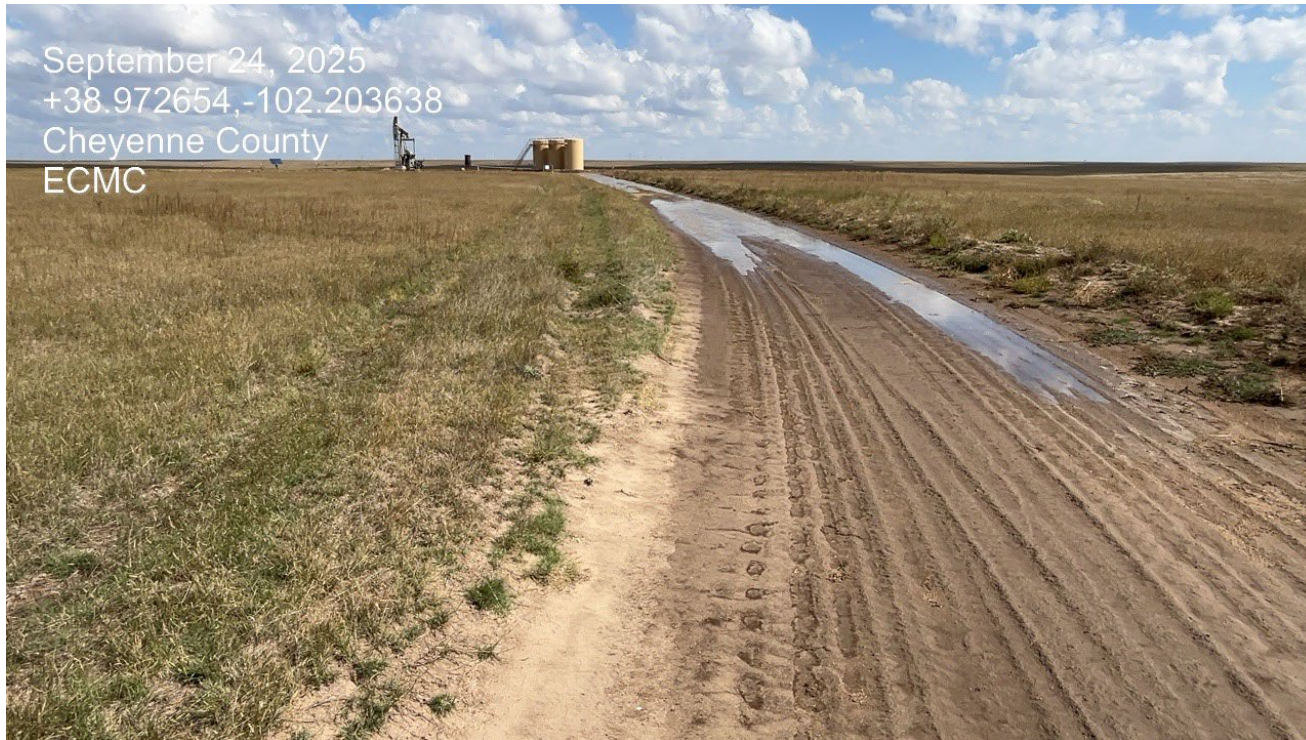
Photo 3. Facing northeast along the access road toward the drill site. There is water pooling on the road which is inaccessible. There are signs of vehicles driving off the access road causing disturbance. The road needs to be constructed with BMP's.

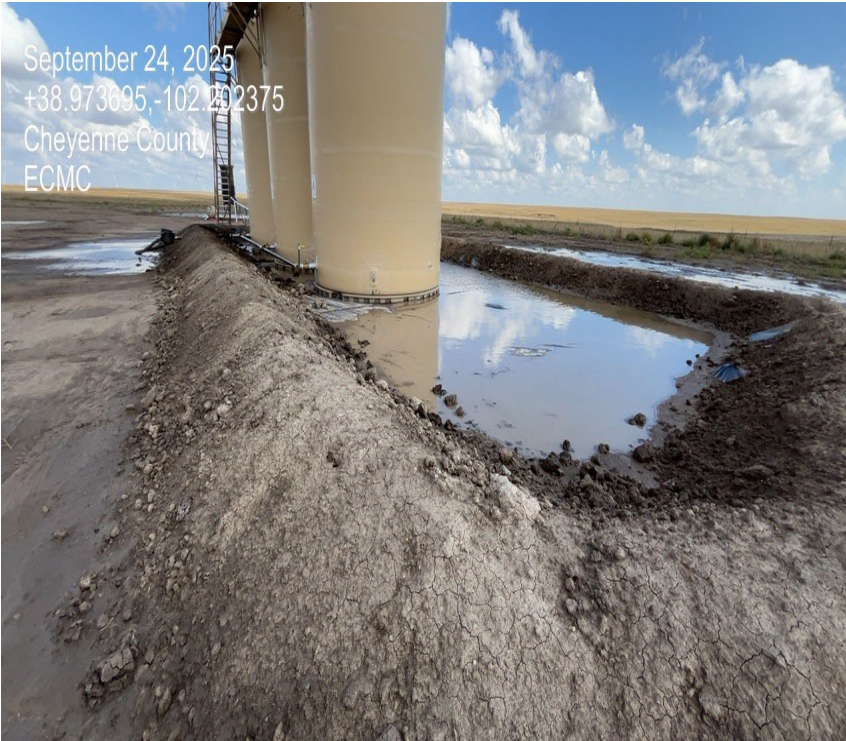
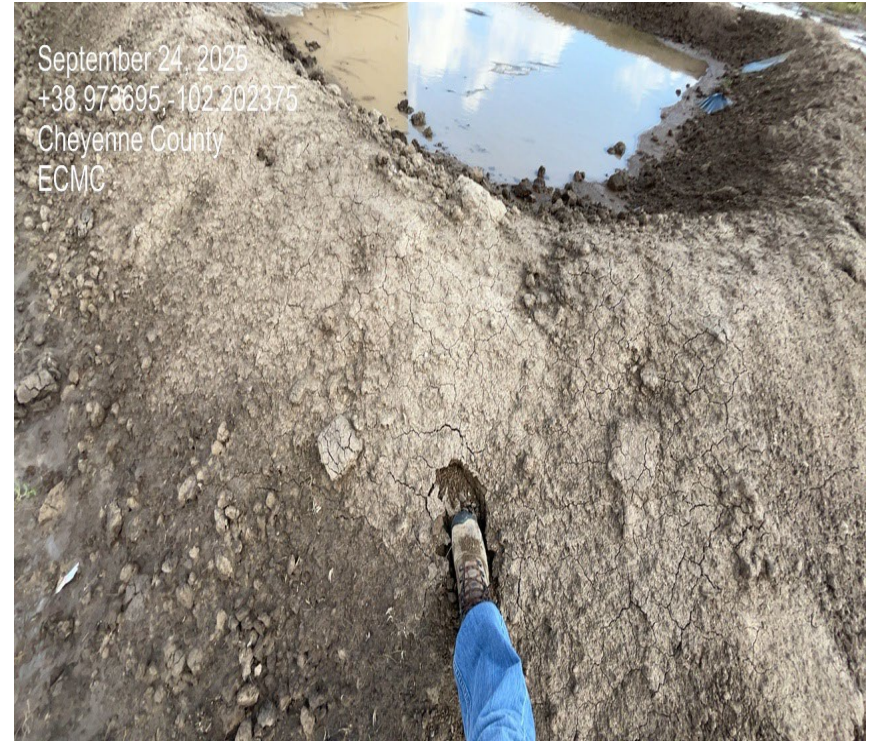
Photo 5. The tank battery earthen berm is not compacted to contain a spill.

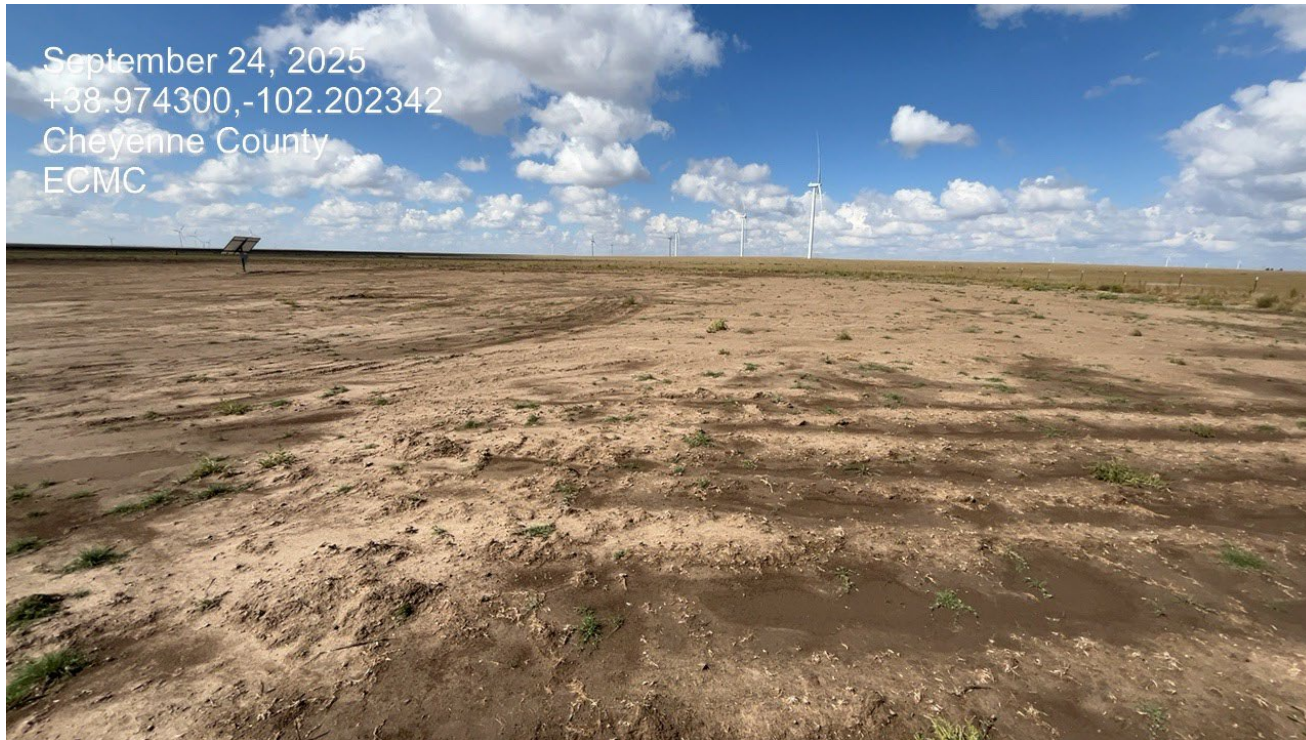
Photo 6. North side of the location facing west. The location has been recontoured but it does not appear reseeding has been performed.

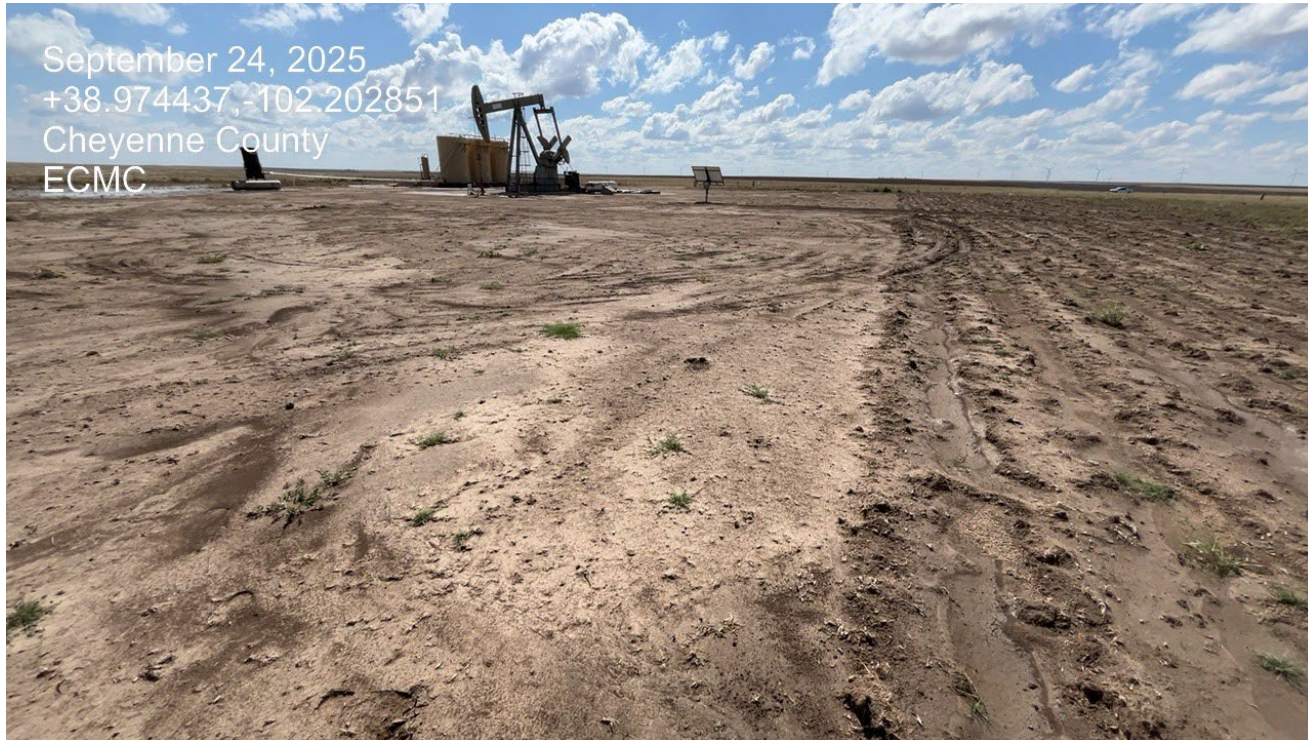
Photo 7. North side of the location facing south. All unused areas of the location will need to be reclaimed.
