# Inspection Photos

**Operator:** TEP Rocky Mountain LLC #96850

**Location ID:** 437879

**Inspection Doc:** 719200243

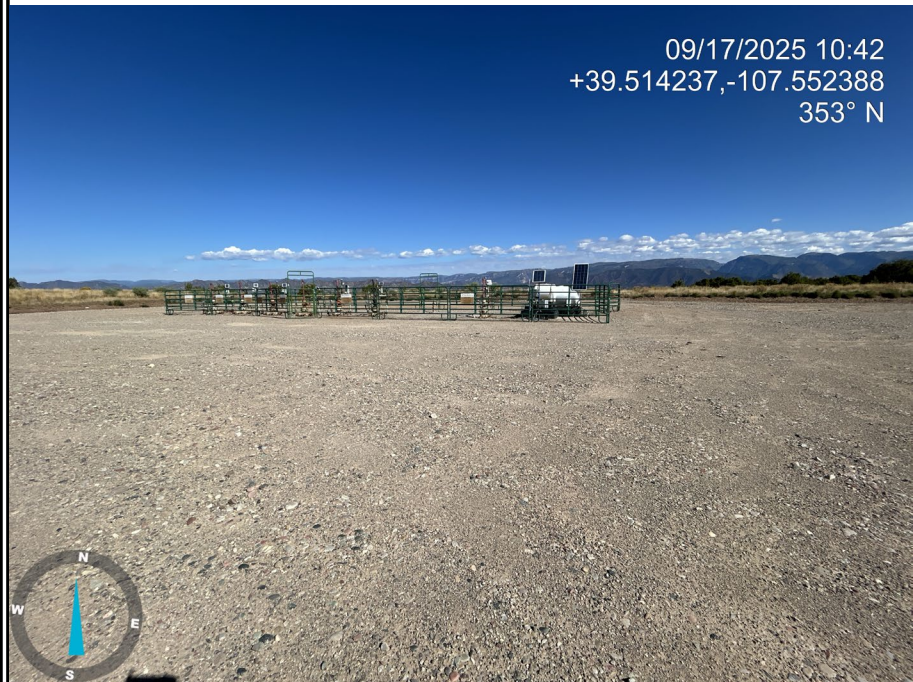
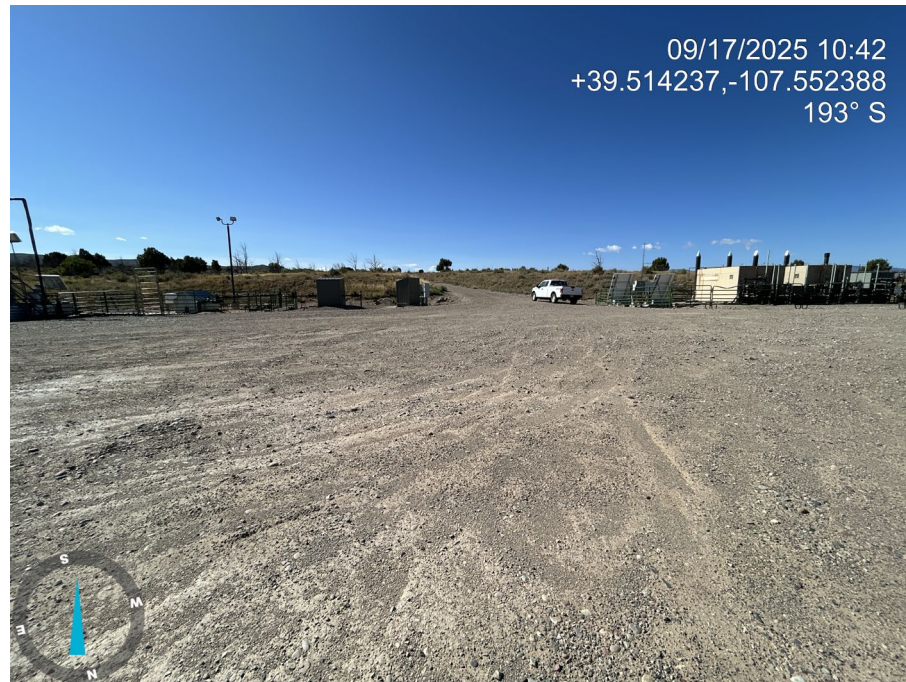
**Photo 1:** Photos showing an overview of the location looking north and south, respectively.

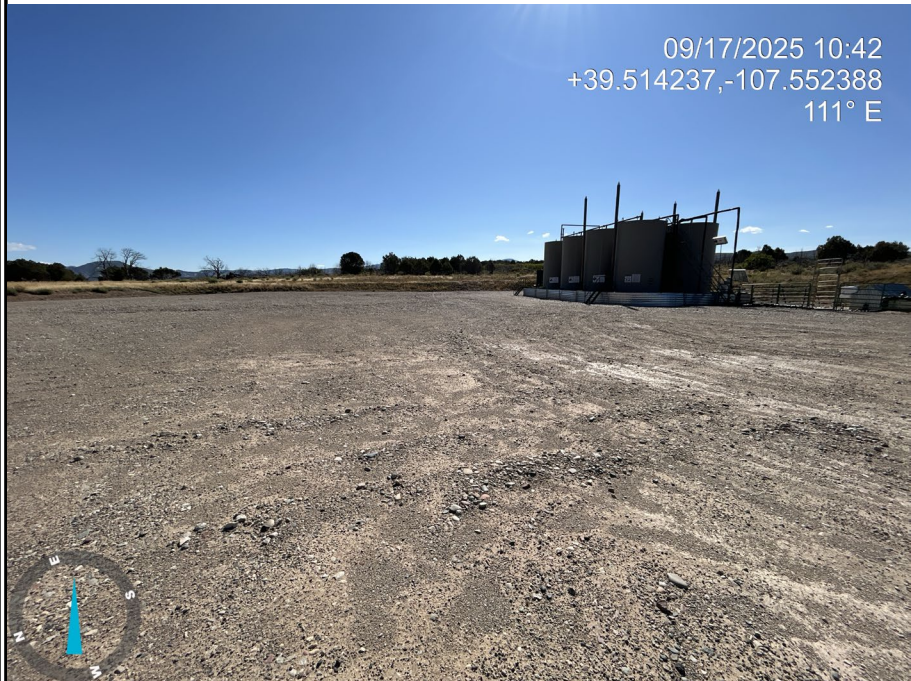
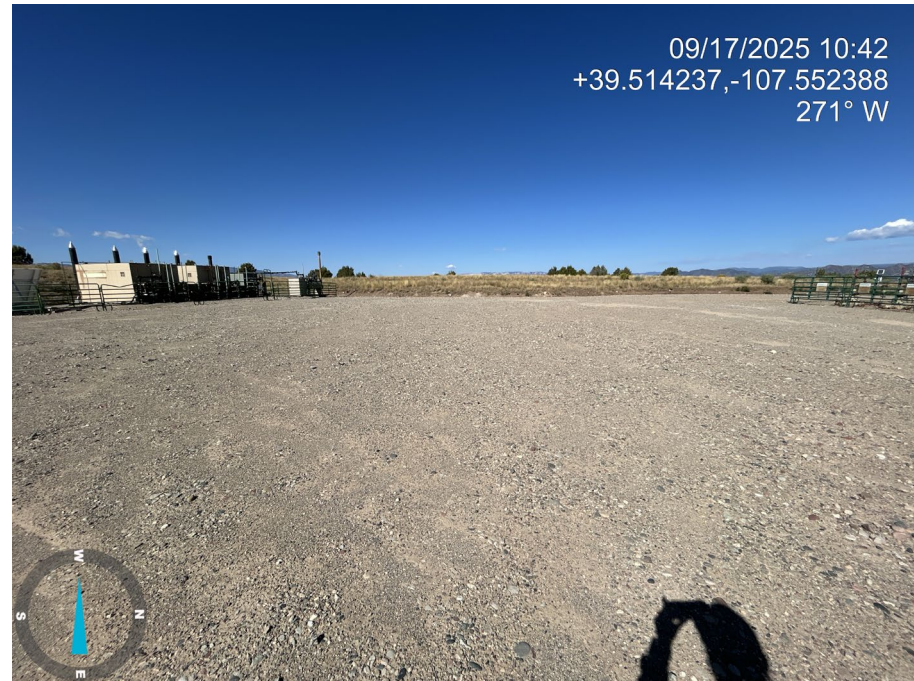
**Photo 2:** Photos showing an overview of the location looking east and west, respectively.

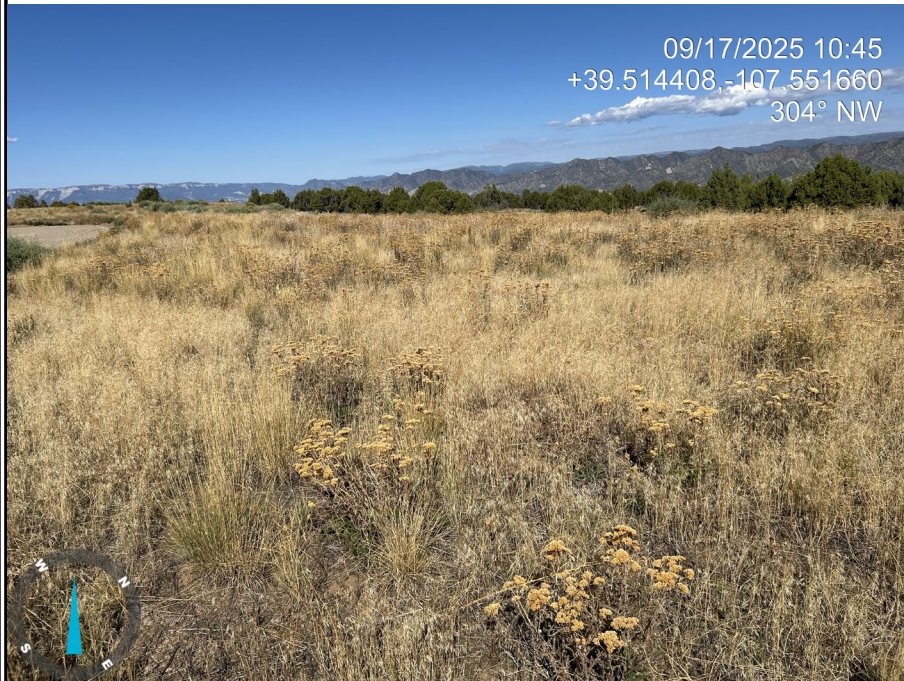
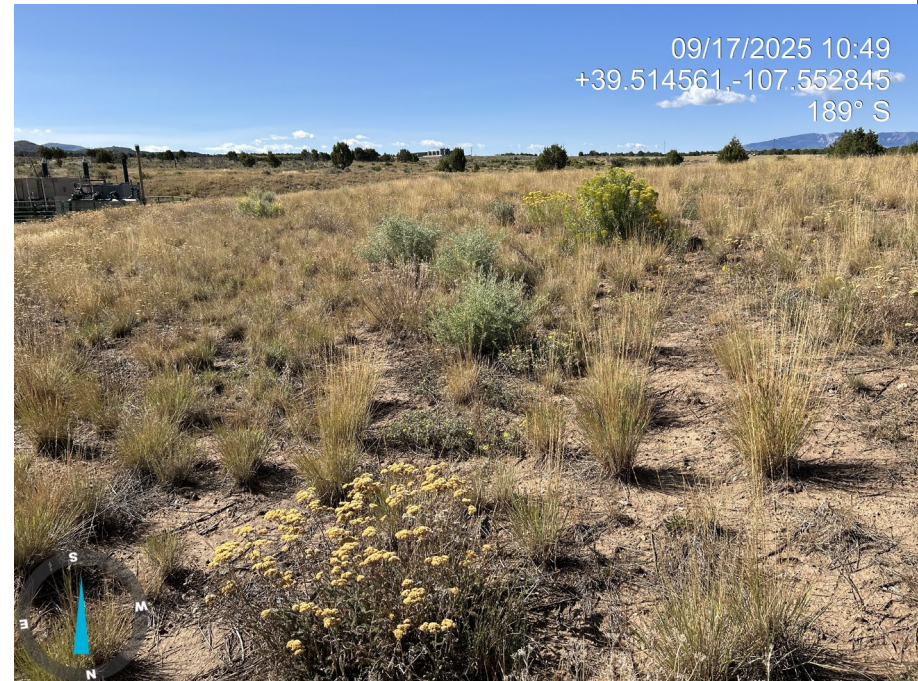
**Photo 3:** Interim areas are composed of common yarrow and slender wheatgrass with secondary amounts fourwing saltbush. Interim areas are In Process.

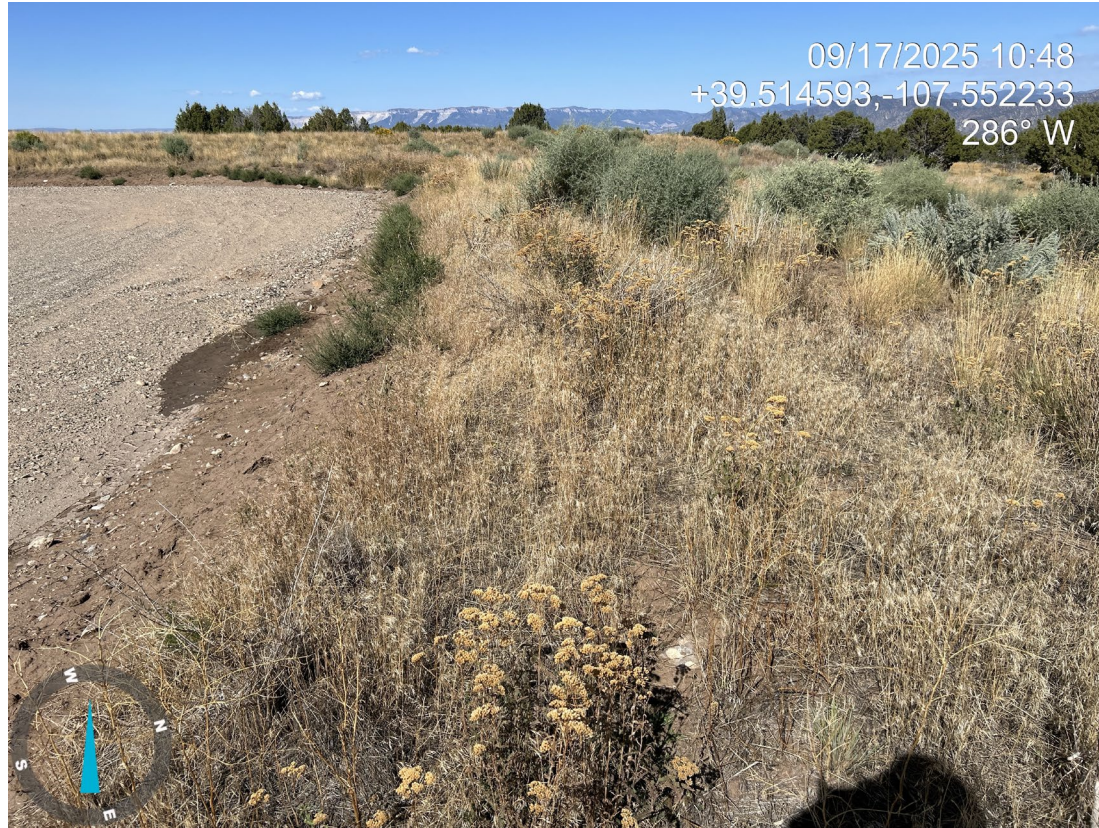
**Photo 4:** Cheatgrass has established on the margin of the working pad surface. Weed management is required. Comply with Rule 606.c.
