Inspection Photos

Operator: TEP Rocky Mountain LLC #96850

Location ID: 418061

Inspection Doc: 719200255

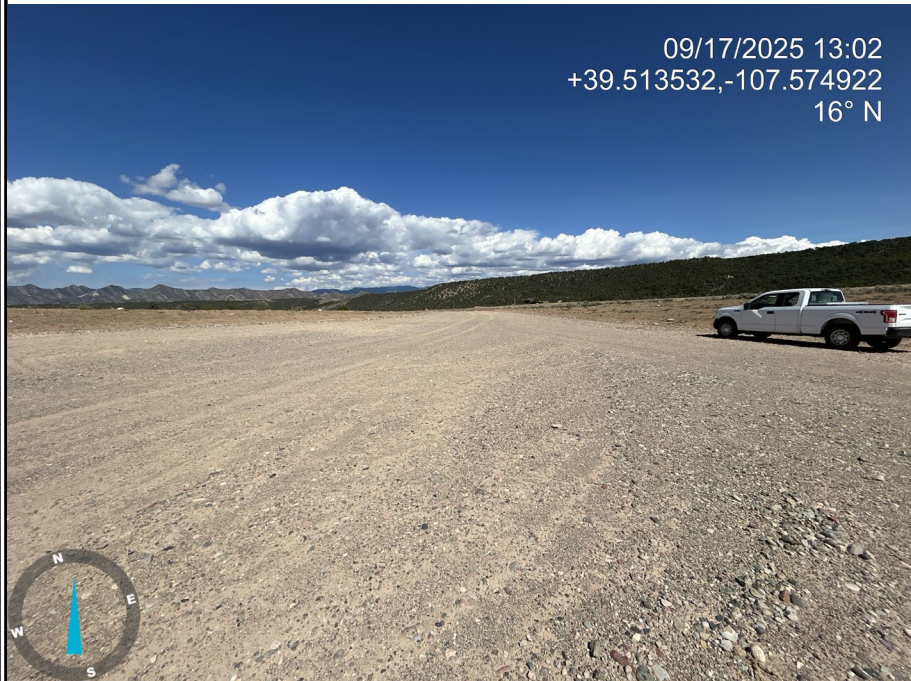
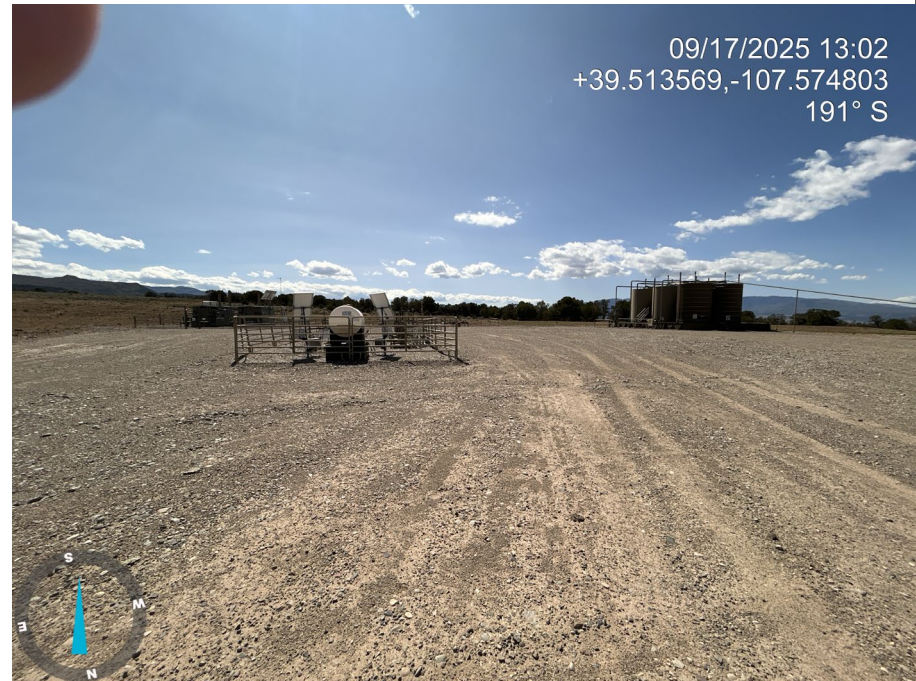
Photo 1: Photos showing an overview of the location looking north and south, respectively.

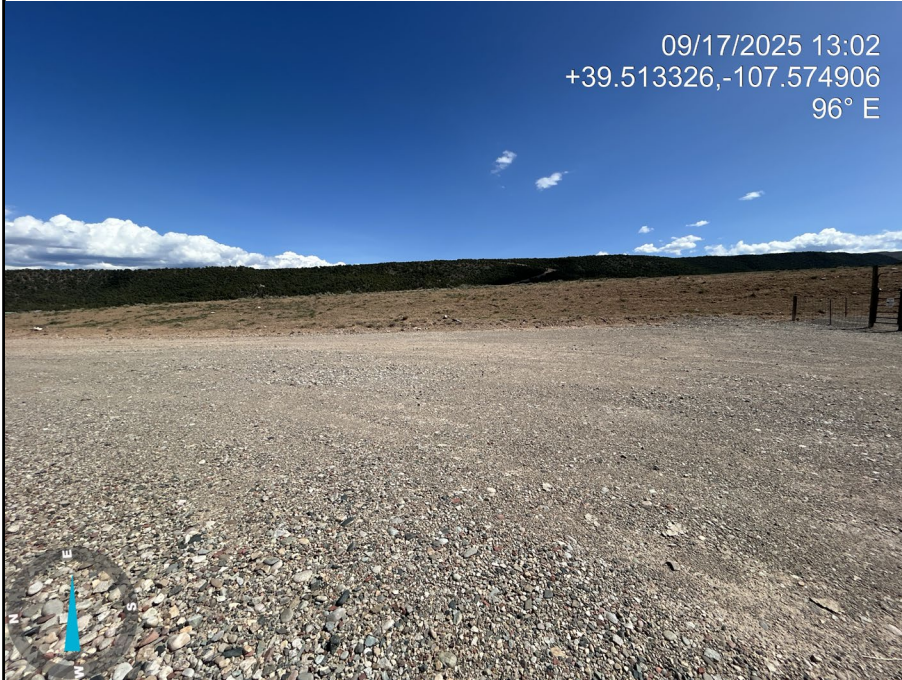
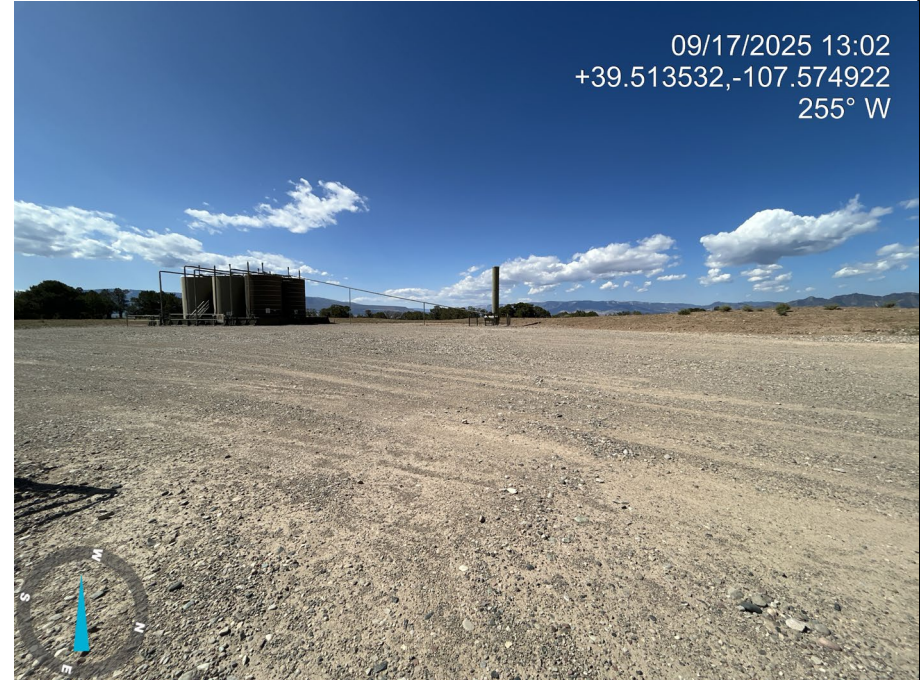
Photo 2: Photos showing an overview of the location looking east and west, respectively.

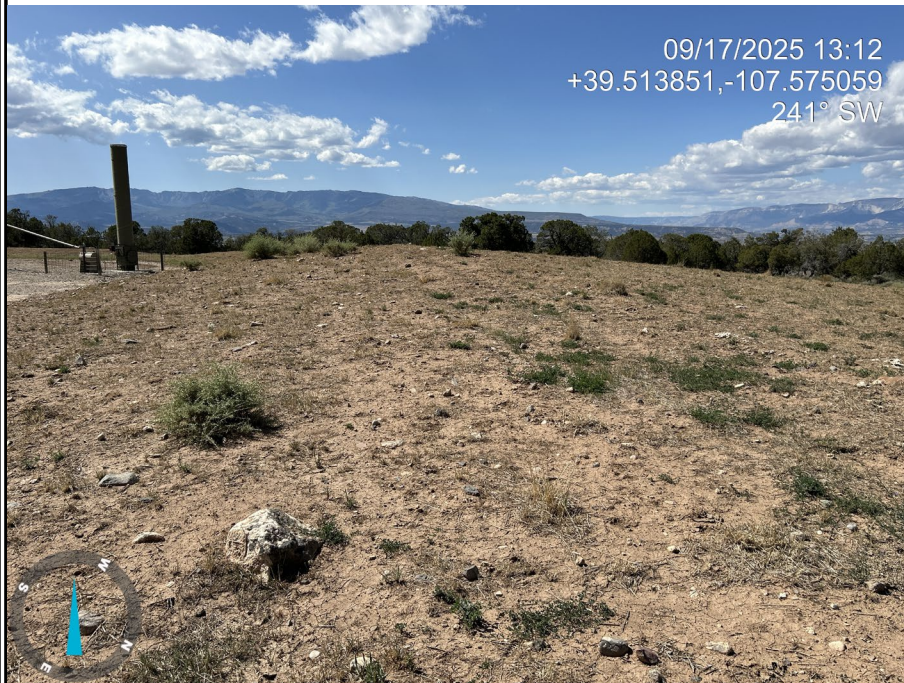
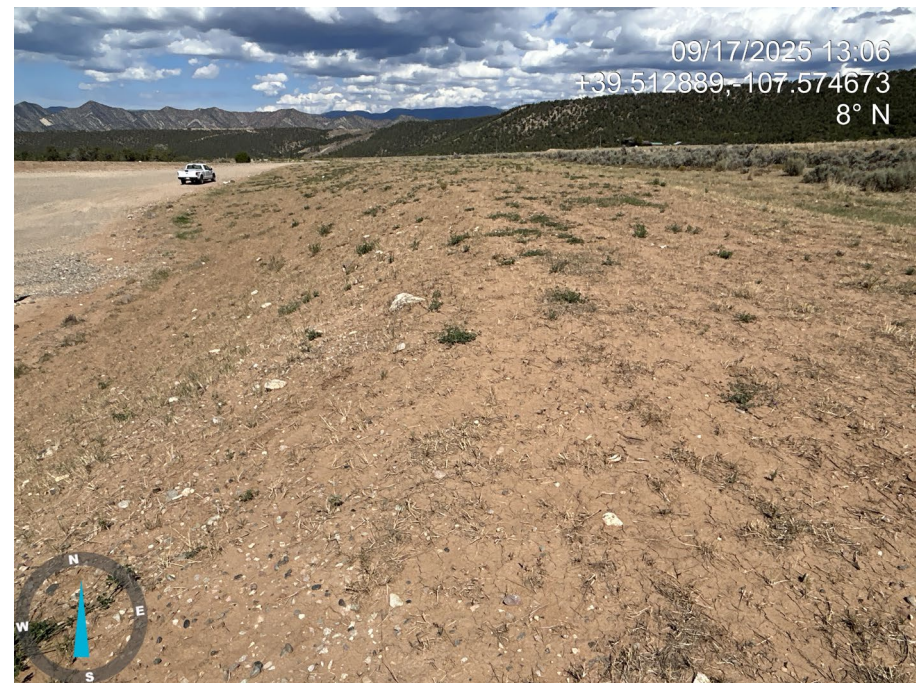
Photo 3: Photos showing an overview of the western and eastern interim areas. Heavy cattle use is evident. Some portions of the interim areas possess perennial vegetation; however, uniformity and progression towards eighty (80) percent is not evident. Other areas remain predominantly bare. Comply with 1003 series rules and conduct additional reclamation efforts.

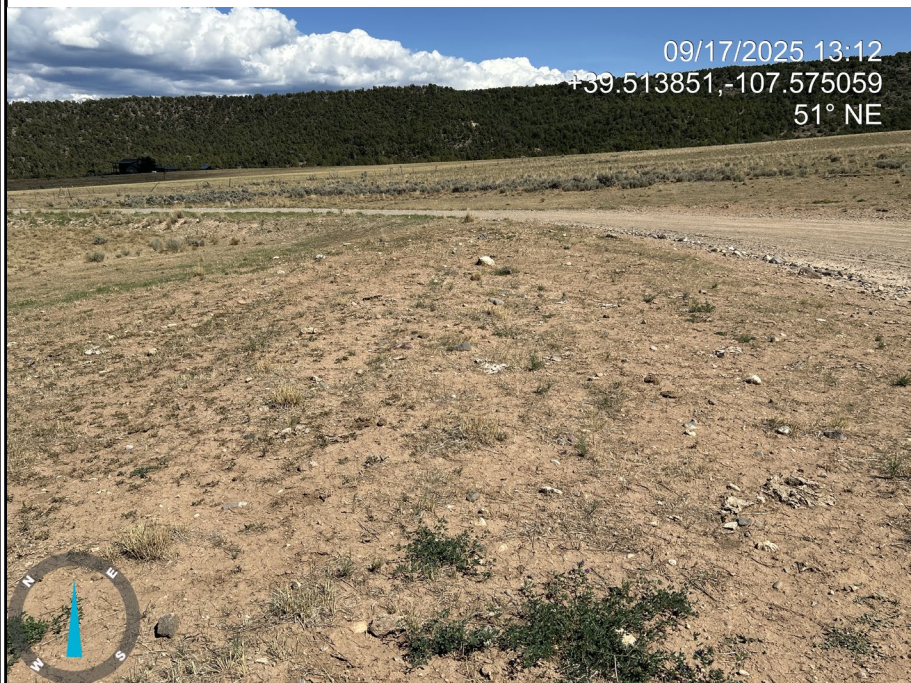
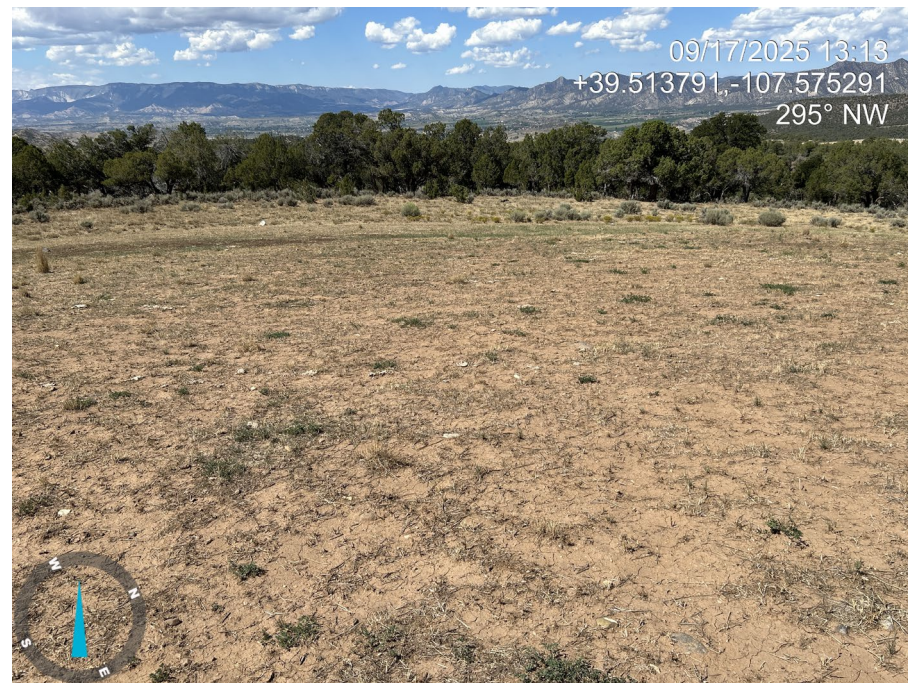
Photo 4: Photos showing an overview of the northern and western interim areas. Heavy cattle use is evident. Some portions of the interim areas possess perennial vegetation; however, uniformity and progression towards eighty (80) percent is not evident. Other areas remain predominantly bare. Comply with 1003 series rules and conduct additional reclamation efforts.
