Inspection Photos

Operator: EAGLE OPERATING INC #26155

Location ID: 397838

Inspection Doc: 718100890

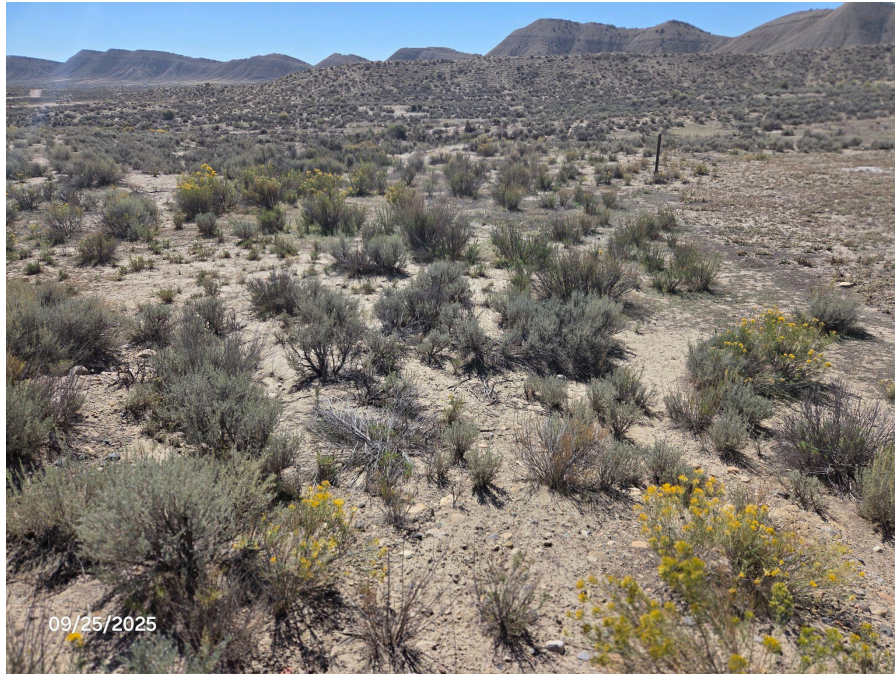
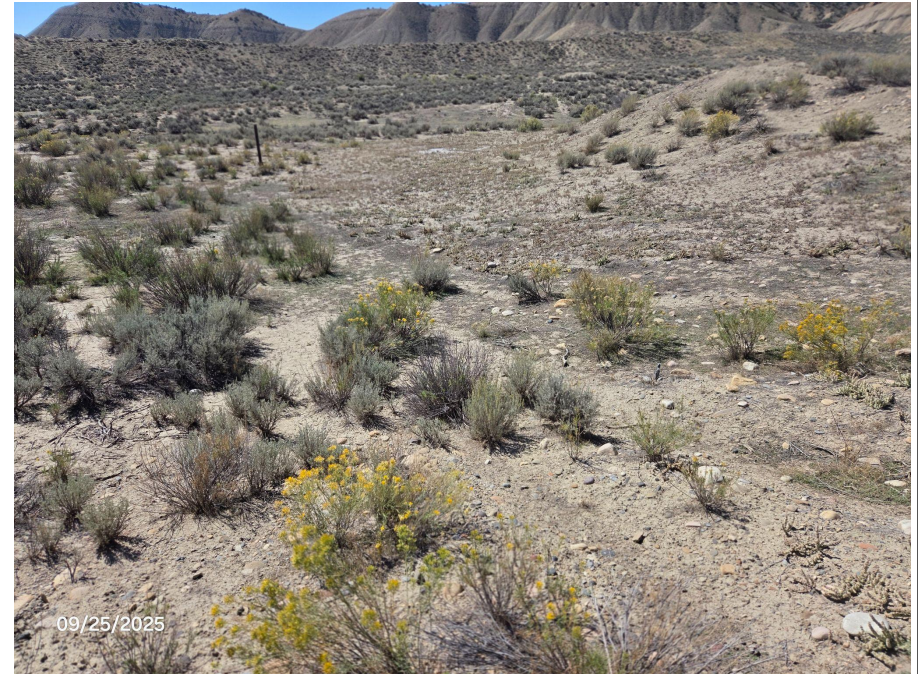
Photo 1: Photos taken from the north end of the Location. Photos provide an overview from southeast southwest. Pursuant to Resolution #404363838 weeds were removed and disposed of properly, and Location reseeded. Weeds have not been removed/disposed as indicated by the FIRR. Unable to find evidence of additional reclamation work.

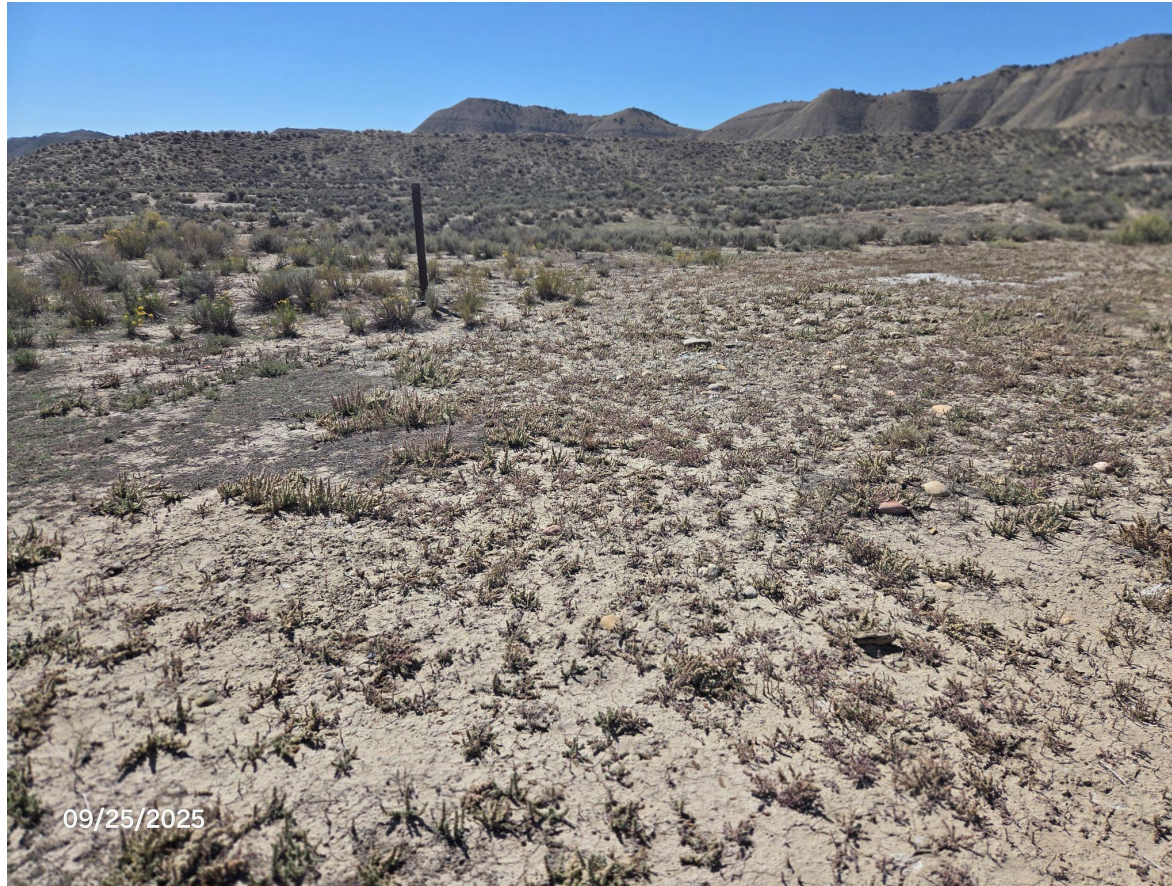
Photo 2: Photo taken from the north end of the Location, facing south.
See comments under photo 1.

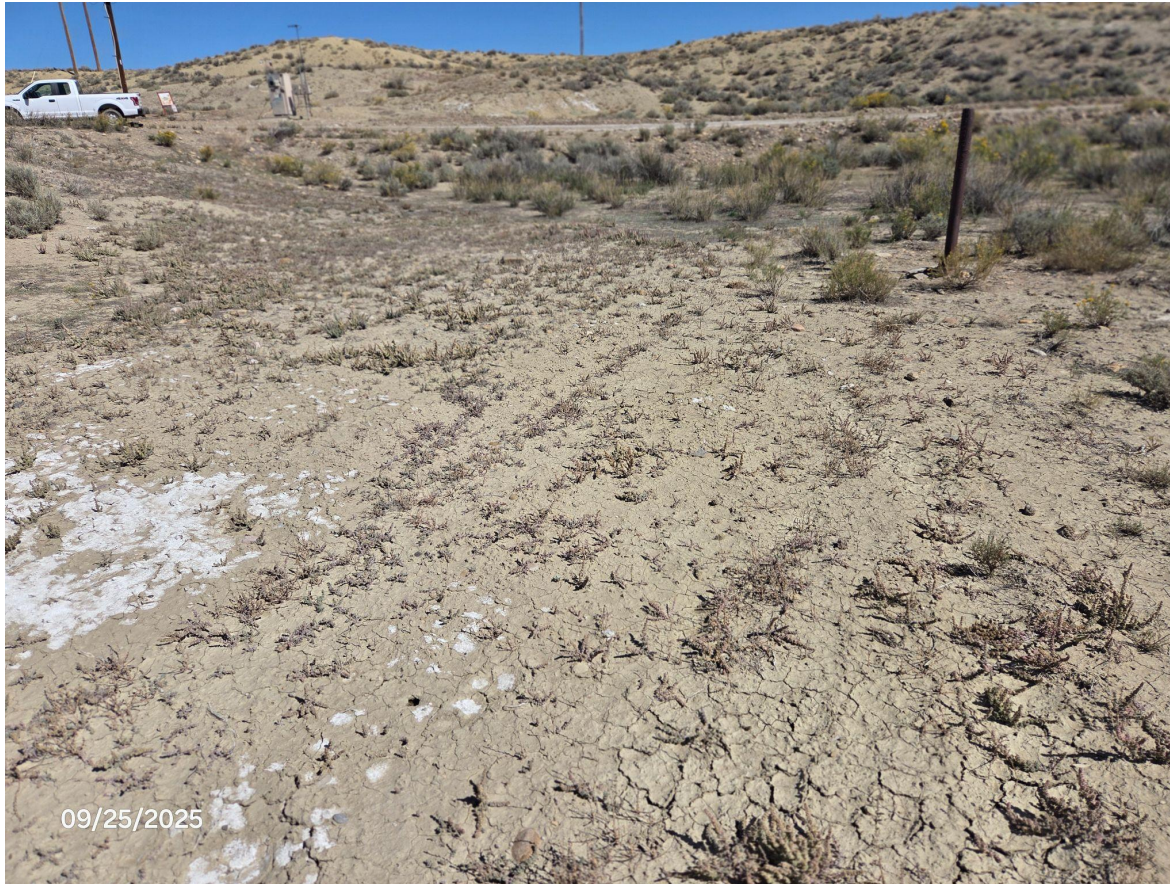
Photo 3: Photo taken from the south end of the Location, facing north. See comments under photo 1.

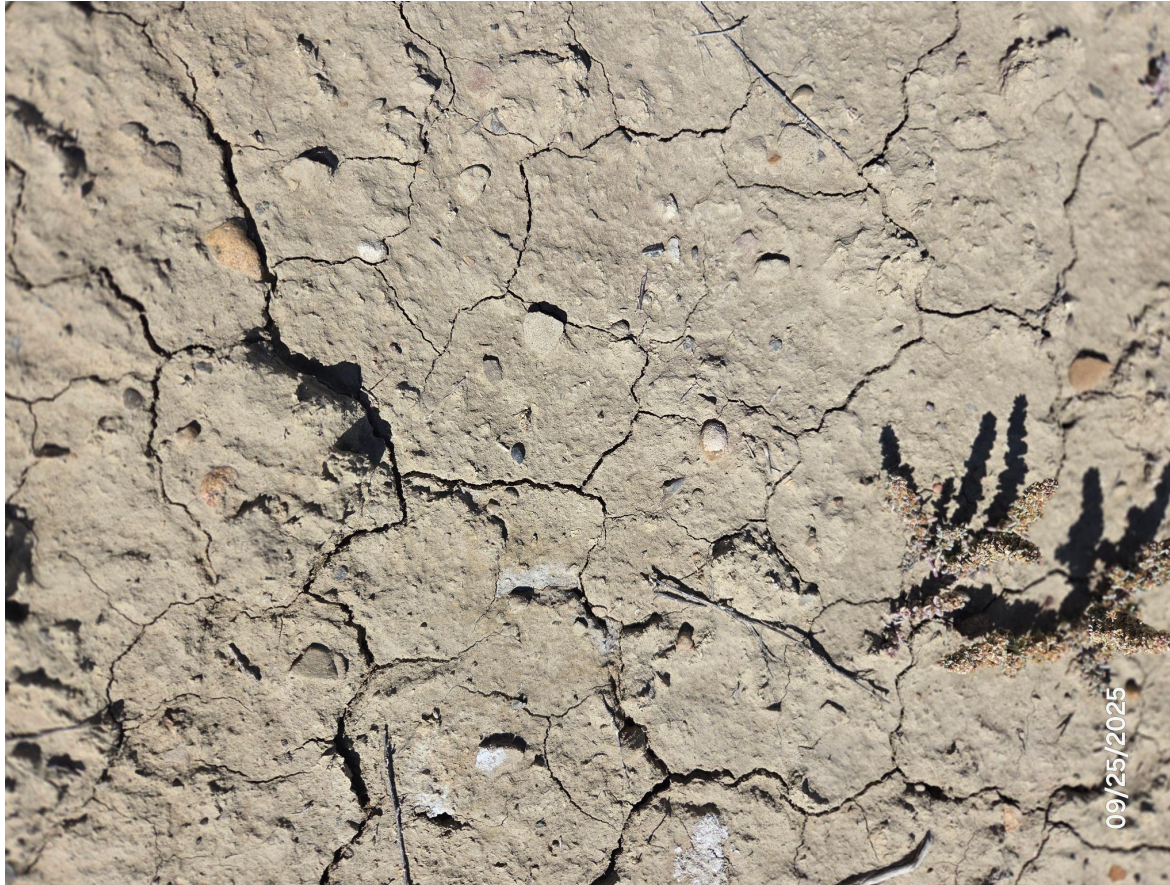
Photo 4: Photo shows the surface of the Location. Photo example showing Noxious weeds (Halogeton) remain established on the Location, and have not been removed or disposed; plants have reached viable maturity and are flowering. Additional seeding efforts also not apparent; drill rows associated with drill seeding not observed; no seed observed on the soil surface if broadcast seeding was performed.
