Inspection Photos

Operator: EAGLE OPERATING INC #26155

Location ID: 398233

Inspection Doc: 718100892

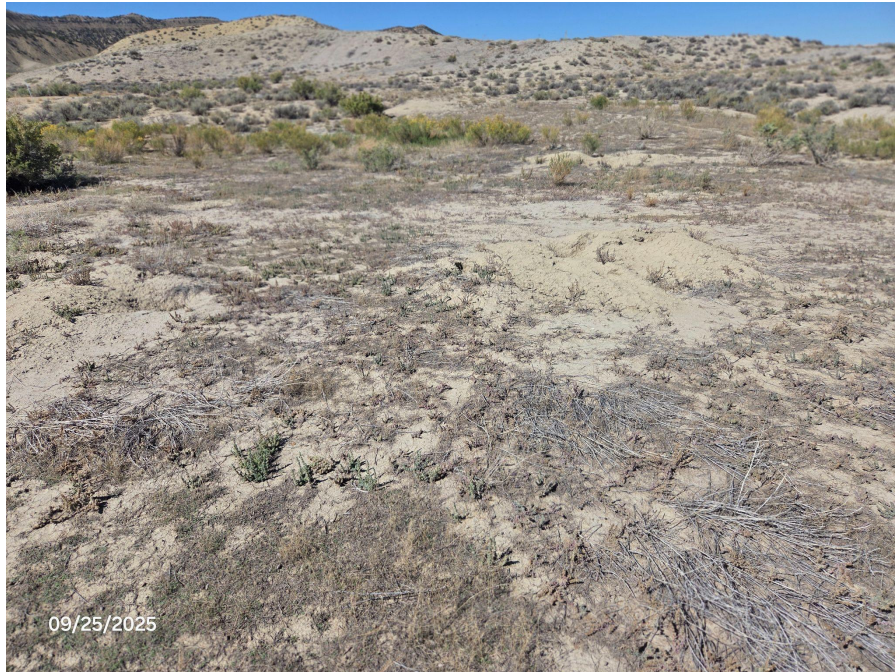
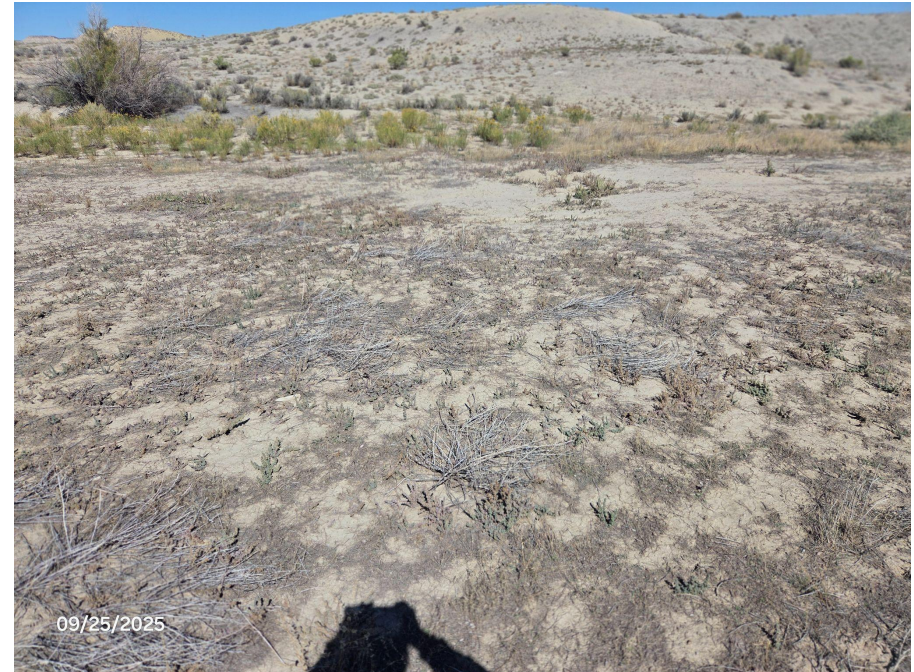
Photo 1: Photos taken from the south end of the Location. Photos provide an overview of the Location from facing northwest and northeast. Pursuant to Resolution #404363886 weeds were removed and disposed of properly, and Location reseeded. Weeds have not been removed/disposed as indicated by the FIRR. Unable to find evidence of additional reclamation work.

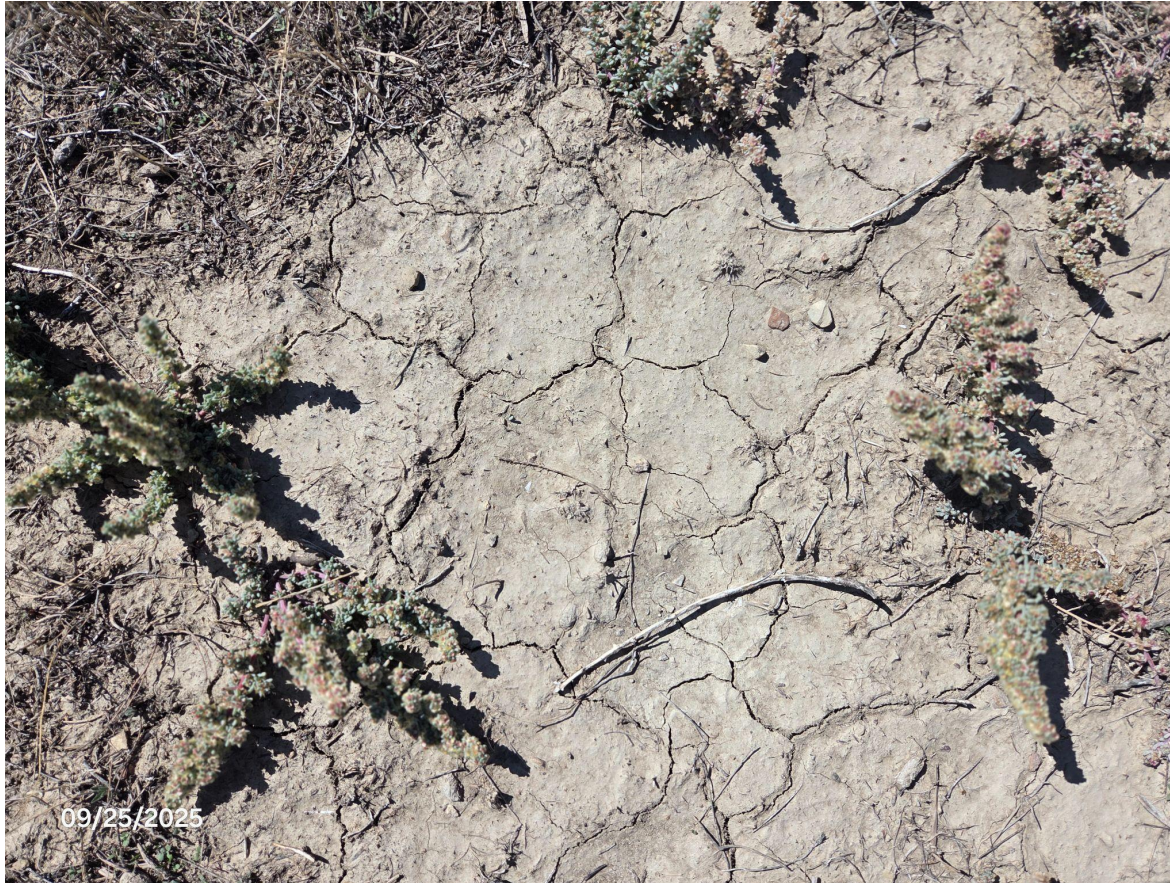
Photo 2: Photo shows the surface of the Location. Photo example showing Noxious weeds (Halogeton) remain established on the Location, and have not been removed or disposed; plants have reached viable maturity and are flowering. Additional seeding efforts also not apparent; drill rows associated with drill seeding not observed; no seed observed on the soil surface if broadcast seeding was performed.
