Lat 40.123517, Long -105.013715
10/09/2025 12:15 PM GMT-06:00
ECMC : Environmental Inspection

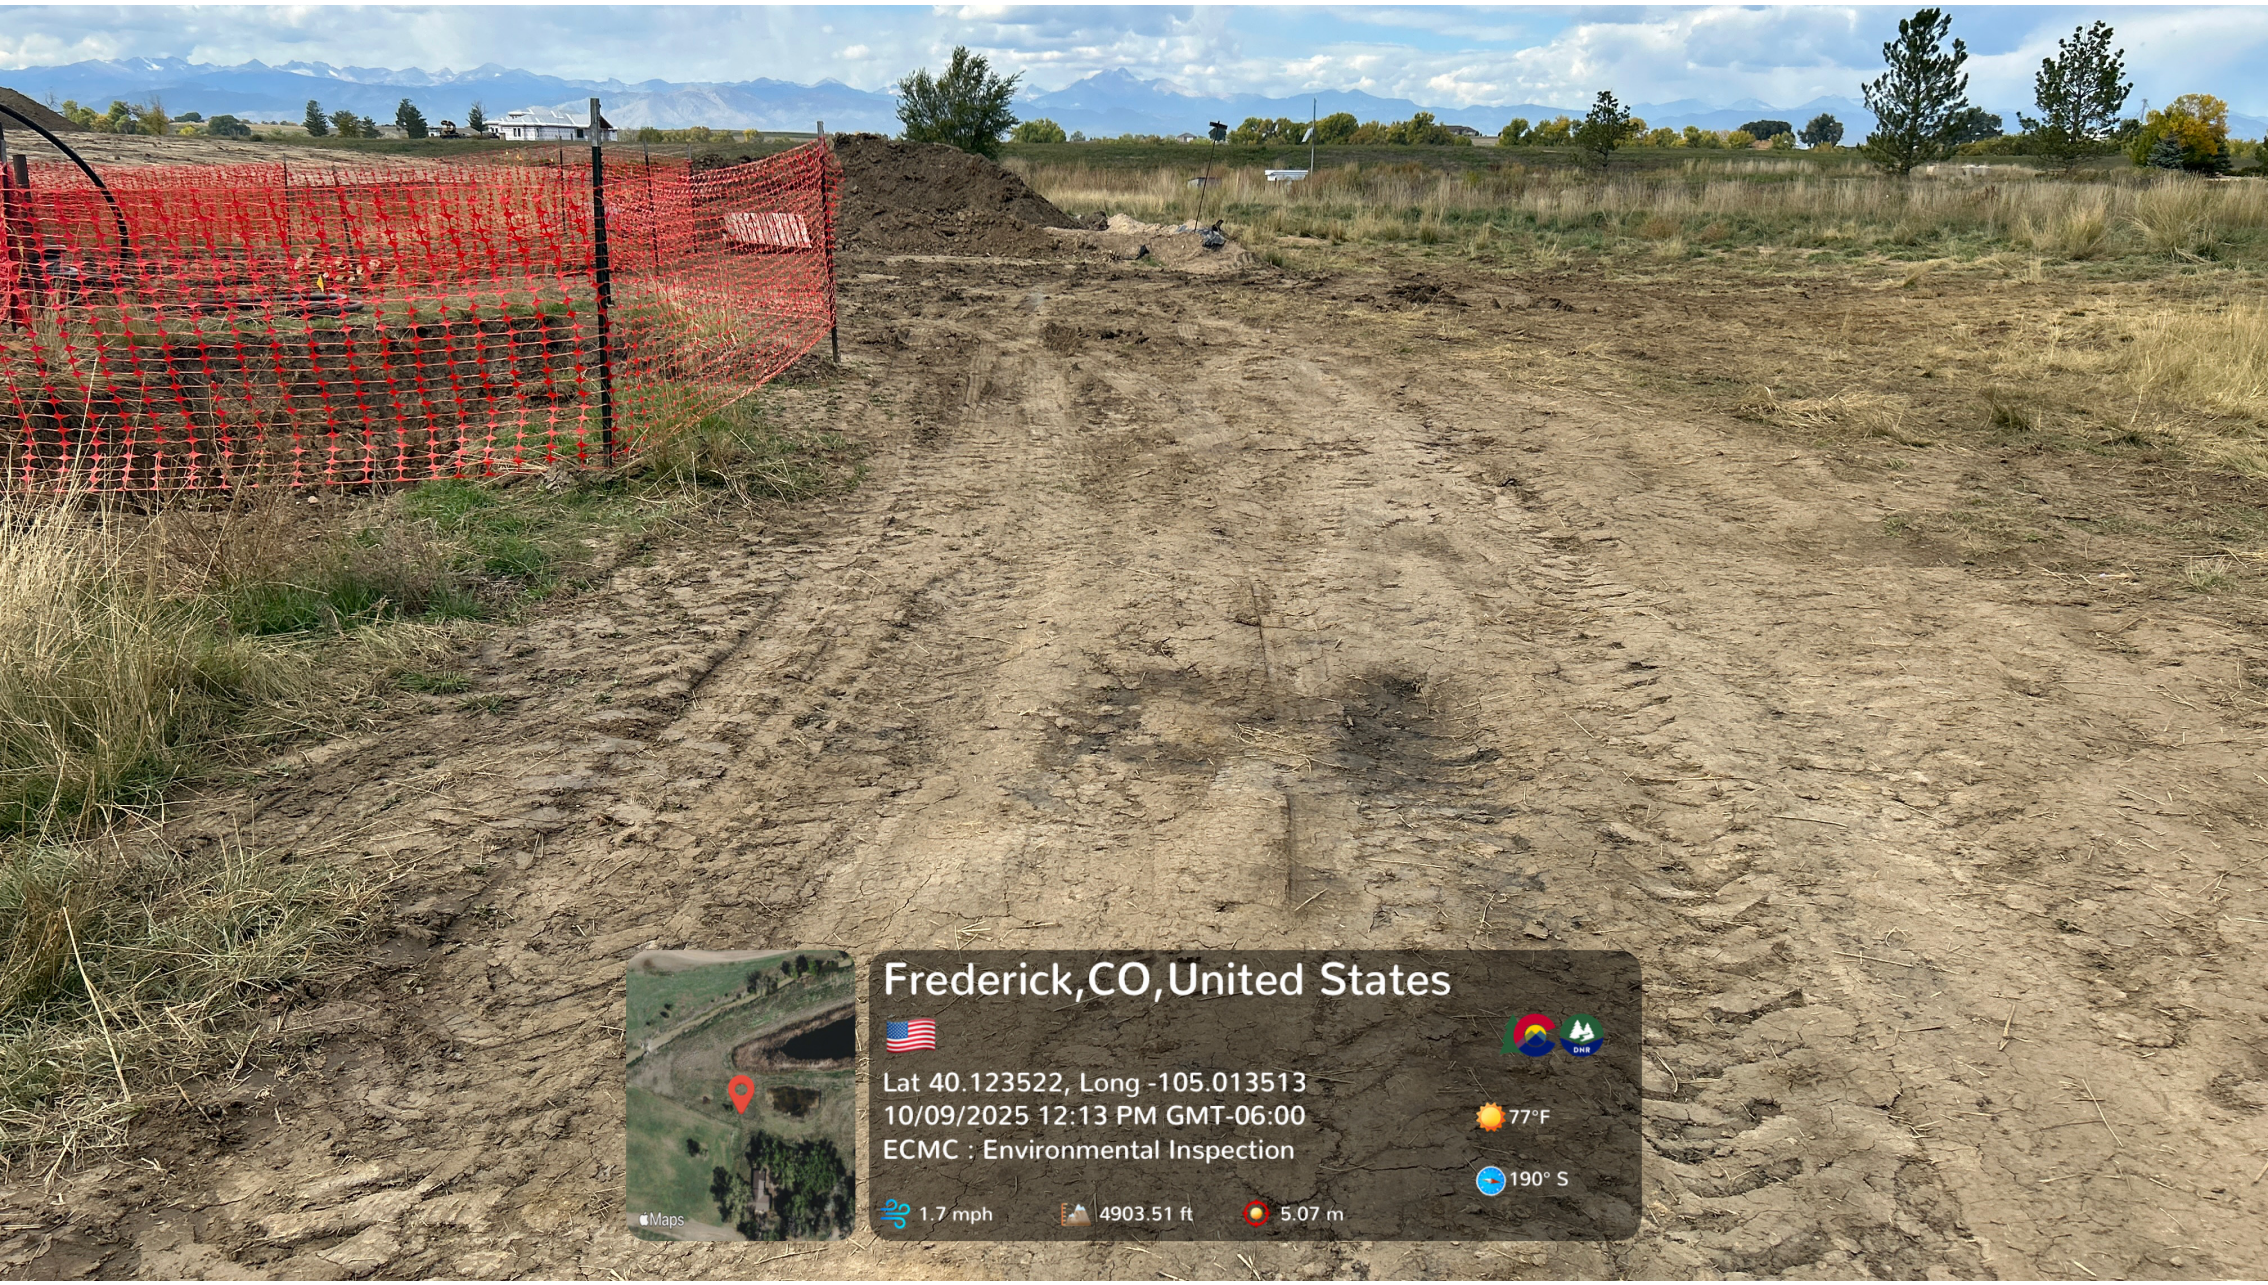
Looking at spill location and spill response area. Soil stockpiles remain on location. Soil with gray staining is visible on the ground surface outside of the excavations. Orange construction fencing surrounds the perimeters of the open excavations.

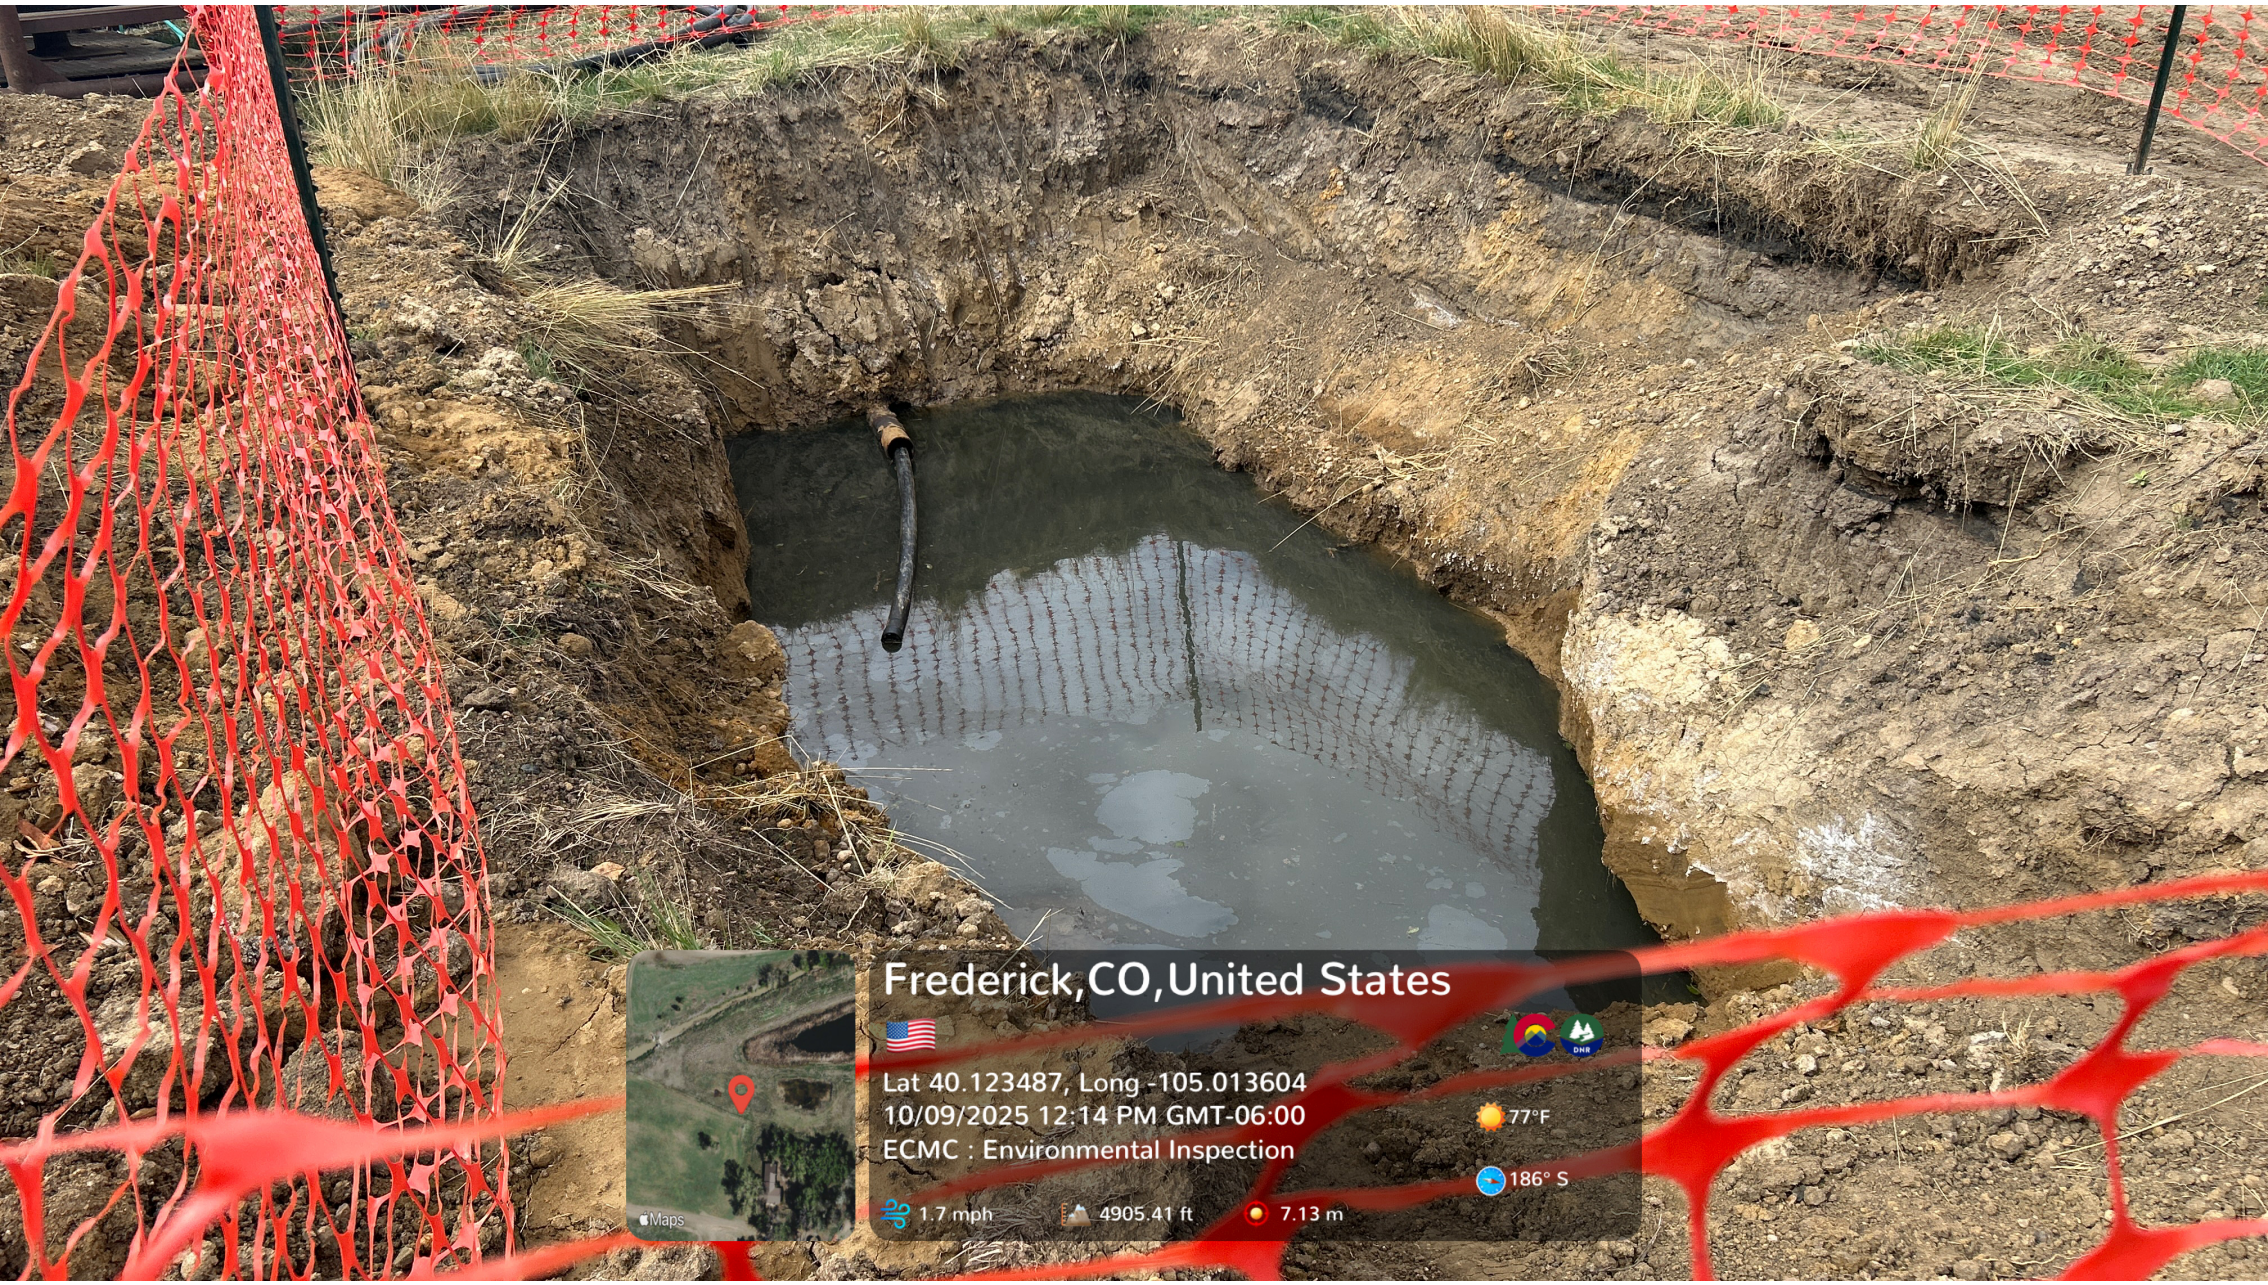
Looking at an excavation Operator personnel previously indicated was opened for flowline repairs. Free product and a petroleum hydrocarbon sheen are visible on groundwater within the excavation. Stained soil is visible on the excavation sidewalls.

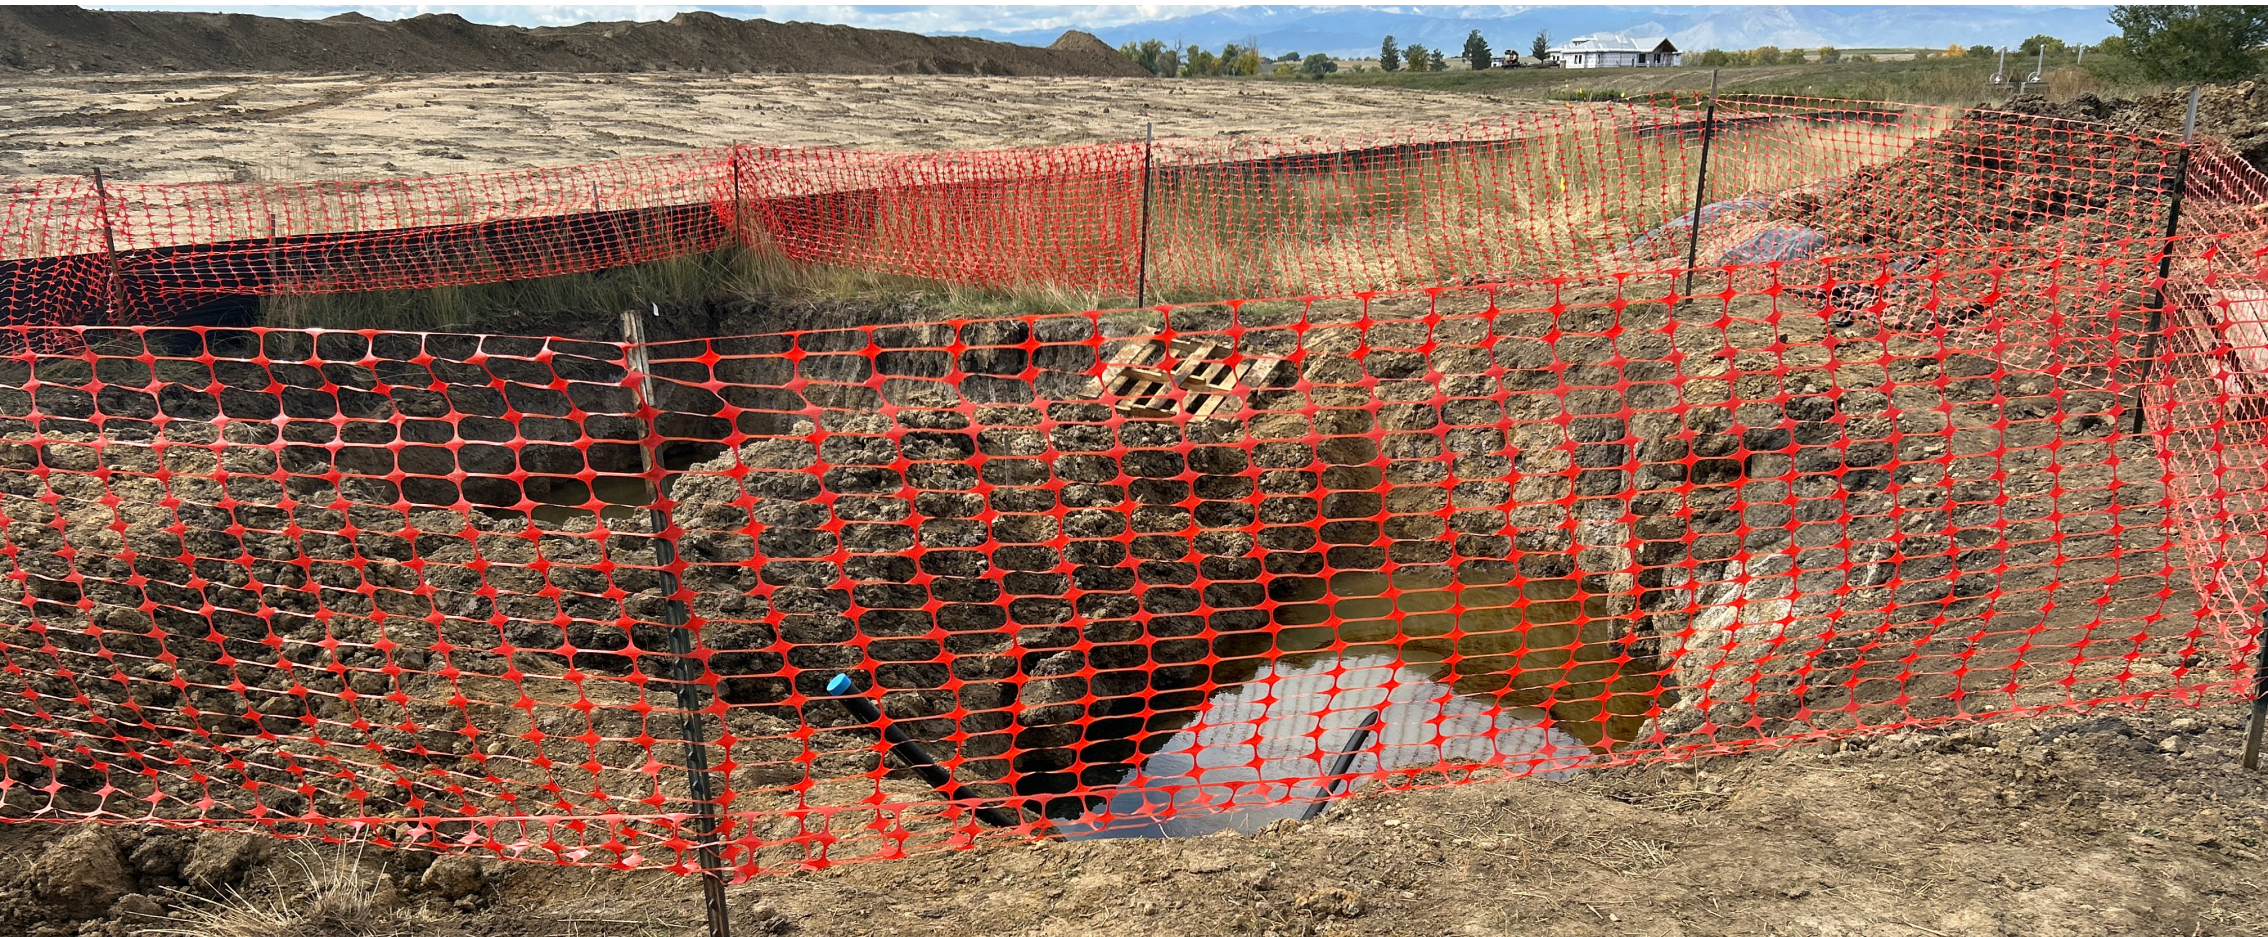
Looking at the spill location. The excavations remain open.

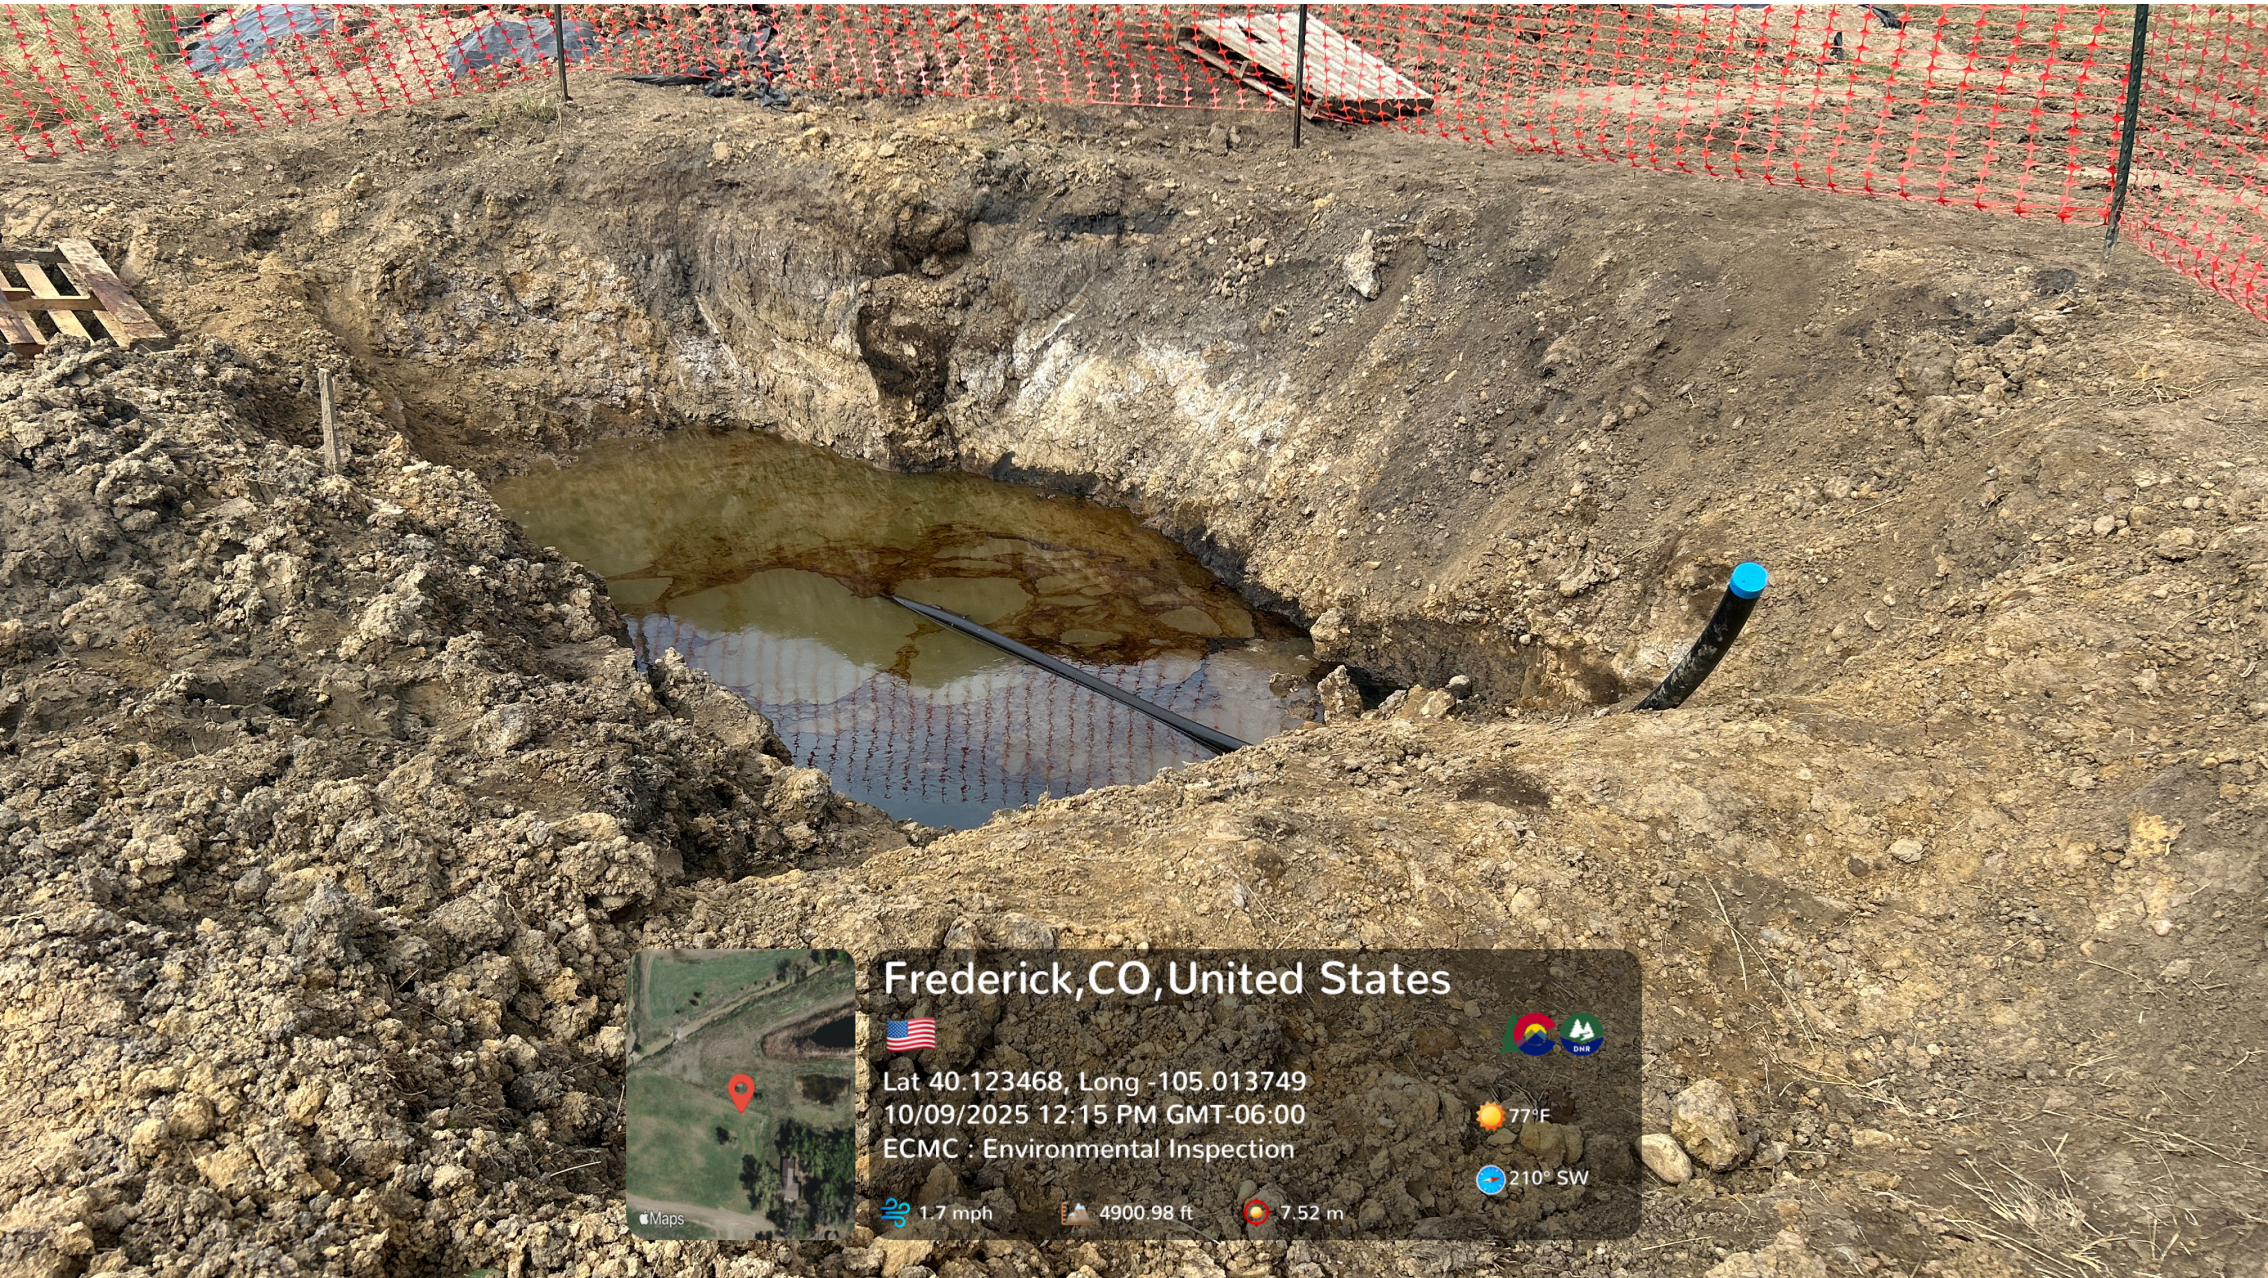
Free product is visible on groundwater within the excavation. Stained soil is visible on the excavation sidewalls. Flowline is visible protruding from the excavation.

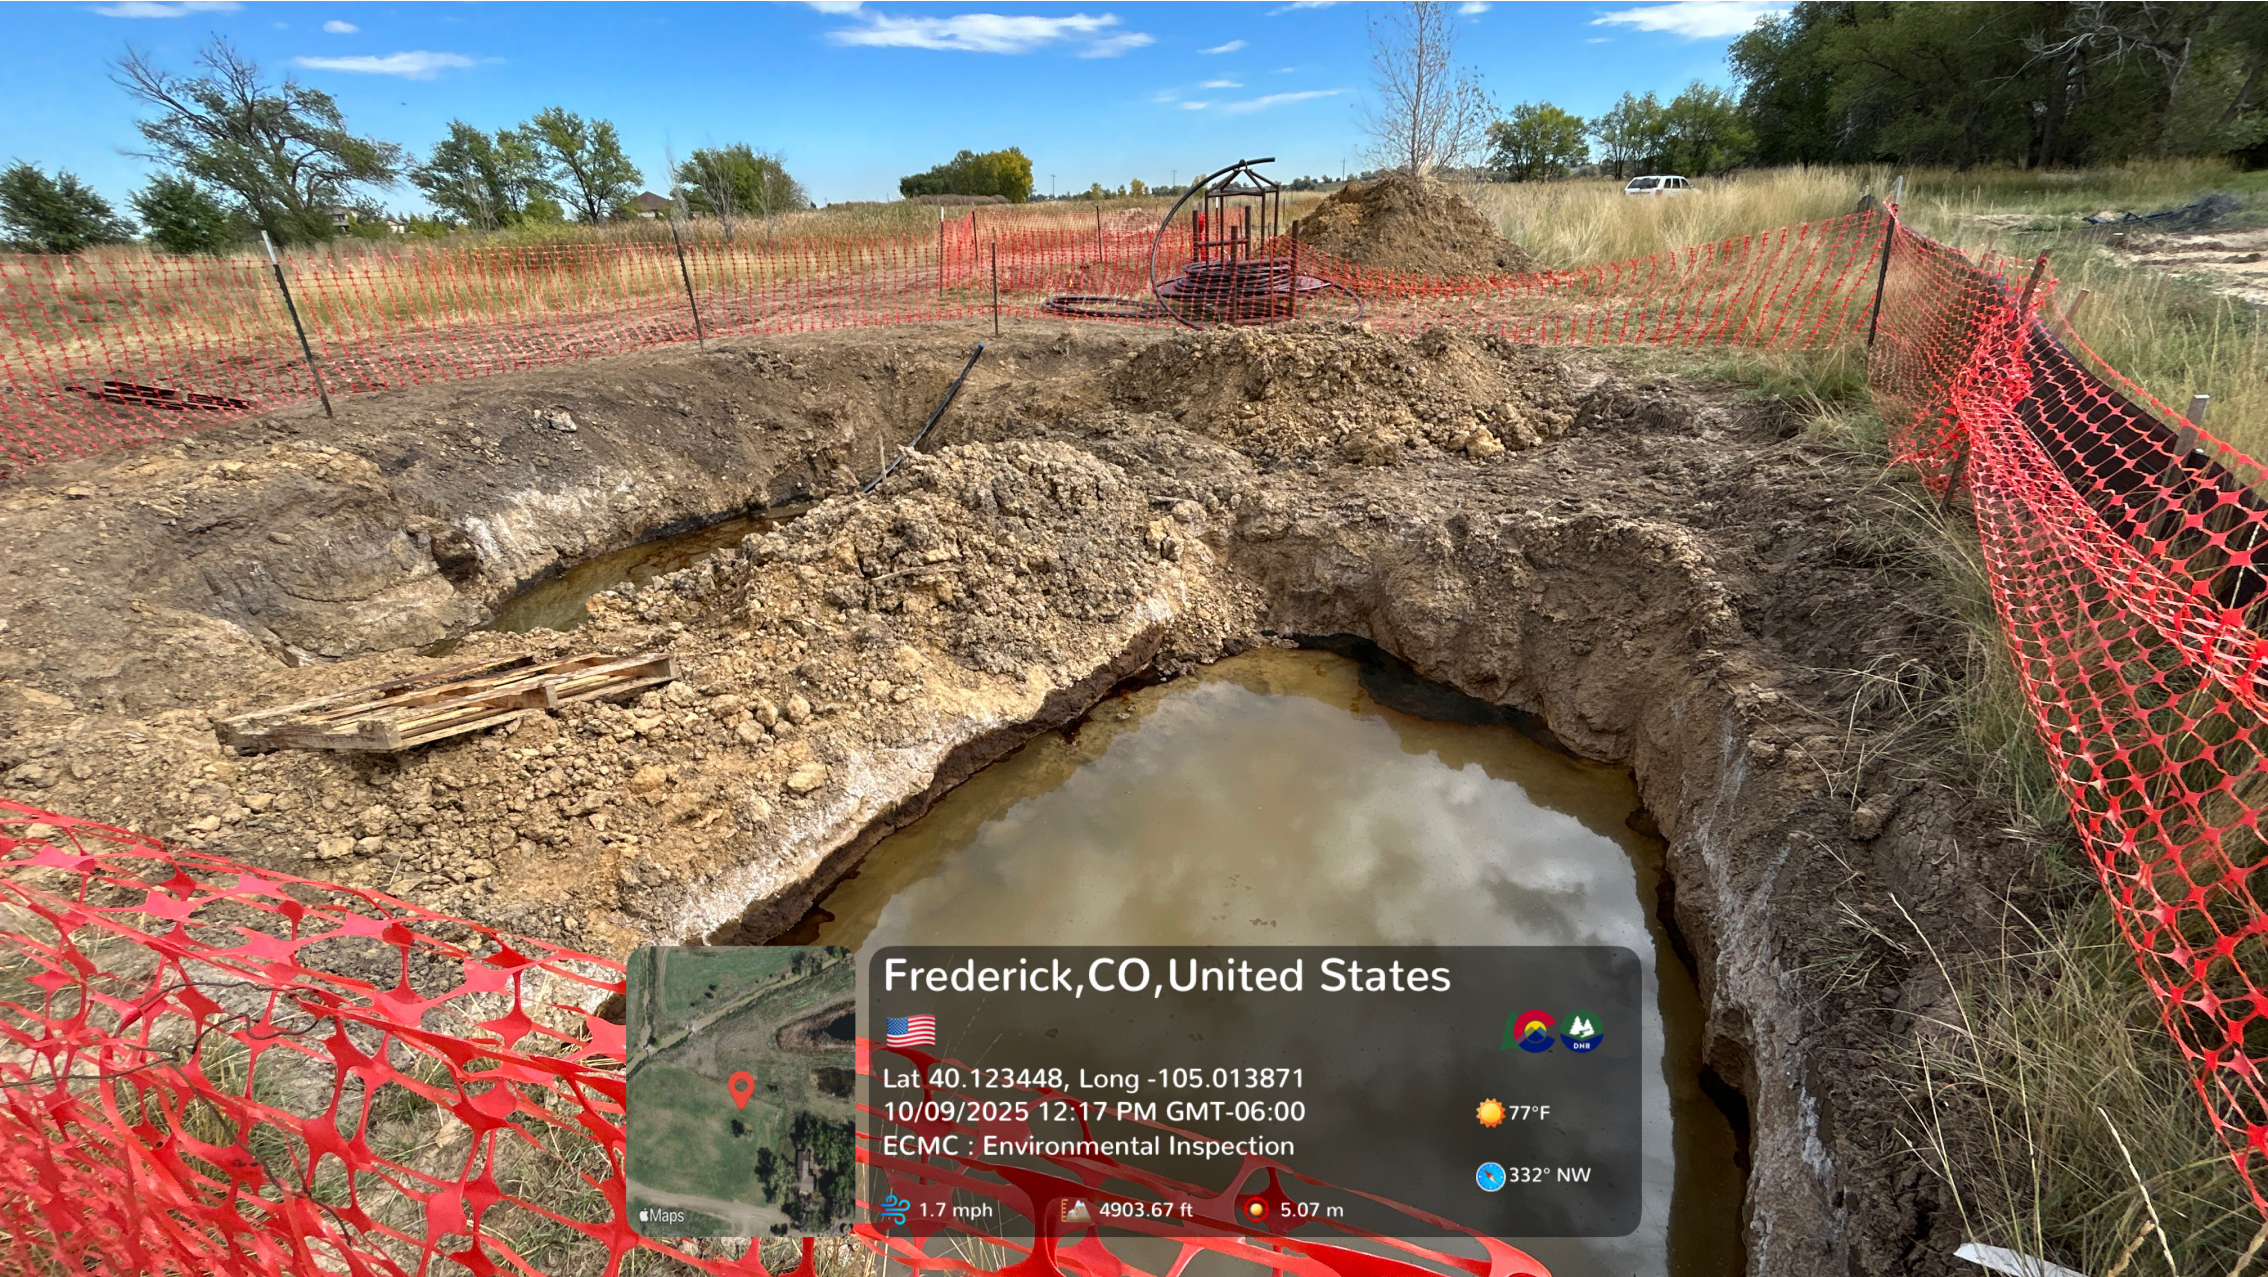
Free product is visible on groundwater within the excavation. Stained soil is visible on the excavation sidewalls. A small, unmarked soil stockpile is visible within the orange construction fencing. No wildlife protection equipment (e.g. bird netting) is visible on location.

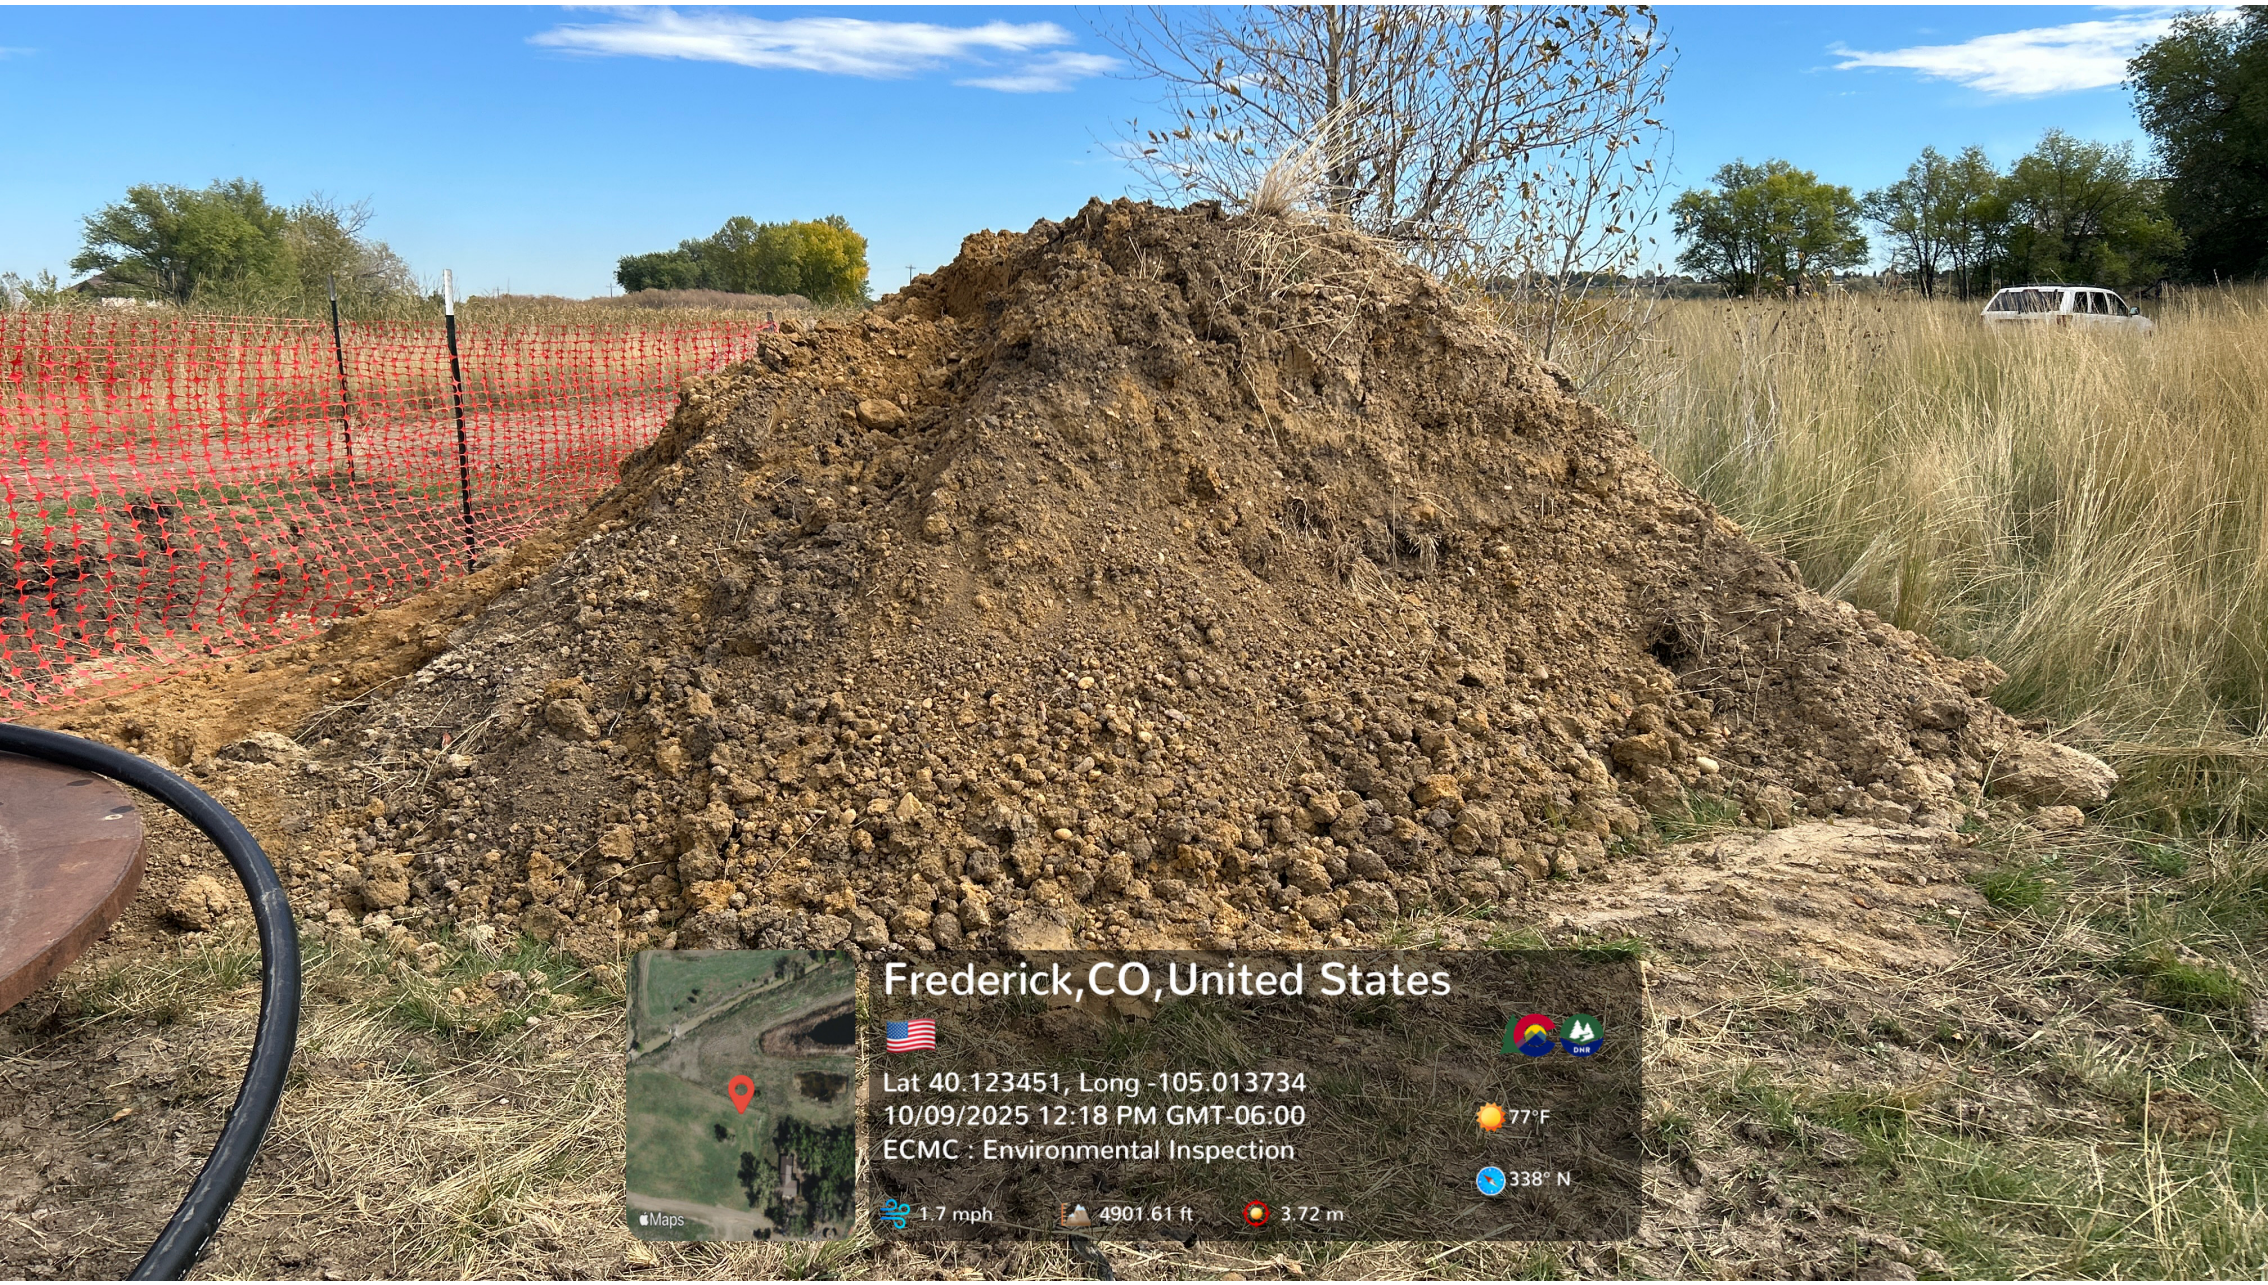
An unmarked soil stockpile with no stormwater BMPs is visible adjacent to an open excavation.

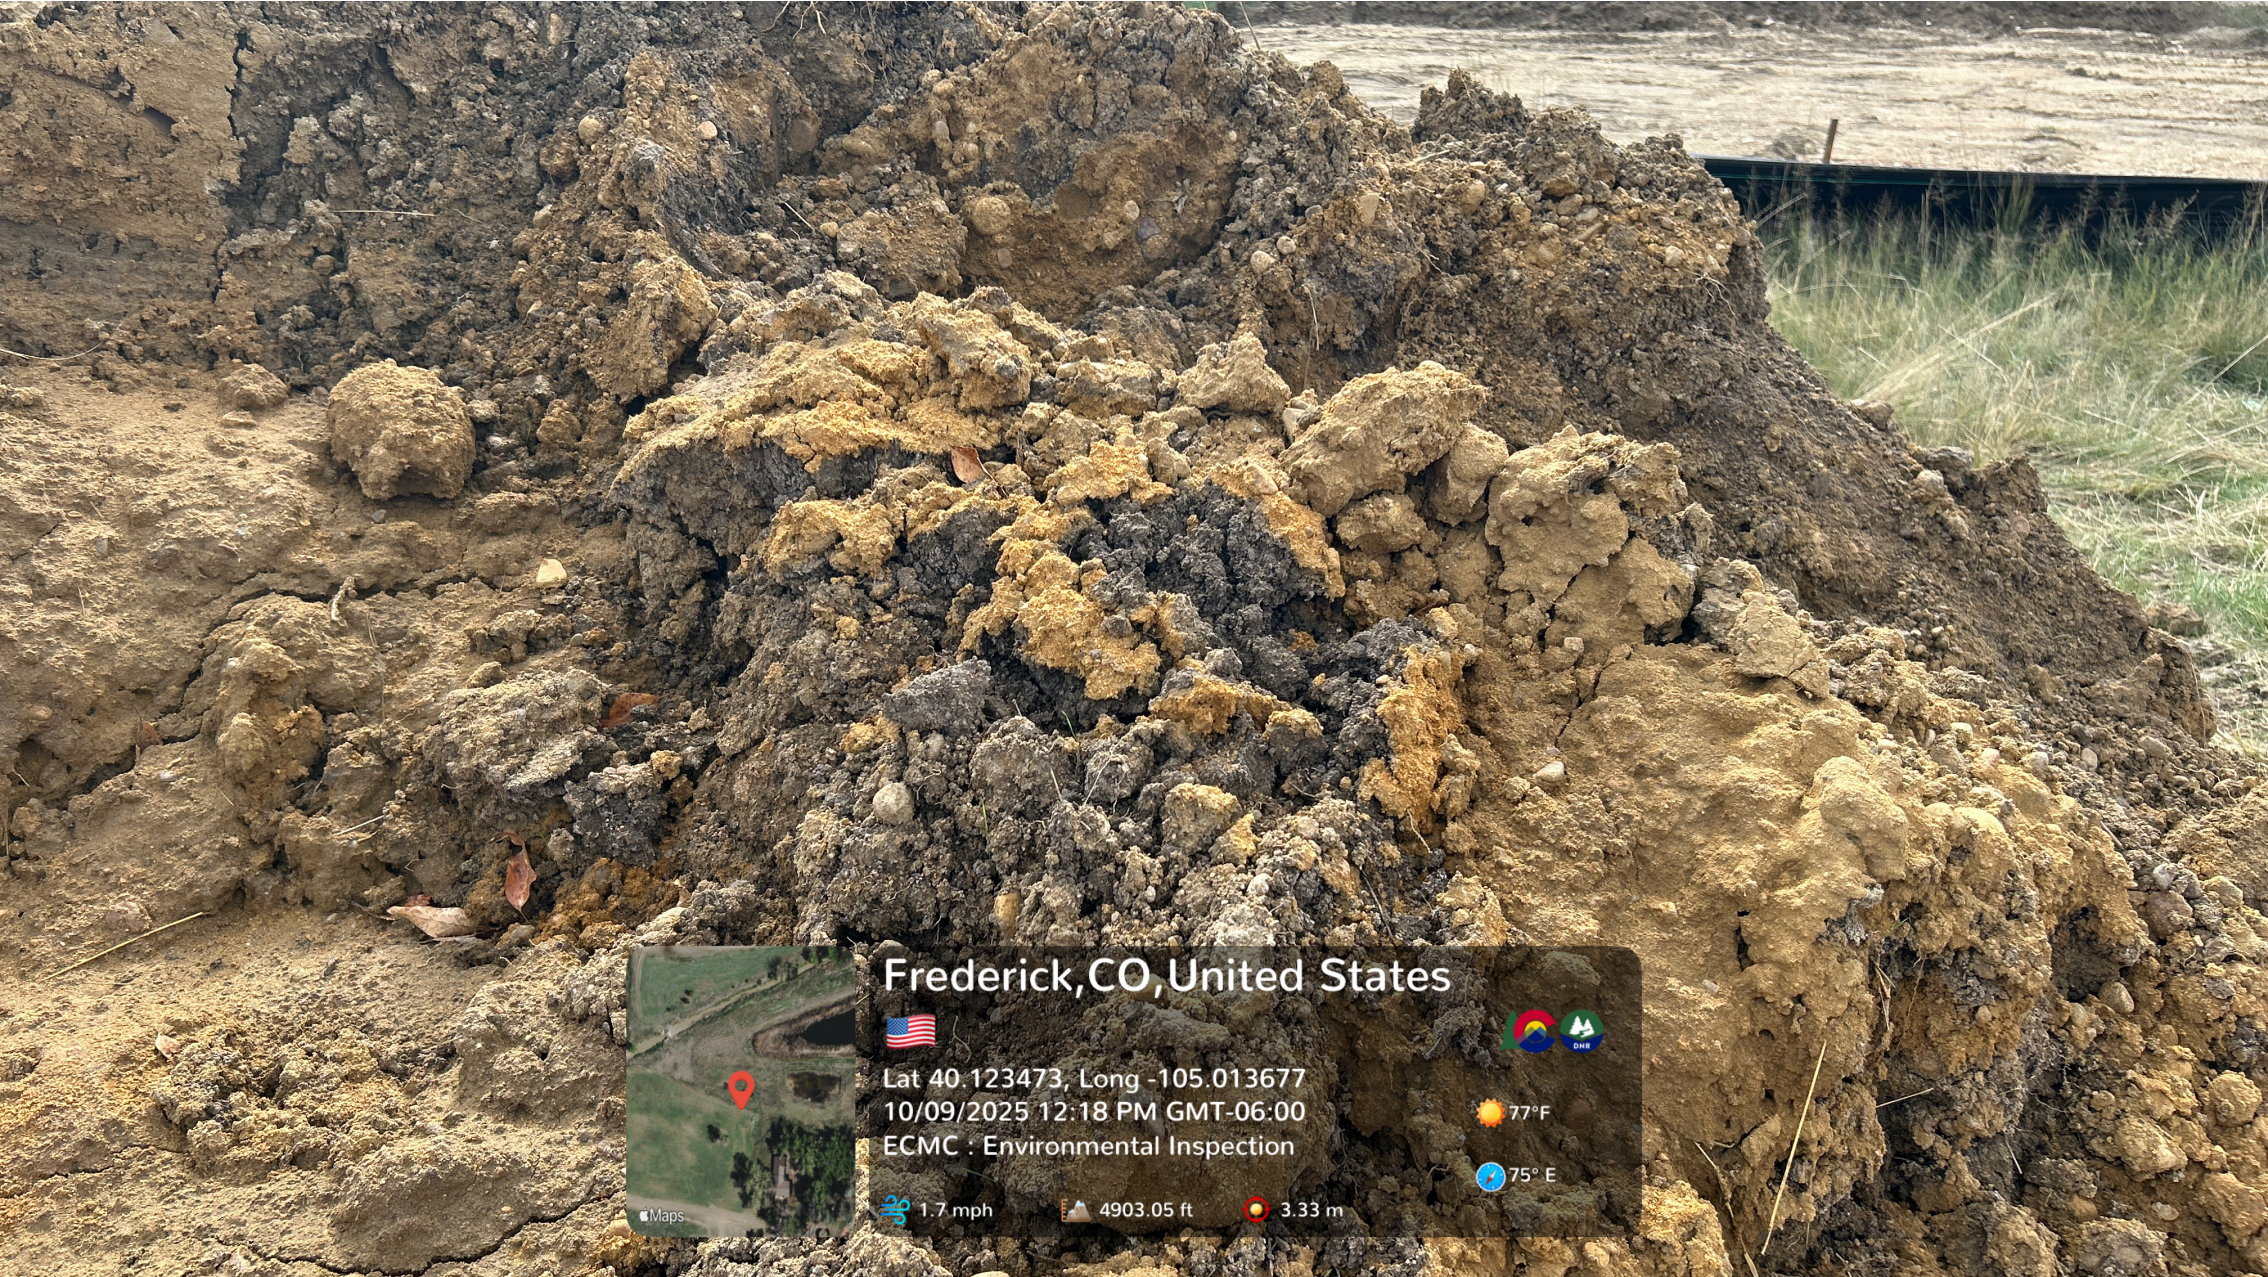
Areas of gray staining are visible within the unmarked soil stockpile.

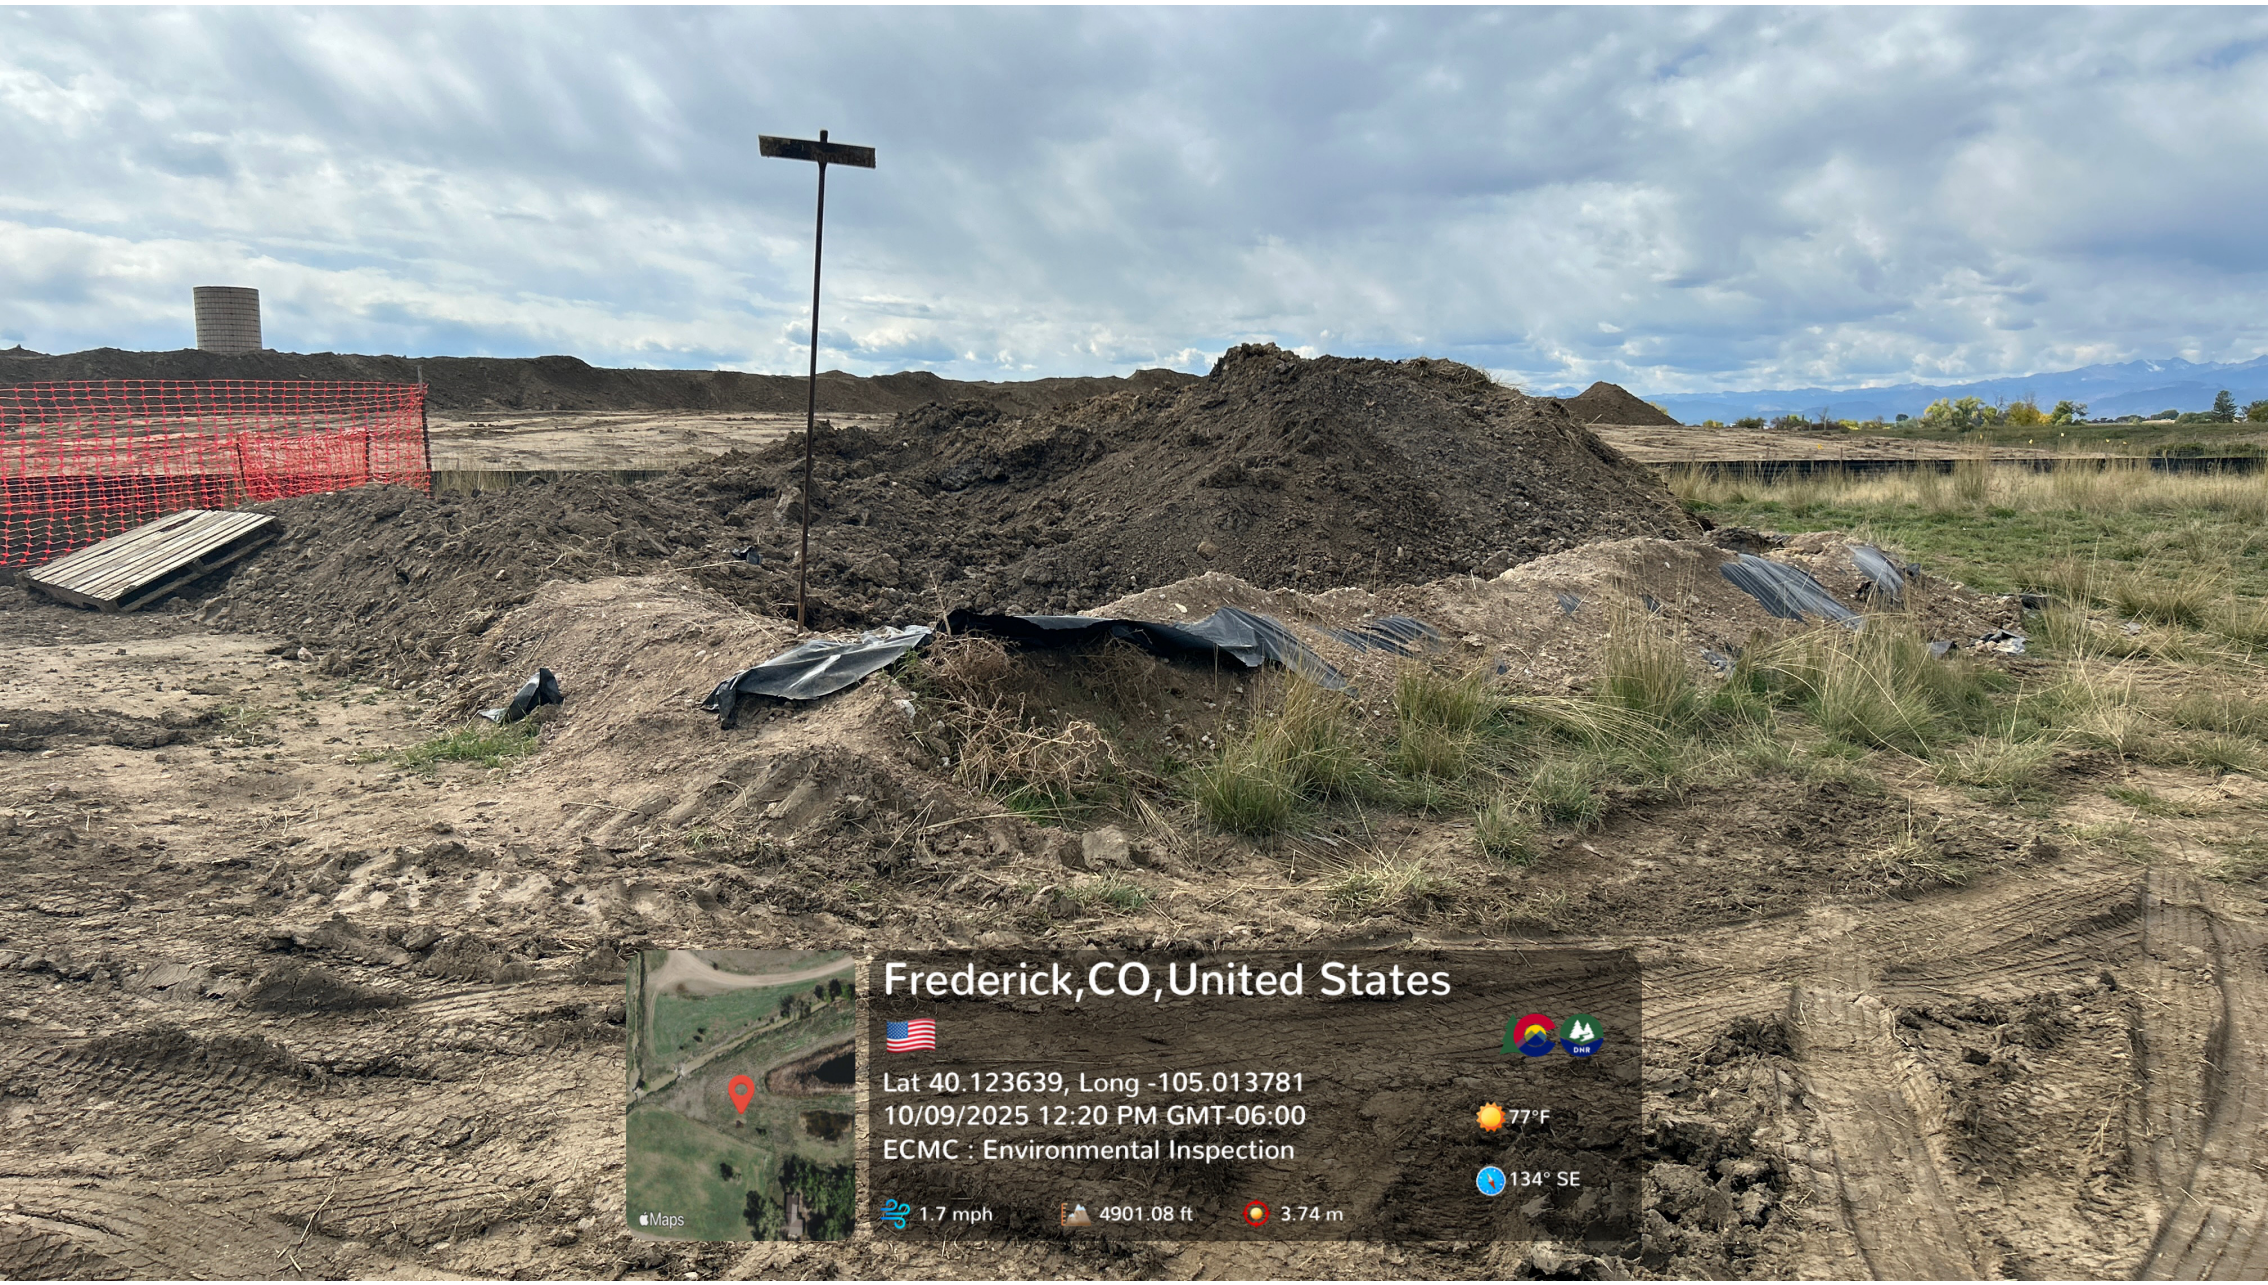
The stockpile marked "contaminated" remains on location. A liner is visible but has been compromised by holes/tears; soil has spilled outside of containment.
