Lat 40.123517, Long -105.013715
10/09/2025 12:15 PM GMT-06:00
ECMC : Environmental Inspection

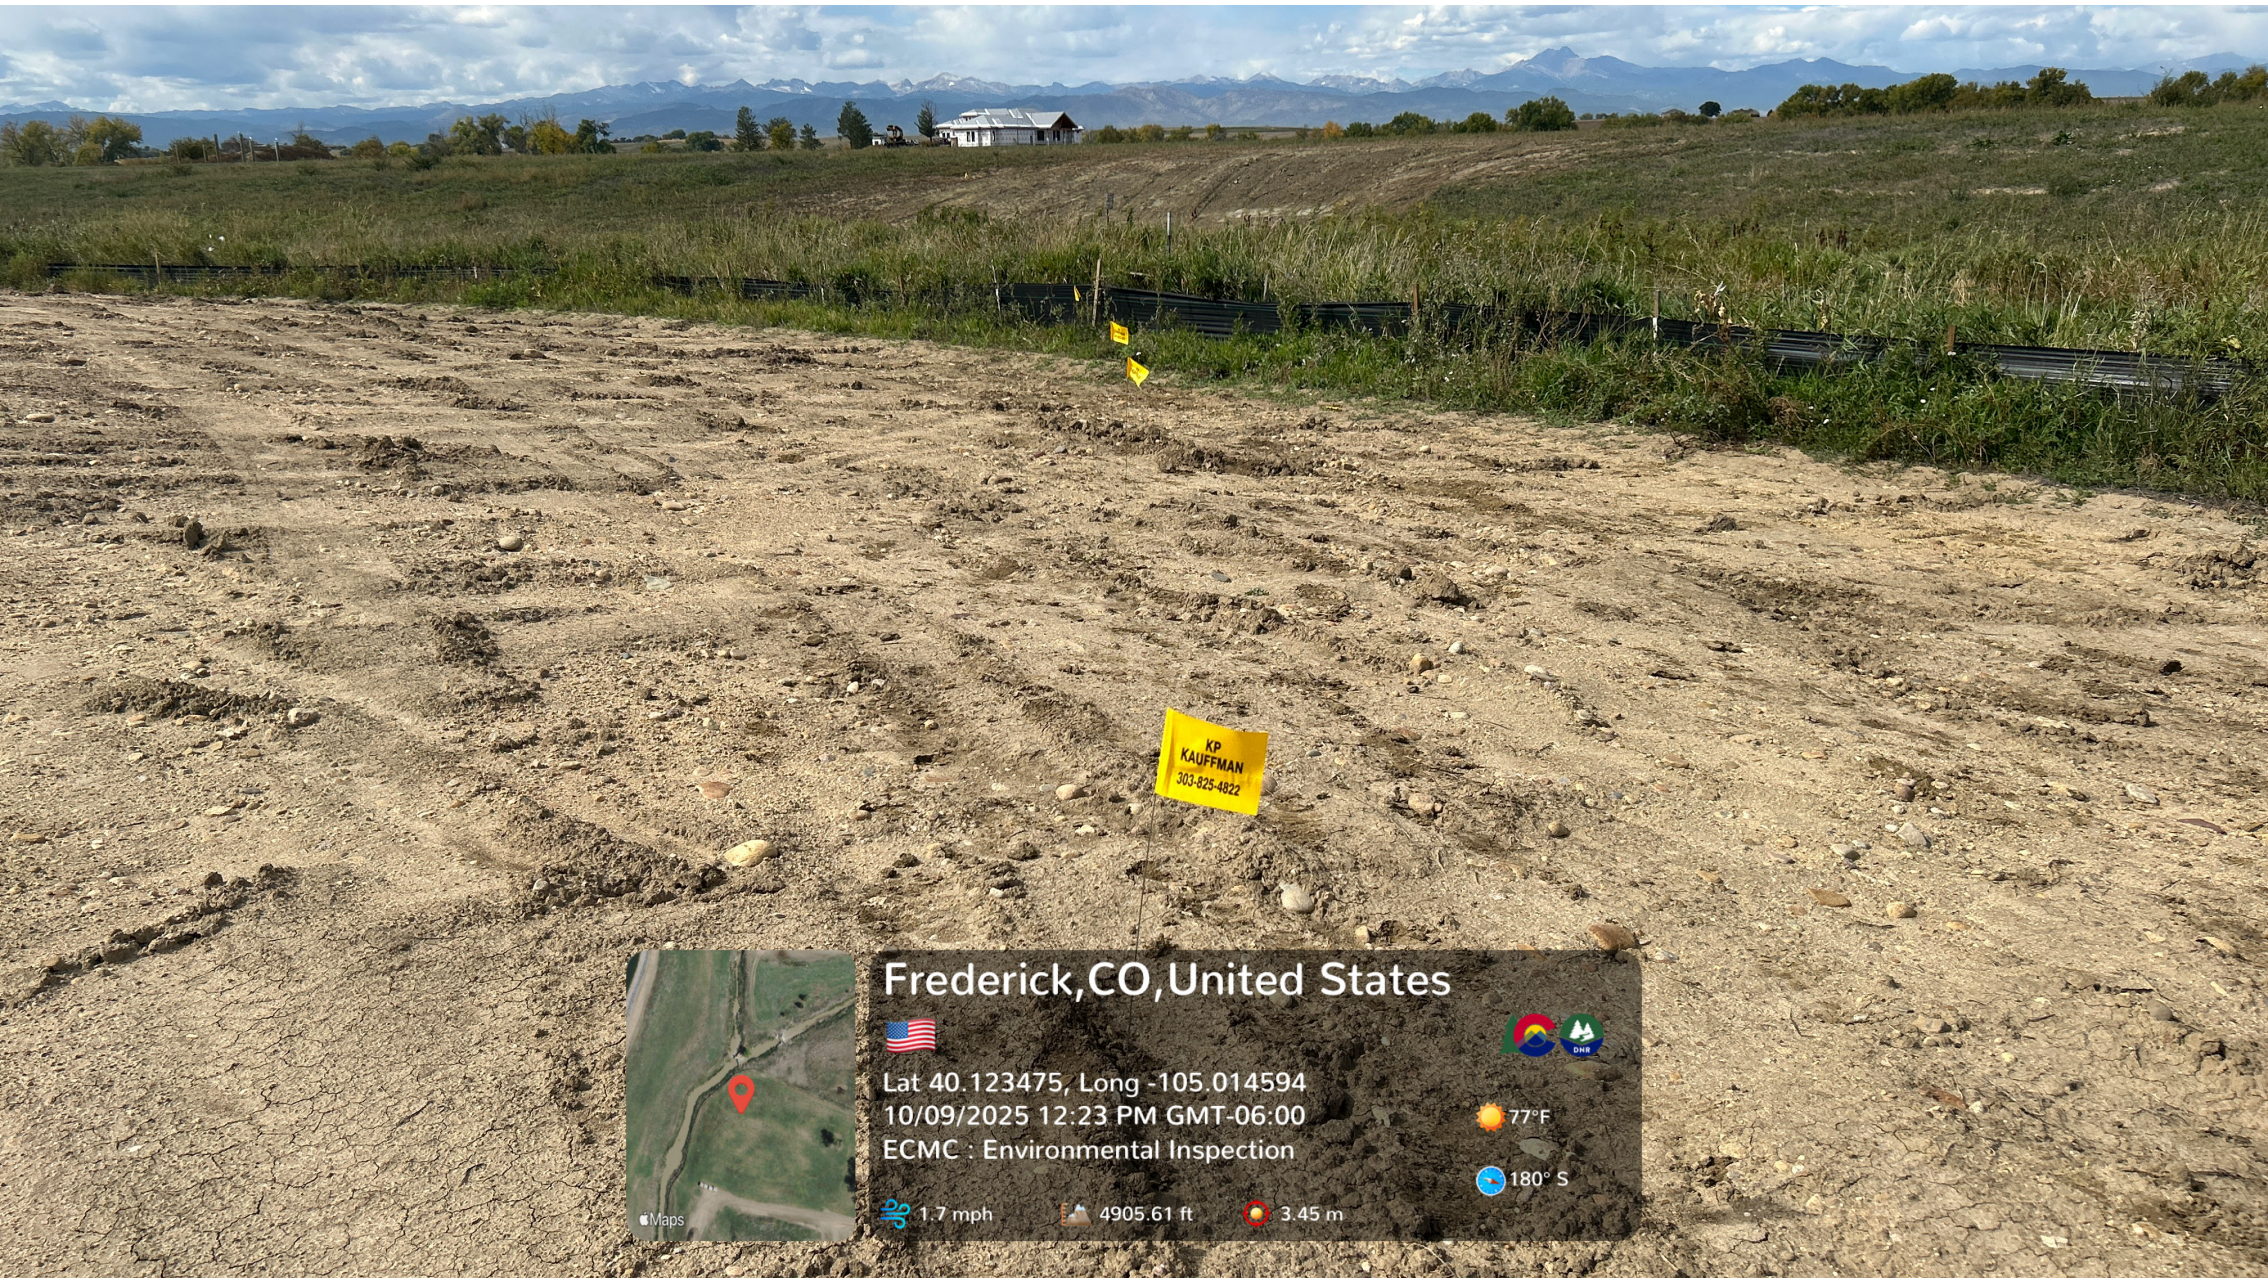
Underground utility flags which read "KP Kauffman" are visible west of the location. An area of ground disturbance is visible on the hillside, in the location at which a backhoe was observed on 10/03/2025.
