Inspection Photos

Operator: TEP Rocky Mountain LLC #96850

Location ID: 413683

Inspection Doc: 719200278

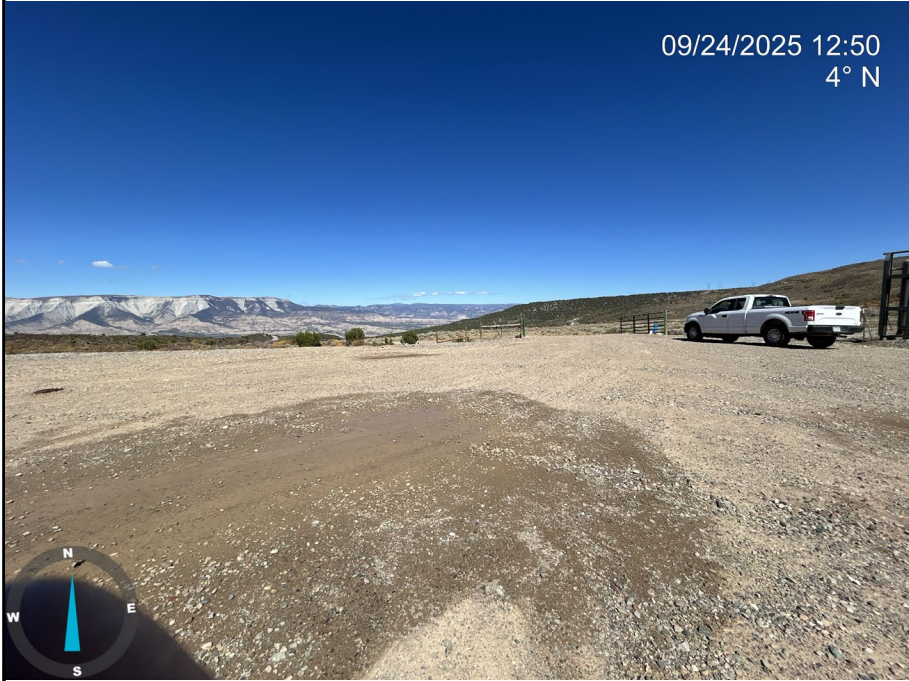
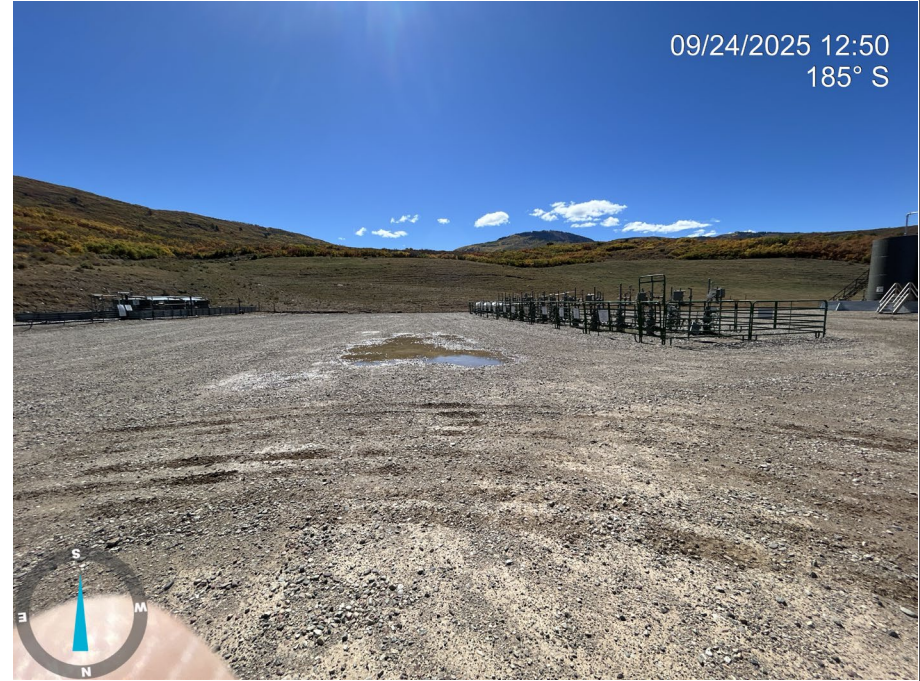
Photo 1: Photos showing an overview of the location looking northeast and south, respectively.

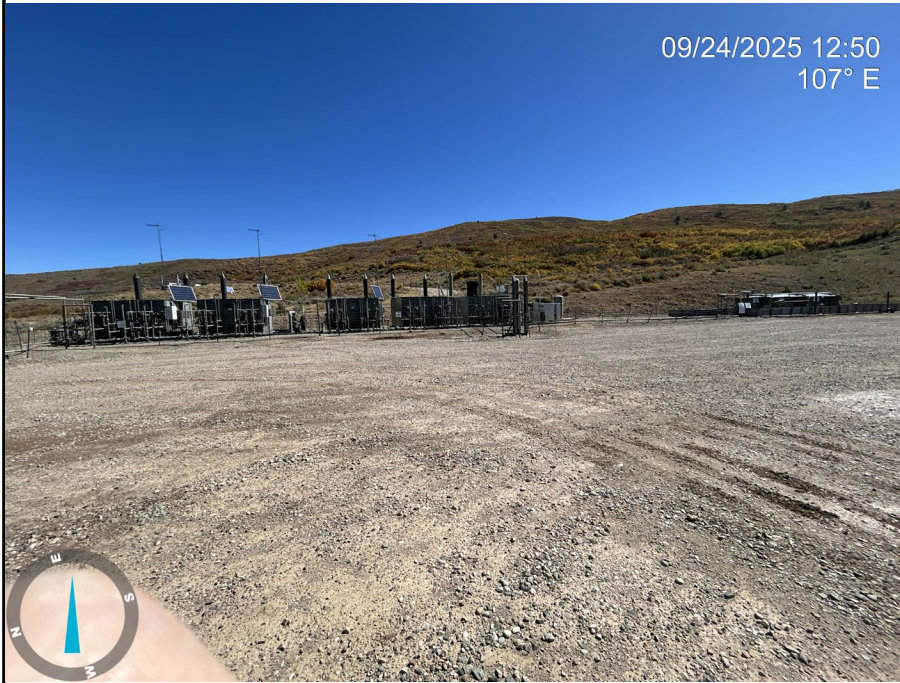
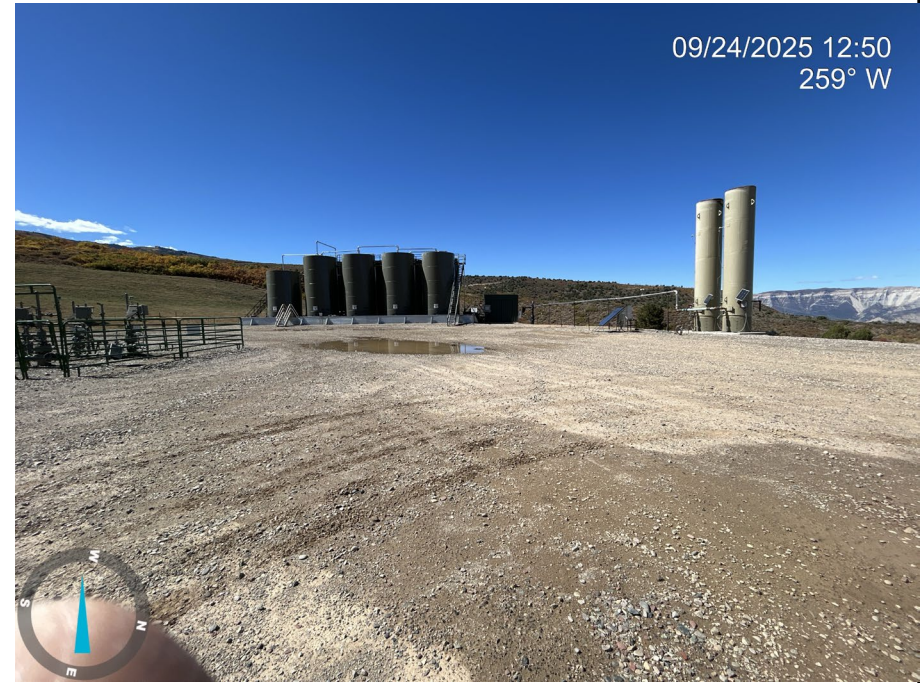
Photo 2: Photos showing an overview of the location looking east and west, respectively.

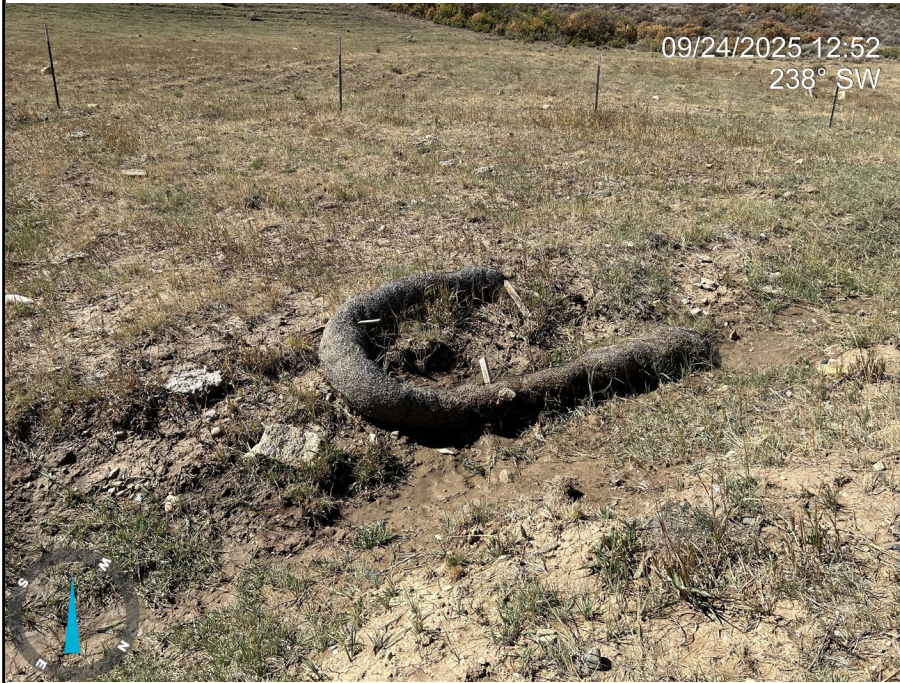
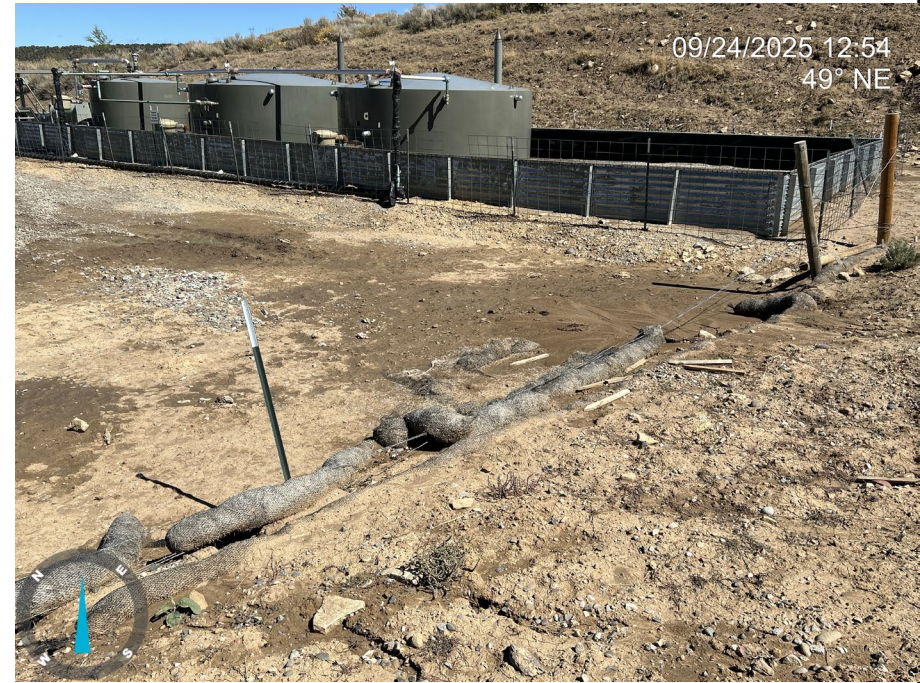
Photo 3: Photos showing straw wattles throughout the location are in disrepair. Maintain or implement stormwater BMPs.

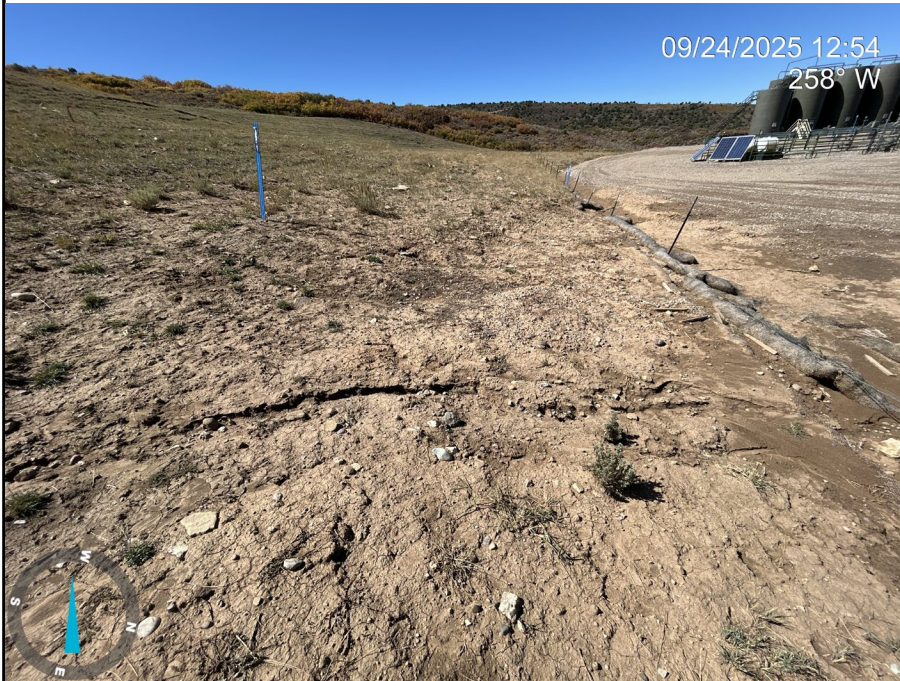
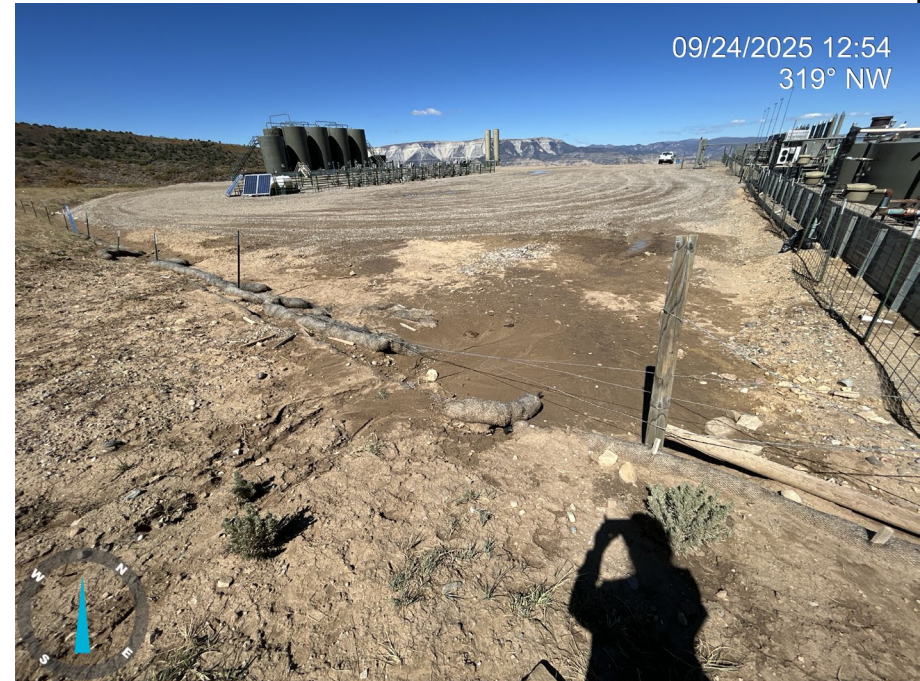
Photo 4: Photos showing erosion and sediment transportation at the XX portion of the location. Stormwater controls appear to be missing or insufficient; comply with 1002.f. and implement or maintain stormwater BMPs.

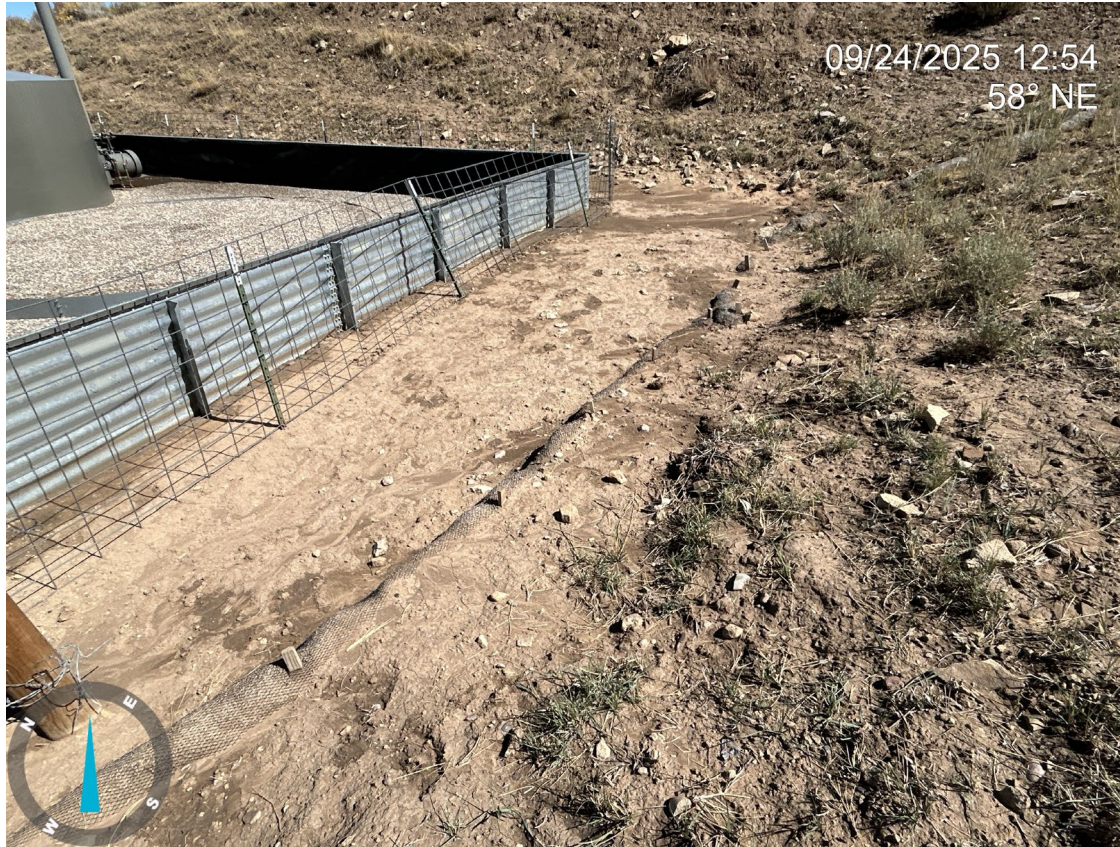
Photo 5: Photos showing sediment is overtopping wattles near and around production equipment. Stormwater BMPs are missing or insufficient. Comply with 1002.f.

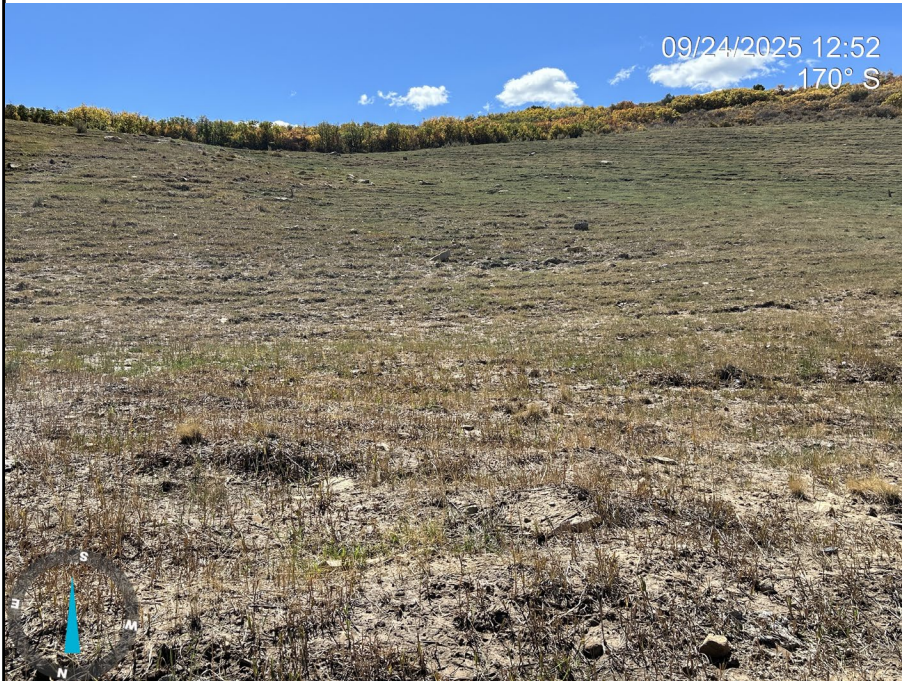
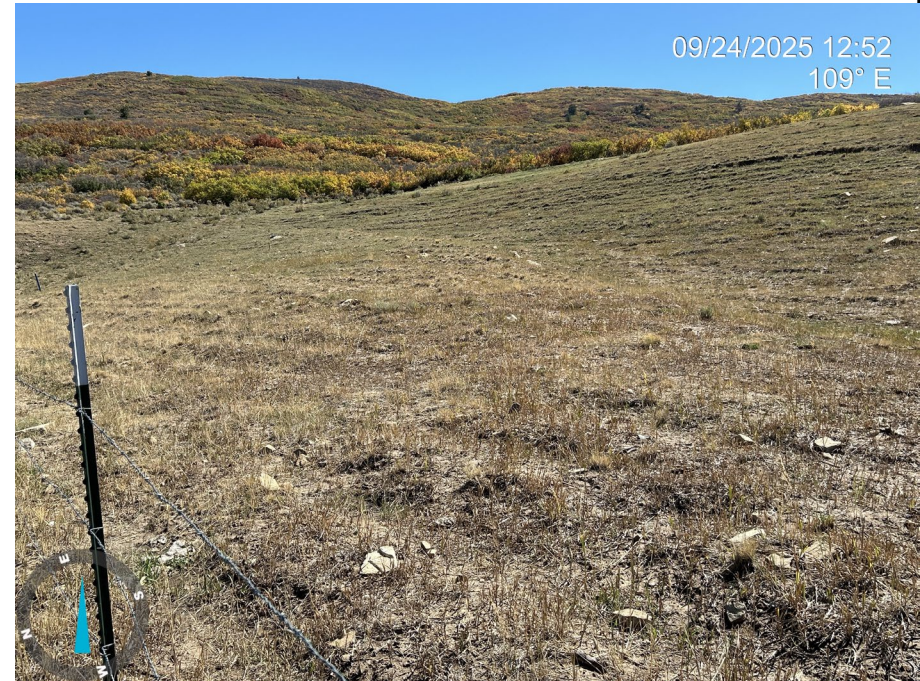
Photo 6: Photos showing an overview of the southern interim areas. Interim areas are composed of smooth brome with trace amounts of big sagebrush. Interim areas are progressing towards 1003 reclamation requirements.
