Inspection Photos

Operator: QB ENERGY OPERATING LLC

Location ID: 416051

Inspection Doc: 718100894

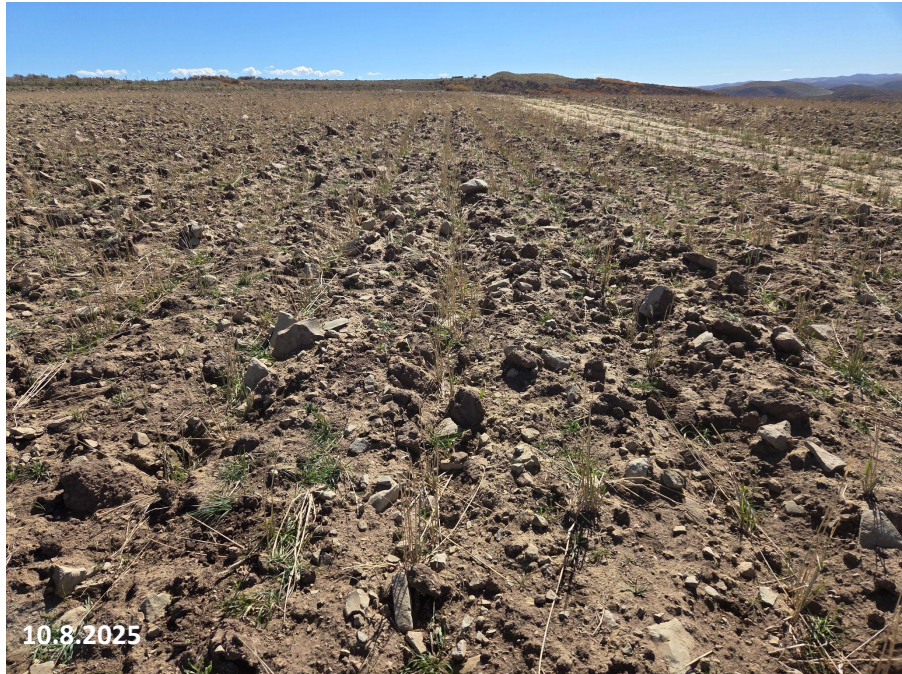
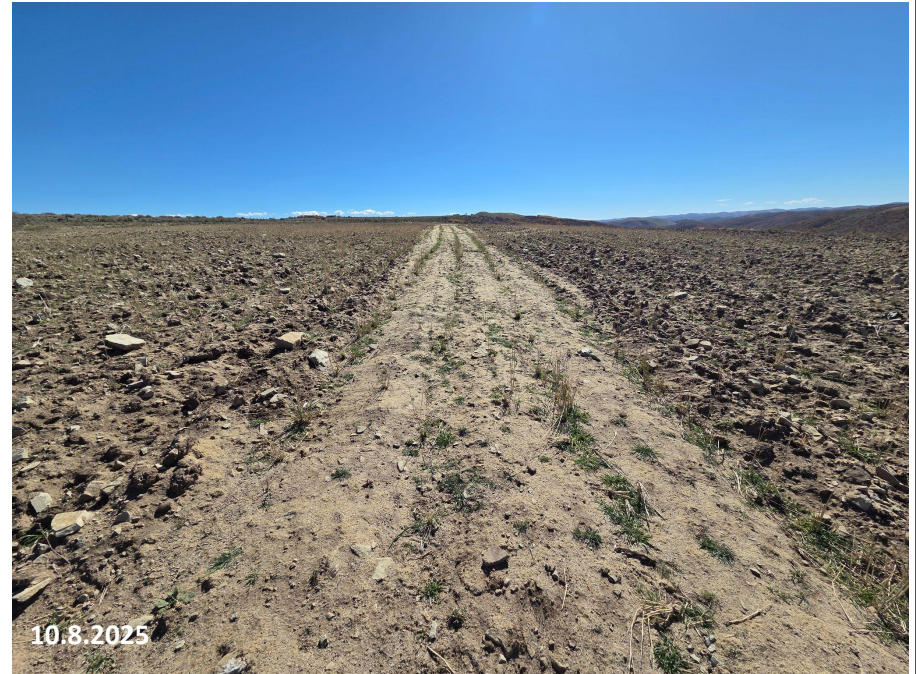
Photo 1: Photos taken from the central areas of the Location, facing south. Photos provide an overview of the Location. Photos also show that compaction alleviation has not been performed in accordance with Rules 1004.a and 1003.c (cross-ripping to a depth of 18 inches). Operator has only ripped in one direction. A compaction test was performed between the furrows of where the rippers traveled, and a zone of compaction was observed at a depth of ~4-6 inches.

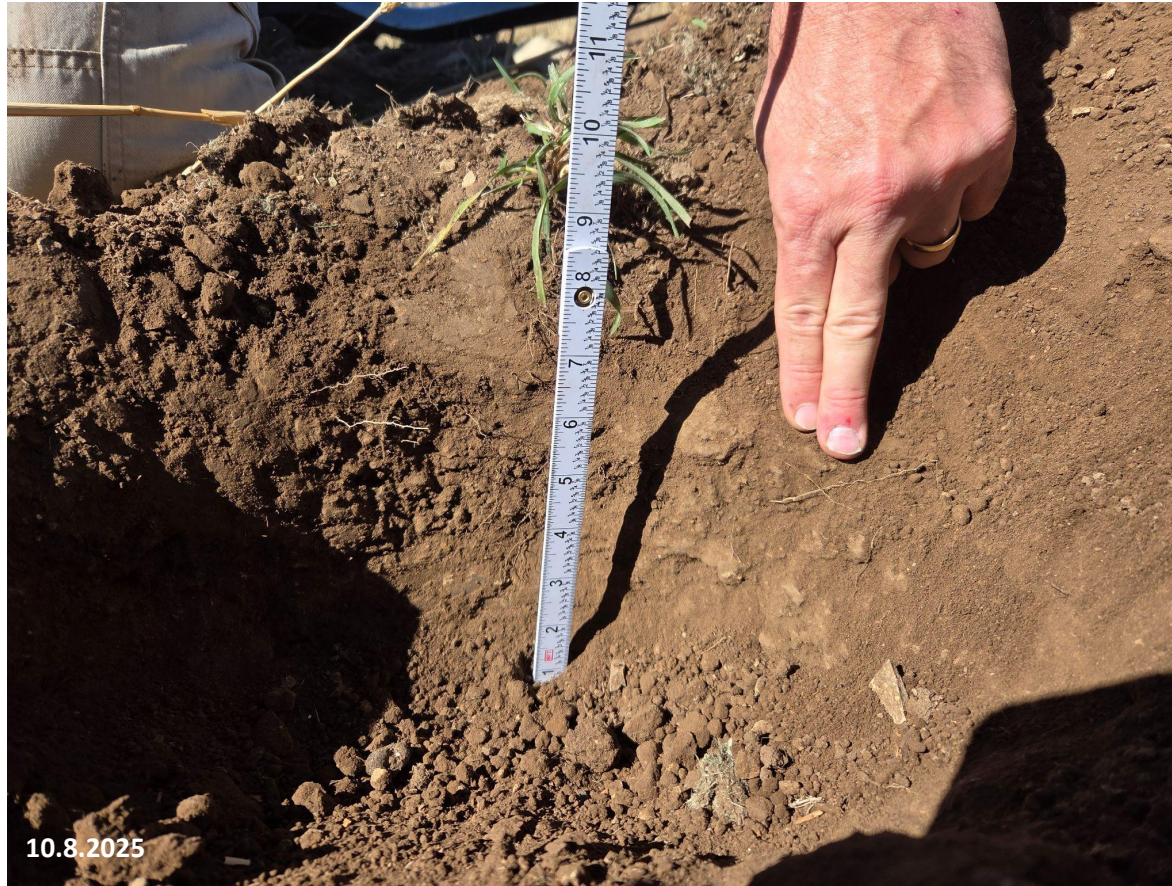
Photo 2: Continued from photo 1. Photo shows compaction at ~4-6 inches subsurface, between the furrows of where the rippers traveled. Location has not been cross-ripped in accordance with Rules 1004.a and 1003.c

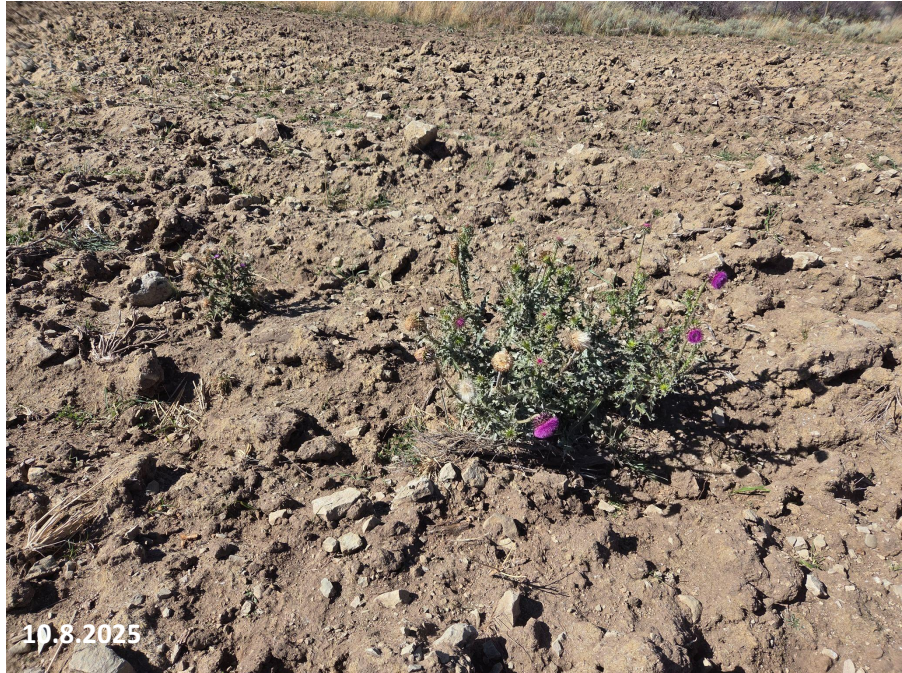
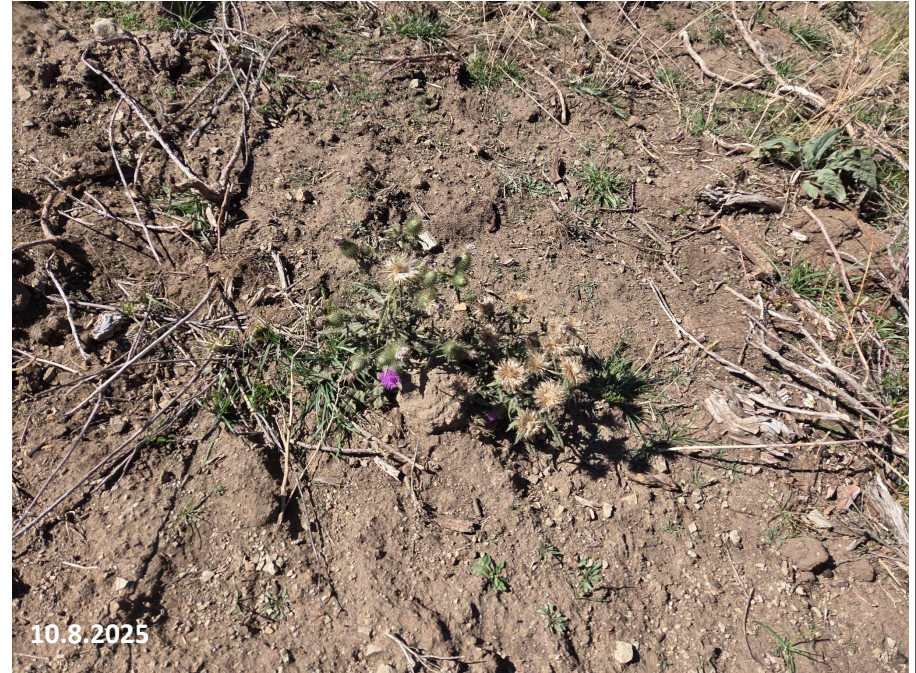
Photo 3: Photos taken from the north and northwest end of the Location. Photos examples showing noxious weed observed establishing.
