# Inspection Photos

**Operator:** QB ENERGY OPERATING LLC

**Location ID:** 335594

**Inspection Doc:** 718100896

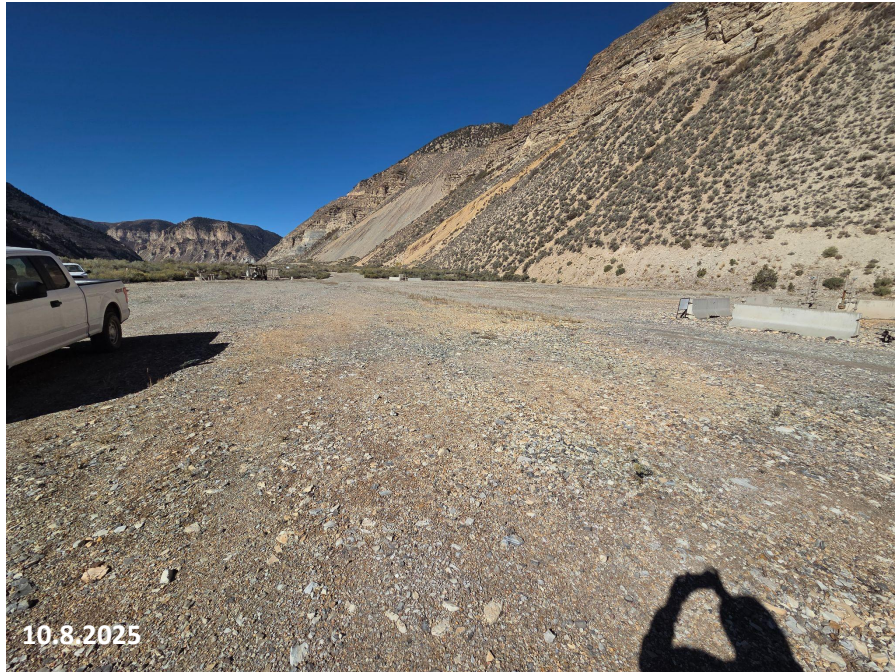
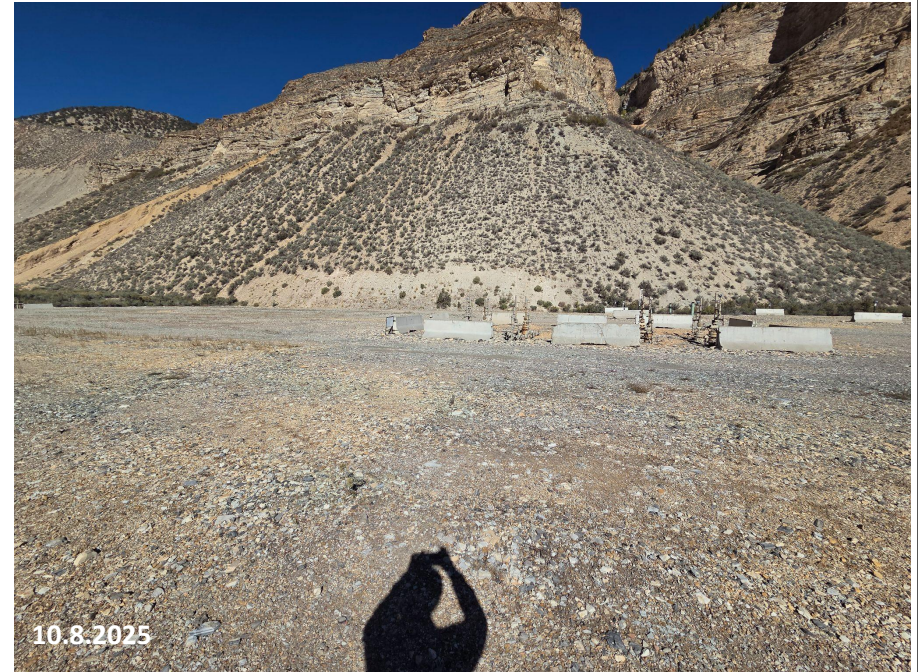
**Photo 1:** Photos taken from the south end of the Location. Photos provide an overview from west, northwest, northeast to east.

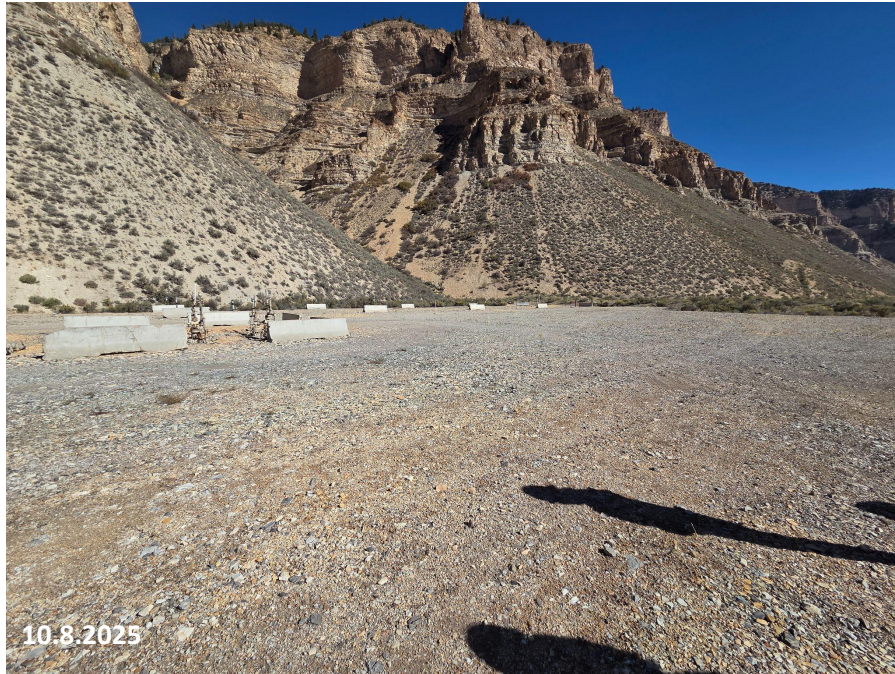
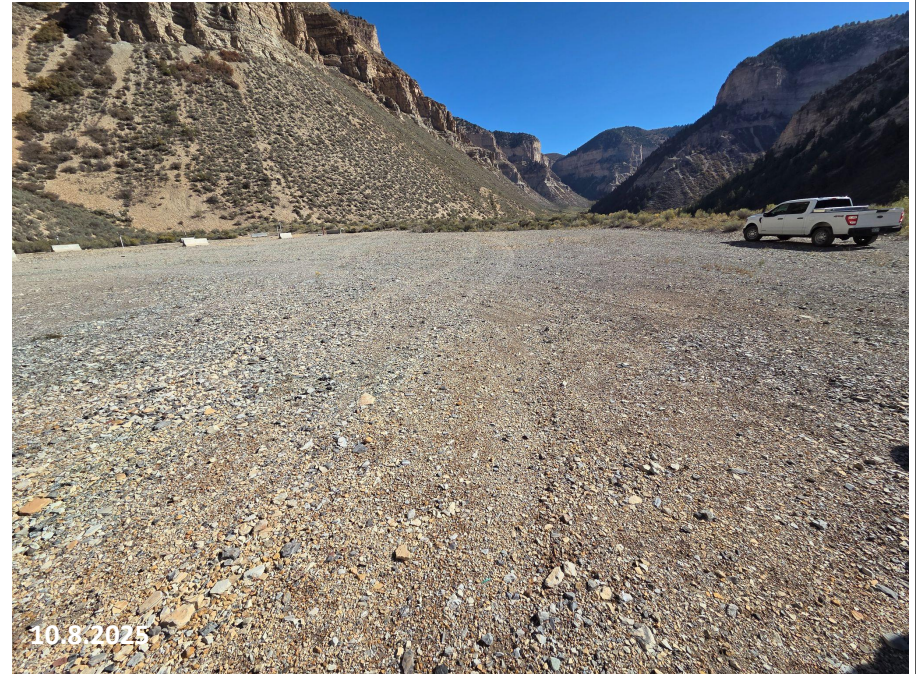
**Photo 2:** See comments under photo 1.

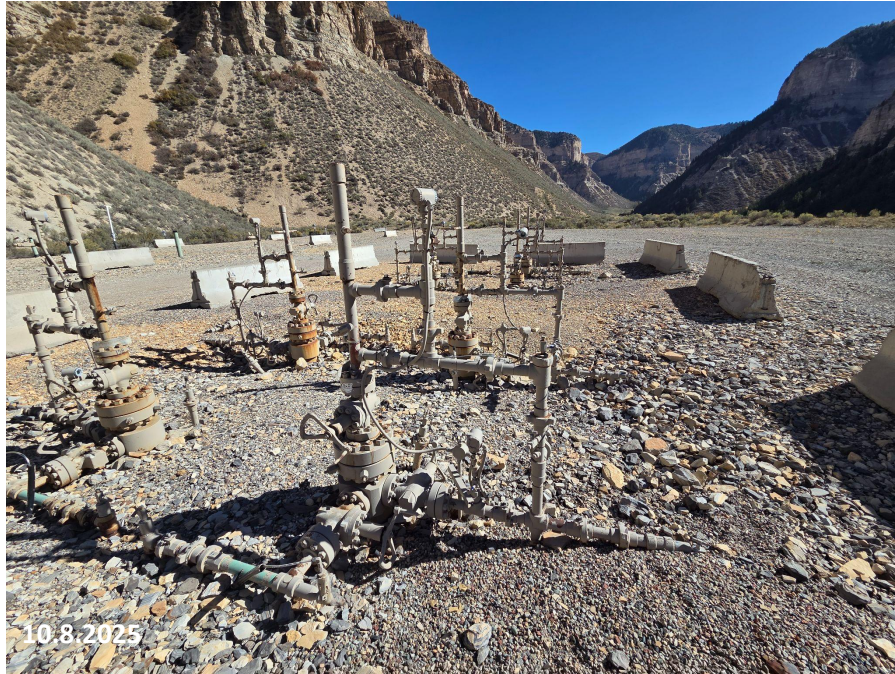
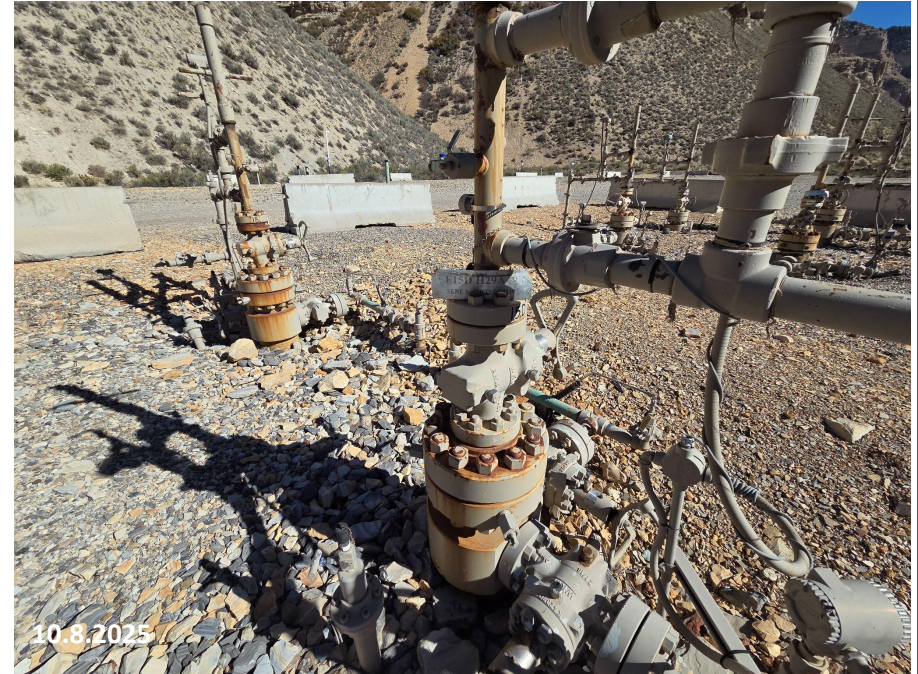
**Photo 3:** Photos taken from the wells. Signage pursuant to Rule 605.d has not been posted at the wellheads.

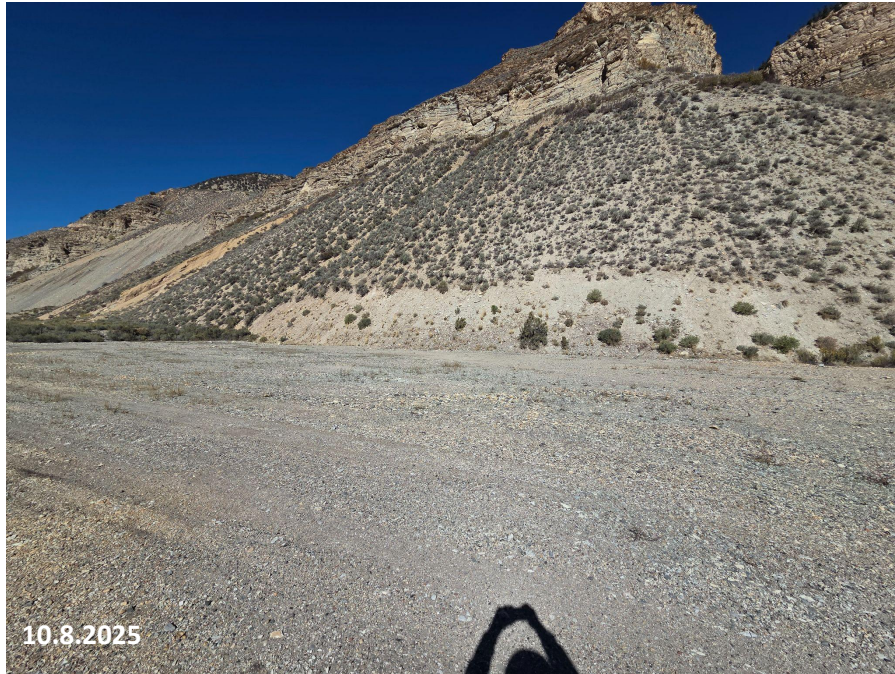
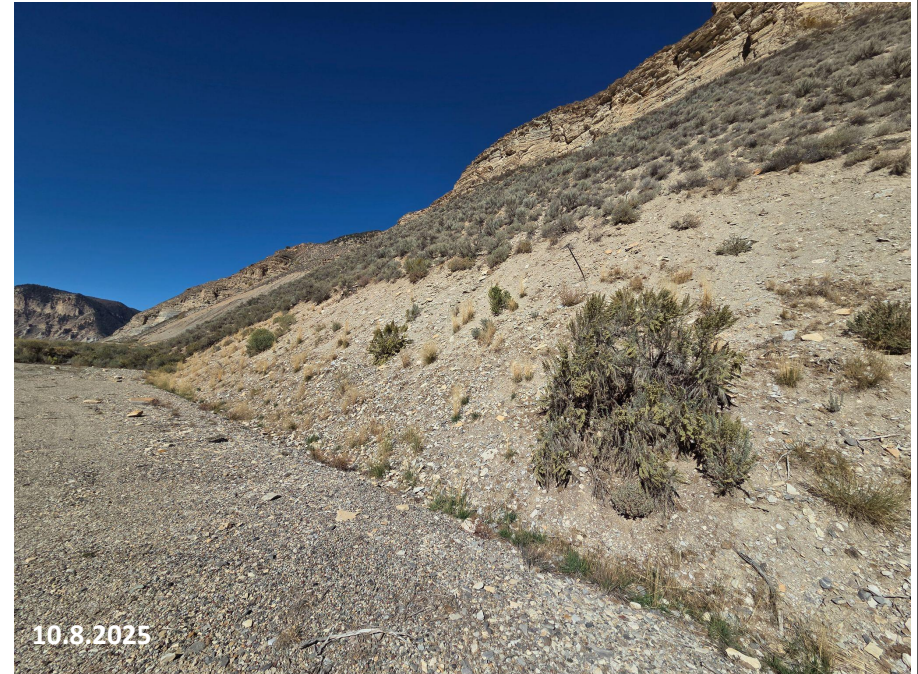
**Photo 4:** Photos taken from the northwest end of the Location, facing north and northwest respectively. BMPs to minimize erosion, degradation and to stabilize the slopes are missing or insufficient.

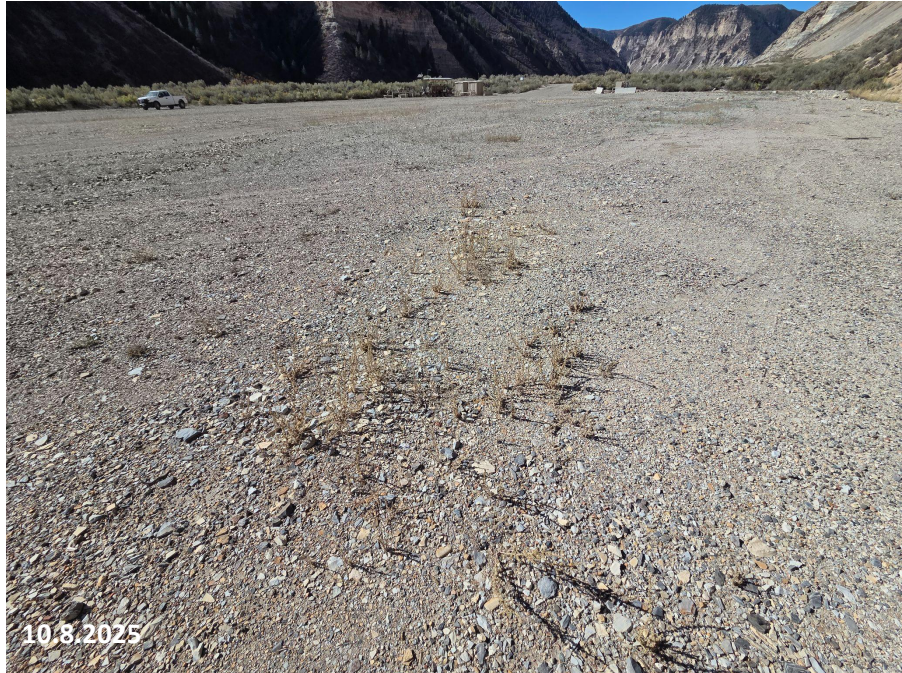
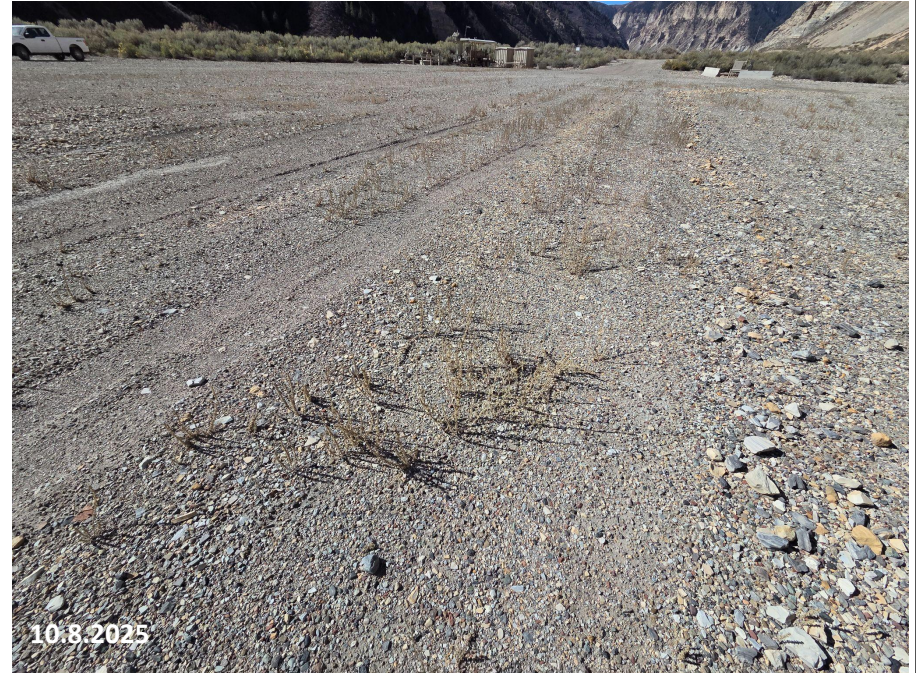
**Photo 5:** Photos examples showing halogeton establishment (brown colored vegetation within photos) on the working pad surface.
