Inspection Photos

Operator: QB ENERGY OPERATING LLC

Location ID: 335822

Inspection Doc: 718100898

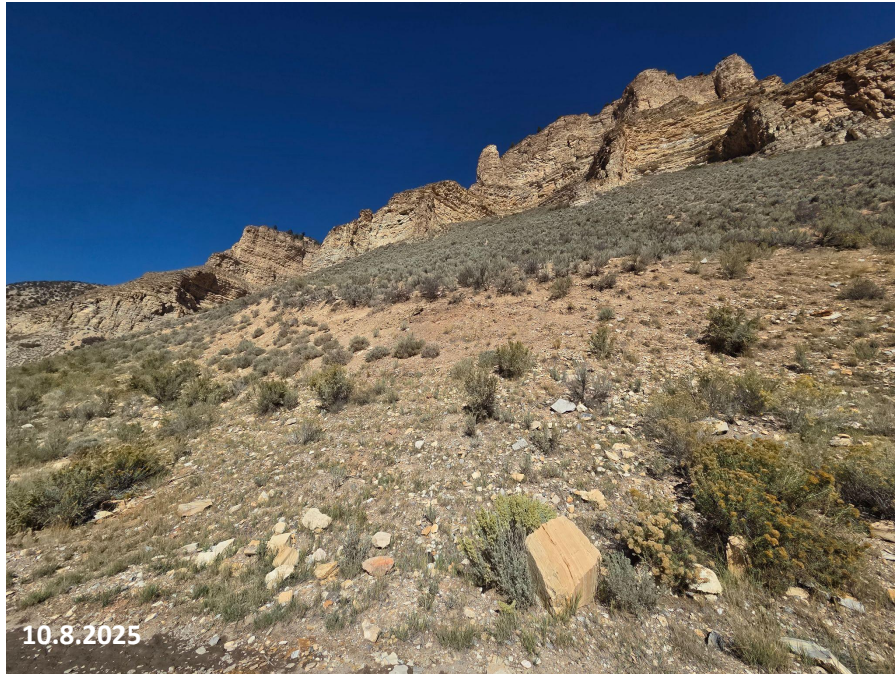
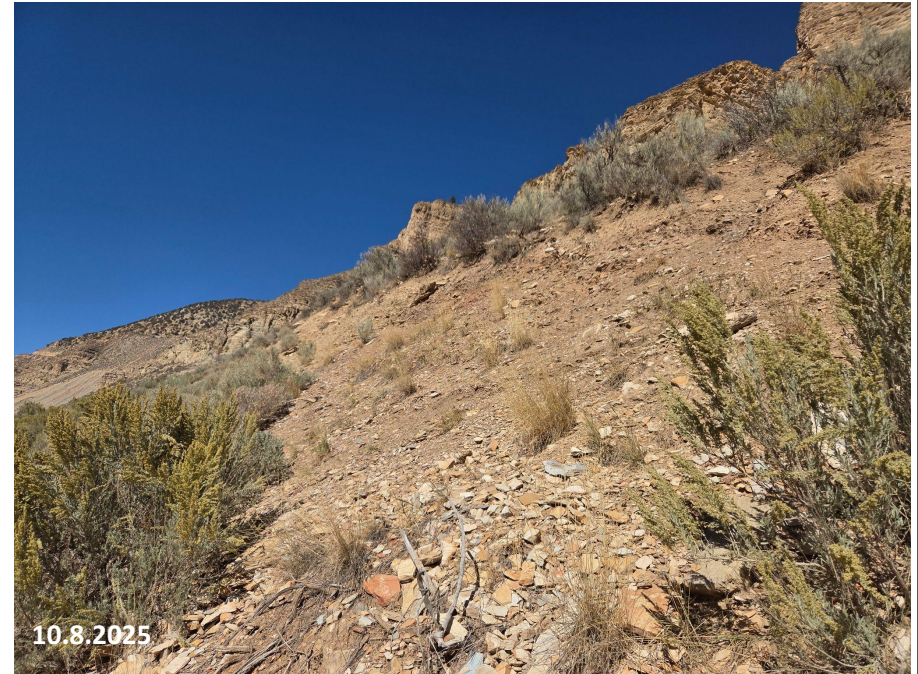
Photo 1: Photos taken from the interim areas on the northwest end of the Location. Though hydromulch previously applied is not longer functioning, desirable perennial vegetative establishment is evident. However additional seeding efforts may be necessary for uniform establishment to be achieved.

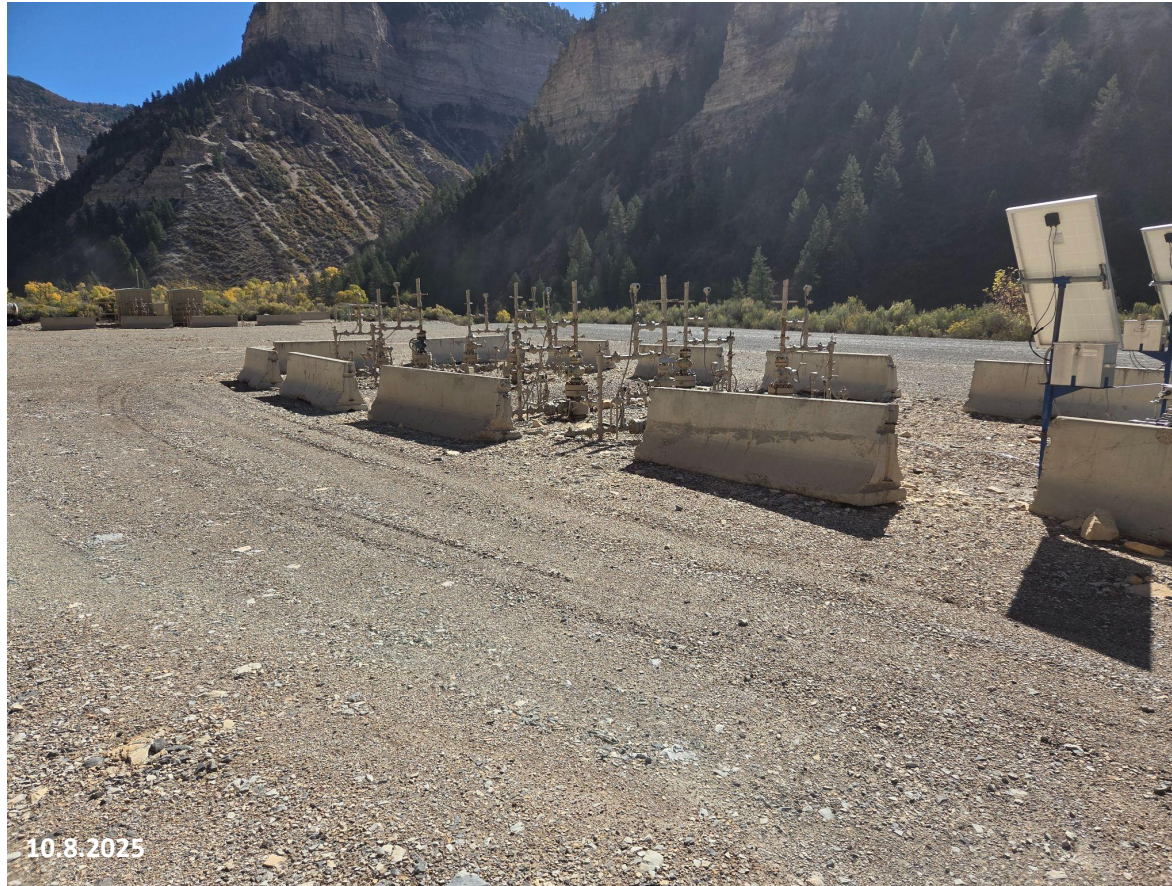
Photo 2: Photos taken from the wells. Signage pursuant to Rule 605.d has not been posted at the wellheads.
