# Inspection Photos

**Operator:** QB ENERGY OPERATING LLC

**Location ID:** 487650

**Inspection Doc:** 718100900

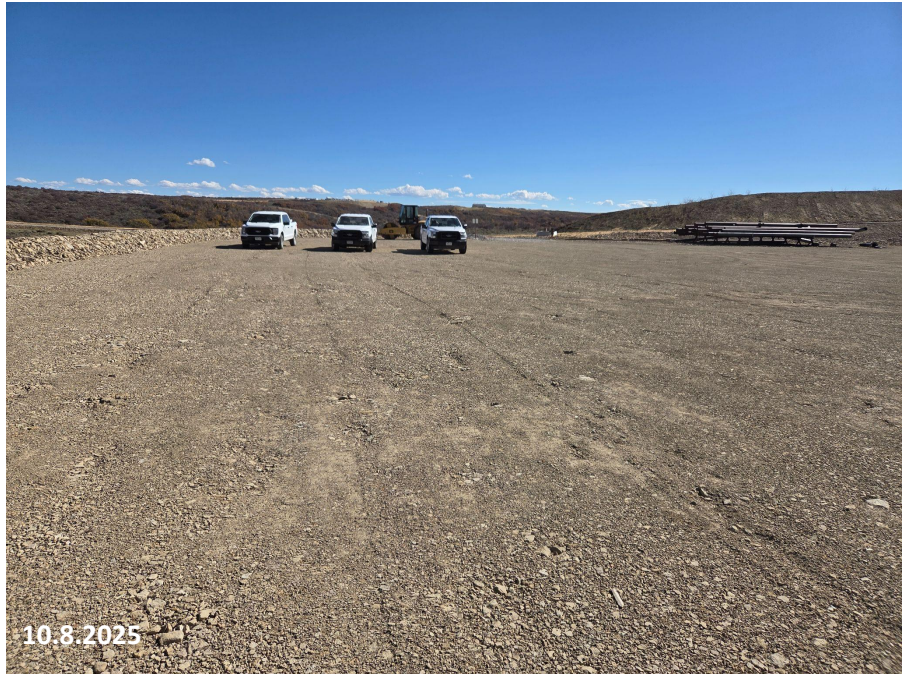
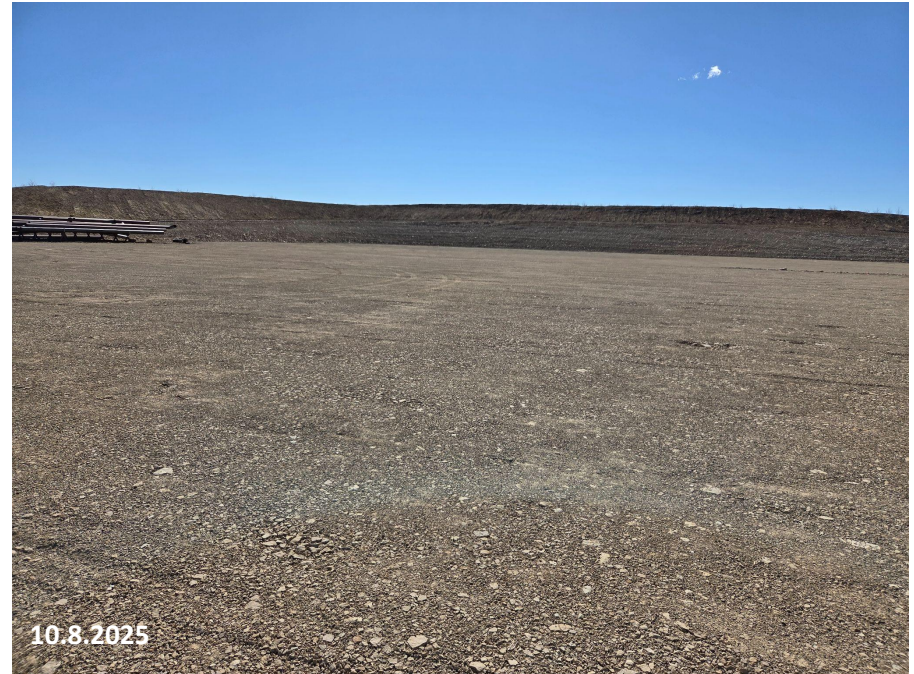
**Photo 1:** Photos 1-2 taken from the northeast end of the working pad surface. Photos provide an overview from southeast, south, west to northwest.

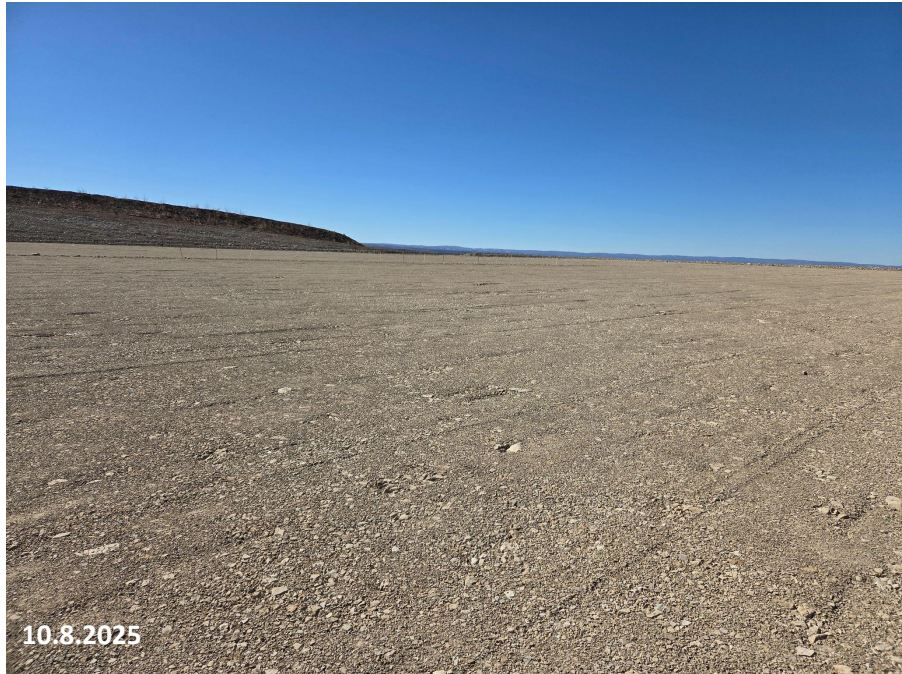
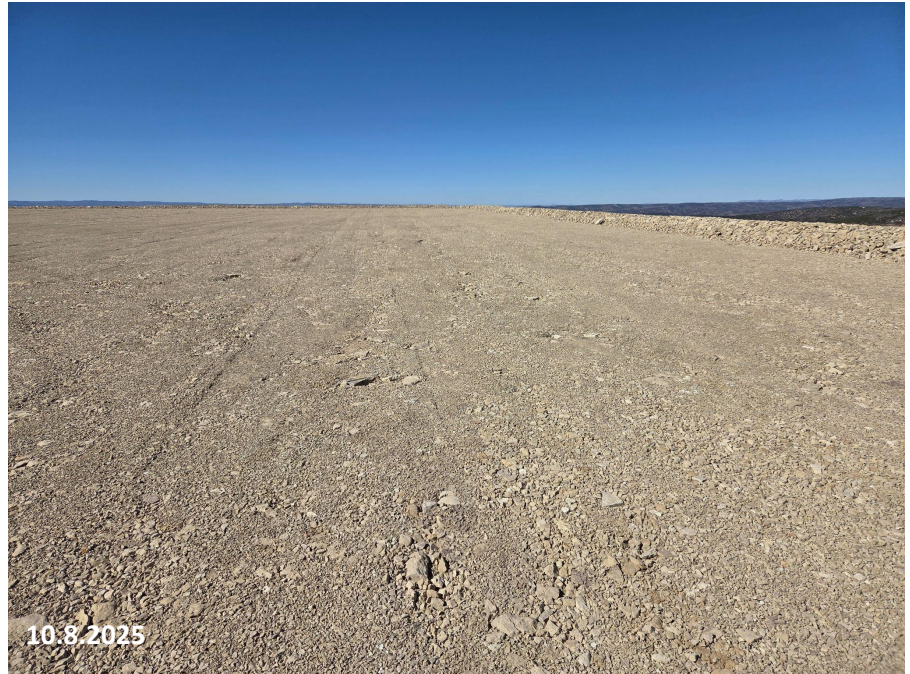
**Photo 2:** See comments under photo 1.

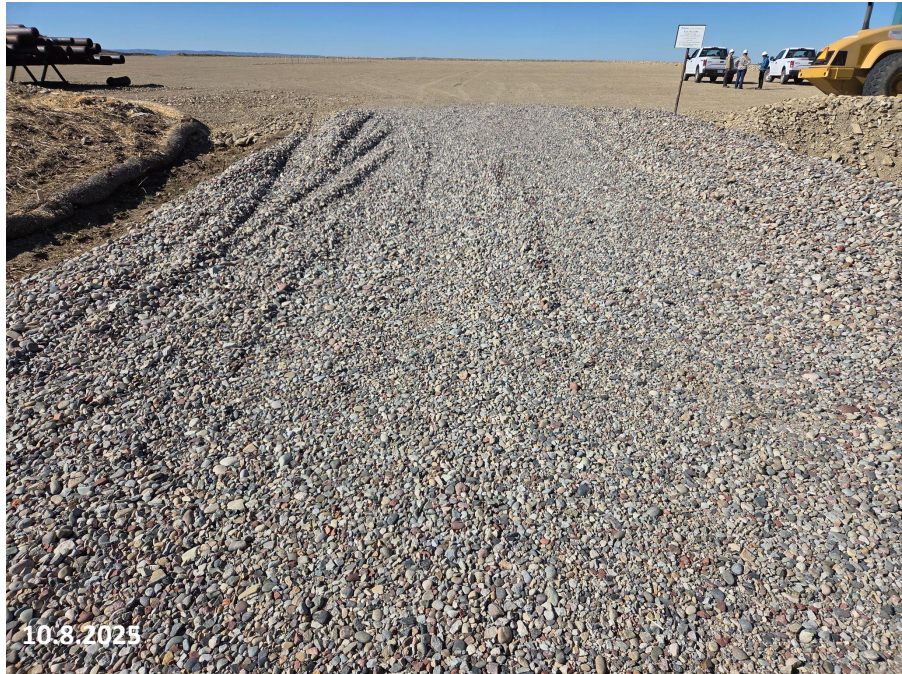
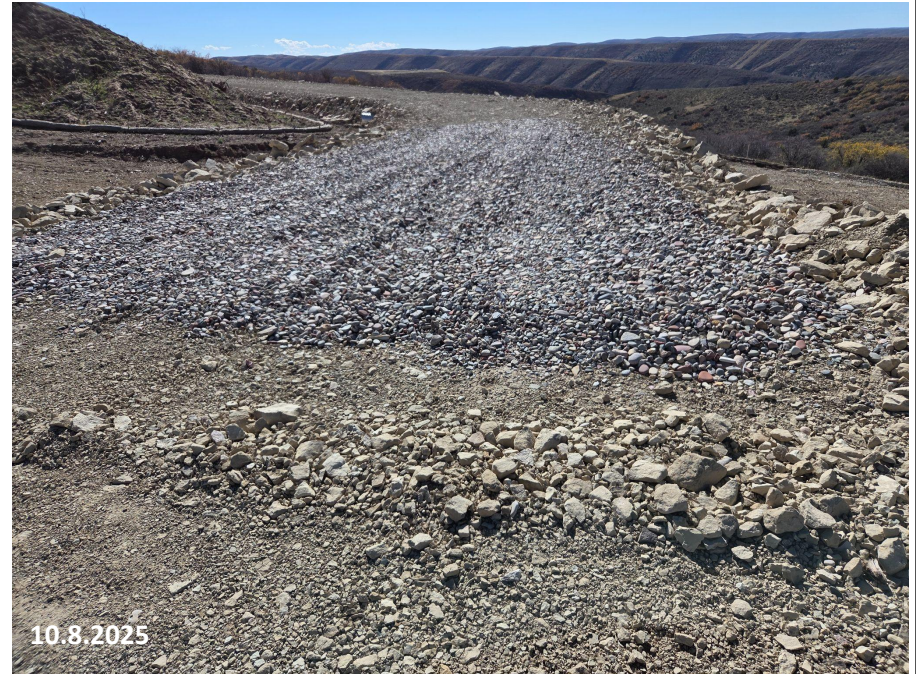
**Photo 3:** Photos taken from the location entrances on the south and west ends of the Location. Photos show a VTC per good engineering practices have not been installed. Operator has placed smooth and small gravel material at the entrances, rather than coarse aggregate. “Tracking Pad” as installed is inadequate.

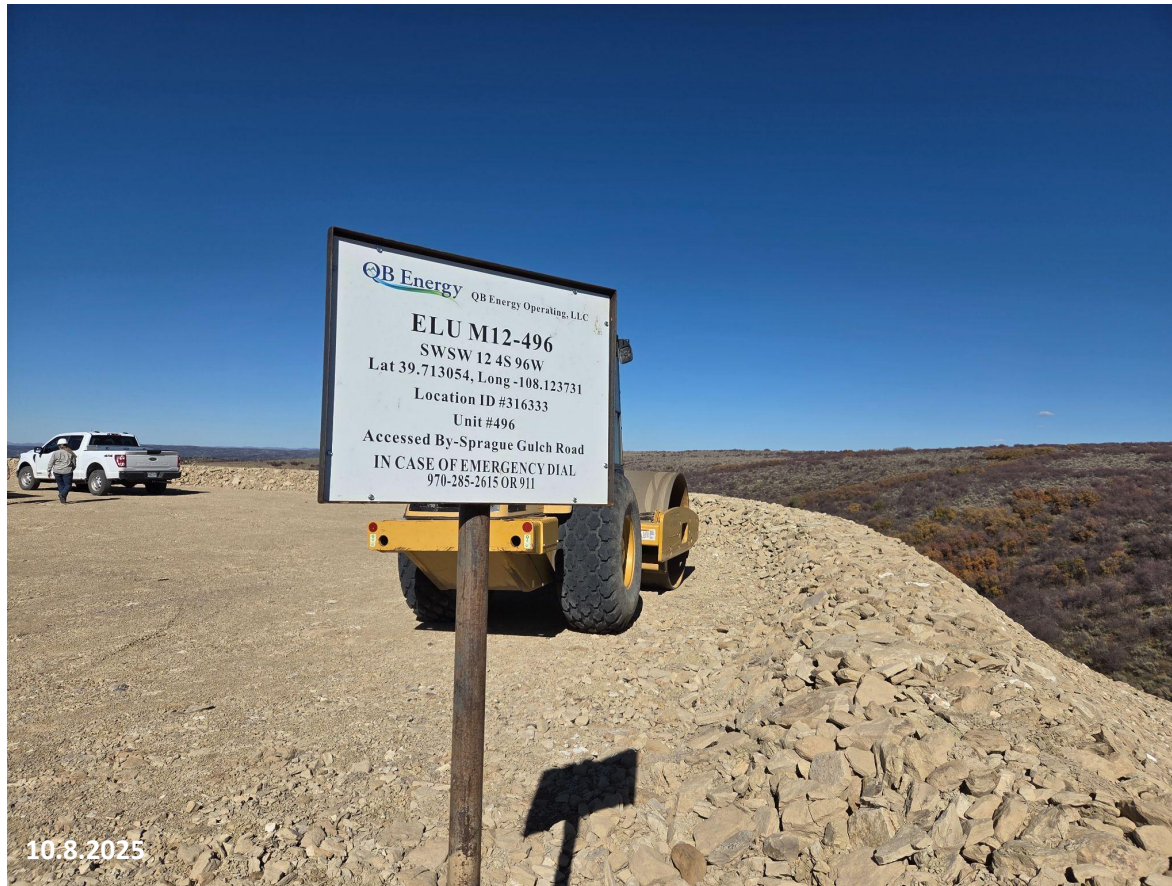
**Photo 4:** Photos shows signage placed at location entrance.
