Inspection Photos

Operator: TEP ROCKY MOUNTAIN LLC #96850

Location ID: 311663

Inspection Doc: 718100902

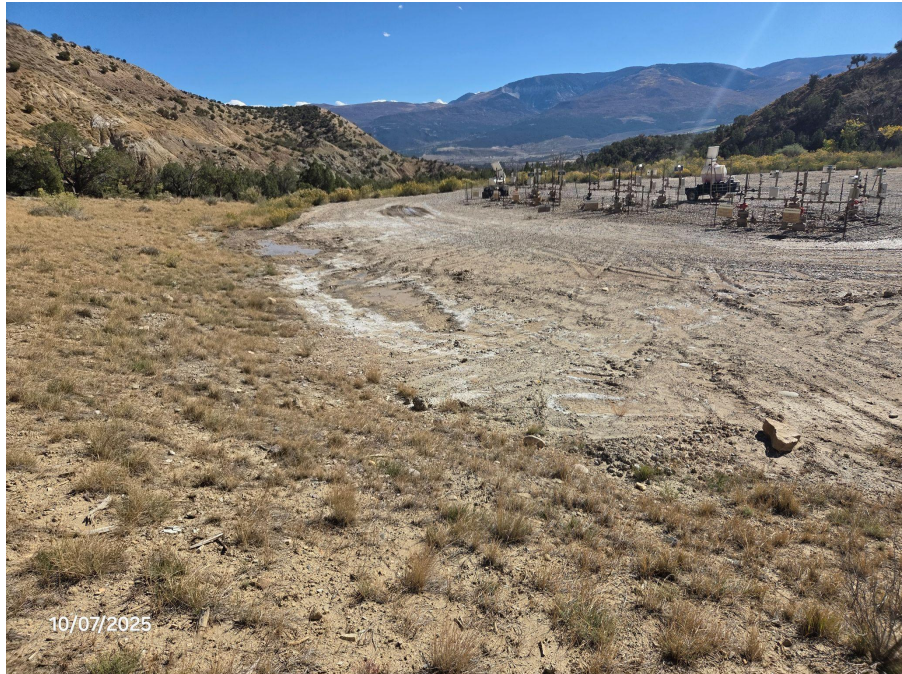
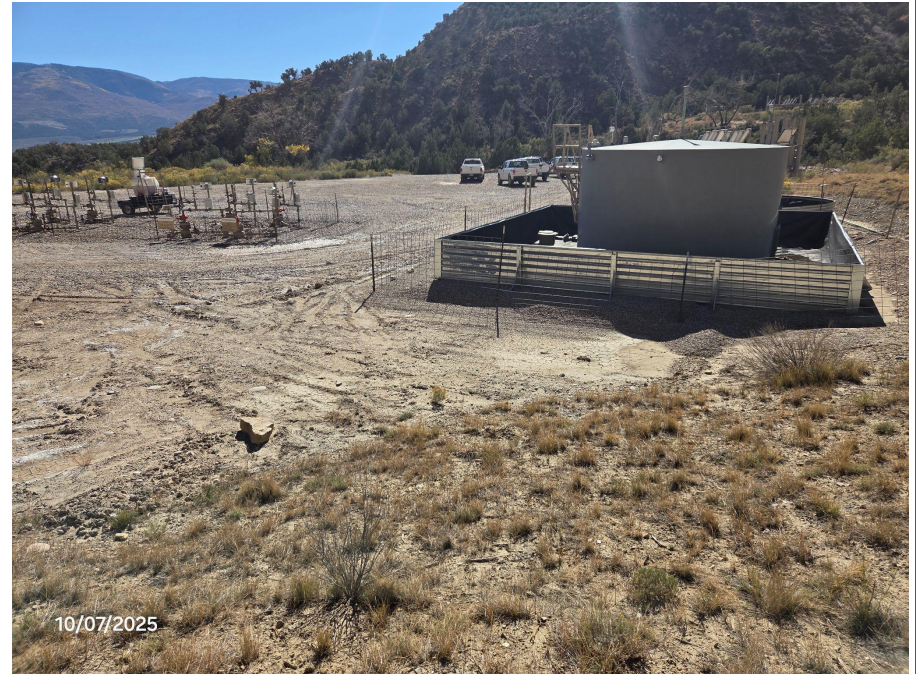
Photo 1: Photos taken from the interim areas on the north end of the Location, facing southeast and south. Photos provide an overview of the Location.

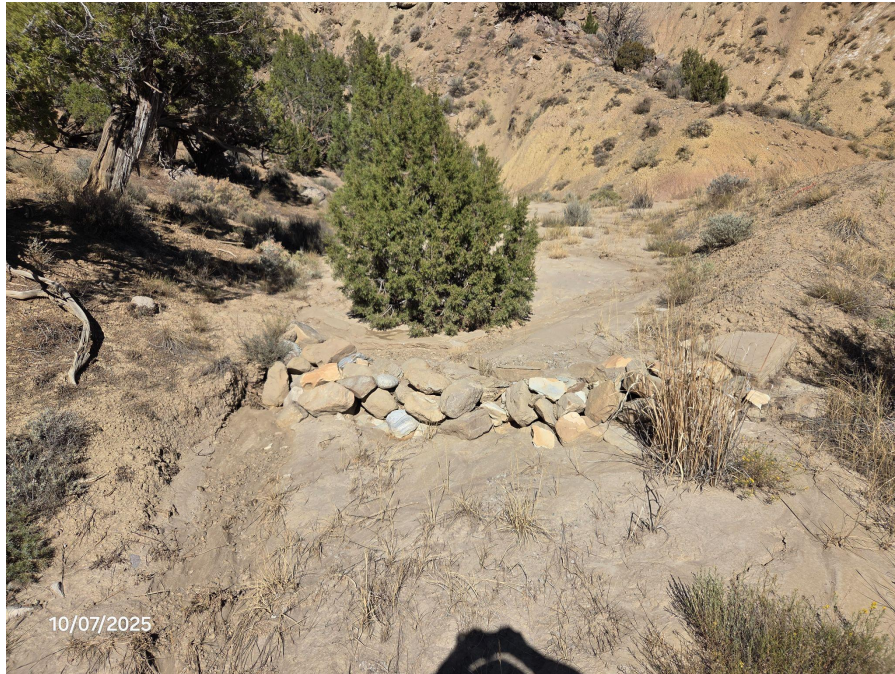
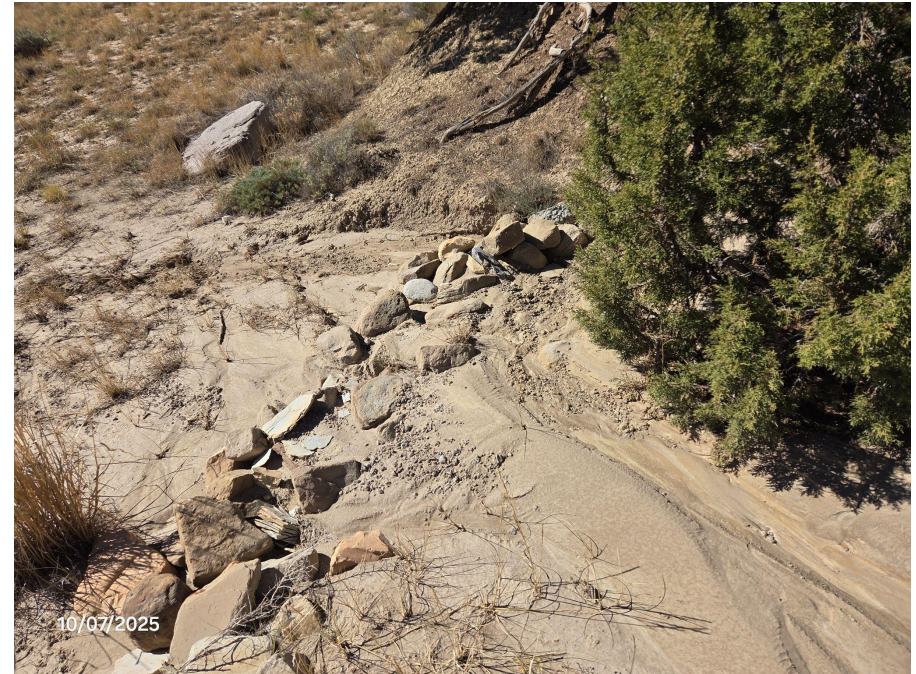
Photo 2: Photos taken from the stormwater diversion ditch within the north end of the Location. BMPs (Rip-rap, check dams) have filled with sediment and/or are no longer in proper functioning condition.

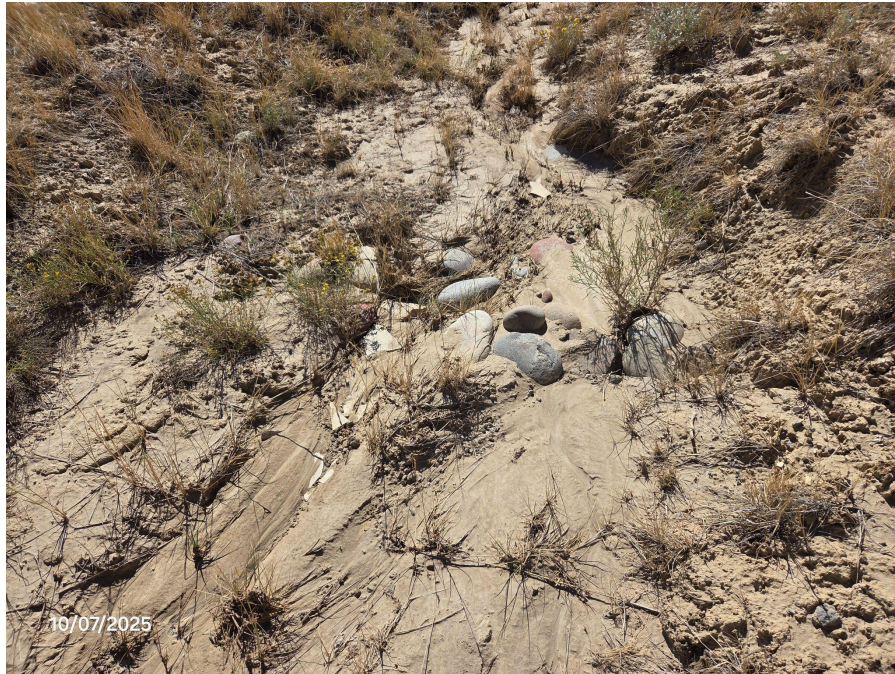
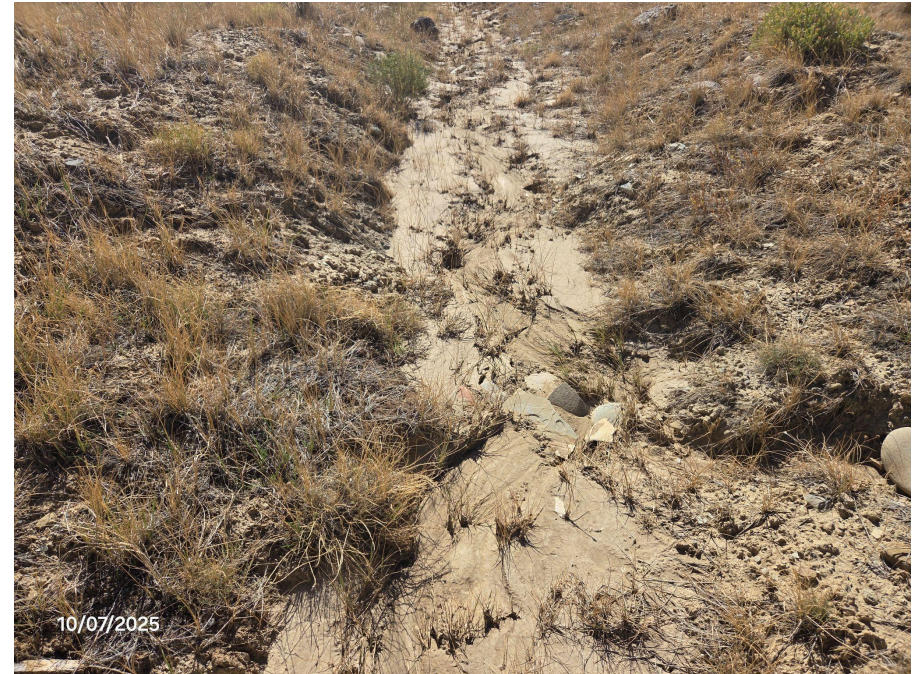
Photo 3: See comments under photo 2.

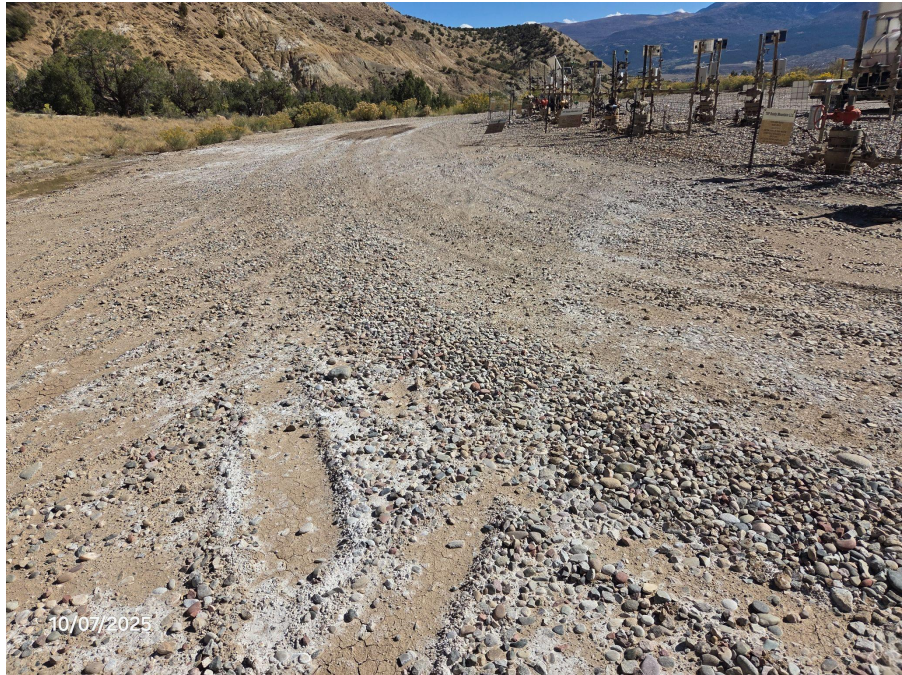
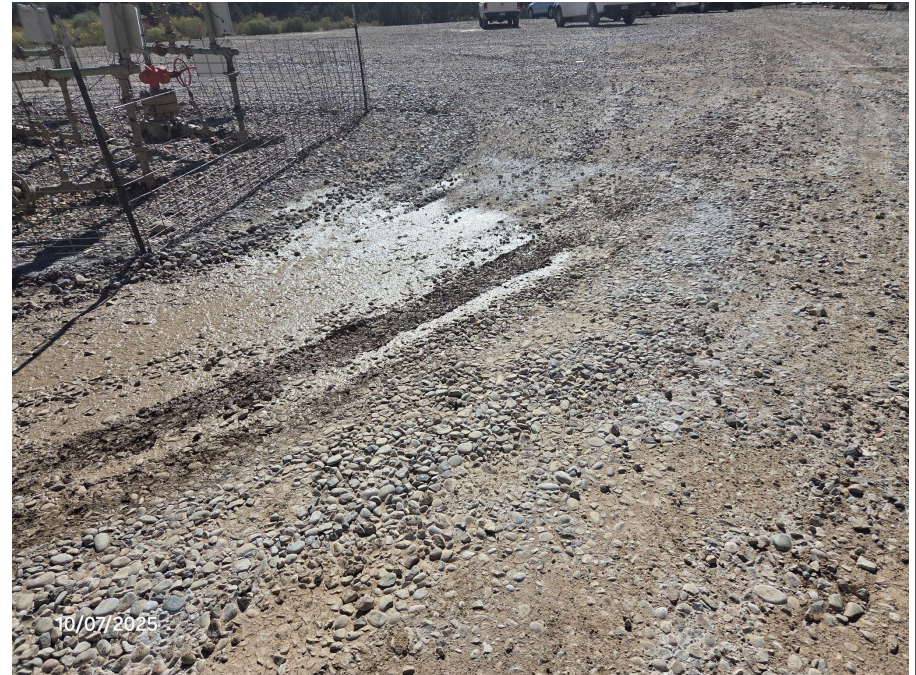
Photo 4: BMPs to stabilize the working pad surface, as well as to minimize vehicle erosion, degradation and sediment transport show sign of disrepair. Maintenance advised.
